SUMMARY REPORT
OF THE EXISTING
STRUCTURAL
CONDITION SURVEYS

Forest City Ratner Companies
One Metrotech Center North
11th Floor
Brooklyn, NY 11201

LZA TECHNOLOGY
641 Avenue of the Americas
New York, NY 10011
917-661-7800

November 07, 2005

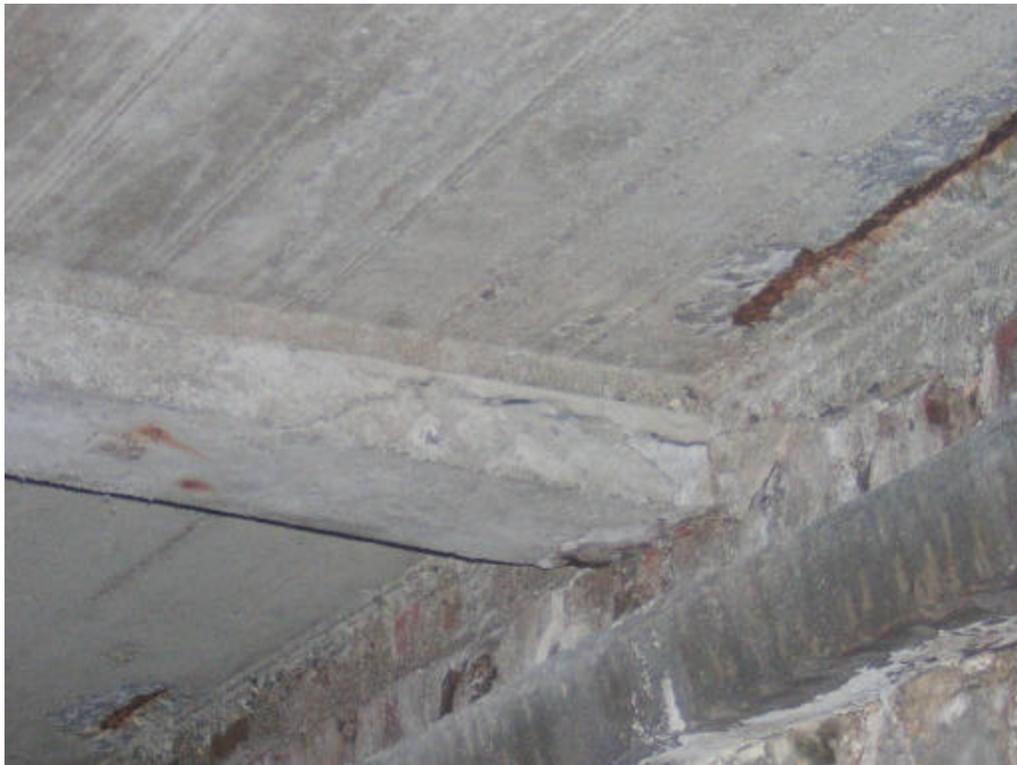
**Photo No. 01 – Concrete Vault Beam Damage Below Sidewalk
of 618 Atlantic Avenue**

In the basement, the undersides of the concrete sidewalk vaults along Atlantic Avenue are visible. There is evidence of significant distress at the ends of the cast-in-place concrete beams supporting the concrete vault slab. The typical evidence of distress observed is cracking at the exterior support point and diagonally cracking and spalling along the span of the concrete beam (Refer to Photo No. 01).

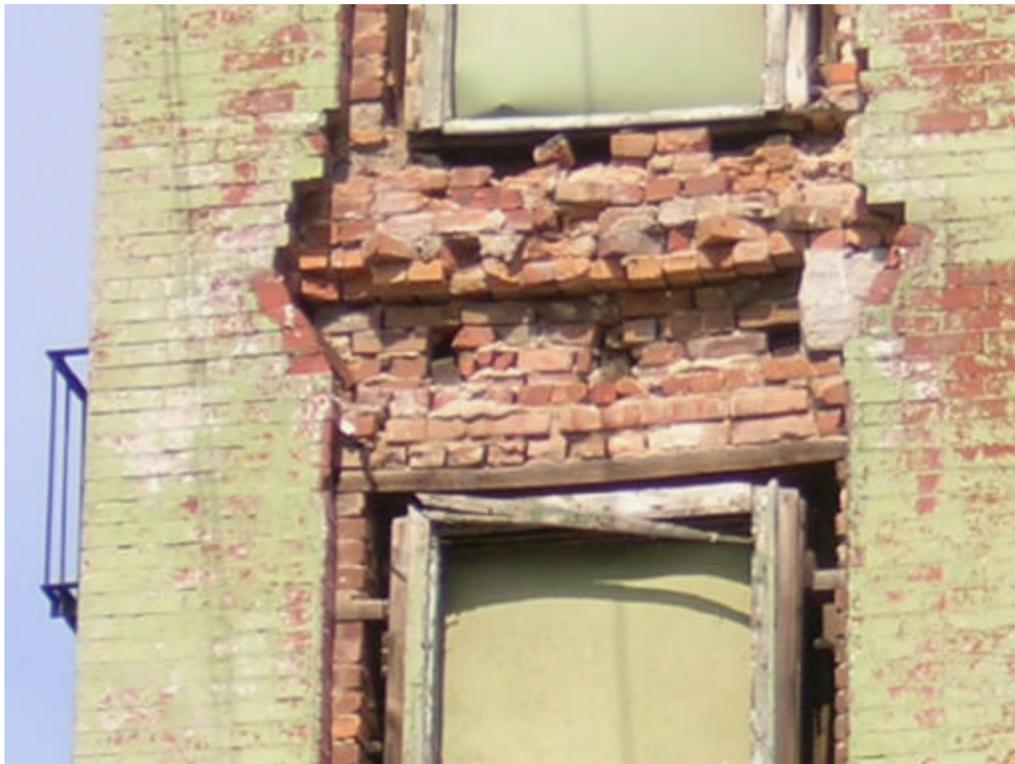
The condition of the southern portion of the East masonry wall of 620 Atlantic Avenue poses a possibility of falling bricks. Since this is a masonry-bearing wall, these conditions if left unchecked will eventually bring about local failure of the masonry-bearing wall and its timber floor system. This is further evidence that a major structural support system of the building is substantially compromised and that the structures are unsafe.

Photo No. 03 – Masonry East Bearing Wall Damage at 3rd & 4th Floors of 620 Atlantic Avenue

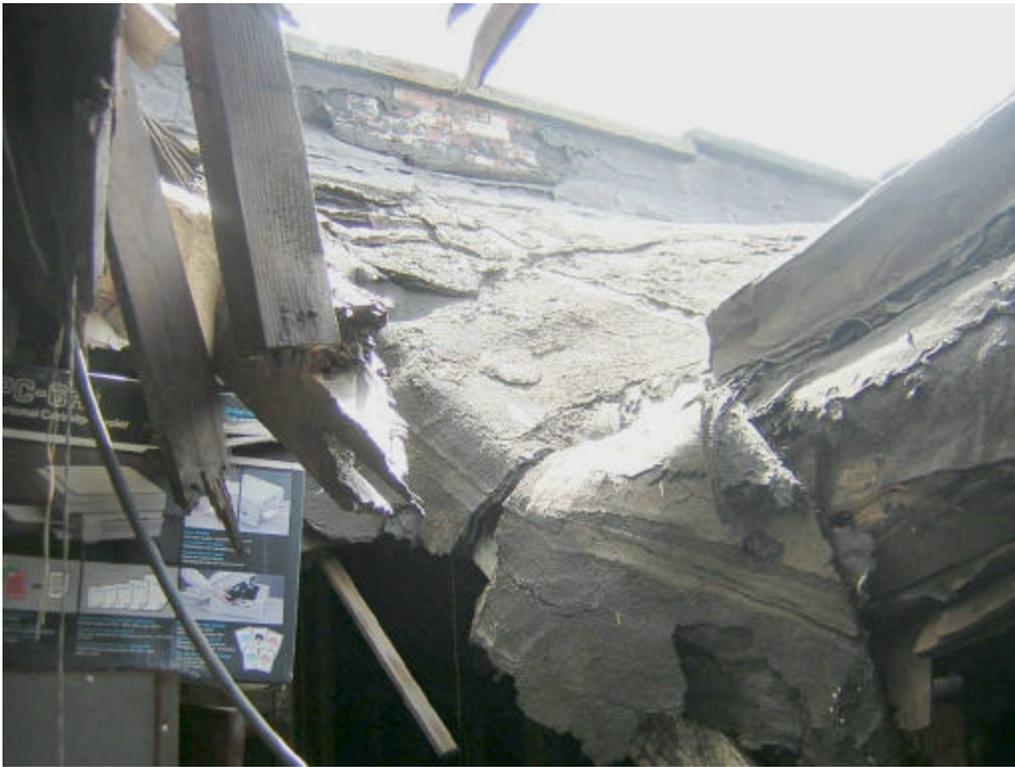
Photo No. 04 – Rear Roof Collapse of 618 Atlantic Avenue

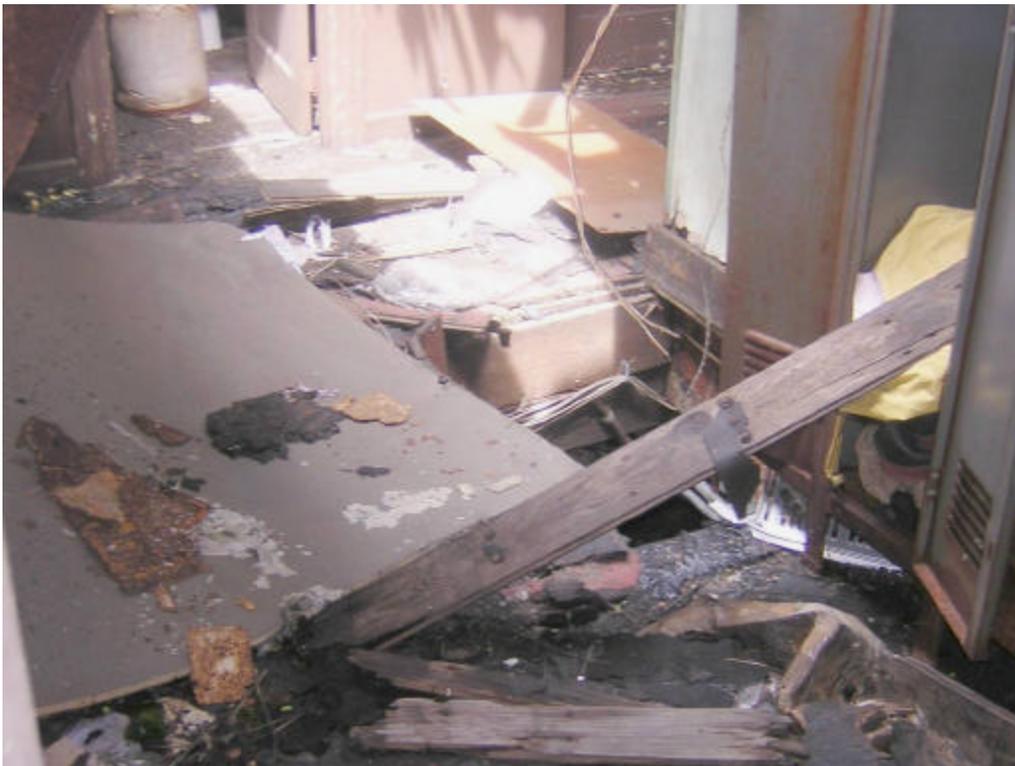
Photo No. 05 – 1st Floor Framing Water Damage of 618 Atlantic Avenue

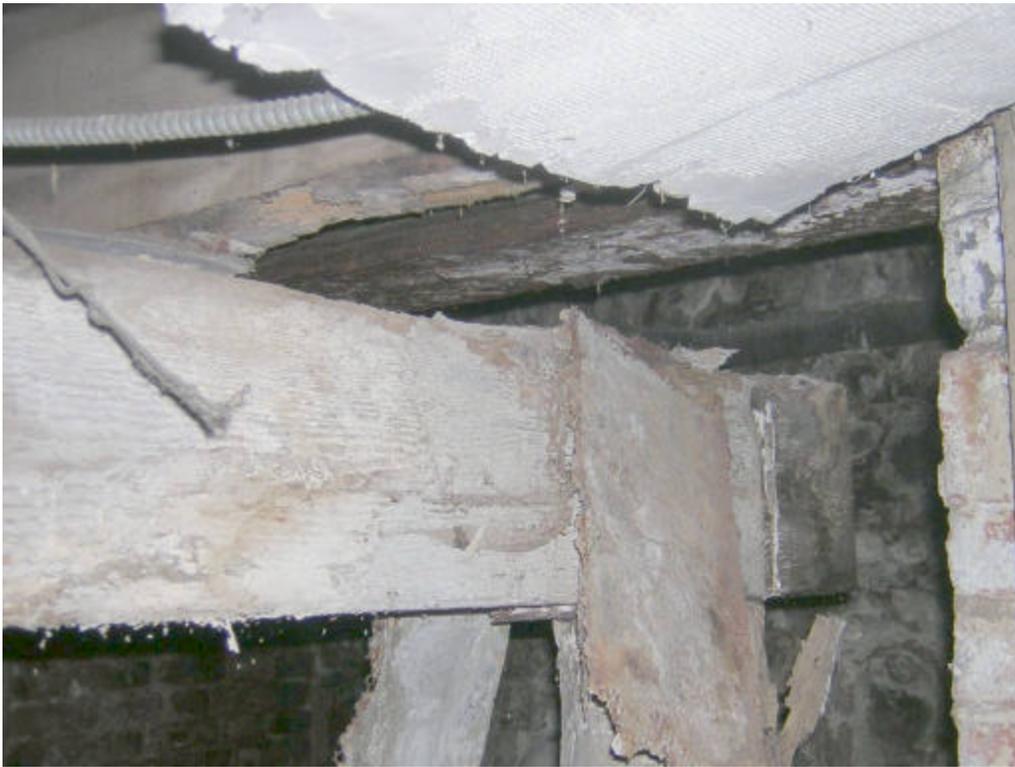
**Photo No. 06 – Timber Column and Girder Support Settlement of
618 Atlantic Avenue**

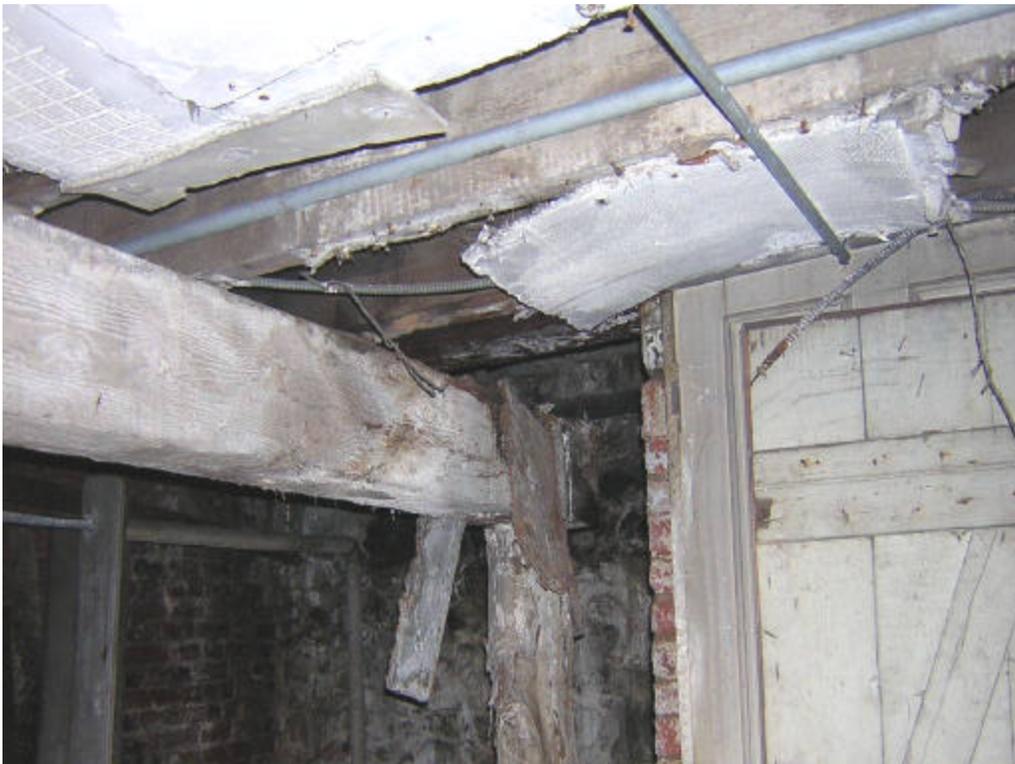
**Photo No. 07 – Further Timber Column and Girder Support Settlement of
618 Atlantic Avenue (Condition on November 01, 2005)**

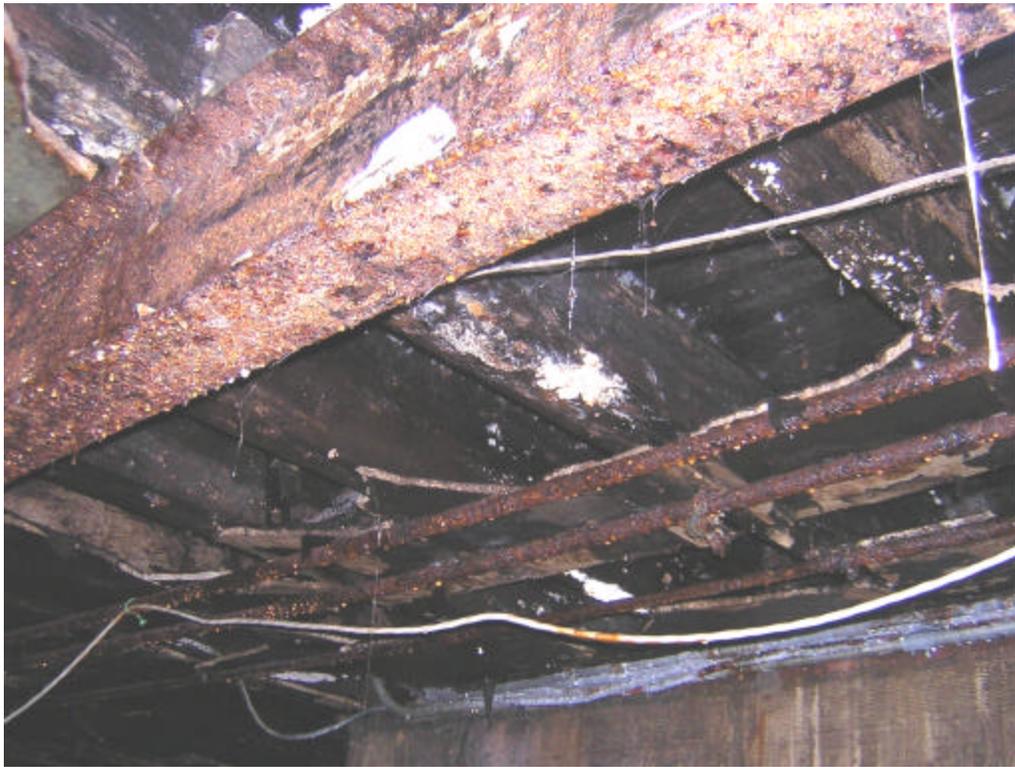
Photo No. 08 – 1st Floor Framing Damage of 616 Atlantic Avenue

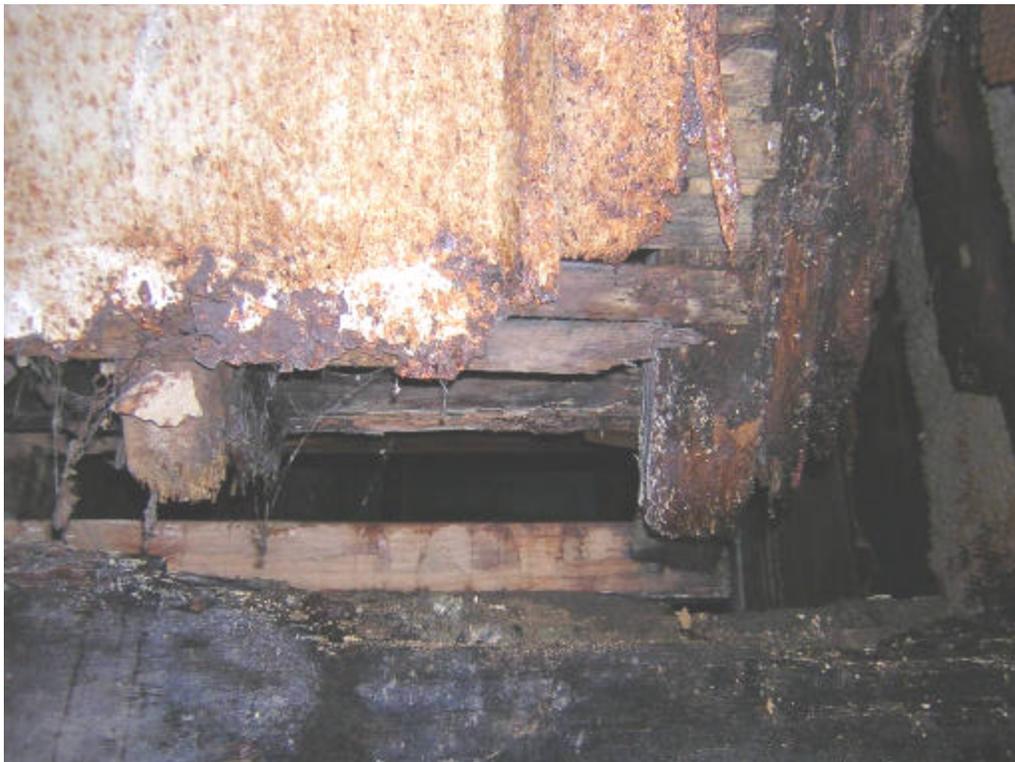
Photo No. 09 – Stair Stringer Support Damage of 616 Atlantic Avenue

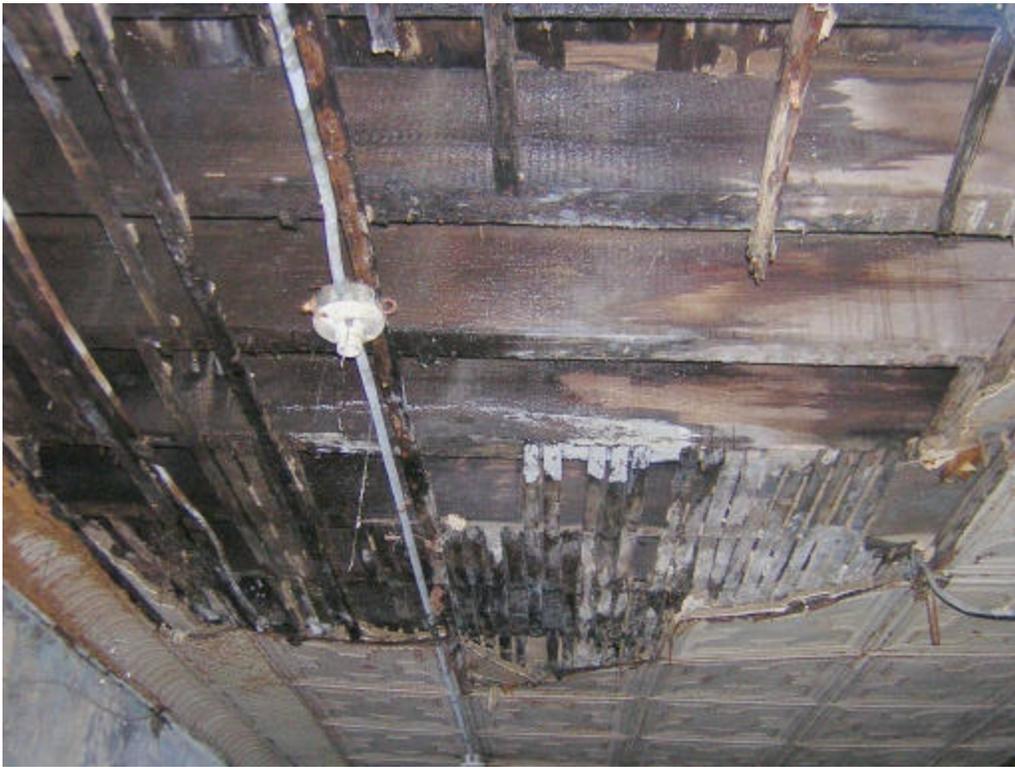
Photo No. 10 – 2nd Floor Framing Damage of 616 Atlantic Avenue

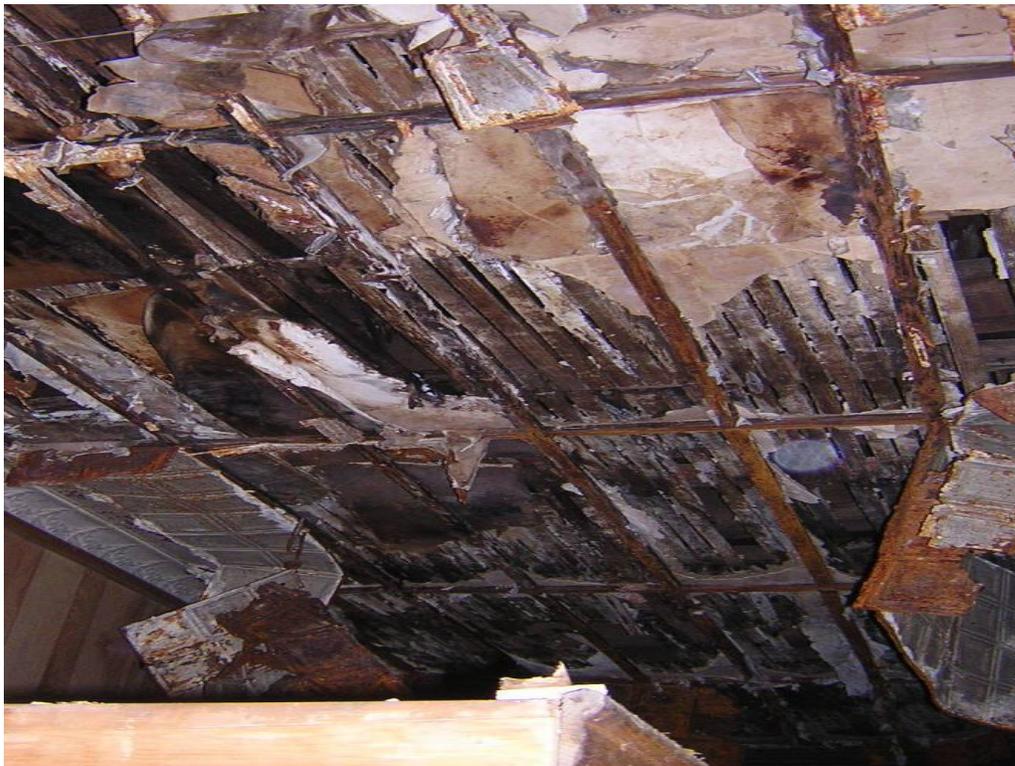
**Photo No. 11 – Further 2nd Floor Framing Damage of 616 Atlantic Avenue
(Condition on November 01, 2005)**

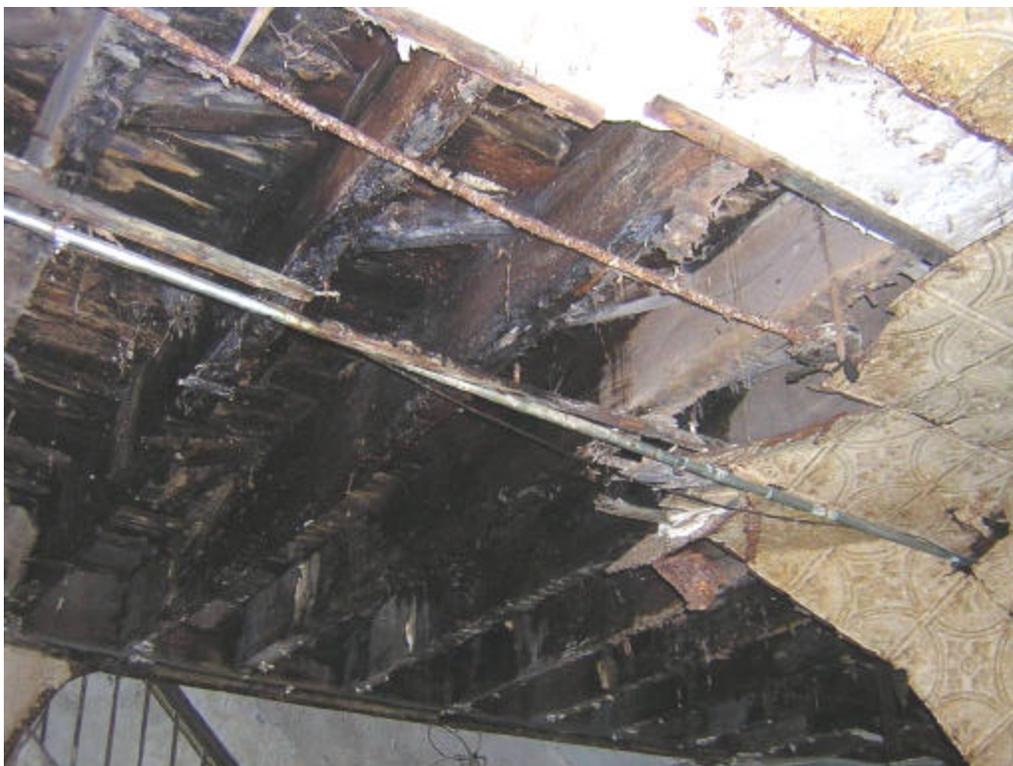
Photo No. 12 – 2nd Floor Framing Damage of 614 Atlantic Avenue

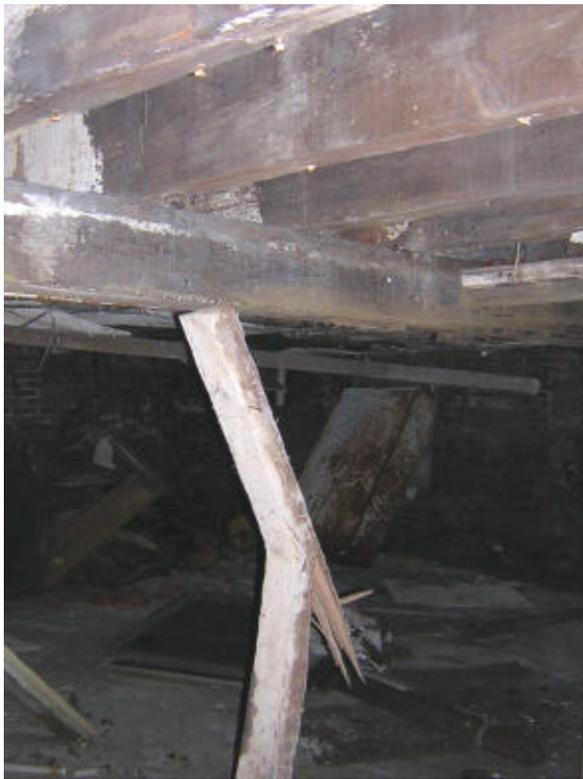
**Photo No. 14 – Further Timber Post Failure At Basement
of 461 Dean Street (Condition on November 01, 2005)**

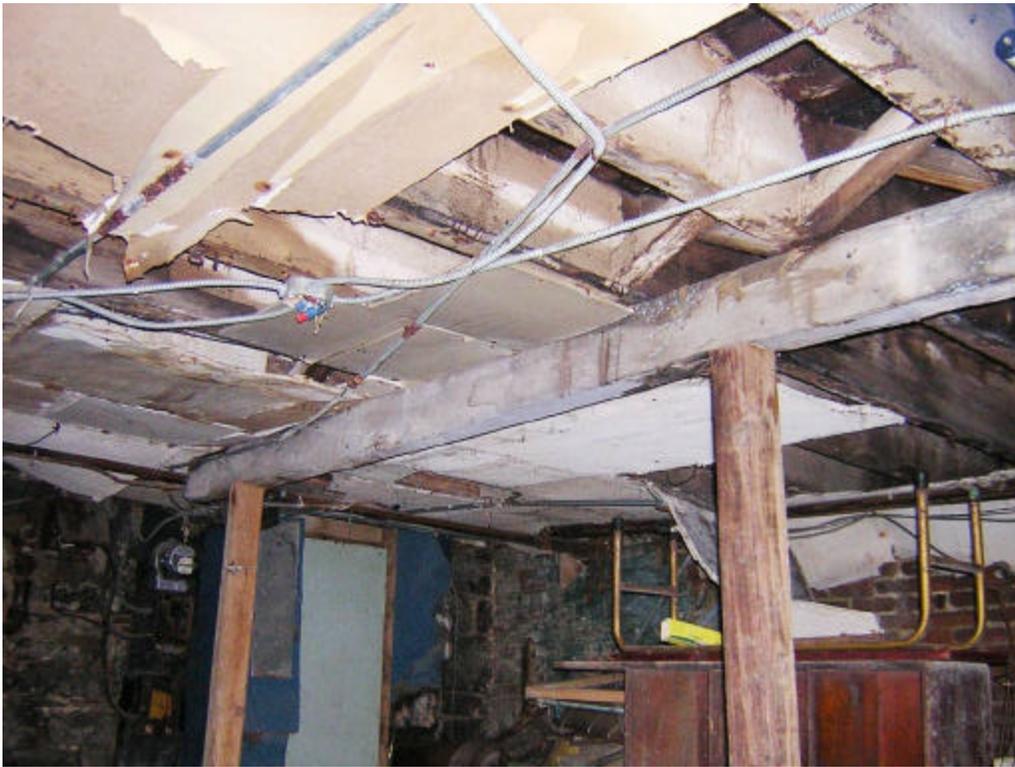
Photo No. 15 – Additional Timber Girder & Timber Shoring At Basement of 461 Dean Street

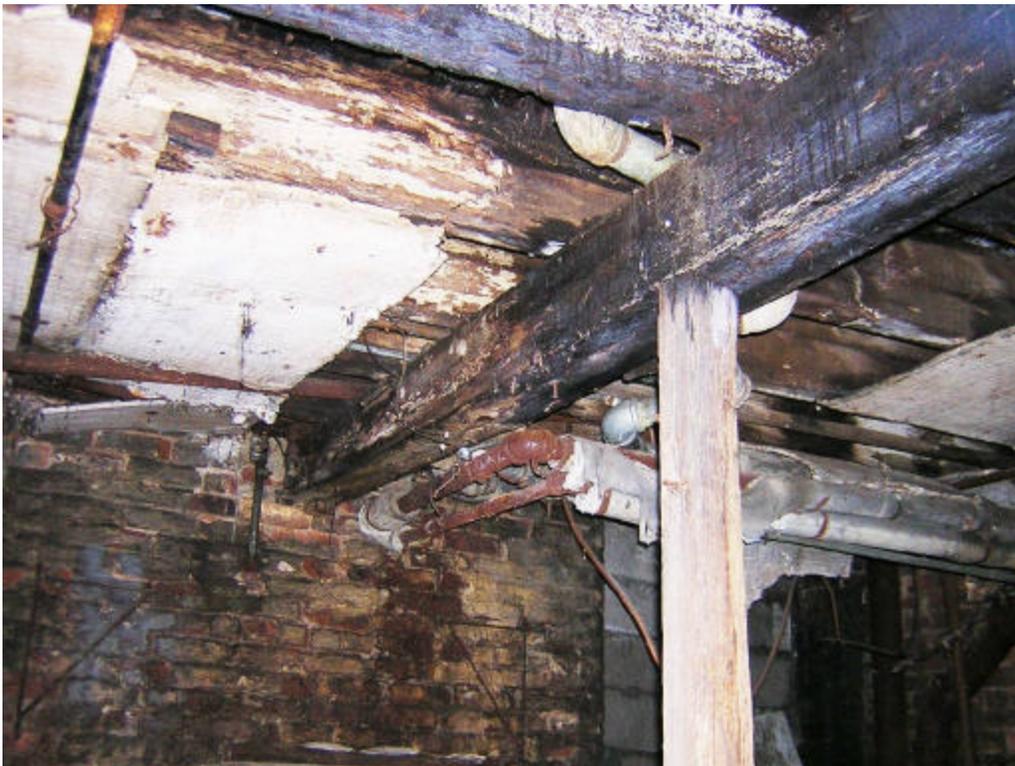
Photo No. 16 – Timber Girder and Floor Joist Water Damage At Basement of 461 Dean Street

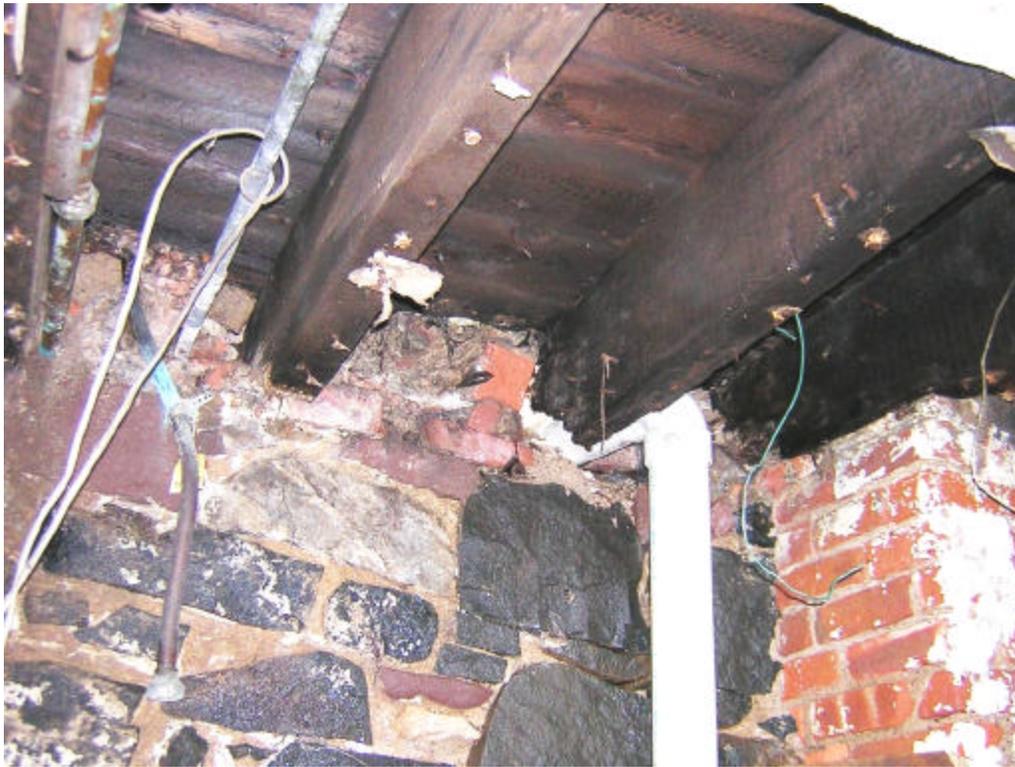
**Photo No. 17 – Timber Floor Joist Water Damage At
Basement of 461 Dean Street**

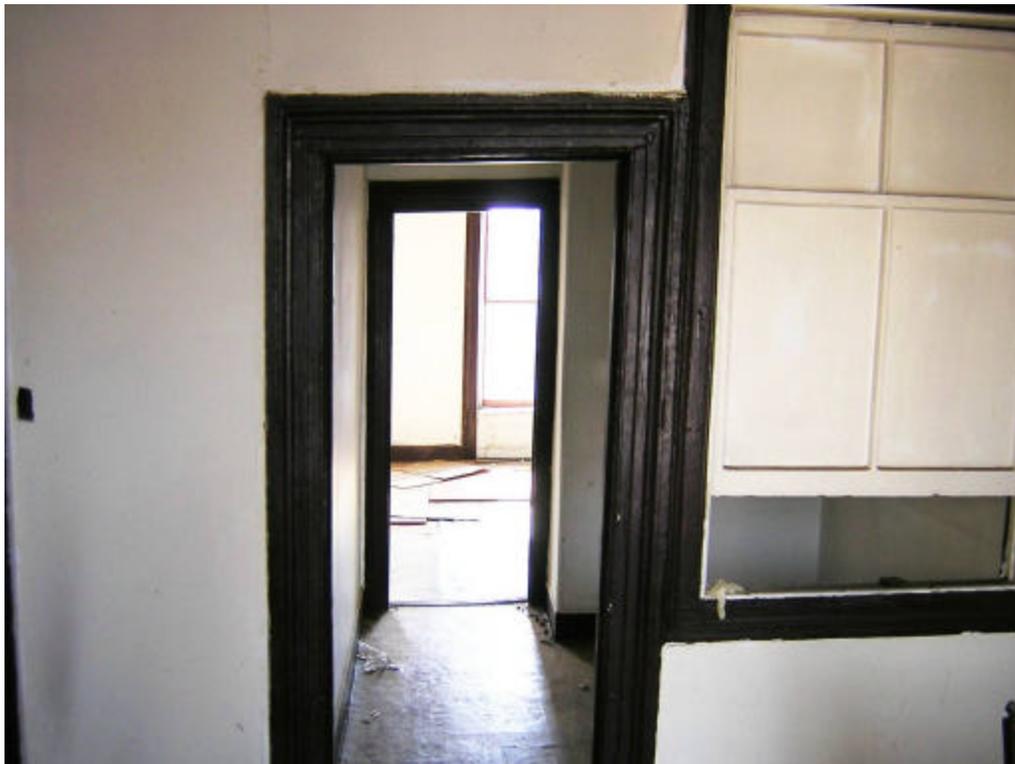
**Photo No. 18 – Sagging Floor and Racked Door & Window
Frames At 3rd Floor of 461 Dean Street**

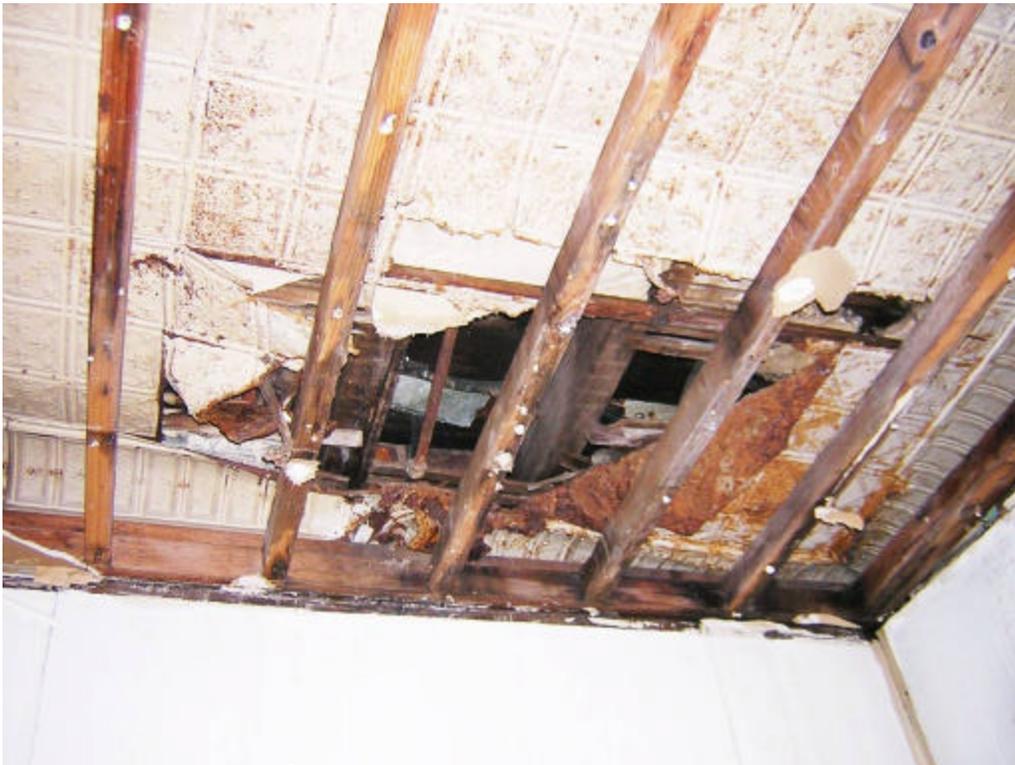
Photo No. 19 – 2nd Floor Framing Water Damage at 1st Floor Ceiling of 461 Dean Street

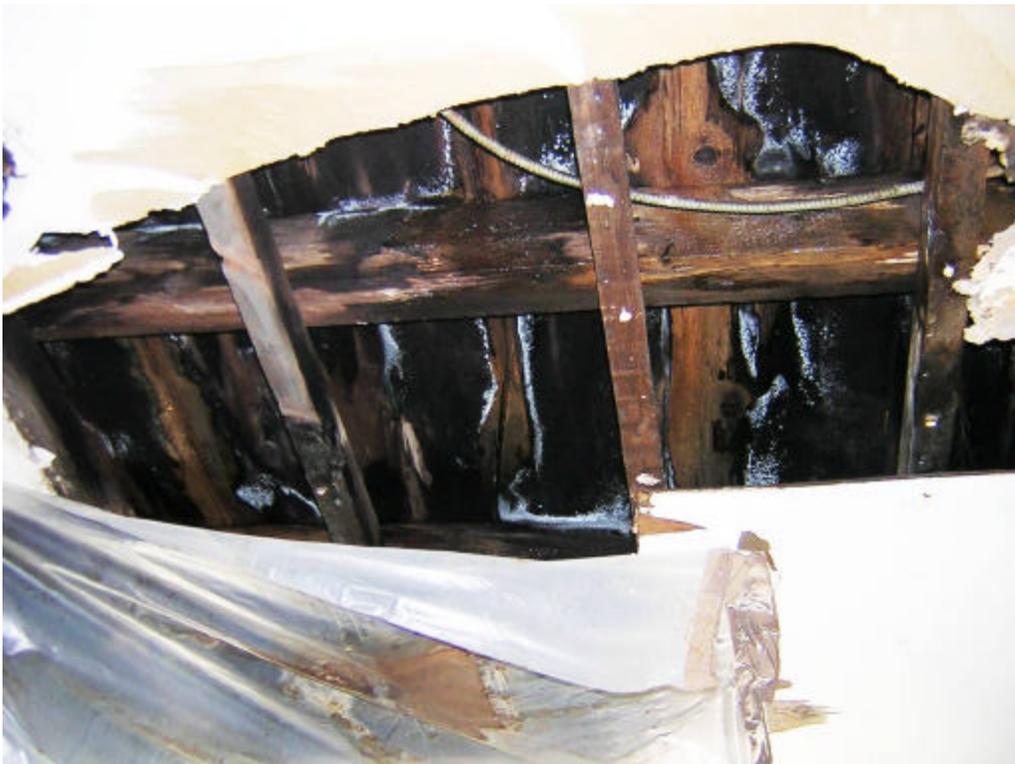
Photo No. 20 – Roof Framing Water Damage At 4th Floor of 461 Dean Street

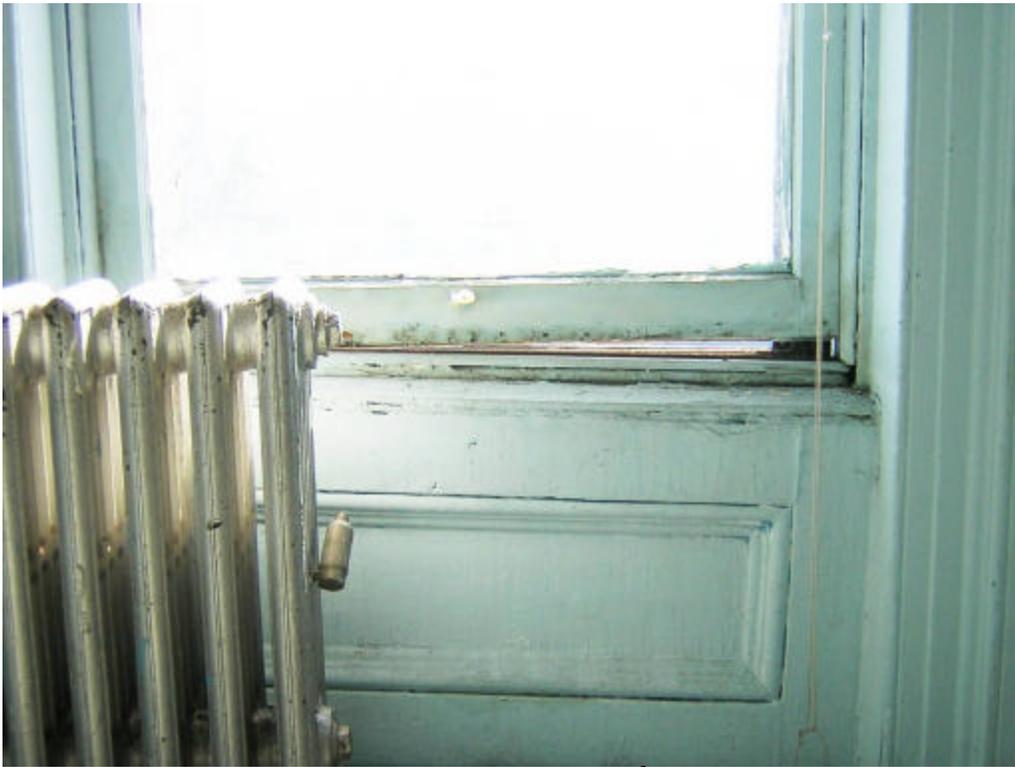
Photo No. 21 – Racked Window Frame At 3rd Floor of 463 Dean Street

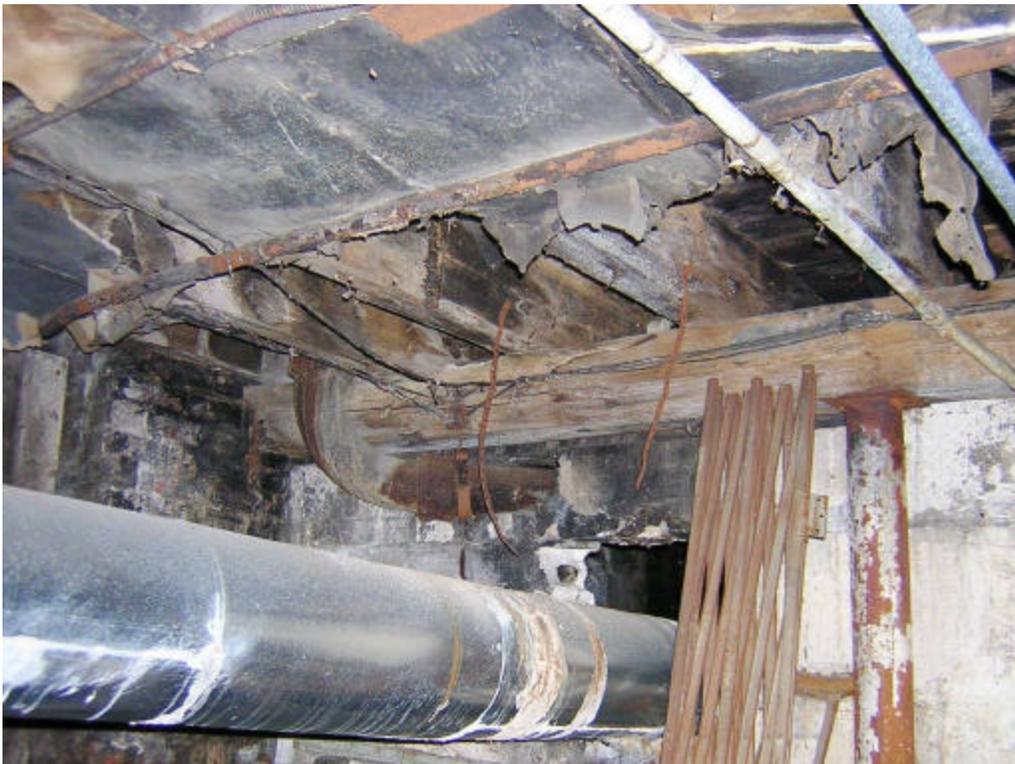
**Photo No. 22 – Timber Girder and Floor Joist Water Damage
At Basement of 463 Dean Street**

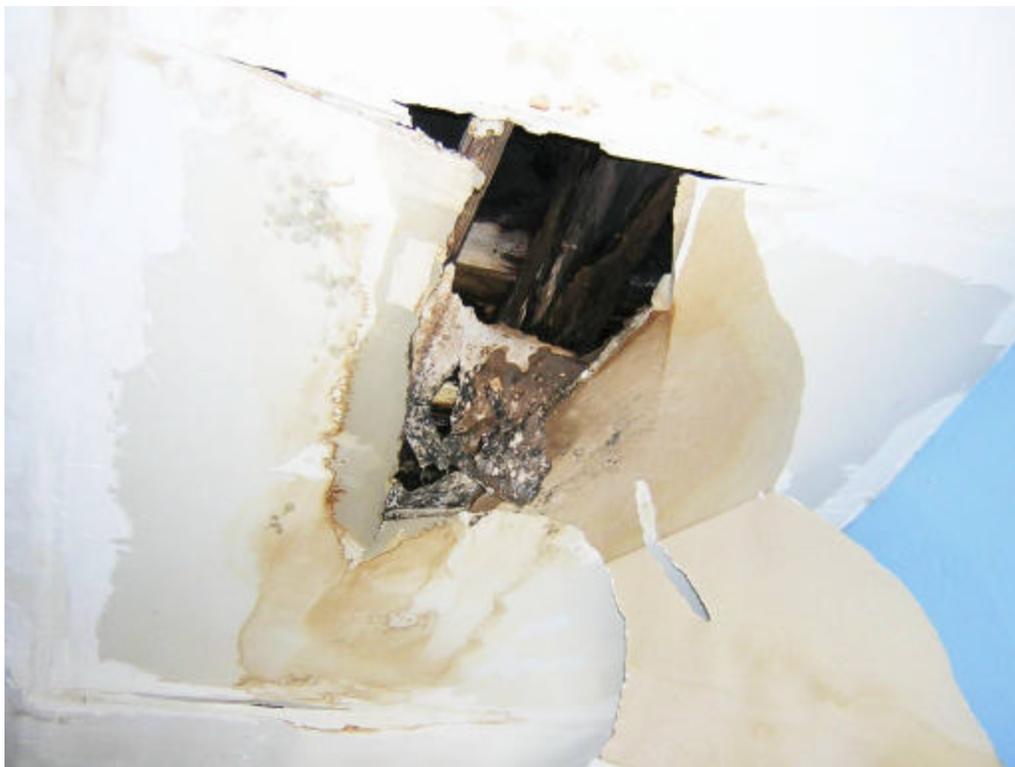
Photo No. 24 – Roof Framing Water Damage At 4th Floor of 463 Dean Street

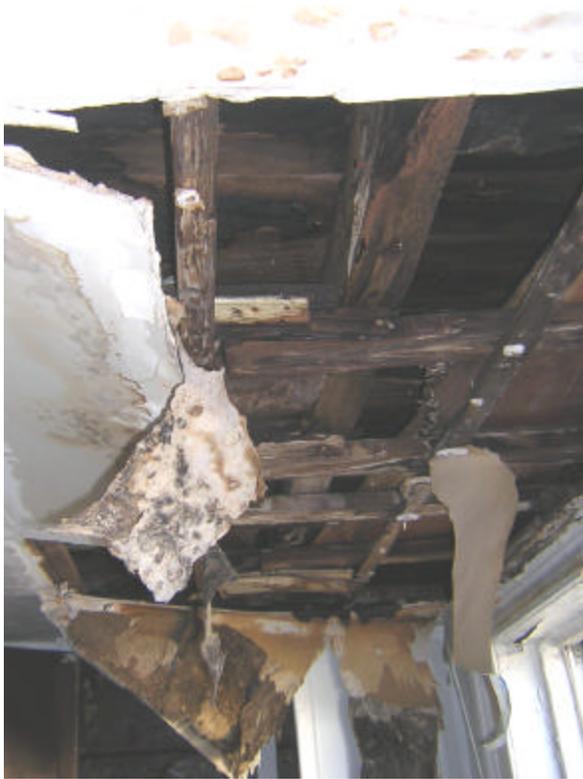
- Continued sagging of the timber flooring on all floors
- Continued timber flooring and floor joist water and rot damage on all floors (Refer to Photo No. 25)

Photo No. 25 – Further Roof Framing Water Damage At 4th Floor of 463 Dean Street (Condition on November 01, 2005)

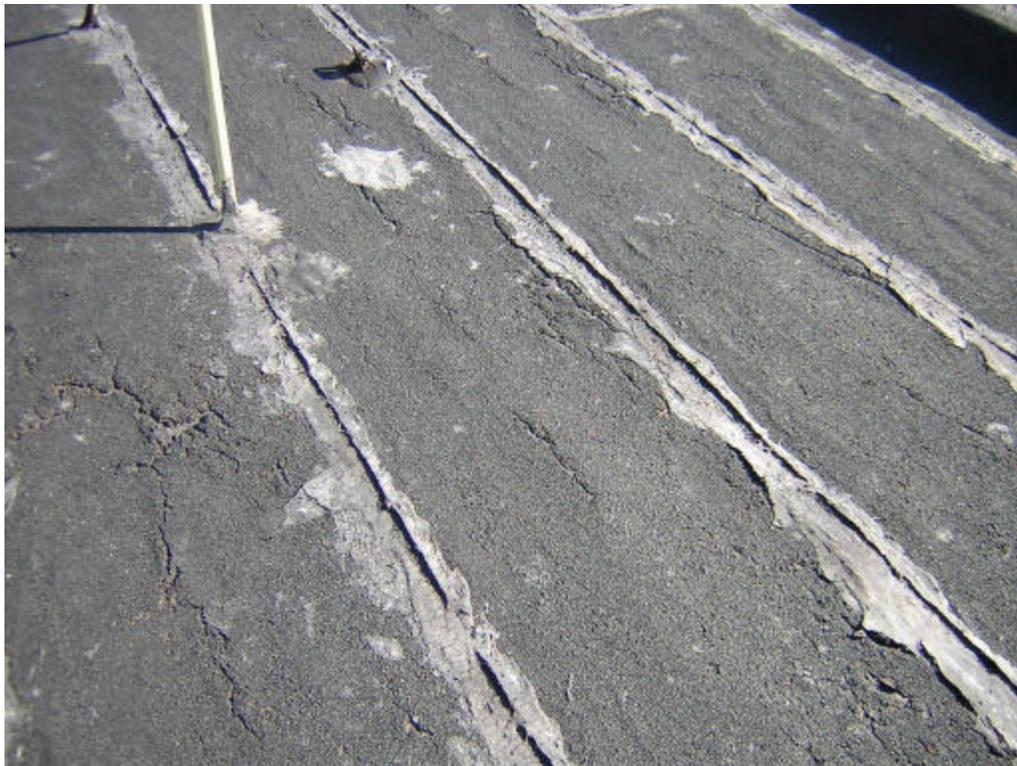
Photo No. 26 – Roof Membrane Deterioration At Roof of 463 Dean Street

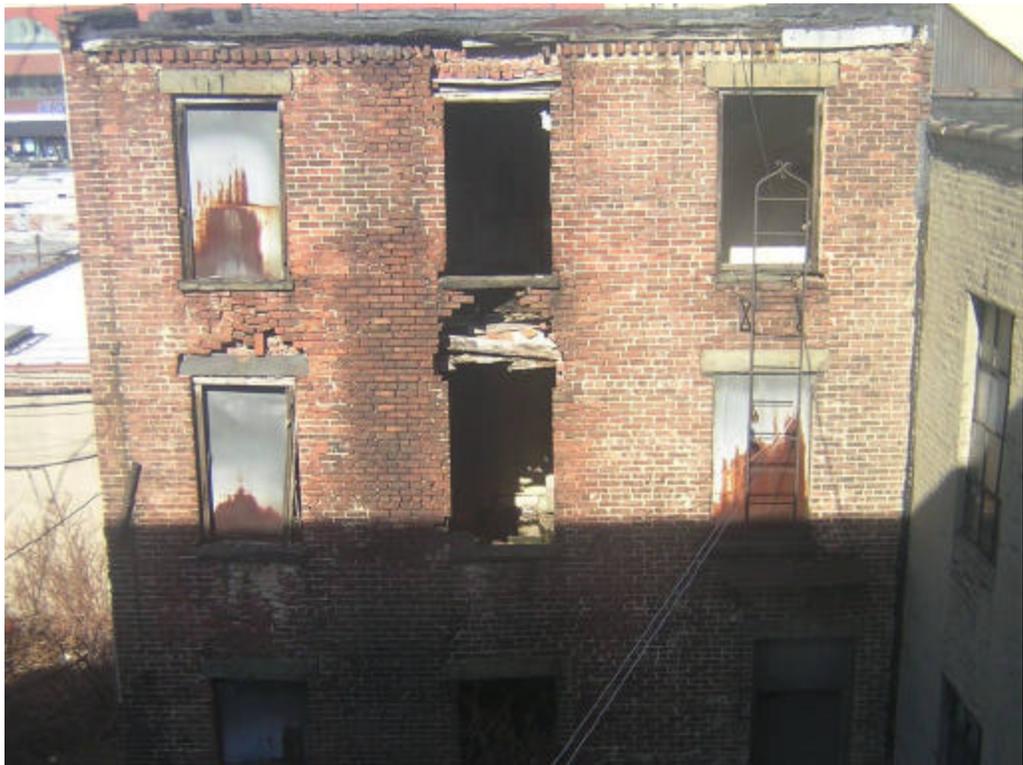
Photo No. 27 – Collapsed & Damaged Portions of the Southern Non-Bearing Masonry Wall of 463 Dean Street

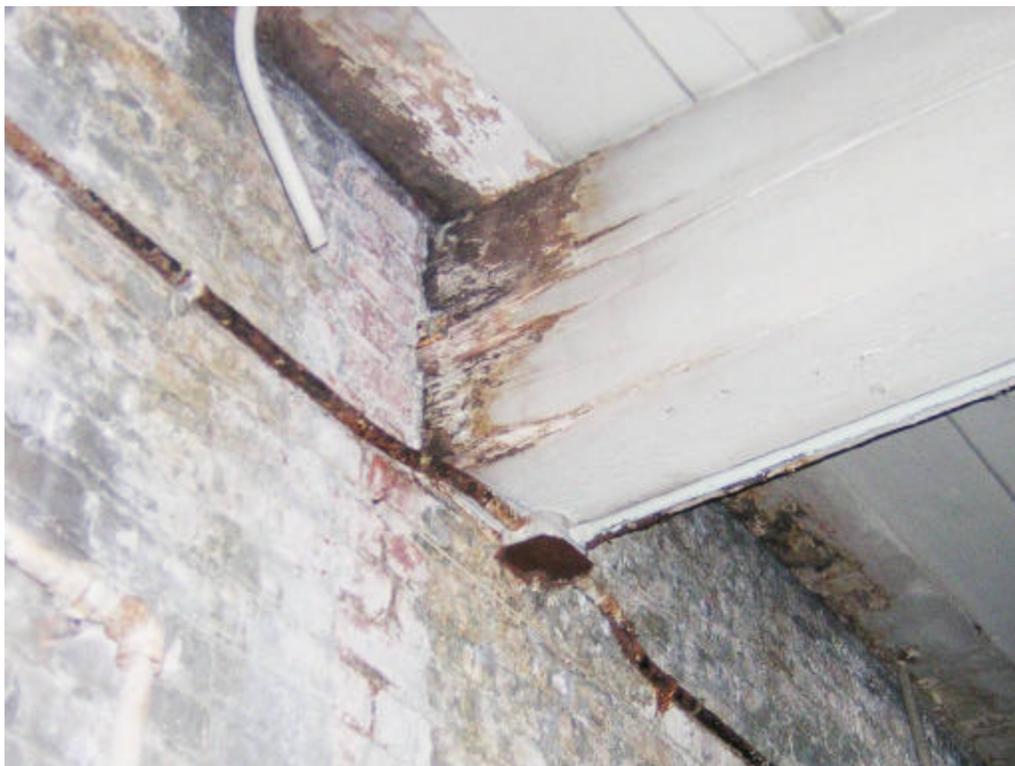
**Photo No. 30 – 3rd Floor Timber Roof Girder Water Damage
(Eastern Portion of Building) of 585-601 Dean Street**

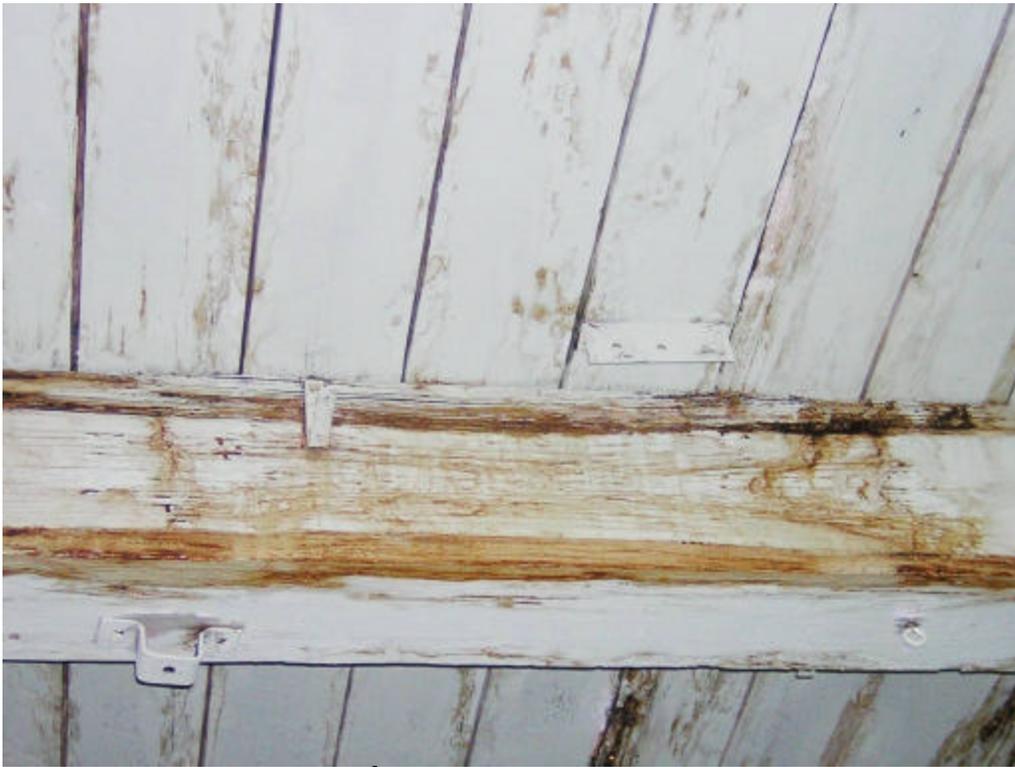
**Photo No. 31 – 2nd Floor Water Damaged Roof Framing
(Eastern Portion of Building) of 585-601 Dean Street**

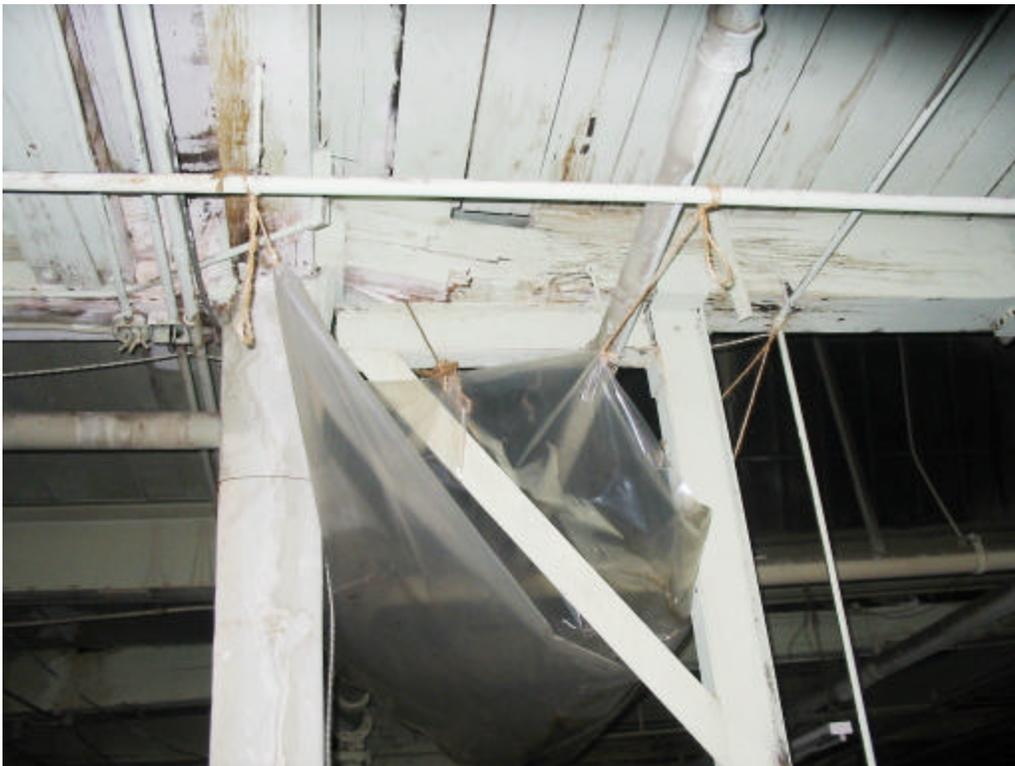
The majority of the building's distresses observed are the consequence of the building being open to the elements and water infiltration. The timber framing at several locations is severely deteriorated and has partially collapsed and is only being held up by temporary shoring. For example, the end of a timber girder supporting the roof framing above the 2nd floor is water damaged, rotted, and has partially collapsed (Refer to Photo No. 32).

**Photo No. 32 – Failed 2nd Floor Roof Girder w/ Temporary Shoring
(Eastern Portion of Building) of 585-601 Dean Street**

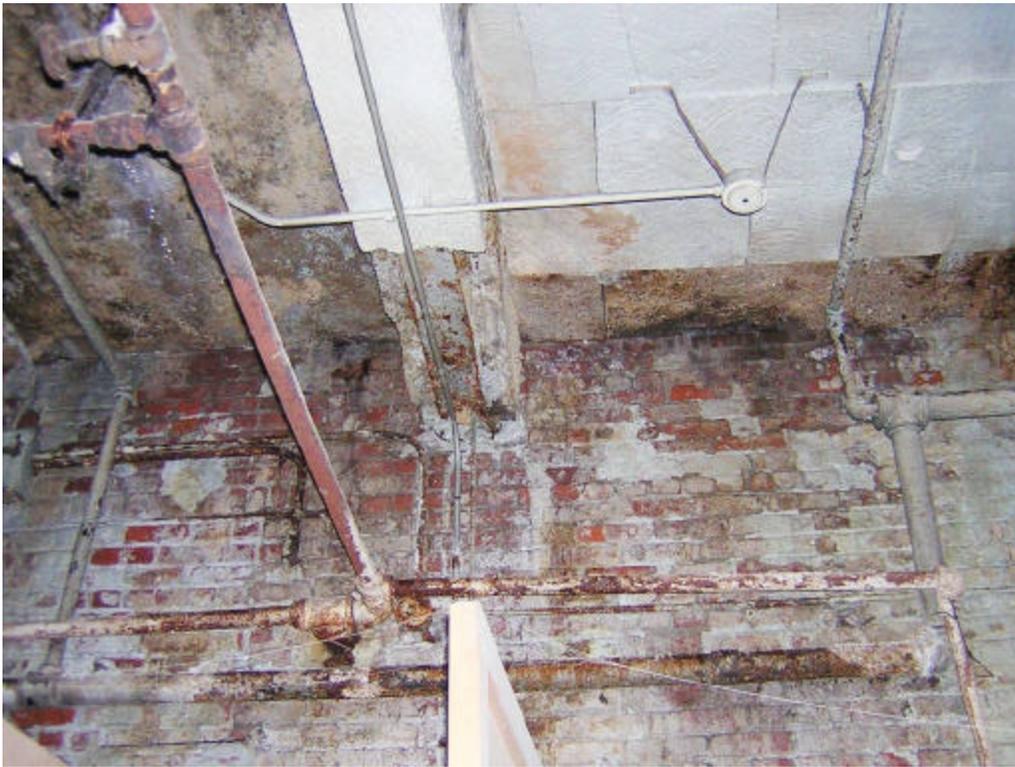
**Photo No. 33 – Water Damaged & Corroded 1st Floor Roof Framing
(Western Portion of Building) of 585-601 Dean Street**

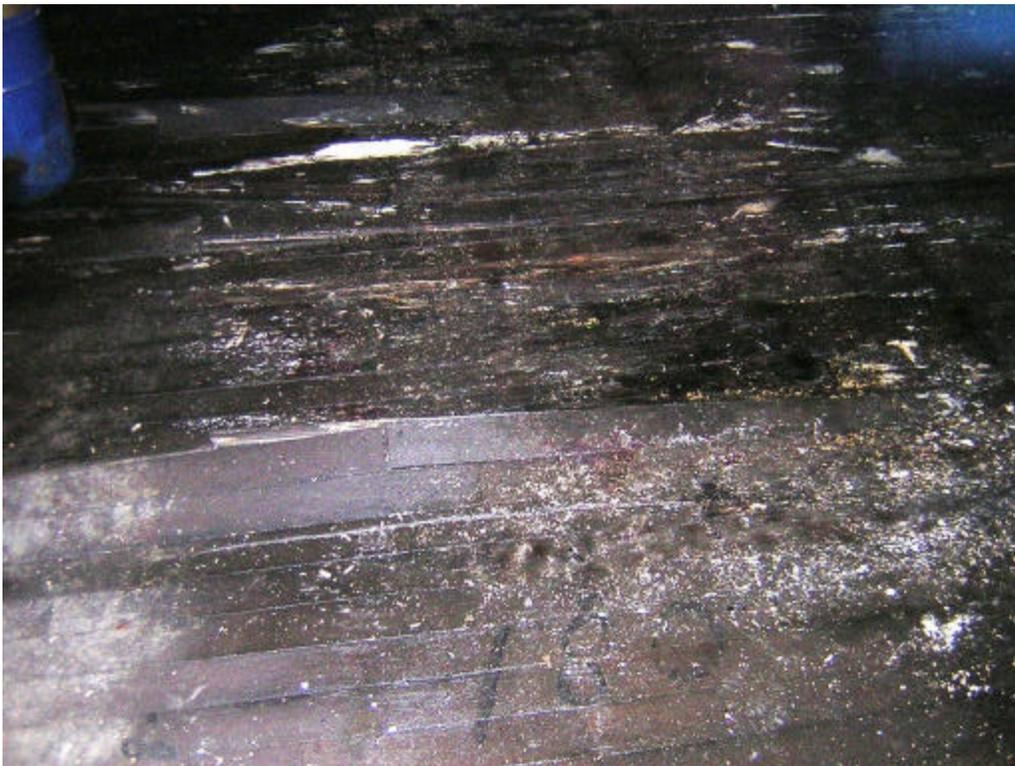
**Photo No. 34 – Water Damaged Flooring at 3rd Floor
(Eastern Portion of Building) of 585-601 Dean Street**
