SUMMARY REPORT
OF THE EXISTING
STRUCTURAL
CONDITION SURVEYS

Forest City Ratner Companies
One Metrotech Center North
11th Floor
Brooklyn, NY 11201

LZA TECHNOLOGY
641 Avenue of the Americas
New York, NY 10011
917-661-7800

November 07, 2005

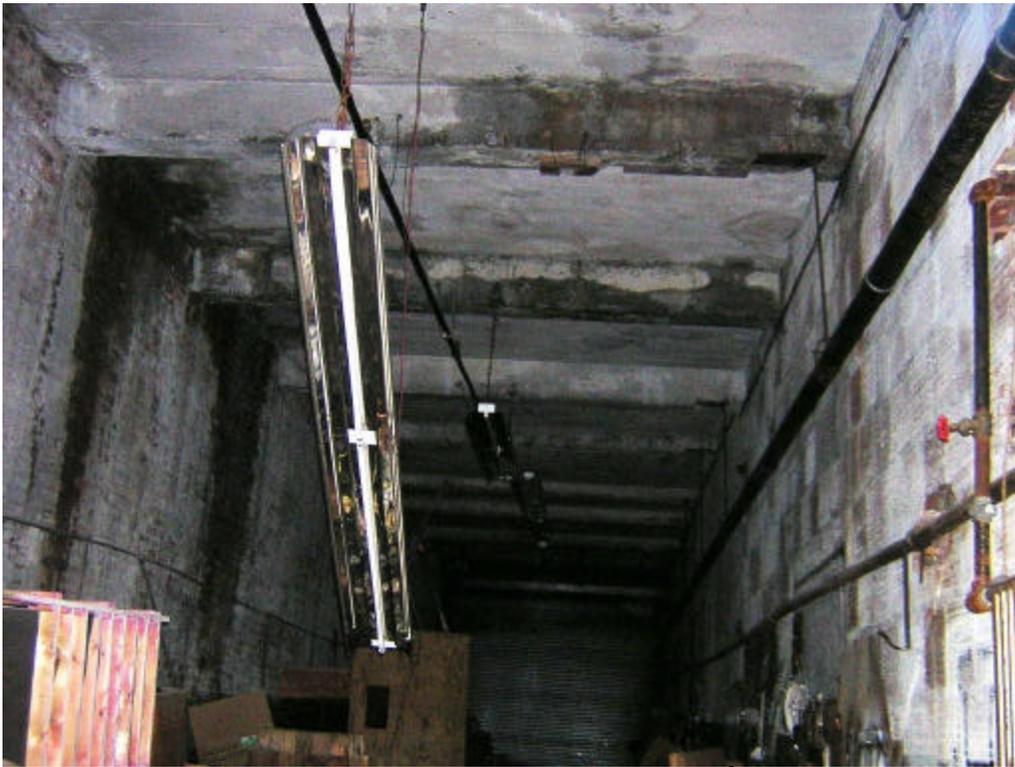
**Photo No. 35 – Water Damaged & Corroded 2nd Floor Framing
(Eastern Portion of Building) of 585-601 Dean Street**

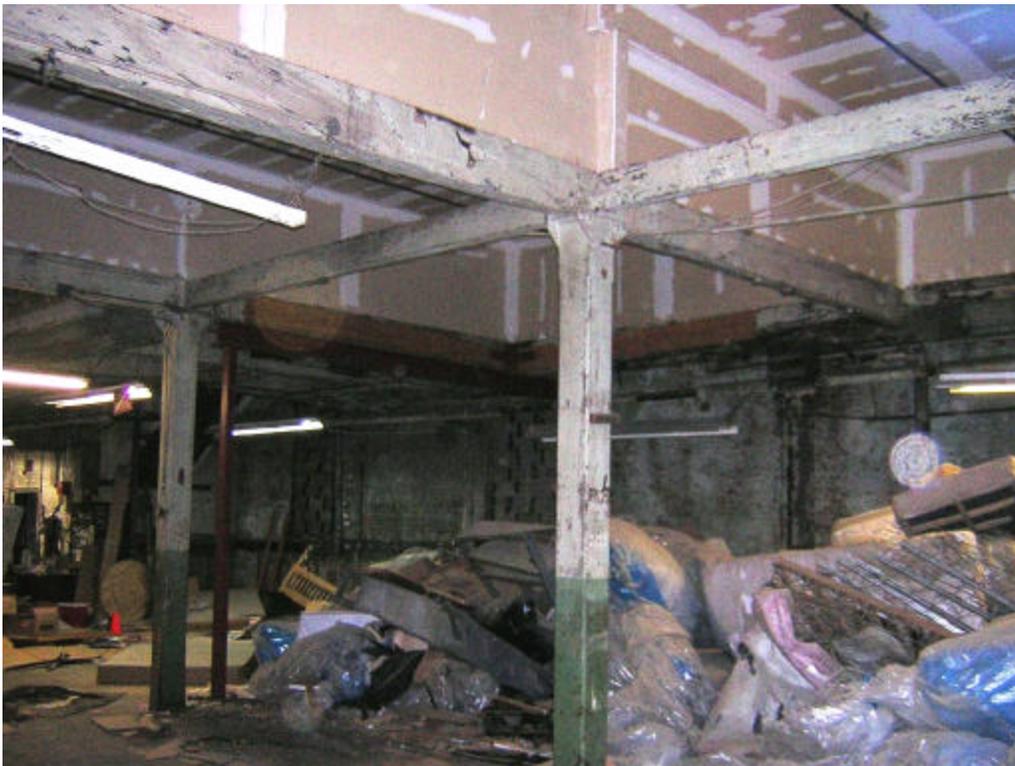
**Photo No. 36 – Failed 2nd Floor Girders & Beams w/ Temporary Shoring
(Western Portion of Building) of 585-601 Dean Street**

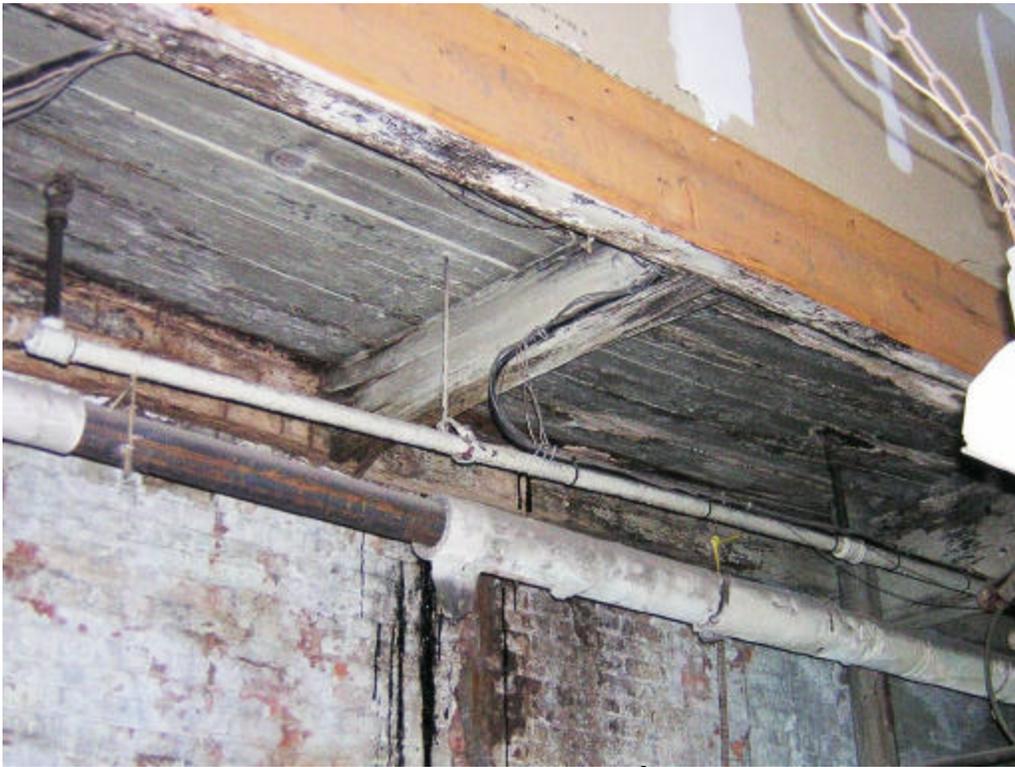
**Photo No. 37 – Water Damaged 2nd Floor Framing
(Western Portion of Building) of 585-601 Dean Street**

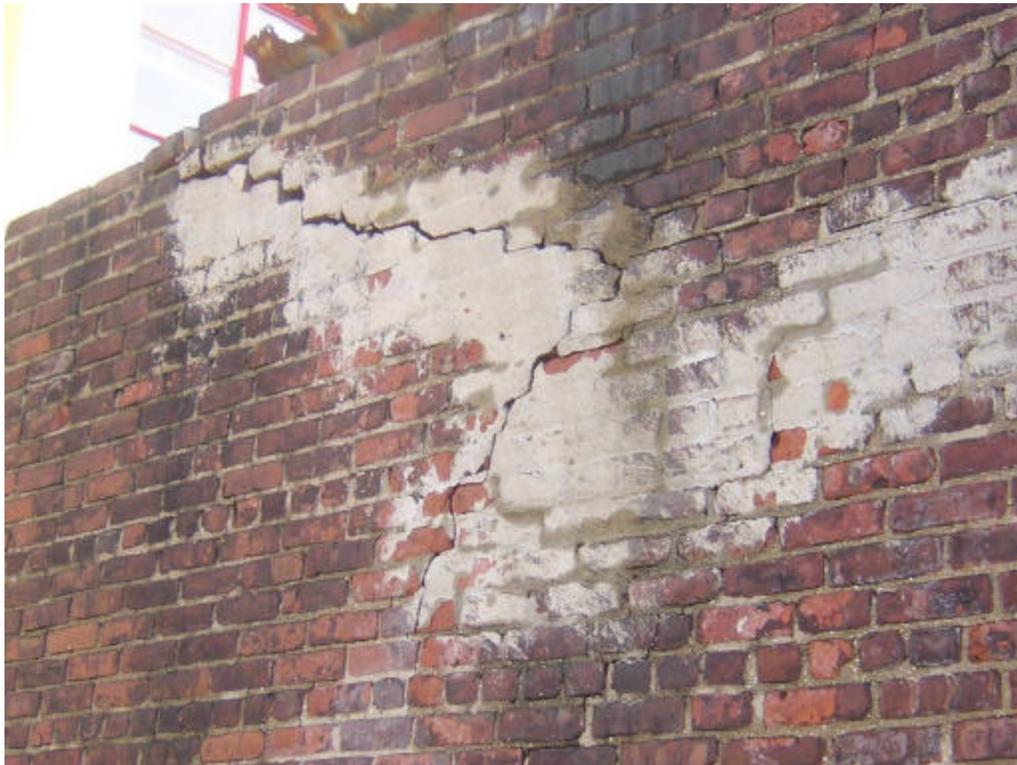
**Photo No. 39 – Cracked Masonry Wall and Loose Bricks
(Eastern Portion of Building) of 585-601 Dean Street**

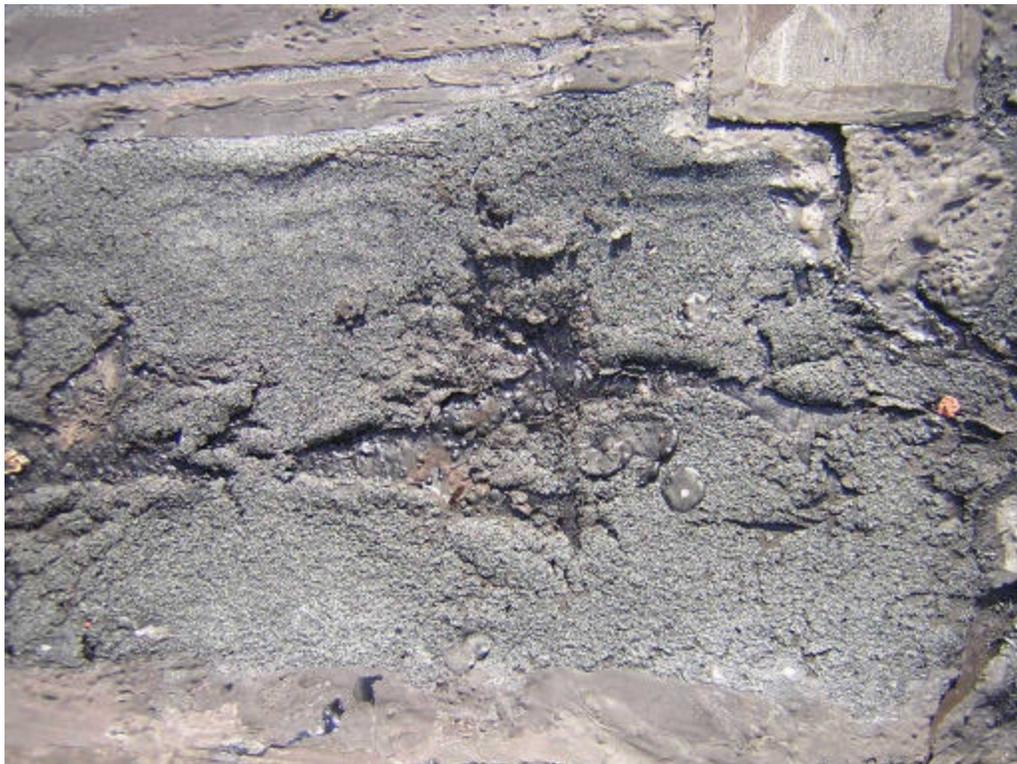
**Photo No. 40 – Roof Membrane Deterioration at 2nd Floor Roof
(Eastern Portion of Building) of 585-601 Dean Street**

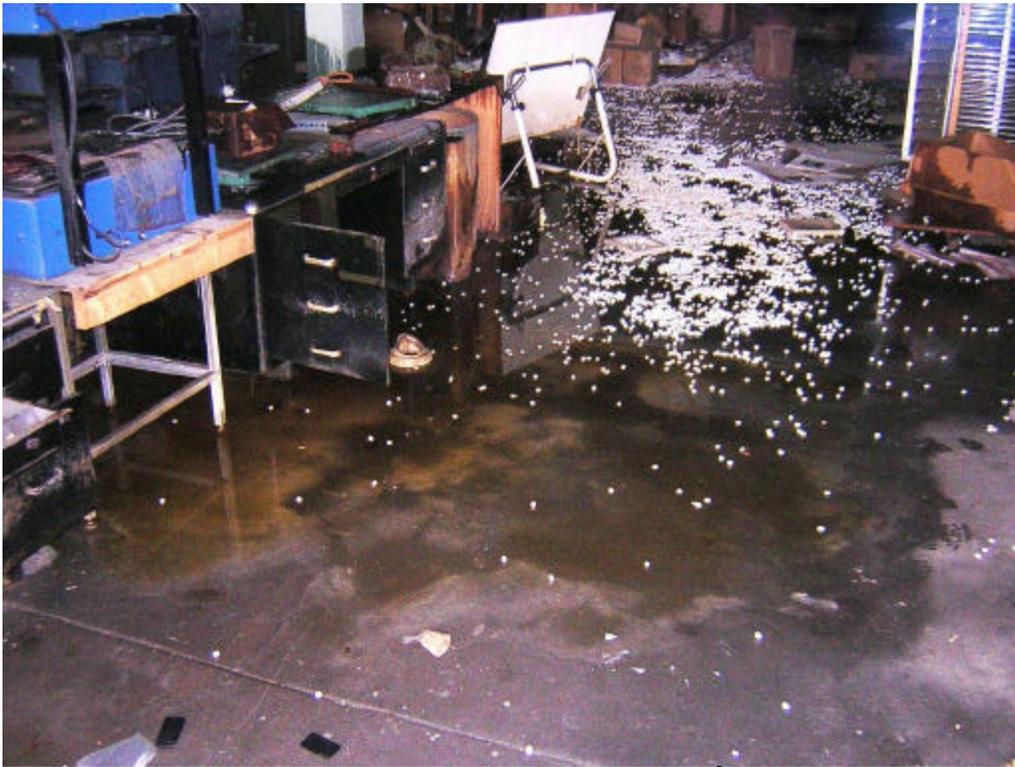
**Photo No. 41 – Water Infiltration onto 2nd Floor Slab
(Eastern Portion of Building) of 585-601 Dean Street**

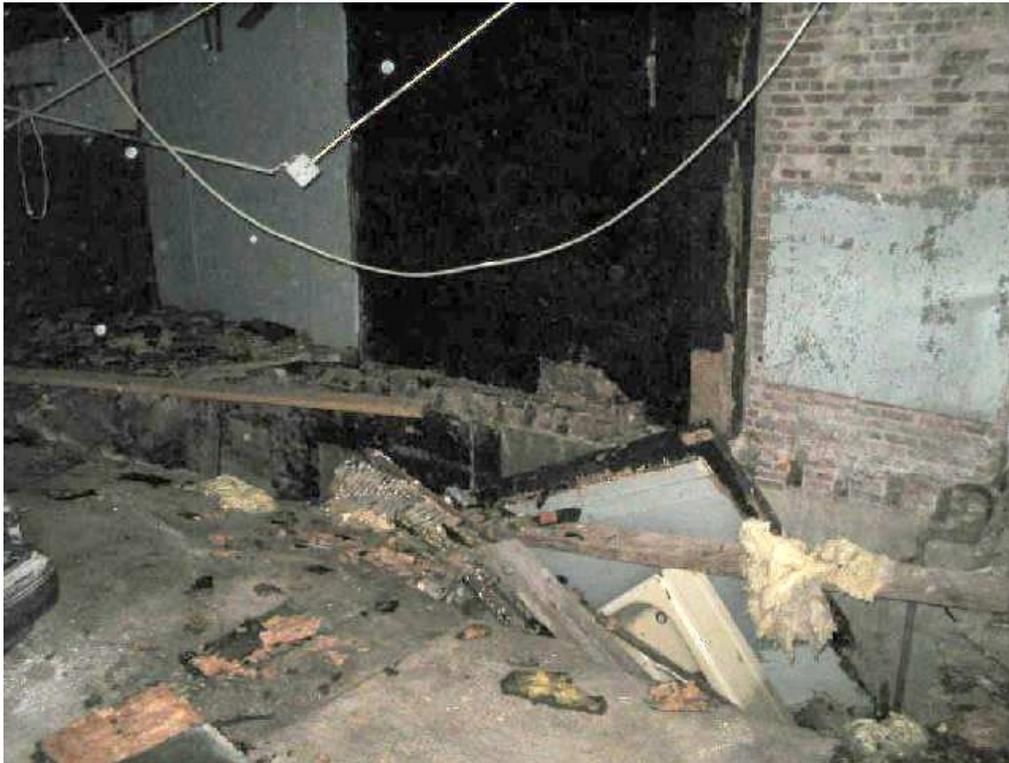
Photo No. 42 – Collapsed Slab At 1st Floor of 620 Pacific Street

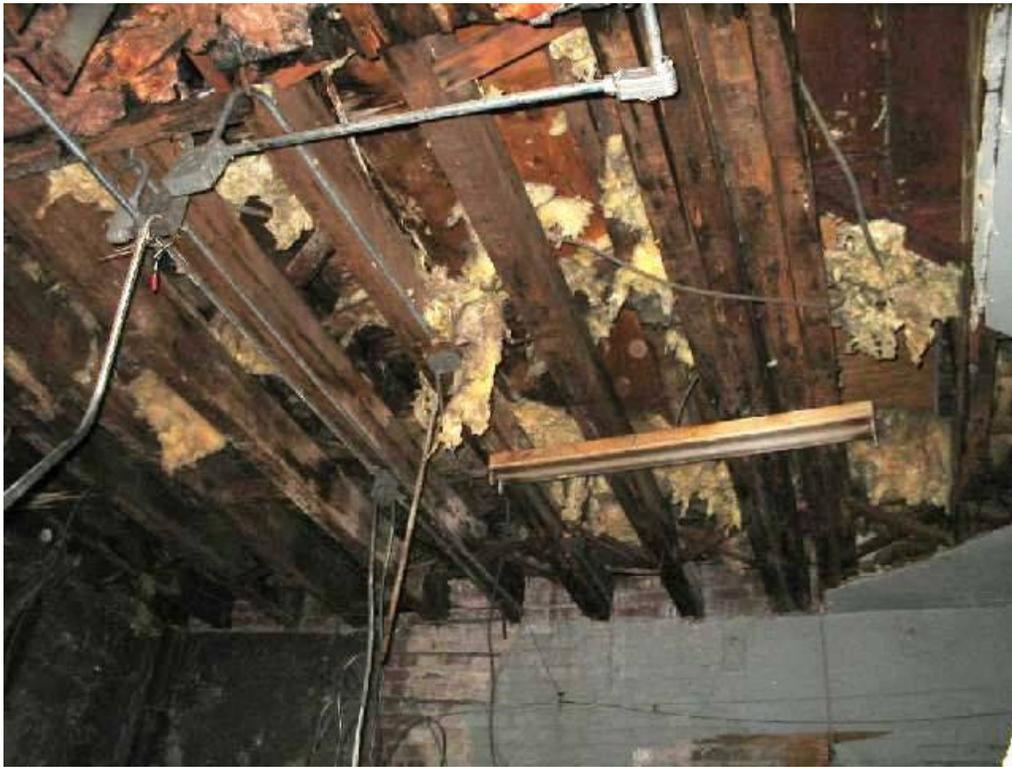
Photo No. 45 – Damaged Timber 1st Floor Framing of 620 Pacific Street

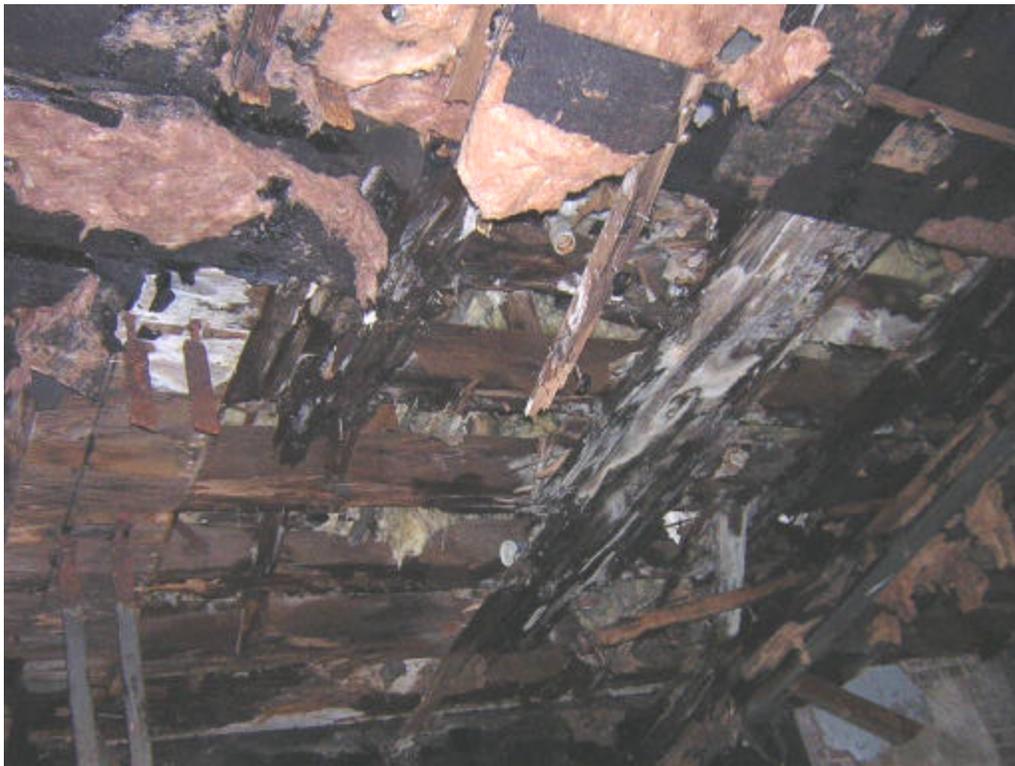
- Further water & rot damage and collapse of the 1st floor framing and slab has occurred (Refer to Photo No. 46)
- Additional holes and local collapse of the roof framing has occurred (Refer to Photo No. 48)

Photo No. 46 – Further Damaged Timber 1st Floor Framing of 620 Pacific Street (Condition on November 01, 2005)

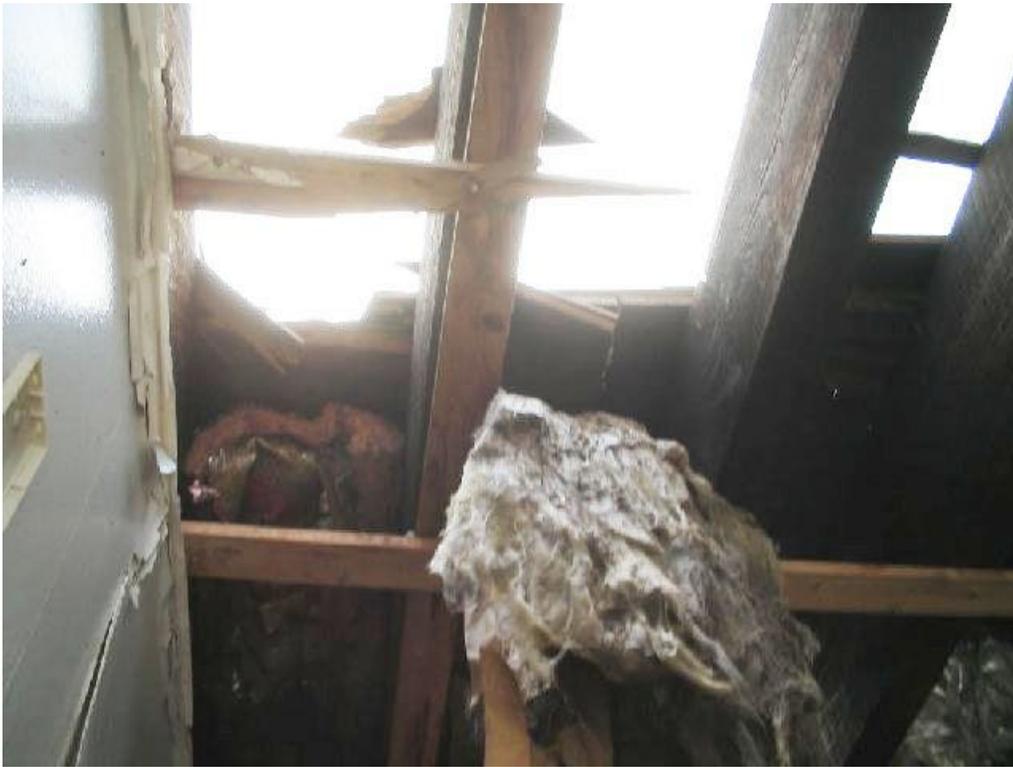
Photo No. 47 – Holes Through Existing Roof of 620 Pacific Street

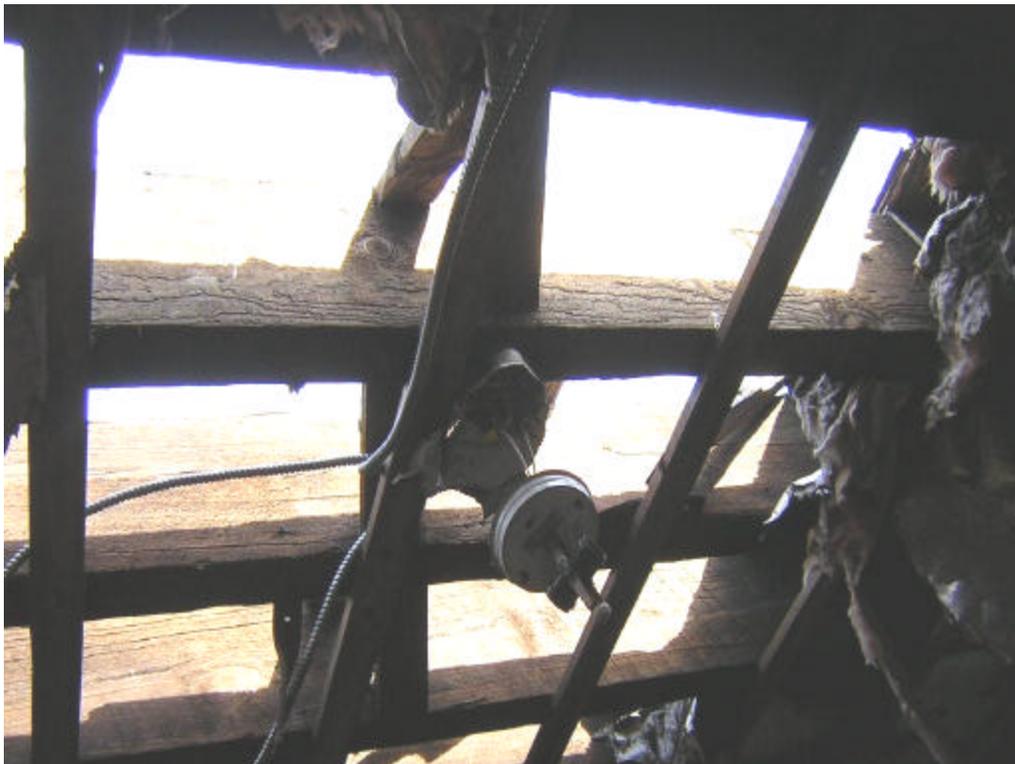
No. 48 – Additional Holes Through Existing Roof of 620 Pacific Street (Condition on November 01, 2005)

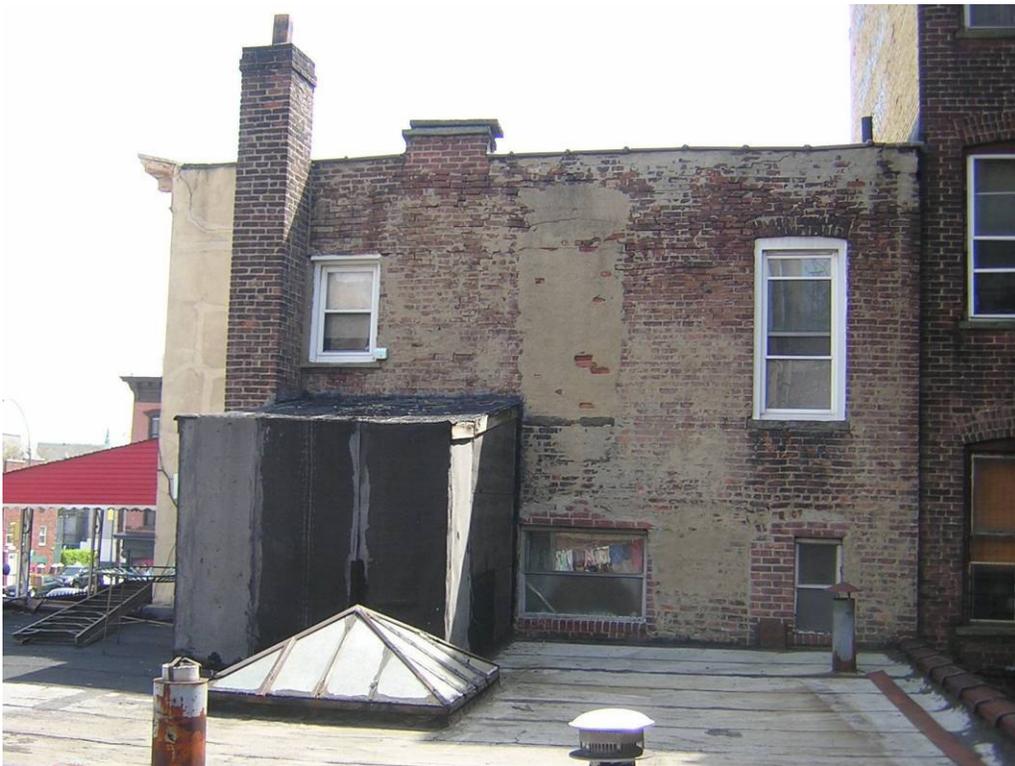
Photo No. 5 – Water Damage & Disrepair at Former Diner

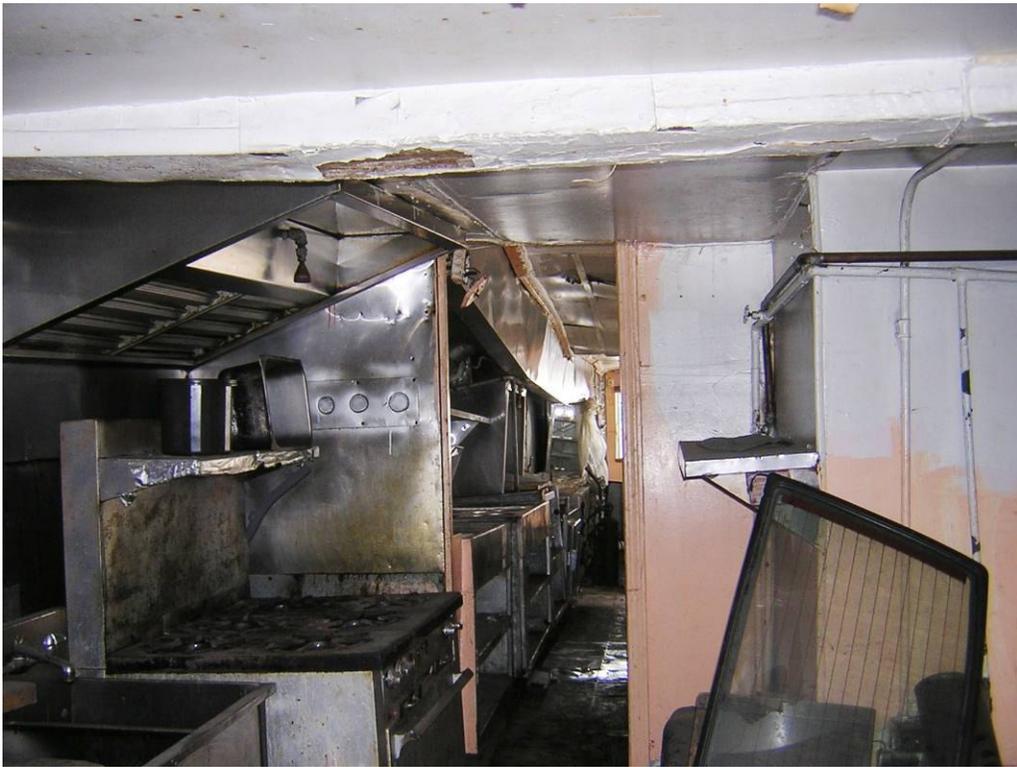
Photo No. 6 – Roof Framing Water Damage & Partial Collapse at Former Diner

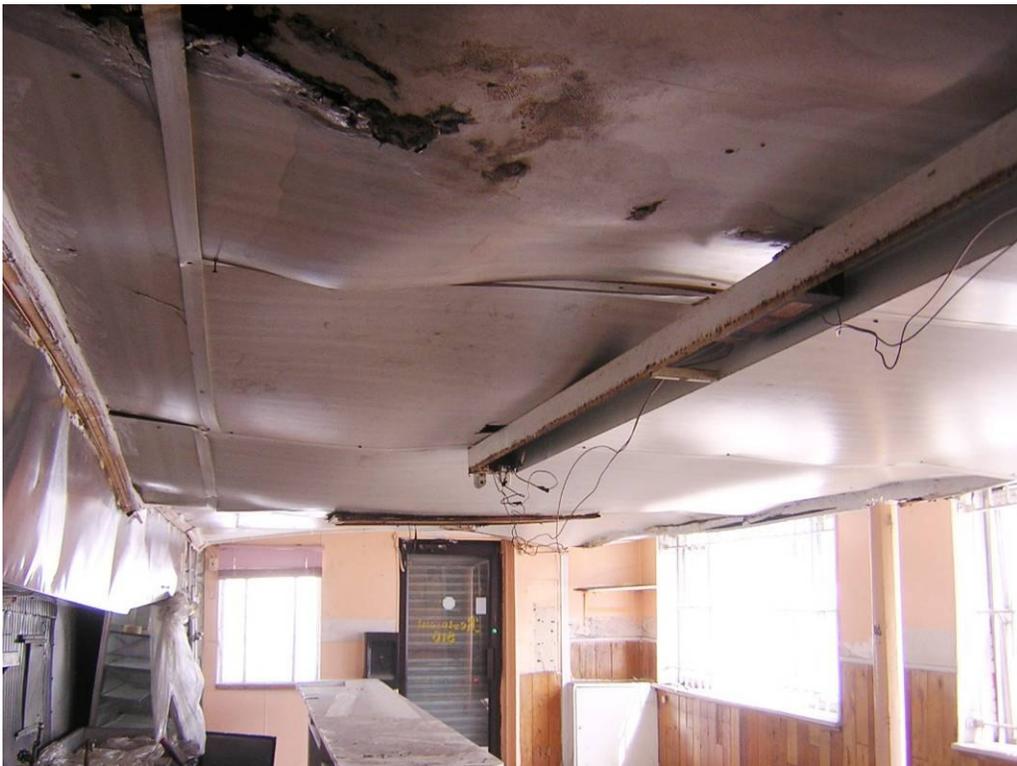
Photo No. 7 – Roof Framing Water Damage At Former Auto Repair Shop

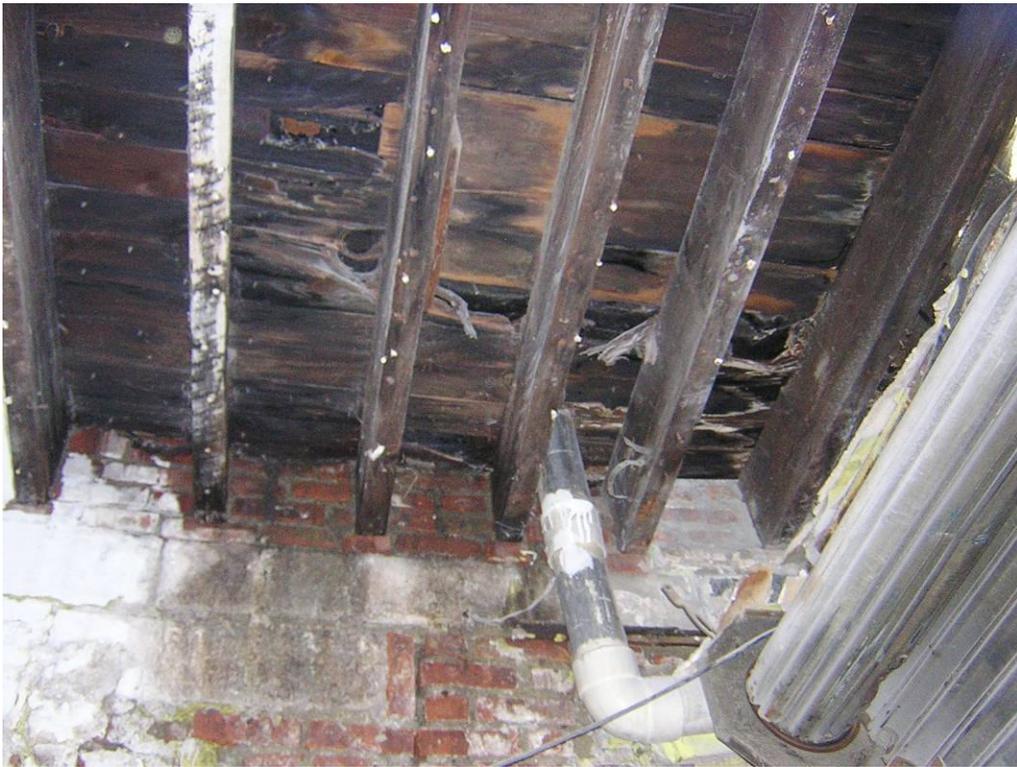
Photo No. 8 – Skylight Framing Water Damage At Former Auto Repair Shop

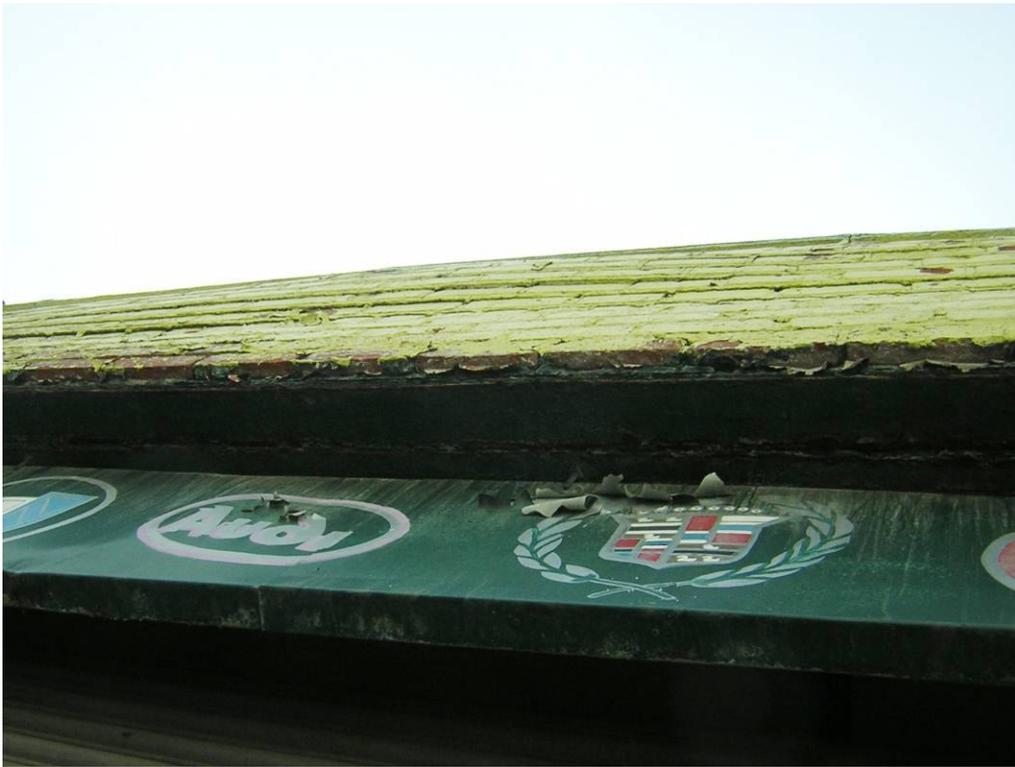
**Photo No. 10 – North Non-Bearing Masonry Wall Damage
At Former Auto Repair Shop**

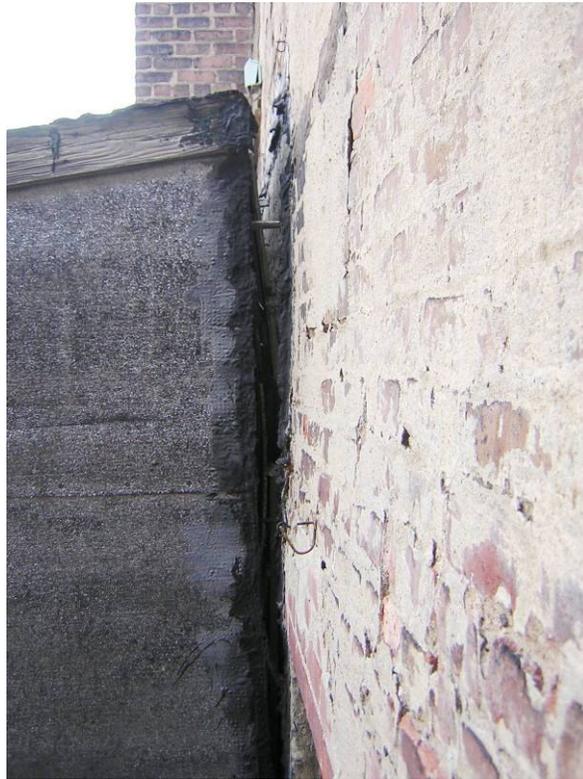
Photo No. 12 – Roof Framing Water Damage at Wood Framed Structure

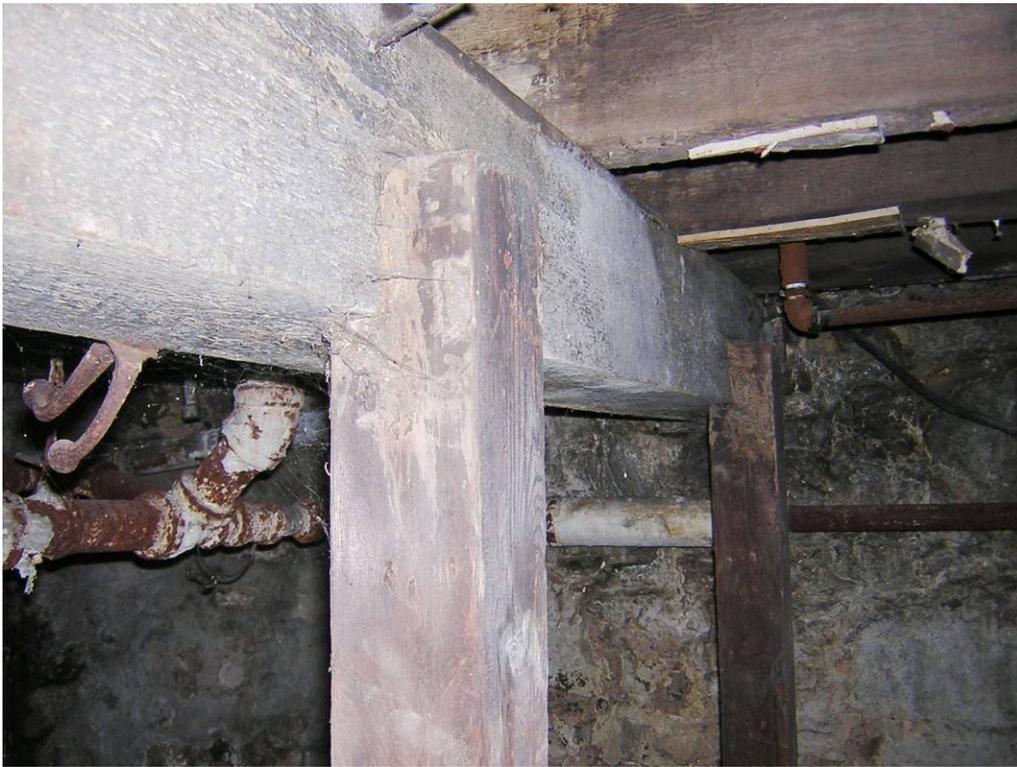
Photo No. 14 – Timber Girder Water Damage At Basement of Three-Story Building

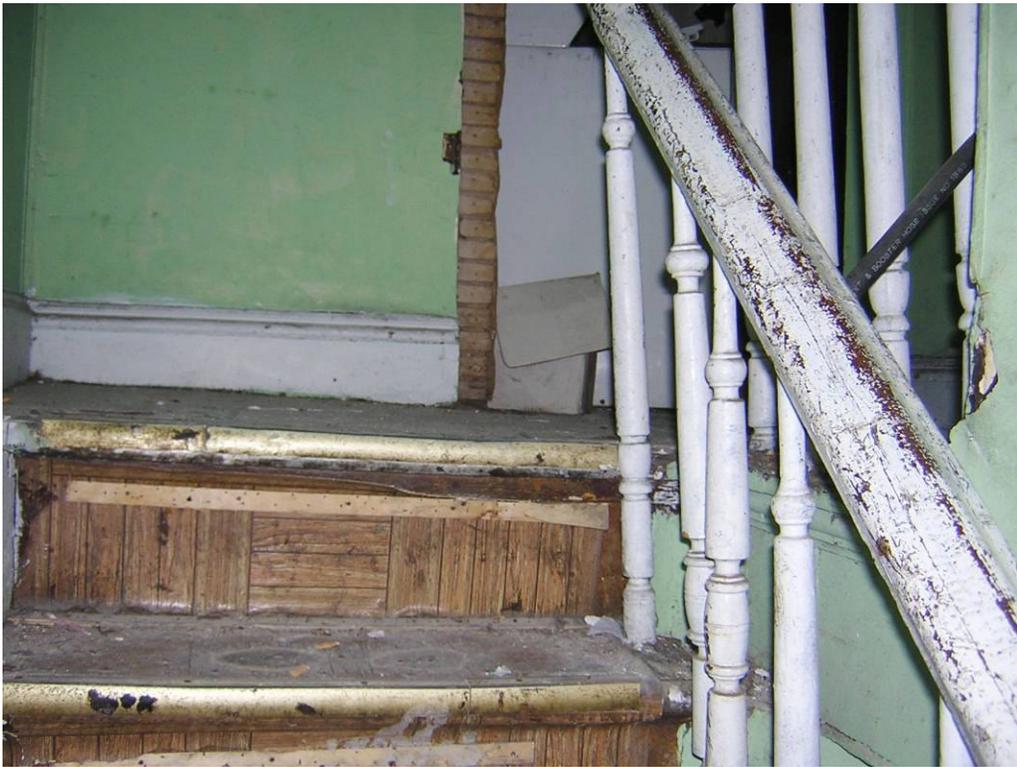
Photo No. 16 – Sloped & Damaged Stairs At 1st Floor of Three-Story Building

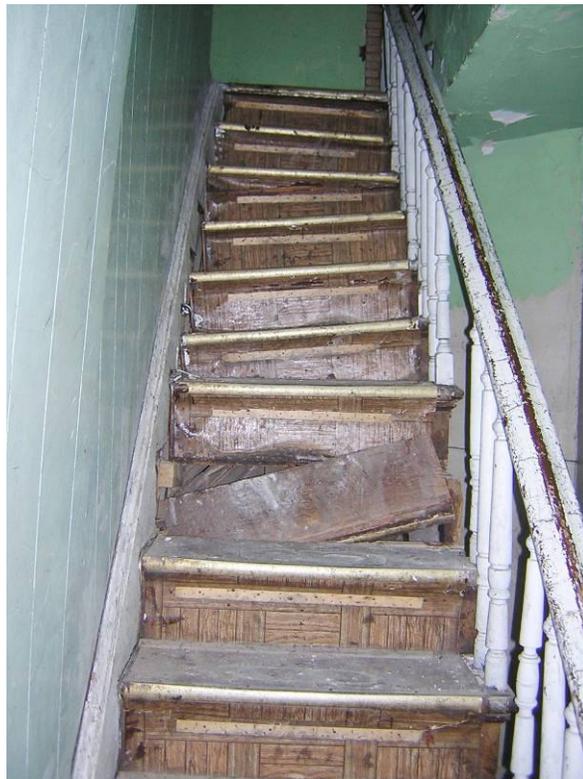
Photo No. 17 – Sloped Stairs At 2nd Floor of Three-Story Building

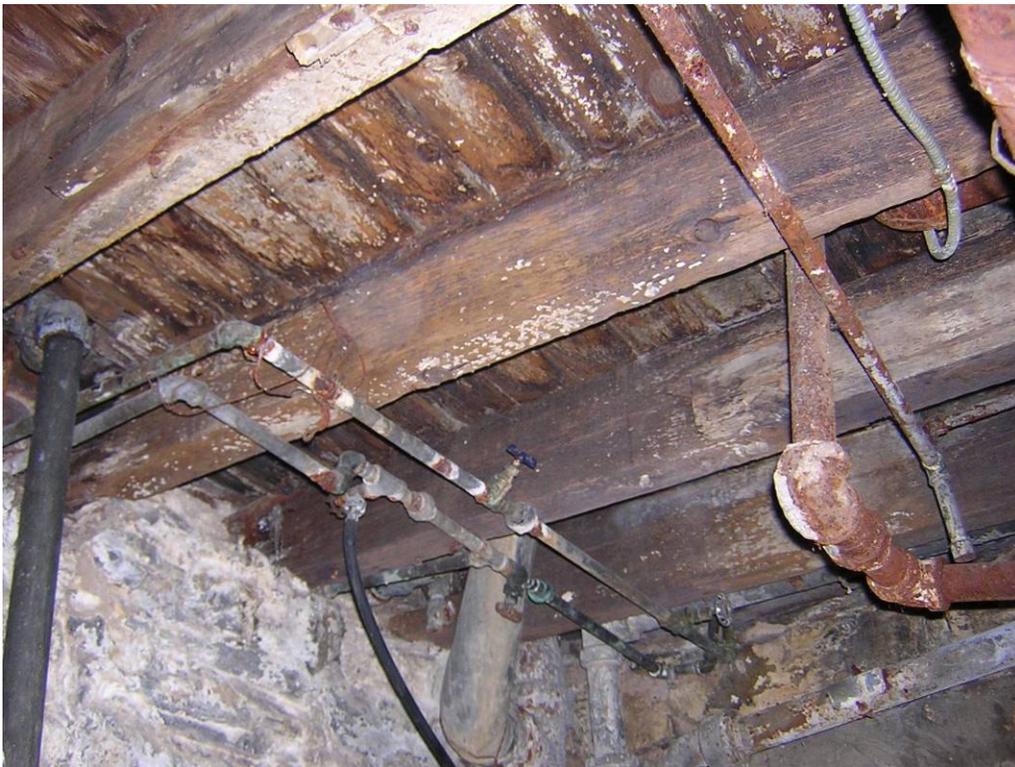
Photo No. 19 – Inadequate Floor Joist Support At Basement of Three-Story Building

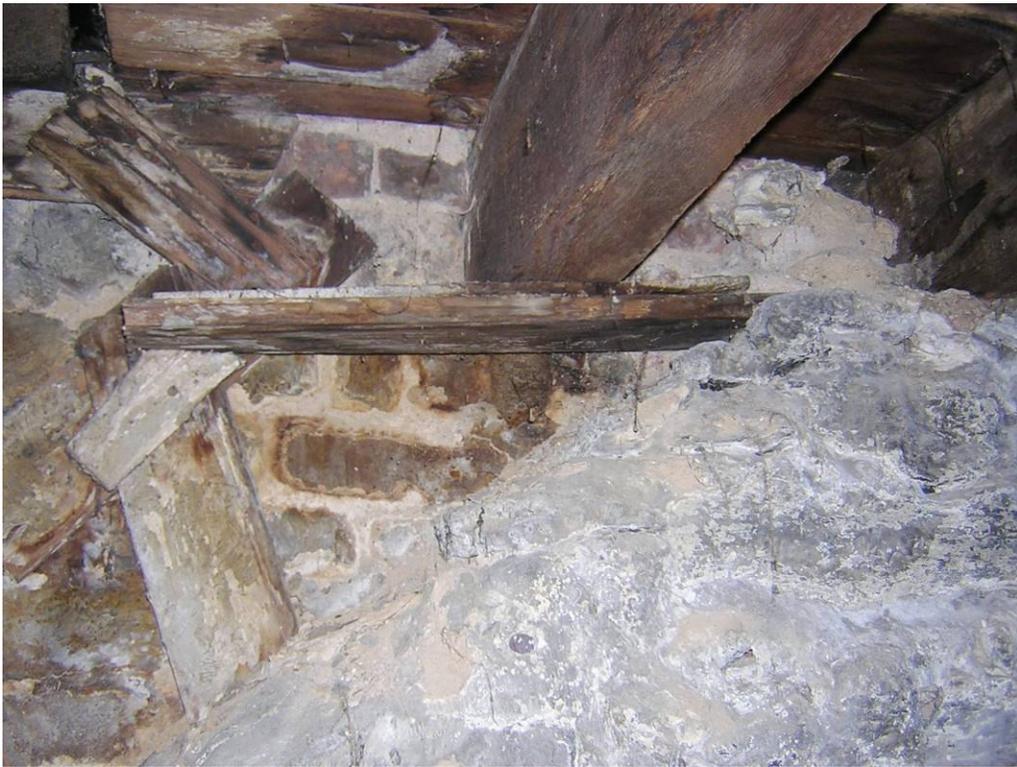
Photo No. 20 – Rotated Floor Joists At Basement of Three-Story Building

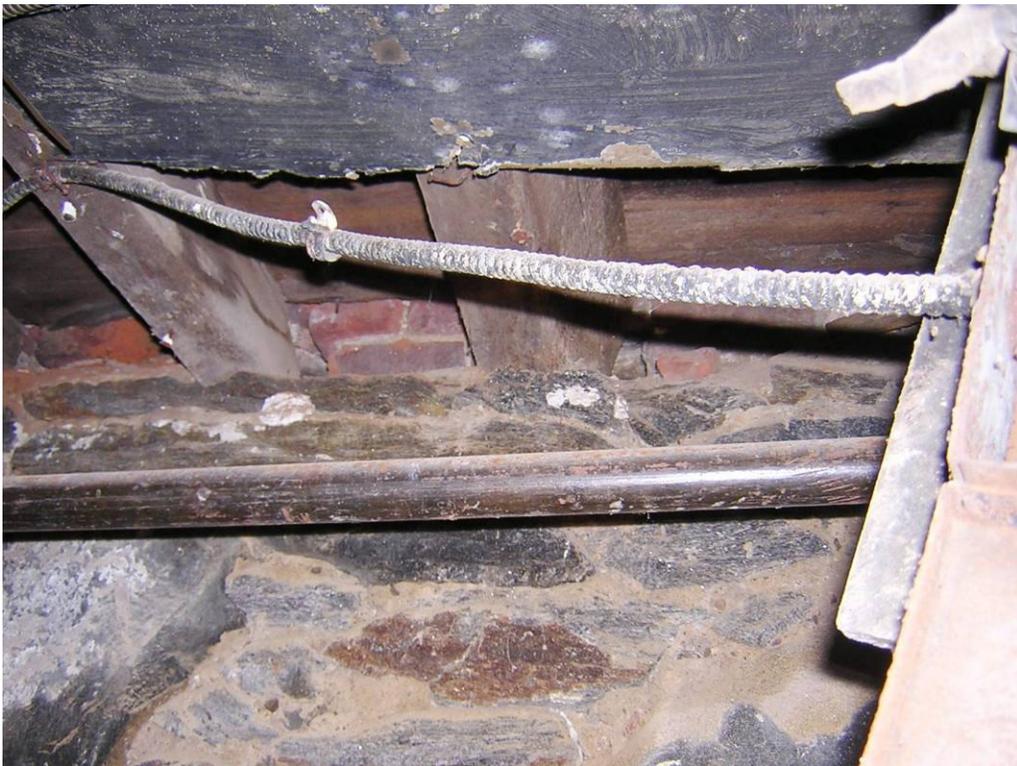
Photo No. 21 – Floor Joist Water Damage At 2nd Floor of Three-Story Building

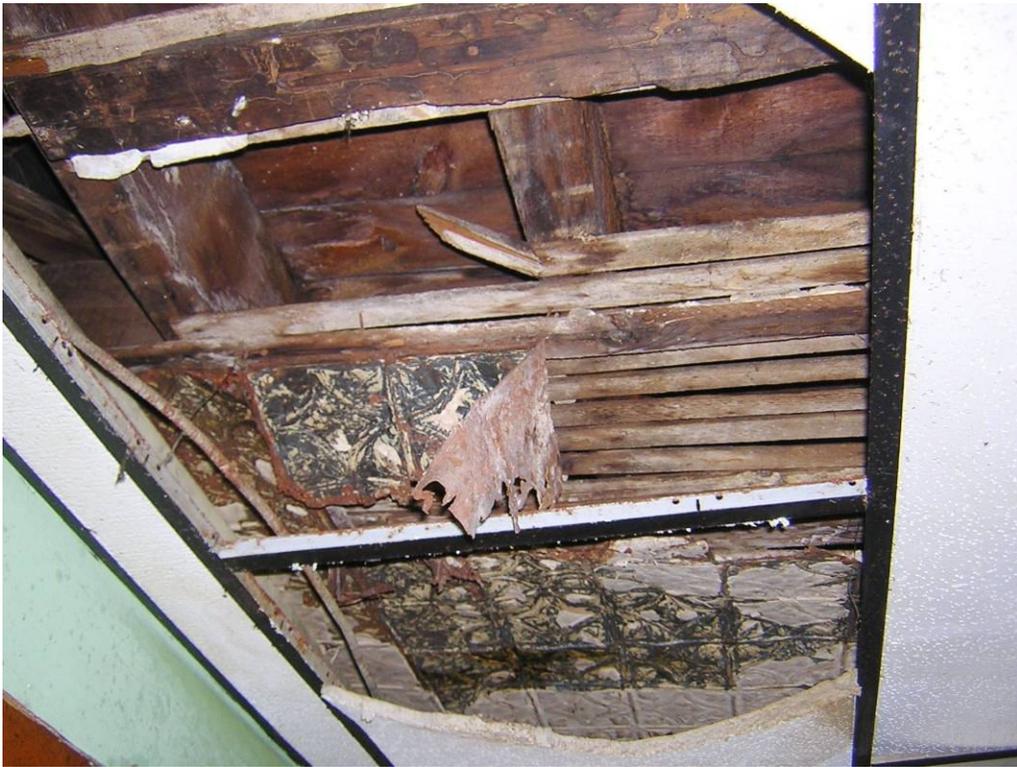
Photo No. 22 – Floor Joist Water Damage At 2nd Floor of Three-Story Building

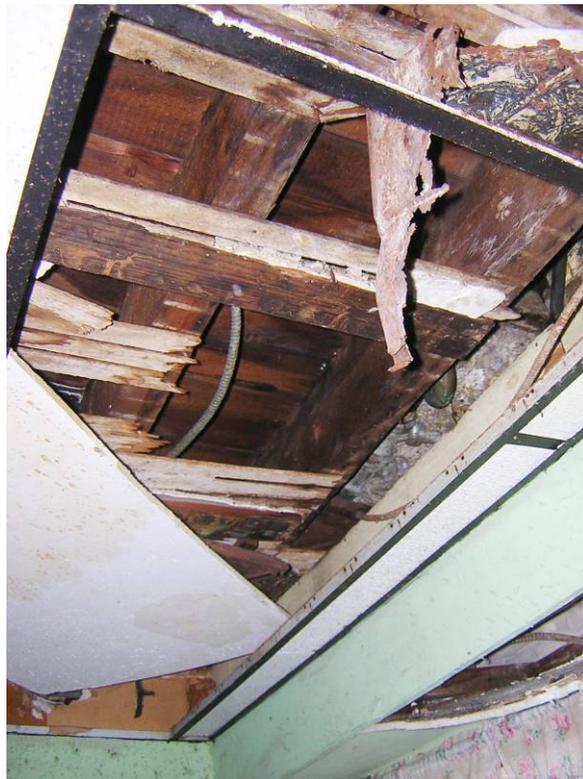
Photo No. 23 – Water Damage At 3rd Floor of Three-Story Building

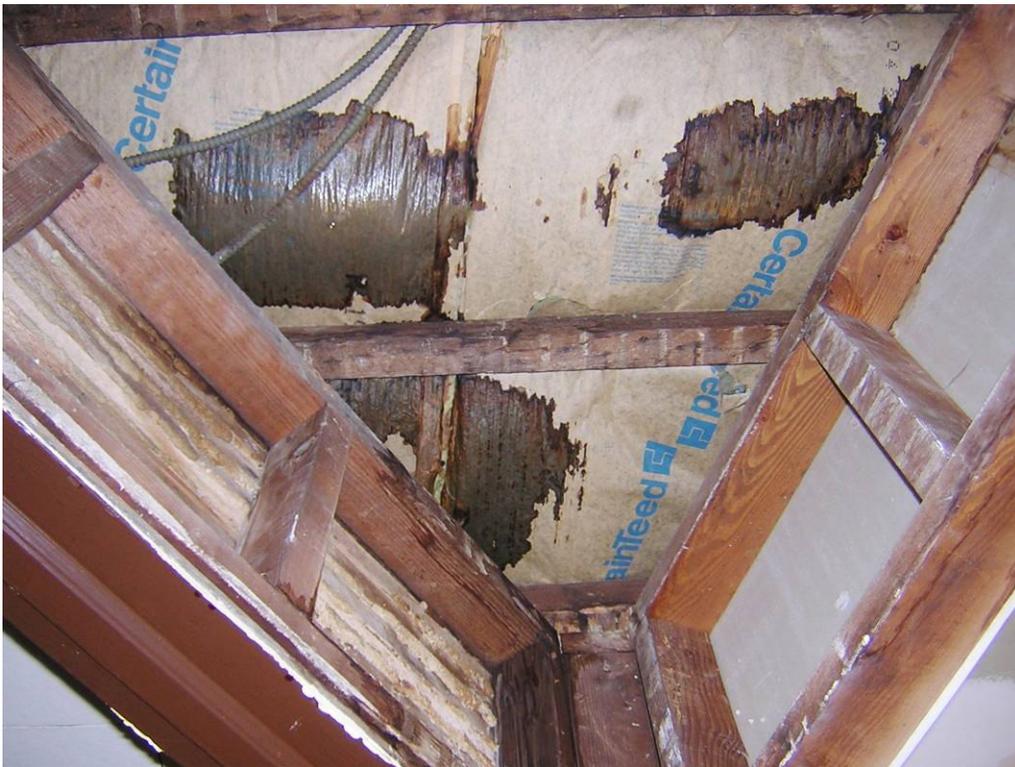
Photo No. 28 – Water Damage At 3rd Floor of Three-Story Building

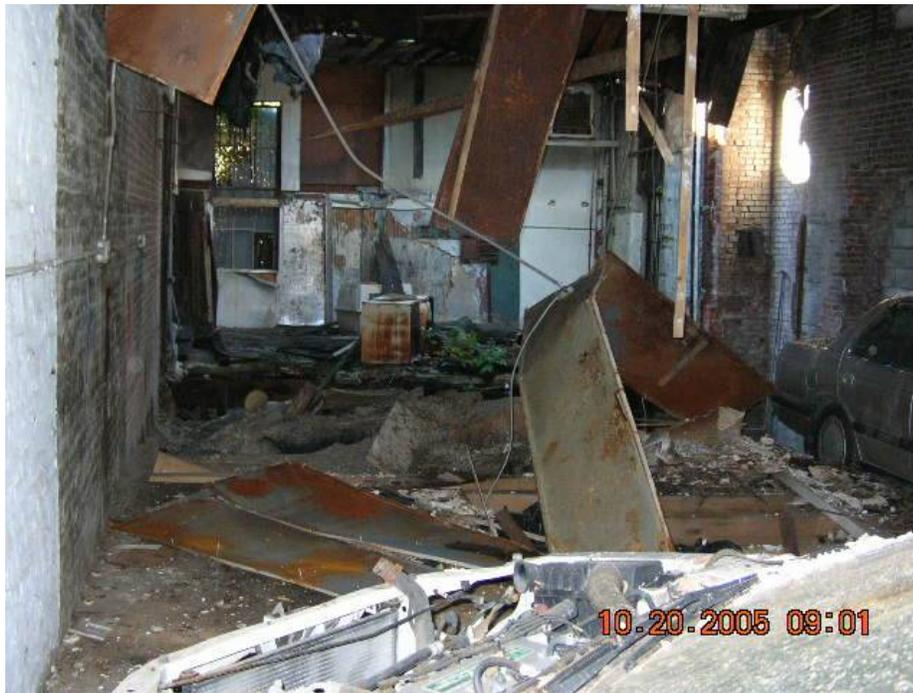
Photo No. 6 – Damaged Timber Floor Framing
