## Block 927, Lot 1

### Location, Use, Zoning, and Ownership

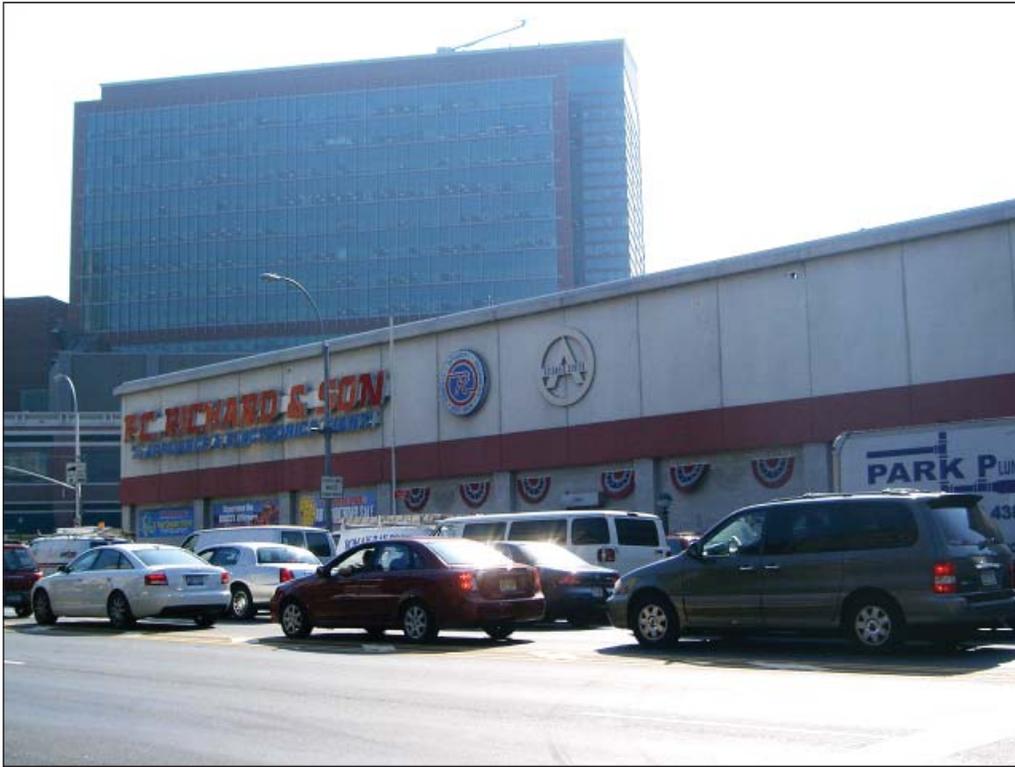
Photograph 927-I-A

Lot 1 is located at 15 4th Avenue, between Atlantic Avenue and Pacific Street. The lot hosts a 30,300 gsf, one-story building currently occupied by a PC Richard & Son appliance store (see Photograph A). Lot 1 is located in a C6-2 zoning district. C6 districts are zoned for a wide range of high-bulk commercial uses requiring a central location, and generally accommodate uses such as corporate headquarters, large hotels, entertainment facilities, and mixed use buildings containing residential, retail, or other commercial uses. C6-2 districts have a maximum commercial FAR of 6.0 (with a bonus to 7.2). According to the New York City Department of Finance, lot 1 is currently owned by AJ Richard & Sons, Inc.

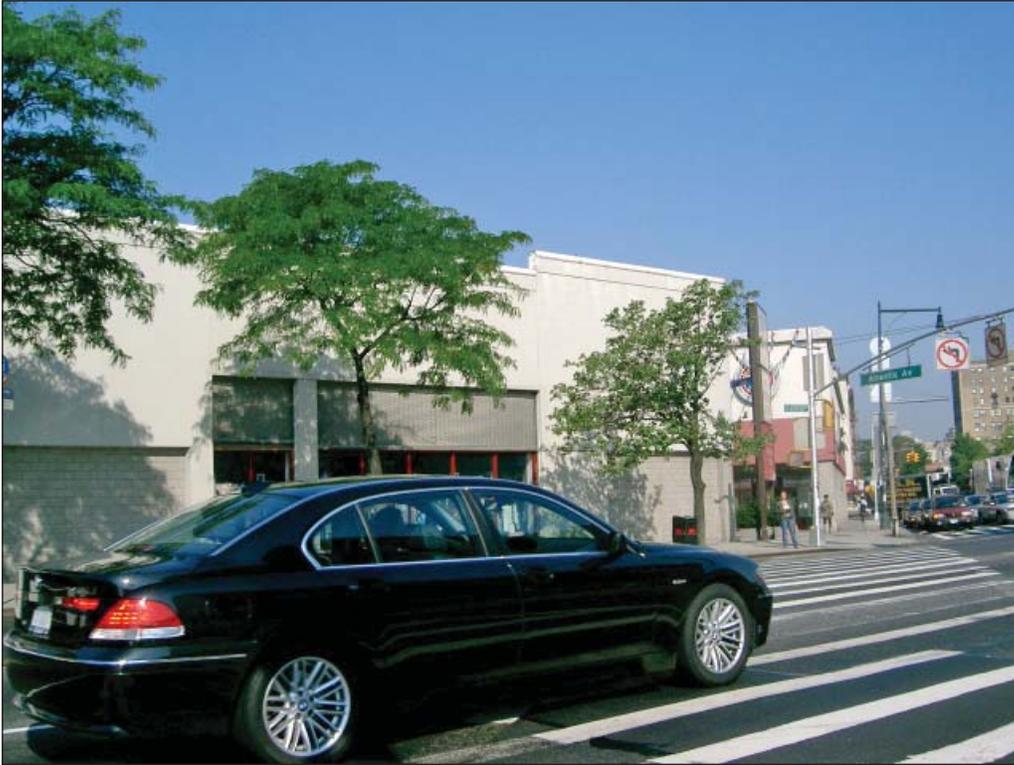
**Photograph 927-16-A**

Lot 16 is located at 617 Pacific Street, with lot area fronting on both Flatbush Avenue and Pacific Street. This lot hosts a 16,950 gsf, one-story building currently occupied by a Modell's sporting goods store (see Photograph A). Lot 16 is located in a C6-2 zoning district. C6 districts are zoned for a wide range of high-bulk commercial uses requiring a central location, and generally accommodate uses such as corporate headquarters, large hotels, entertainment facilities, and mixed use buildings containing residential, retail, or other commercial uses. C6-2 districts have a maximum commercial FAR of 6.0 (with a bonus to 7.2). Lot 16 is currently owned by AYDC.

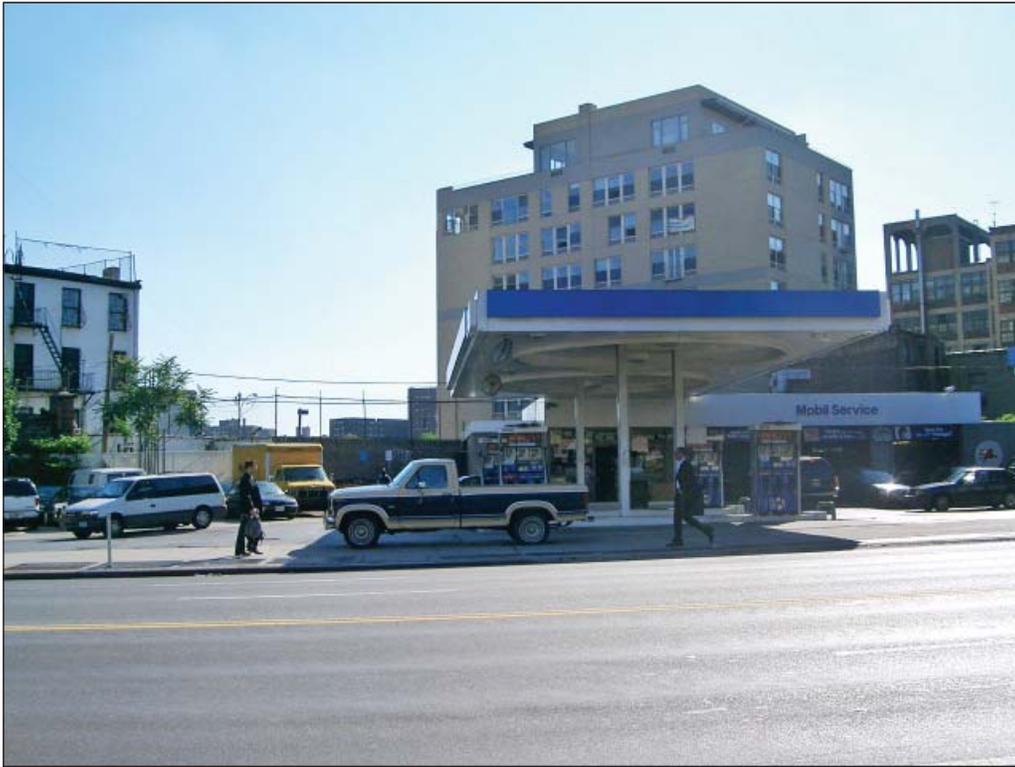
Photograph I 127-I-A

Lot 1 is located at 195 Flatbush Avenue at the intersection of Flatbush Avenue and Dean Street. The lot is occupied by a Mobil gas station and service center (see Photograph A). Lot 1 is located in an R7A zoning district with a C2-4 overlay. R7A districts permit medium-density housing with a maximum FAR of 4.0. C2-4 districts accommodate retail and personal service shops needed in residential neighborhoods. When mapped in R7 districts, the maximum commercial FAR in C2-4 districts is 2.0. Lot 1 is owned by AYDC, which purchased the property in March 2006.

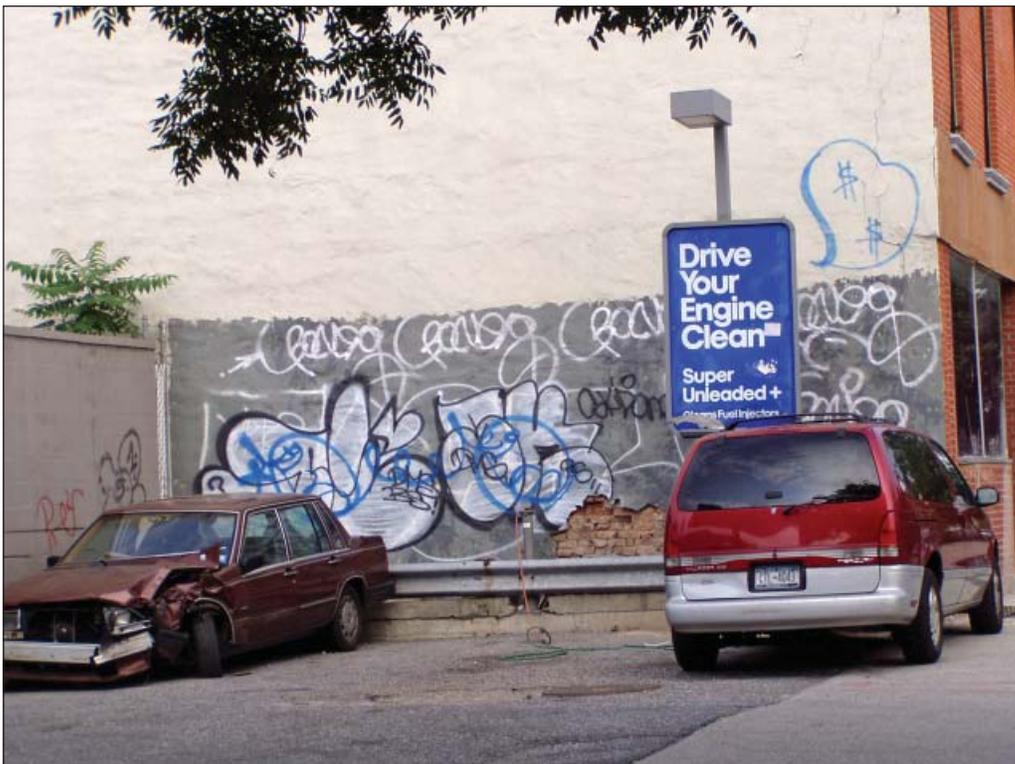
Photograph I 127-I-B

The structures located on lot 1 itself appear to be in fair condition. However, the façade on the building east of lot 1 (lot 56), which faces the gas station and parking area, is in poor condition. As shown in Photograph B, the façade has been plastered over and is painted with graffiti. The plaster has crumbled in areas, exposing the underlying brick. In addition, as shown in Photographs C and D, portions of the lot's asphalt surface are pot holed (Photograph C shows a drainage grate near the lot's entrance that has sunk below grade) and areas of the sidewalk surrounding the lot are cracked and uneven.

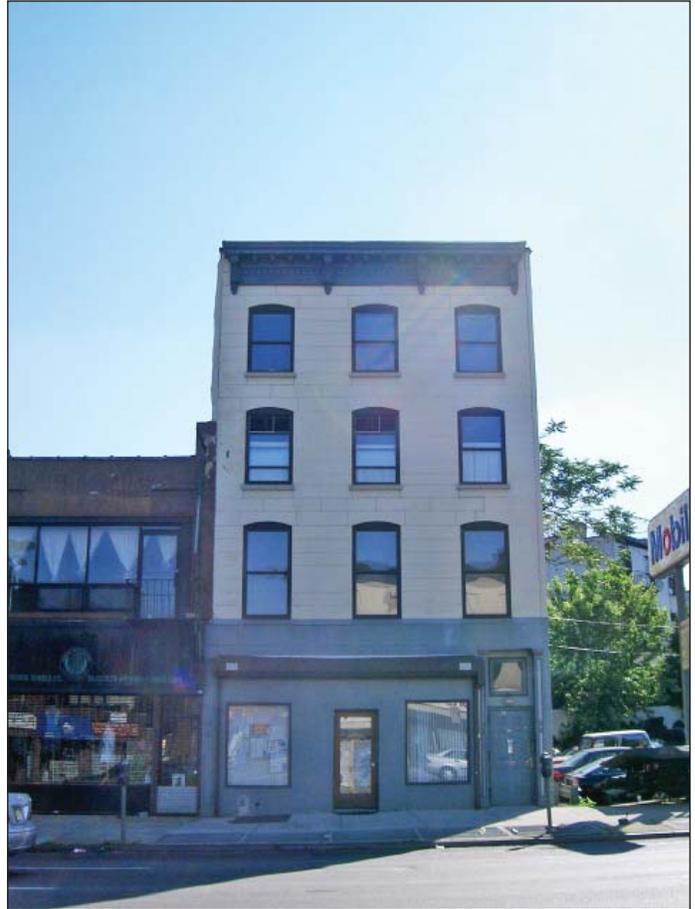
**Photograph 1127-10-A**

Lot 10 is located at 193 Flatbush Avenue between Dean and Pacific Streets. The lot is occupied by a four-story, 5,350 gsf residential building with ground floor commercial use (see Photograph A). Lot 10 is located in an R7A zoning district with a C2-4 overlay. R7A districts permit medium-density housing with a maximum FAR of 4.0. C2-4 districts accommodate retail and personal service shops needed in residential neighborhoods. When mapped in R7 districts, the maximum commercial FAR in C2-4 districts is 2.0. Lot 10 is owned by AYDC, which purchased the property in April 2005.

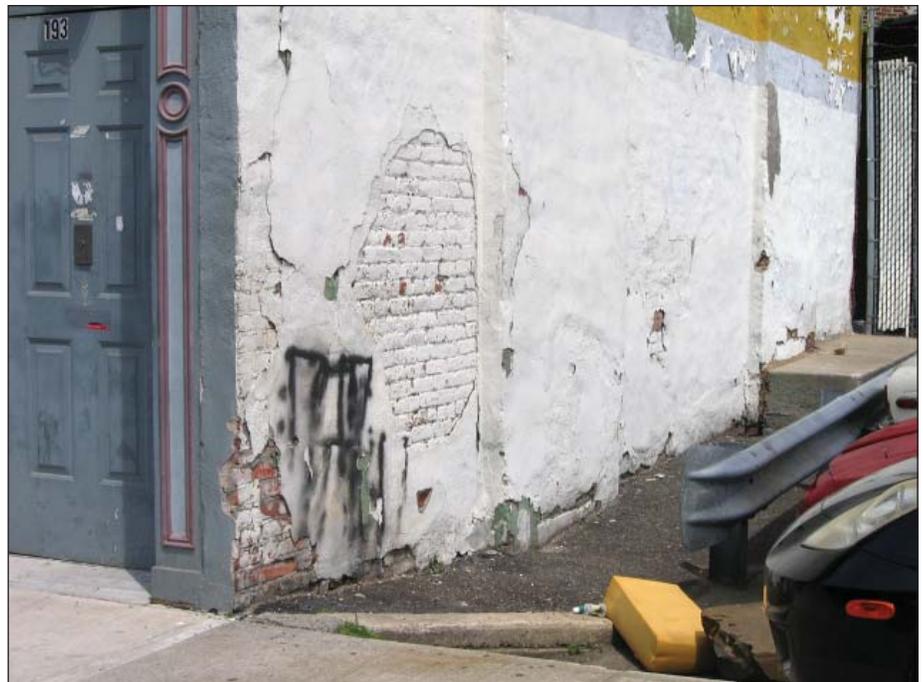
**Photograph 1127-10-B**

Apart from the peeling paint and loose brickwork on the building's eastern wall (see Photograph B), no unsanitary or unsafe conditions were identified as part of the visual assessment.

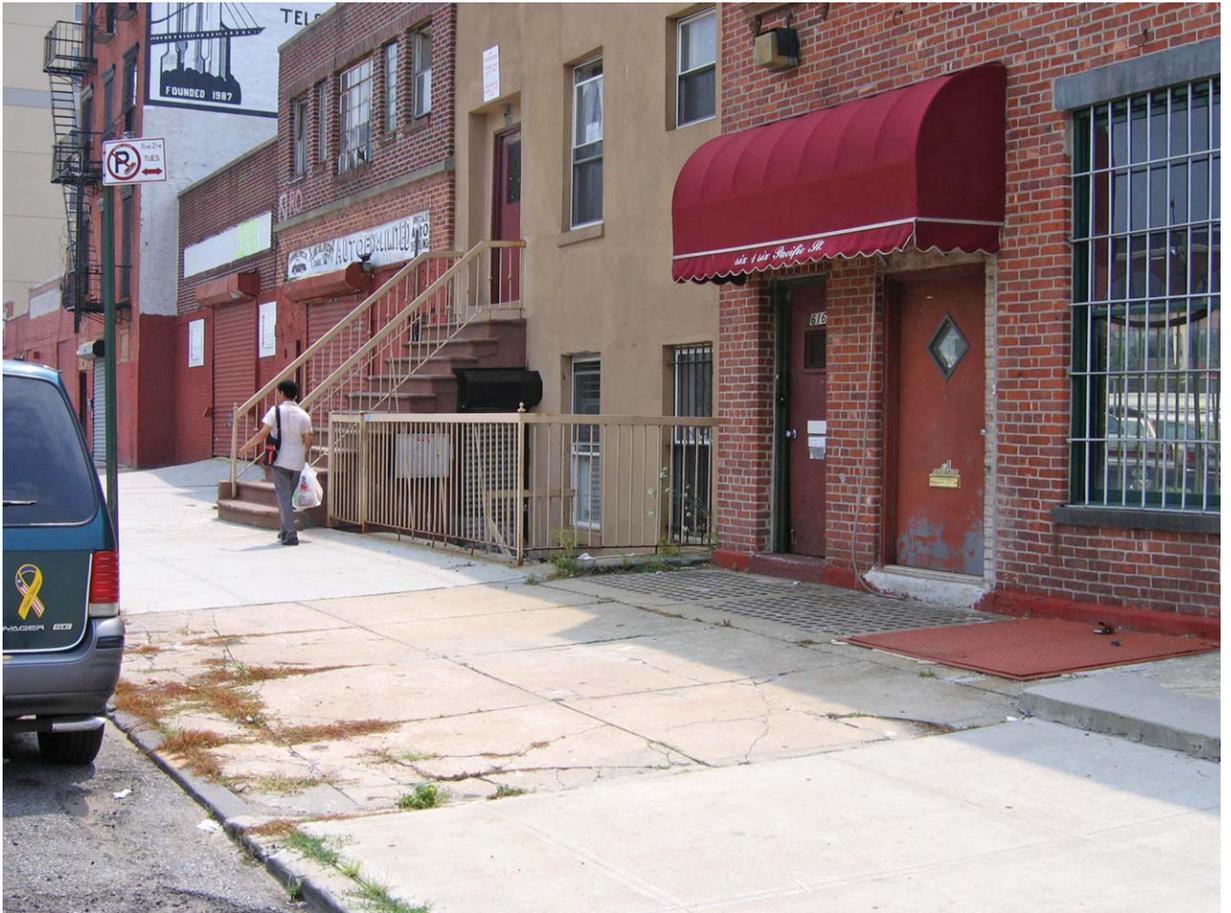
Photograph I127-11-C

As shown in Photograph C, the sidewalk in front of the Pacific Street portion of lot 11 is cracked in many places and weeds are growing through the cracks closest to the curb.

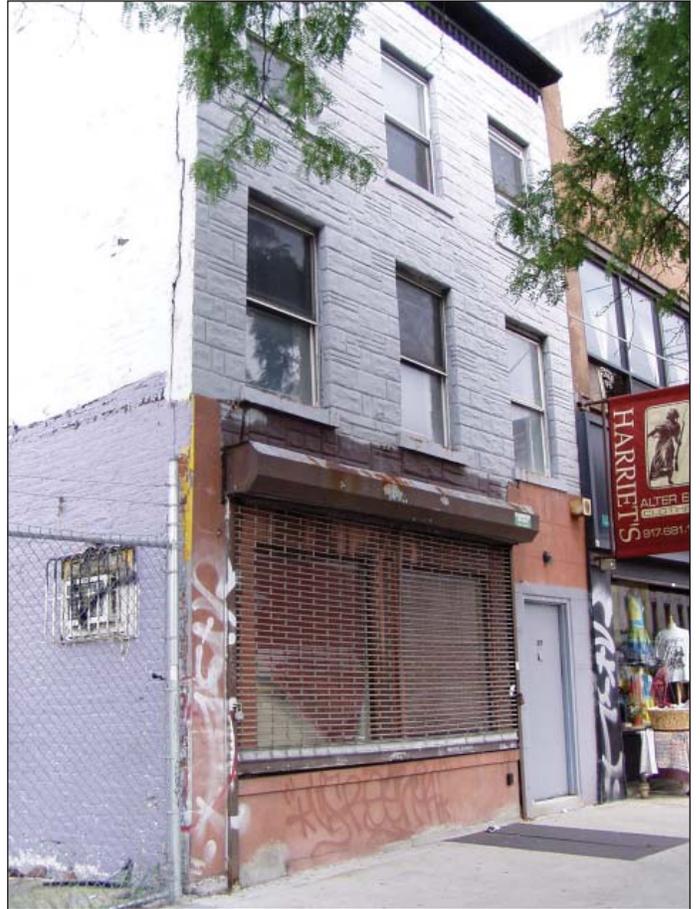
**Photograph 1127-12-A**

Lot 12 is located at 189 Flatbush Avenue. As shown in the map above, the lot runs across the narrow western end of Block 1127 and fronts on both Flatbush Avenue and Pacific Street. The southern portion of the lot hosts a vacant three story mixed use residential and commercial building fronting Flatbush Avenue (see Photograph A) and the northern portion of the lot hosts a vacant one story building fronting Pacific Street (see Photograph B). Combined, the buildings contain 2,642 gsf of space.

The vertical crack that runs almost the entire length of the building fronting Flatbush Avenue (see Photographs A and C) may be indicative of some structural degradation. However, a structural due diligence survey has not been conducted for this lot.

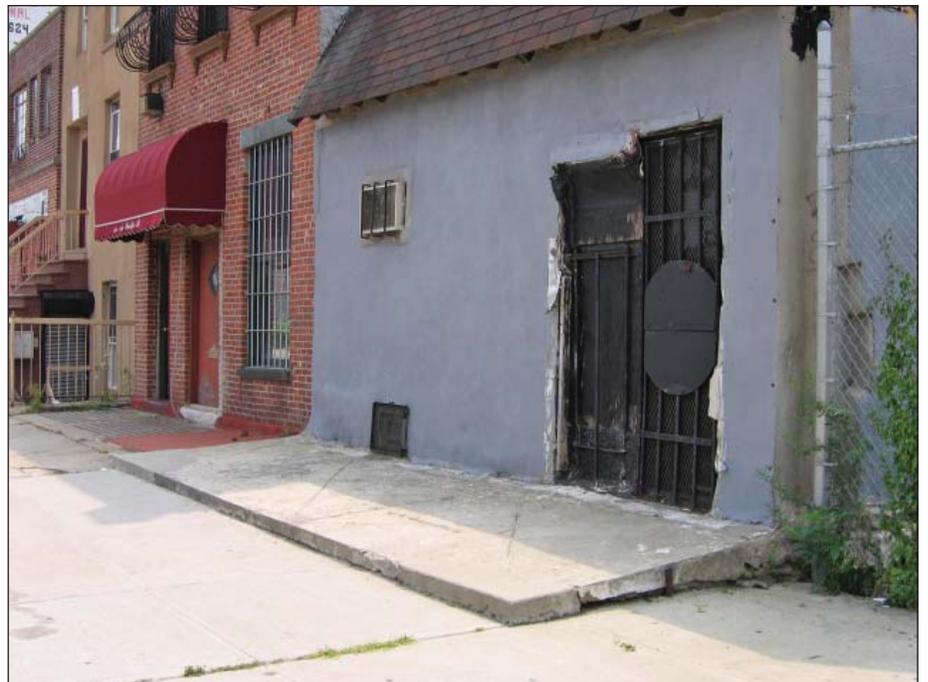
**Photograph 1127-12-B**

The façade of the building fronting Pacific Street is deteriorating in the area surrounding the gated doorway. The concrete platform in front of the building is chipped and there is a gap between the eastern part of the platform and the underlying sidewalk (see Photograph B). There is graffiti painted on the lower façade of the building fronting Flatbush Avenue (see Photograph A) and as shown in Photographs A and C, paint is flaking off of the facade that faces the adjacent vacant property (lot 13). A large vertical crack runs along that same side of the building, close to Flatbush Avenue.

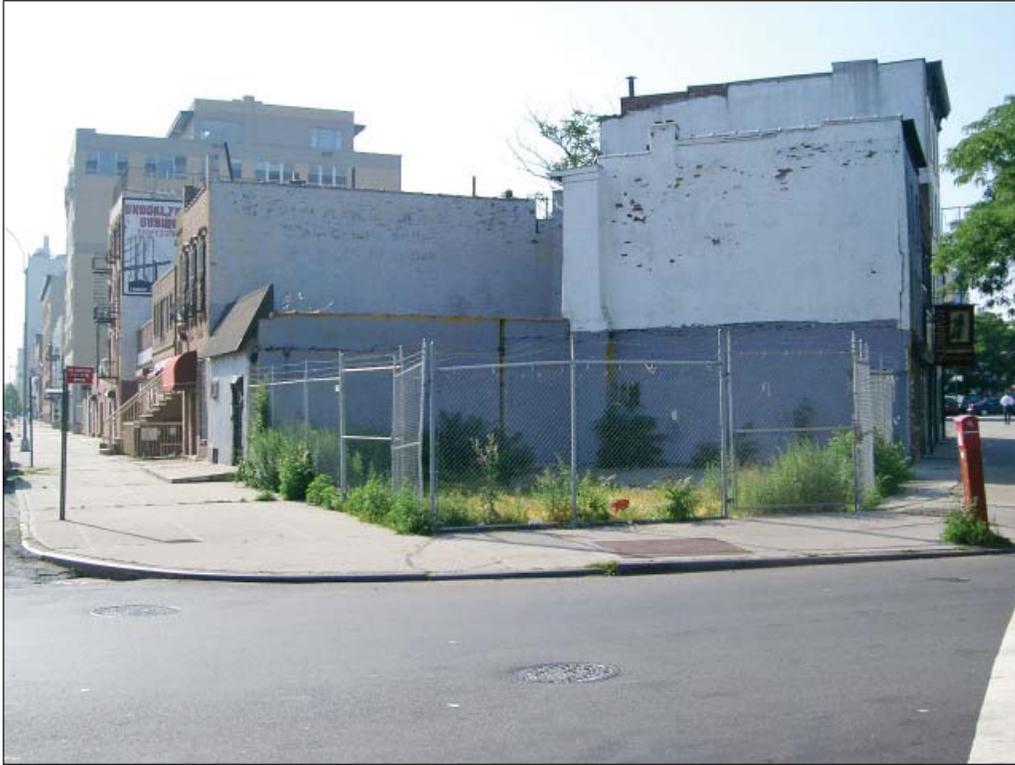
Photograph I 127-13-A

Lot 13 is a small, vacant, irregularly shaped lot located at 185 Flatbush Avenue, at the corner where Pacific Street, 5th Avenue, and Flatbush Avenue converge (see Photograph A). Lot 13 is located in an R7A zoning district with a C2-4 overlay. R7A districts permit medium-density housing with a maximum FAR of 4.0. C2-4 districts accommodate retail and personal service shops needed in residential neighborhoods. When mapped in R7 districts, the maximum commercial FAR in C2-4 districts is 2.0. Lot 13 is owned by AYDC, which purchased the property in April 2005.

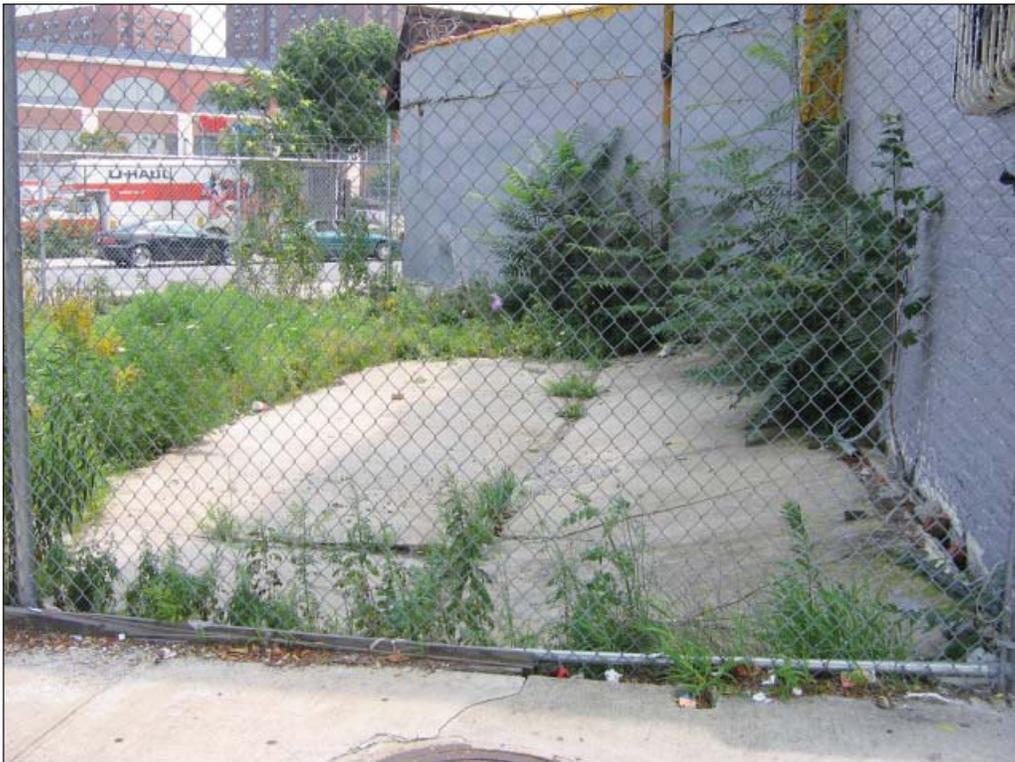
Photograph I 127-13-B

As shown in Photograph B, a sunken concrete slab—possibly a remnant from a structure previously located on lot 13—covers about a third of the lot area. Tall weeds grow in the crack between this concrete slab and the building on lot 12, and the portion of the lot that is not covered by the slab is also overgrown with vegetation (see Photographs B and C).

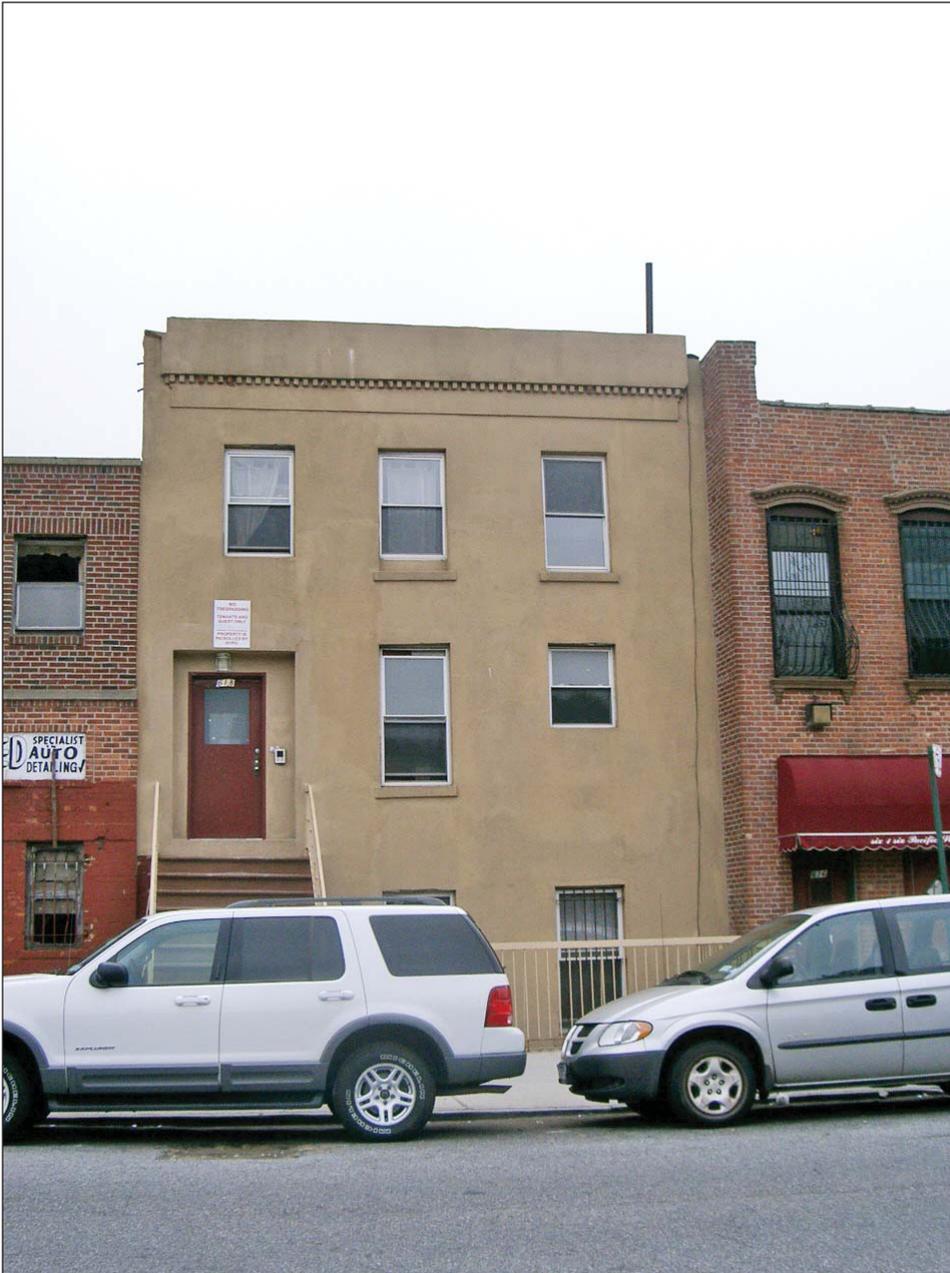
**Photograph I 127-18-A**

Lot 18 is located at 618 Pacific Street between 5th and 6th Avenues. The lot hosts a three-story, 2,850 gsf multifamily residential building (see Photograph A). Lot 18 is located in an R7A zoning district with a C2-4 overlay. R7A districts permit medium-density housing with a maximum FAR of 4.0. C2-4 districts accommodate retail and personal service shops needed in residential neighborhoods. When mapped in R7 districts, the maximum commercial FAR in C2-4 districts is 2.0. Lot 18 is owned by the US Department of Housing and Urban Development (HUD).

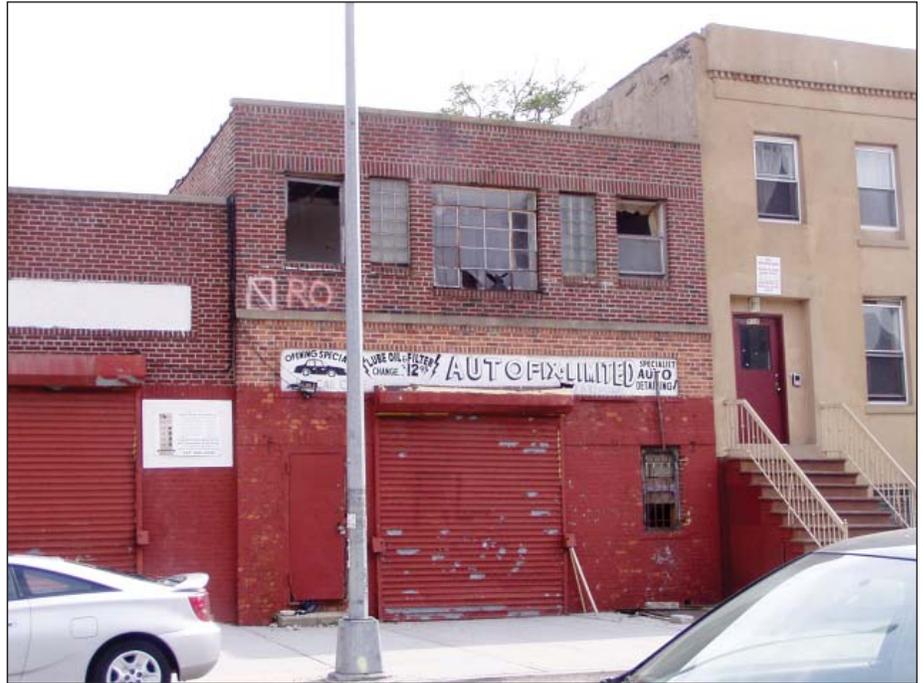
**Photograph 1127-19-A**

Lot 19 is located at 620 Pacific Street, between 5th and 6th Avenues. Until Spring 2006, the lot was occupied by a vacant two-story, 3,158 gsf structure, which was formerly an auto repair shop (see Photograph A). The building was demolished by AYDC with approval from ESDC because of its dangerously deteriorated condition, as described below.

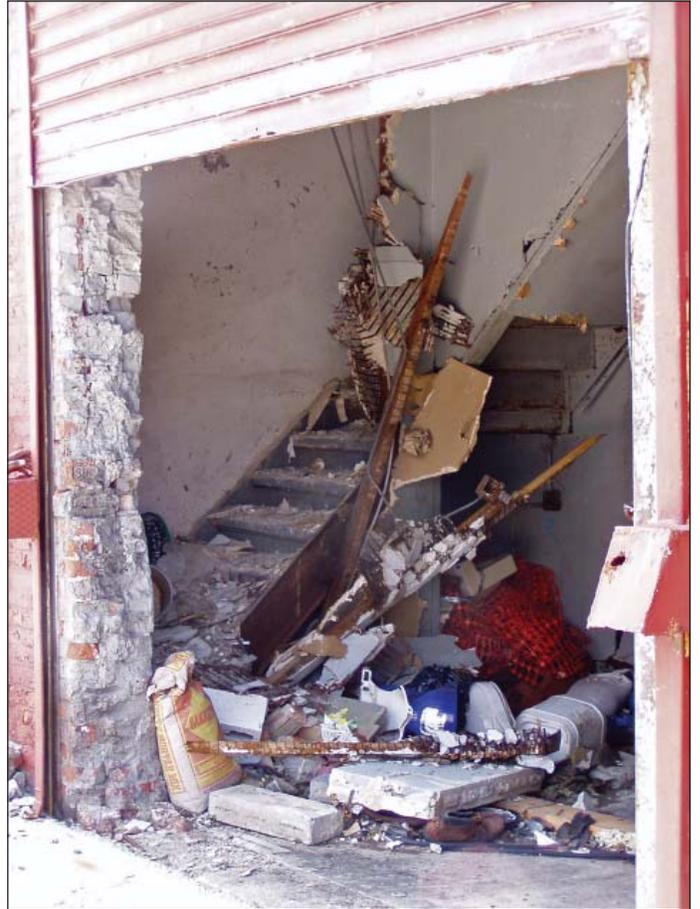
**Photograph 1127-19-C**

As indicated above, the building on lot 19 was demolished in Spring 2006. Although the façade of the 3,158 gsf building appeared to be physically intact with the exception of some peeling paint and several broken windows in the front, the interior of the building was in extremely poor condition, suffering from years of neglect. A pit in the ground floor (perhaps used in auto repair) covered almost the entire length of the building and was littered with pieces of broken wood beams and old window parts (see Photograph B). The ceiling was stripped bare with exposed electrical wiring hanging from lighting fixtures. The staircase joining the first and second floors was severely damaged with crumbling walls and heavy construction debris scattered throughout (see Photograph C).

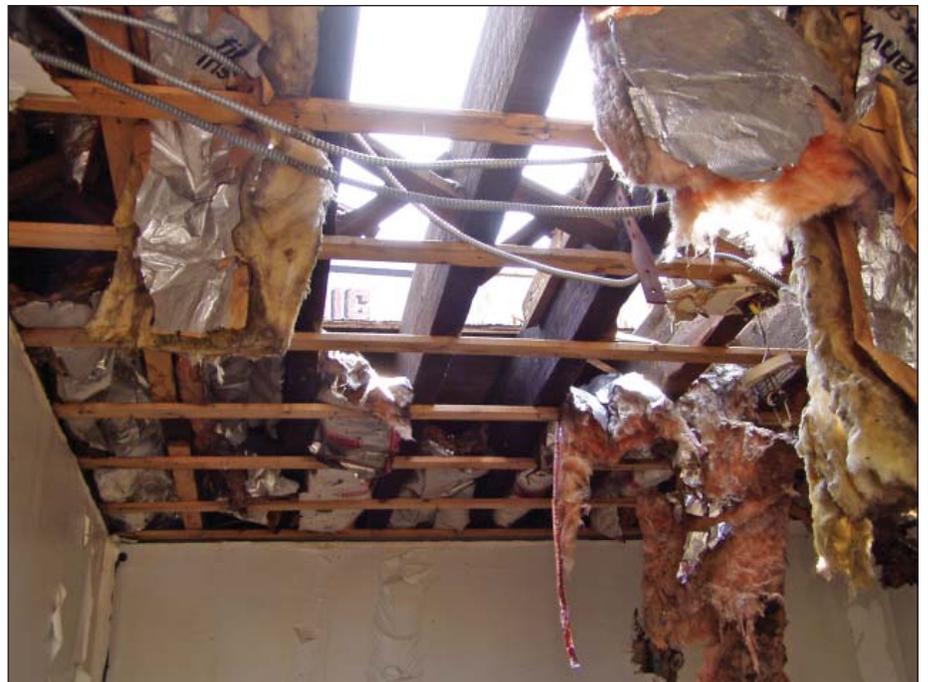
**Photograph 1127-19-D**

A structural due diligence survey, completed by LZA Technology in November 2004 (see Appendix A), indicated that the building on lot 19 was in danger of collapse and recommended that the building be demolished because it posed an immediate threat to health and safety. As shown in Photograph D, there was a large hole in the roof of the building, and insulation material hung from the roof ceiling. There was excessive damage to the walls on the second floor of the building (e.g., peeling plaster and torn plywood), some of which probably occurred as a result of the open roof. The LZA report states that active leaks throughout the building, along with numerous cracked and broken glass window panes, had left the building permanently exposed to the elements, and that continued deterioration would have eventually led to additional local collapses of the timber floor and roof joist systems. The report further indicates that the structure was extremely dangerous and could have collapsed at any time.
