Block I 129, Lot 25

Location, Use, Zoning, and Ownership

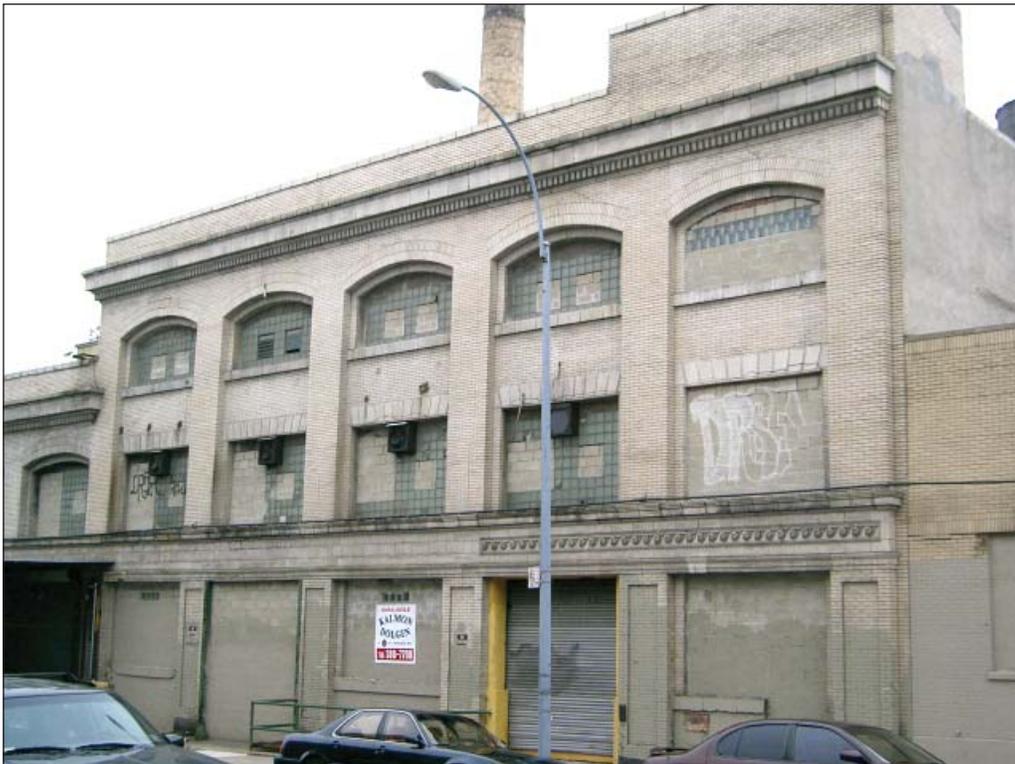
Photograph I 129-25-B

AYDC has maintained lot 25 in substantially the same condition it was in when the property was purchased in March 2006. All of the windows in the building on lot 25 have been partially or wholly filled in with cement blocks (see Photograph B). Graffiti has been painted onto the building's façade in several locations (see Photographs B and C) and large cracks are visible on portions of the façade around the base of the building (see Photograph D). The building's location across from the eastern portion of the rail yard, coupled with the scaffolding that surrounds the building, create a feeling of isolation. As shown in Photographs E and F, it appears that homeless persons have used the recessed area between the building's façade and the sidewalk on the Pacific Street side of the building for shelter. The tarp, plastic sheeting, and personal belongings (e.g., clothing, soda bottles) shown in Photographs E and F were present on lot 25 over the course of multiple visits to the site during the Summer and Fall of 2005.

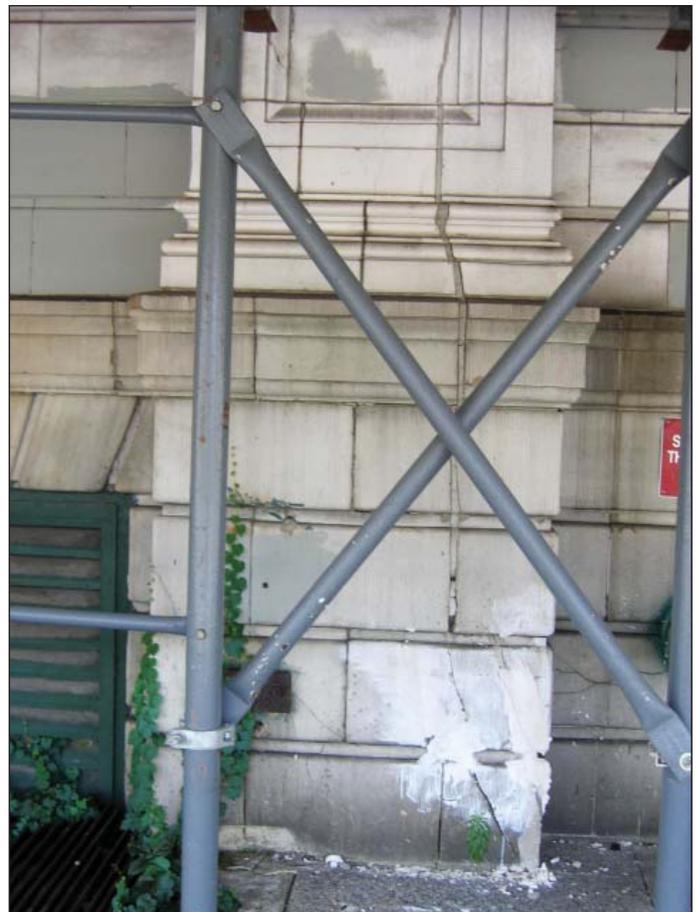
Photograph I 129-25-D

A structural due diligence survey has not been conducted for this lot. Although the visual assessment did not indicate that the building structure is substantially compromised, cracks such as the one shown in Photograph D, loose brickwork along other portions of the façade and interior water damage and pooling water as shown in Photographs M and N may be indicative of structural degradation.

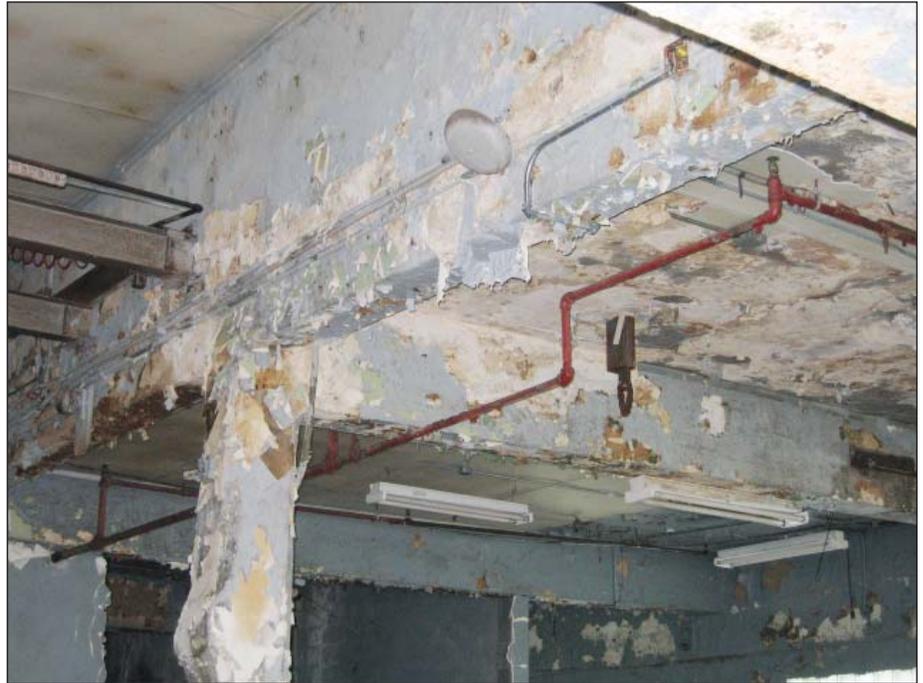
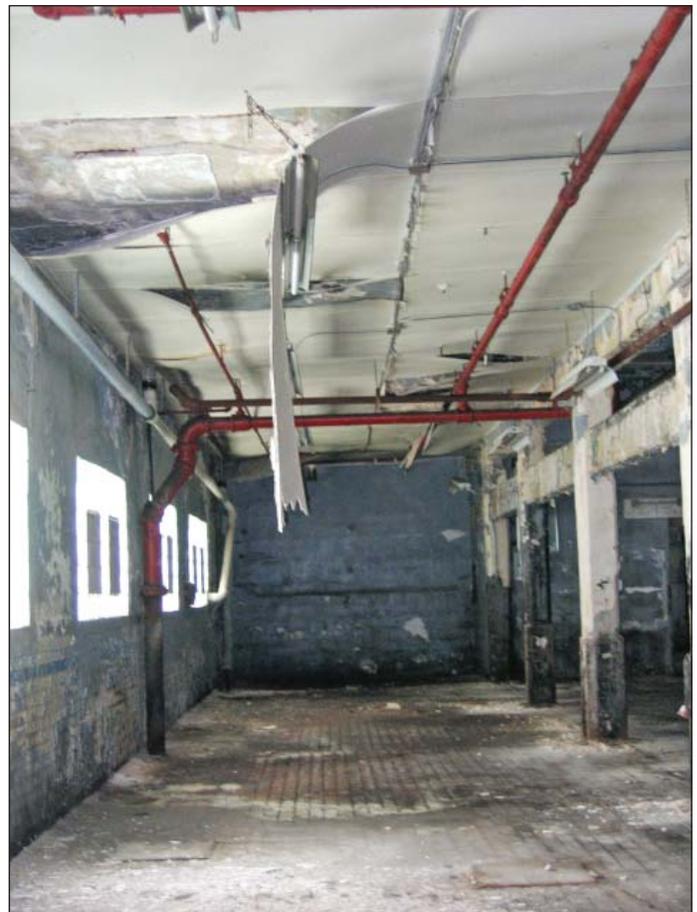
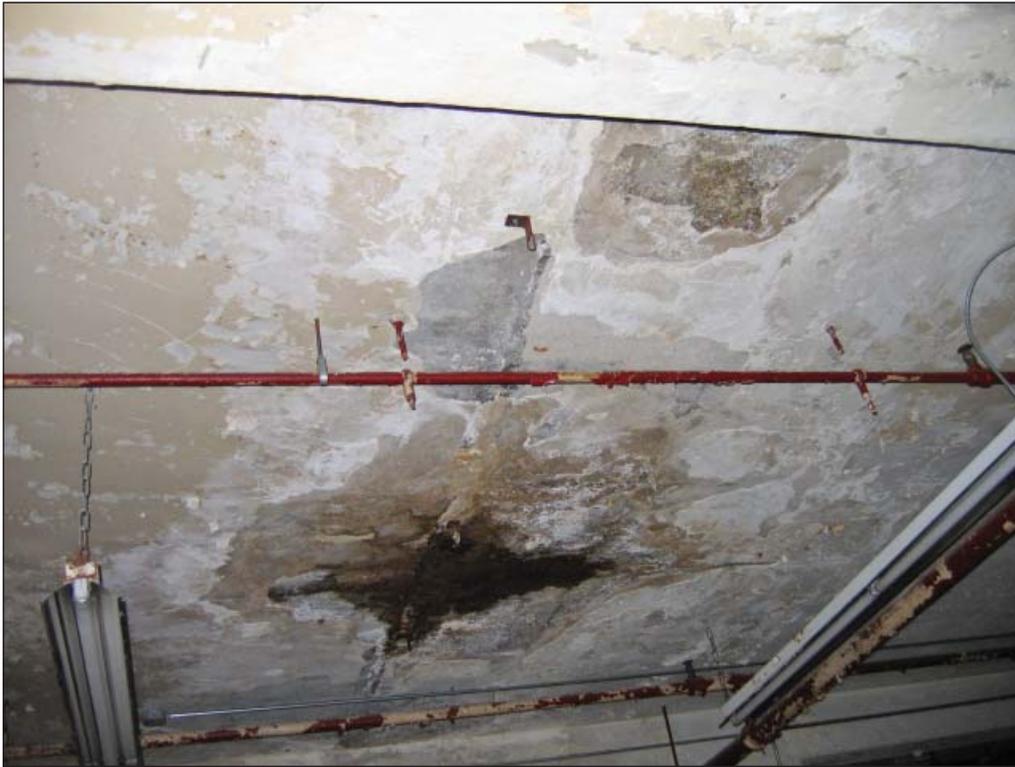
The interior of the building on lot 25 is in very poor condition. As shown in Photographs G through I there are multiple layers of paint and plaster flaking off many of the interior surfaces and there are holes in the walls and ceiling in several portions of the building (see Photographs J and K). Some of these holes appear to be due to water damage. As evidenced by Photographs L through N, parts of the building are open to the outside, allowing pigeons to settle in the building (see pigeon droppings in Photograph L) and water to pool on the floor (see Photographs M and N).

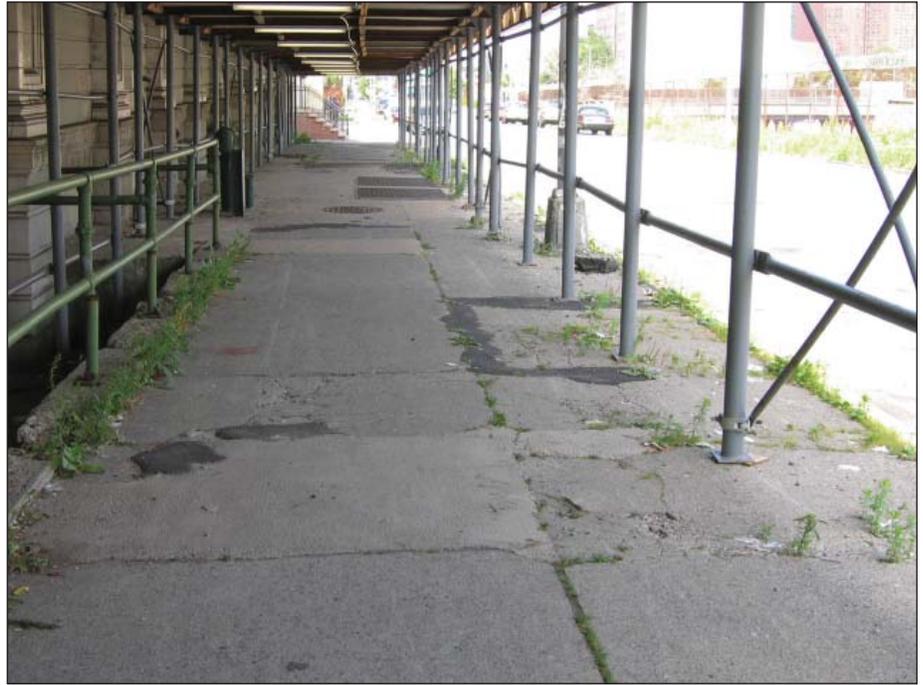
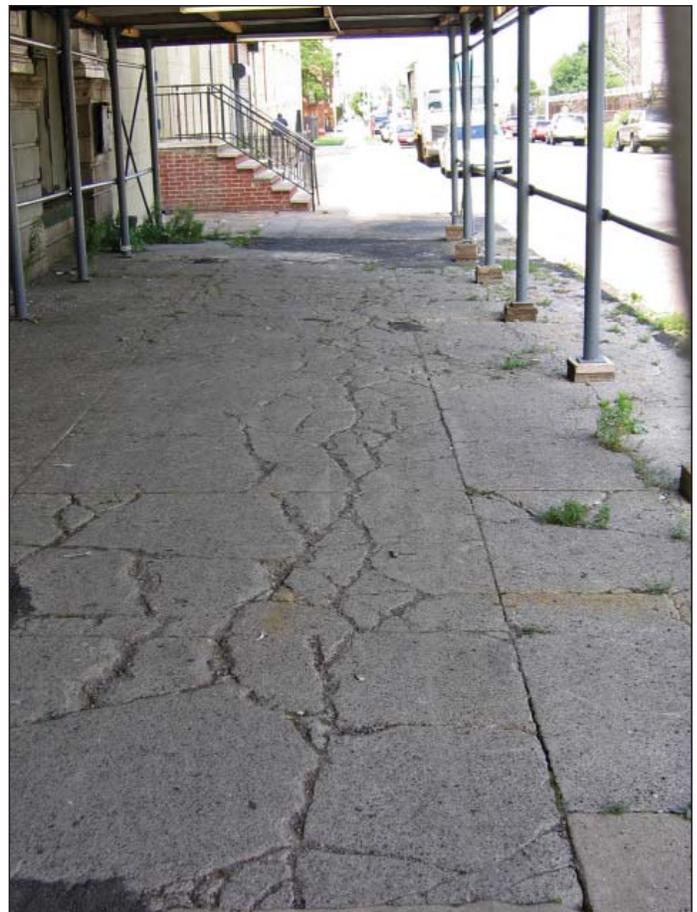
In addition, the sidewalk along lot 25—particularly on the Pacific Street side of the lot—is in very poor condition. As shown in Photographs O and P, portions of the sidewalk are severely cracked and crumbling, and weeds grow through the cracks along the length of the sidewalk. In some areas, holes have been patched with asphalt, but the asphalt is now coming loose.

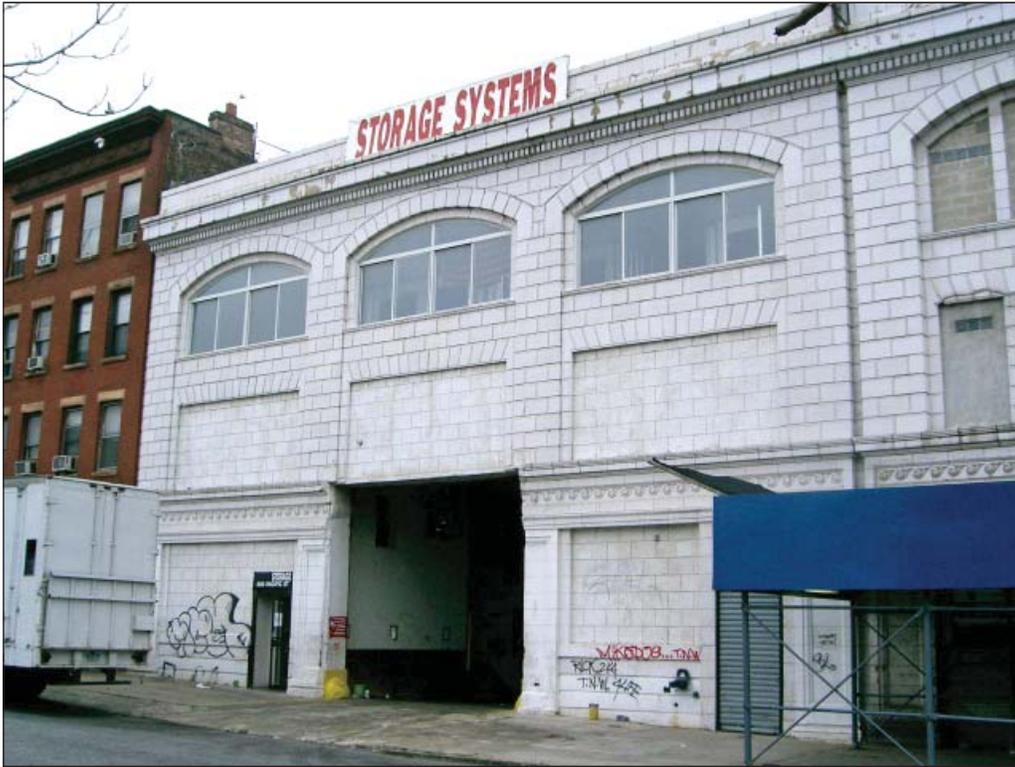
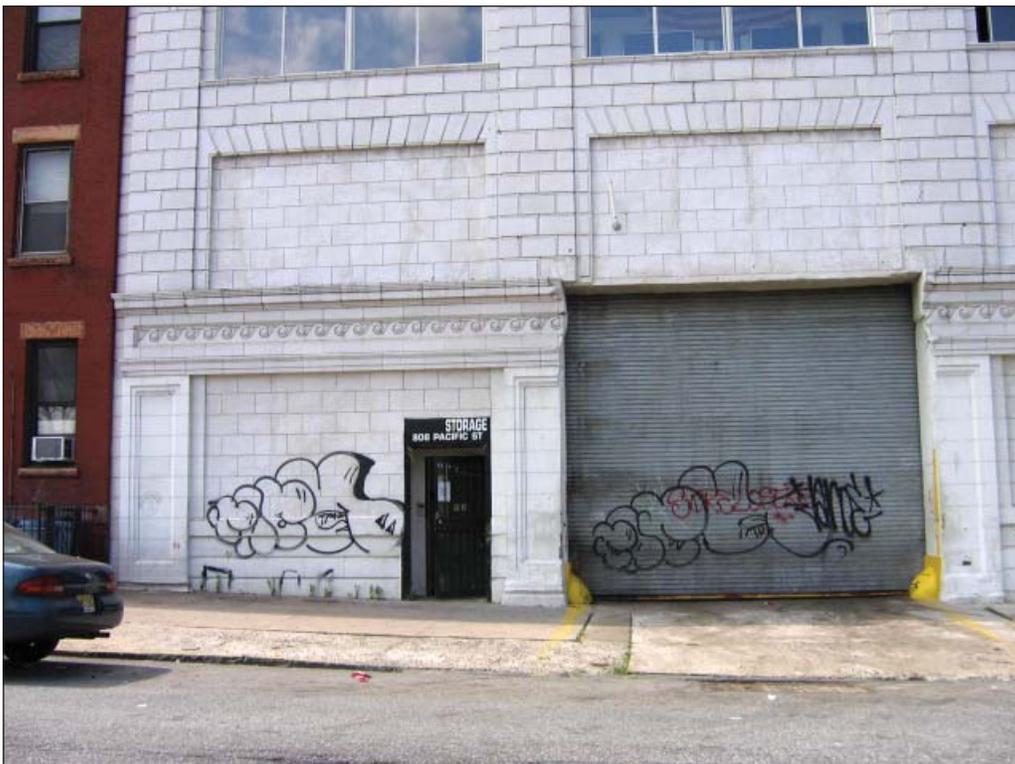
As shown in Photographs A and B, there is graffiti on the façade of the building and on the building's metal door. Apart from this graffiti, no unsanitary and unsafe conditions were identified as part of the visual assessment.

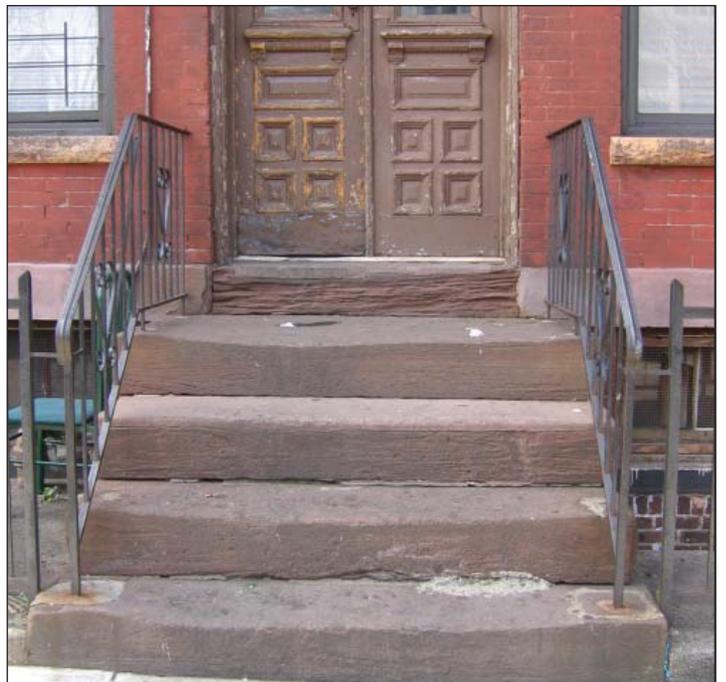
Photograph 1129-43-B

AYDC has maintained lot 43 in substantially the same condition it was in when the property was purchased in April 2005. The exterior of the building on lot 43 is in generally fair condition. As shown in Photograph B, the building's wooden door is dented and chipped, and the steps leading to the door are chipped and worn down in places, but overall the façade appears to be in fair condition. However, the interior of the building shows signs of many years of disrepair. As shown in Photographs C and D, the hallways floors and stairwells are severely worn and dirty. And as illustrated in Photographs E through H, which were taken in one of the ground floor vacant apartment units, the building's walls and ceilings have suffered from water damage. The paint and plaster on the walls is bubbling, peeling, and falling off in several areas, and as shown in Photograph G, plaster has fallen from the ceiling along some of the window frames. Graffiti has been painted inside the cupboard near the sink and on the brick fill in the fireplace.

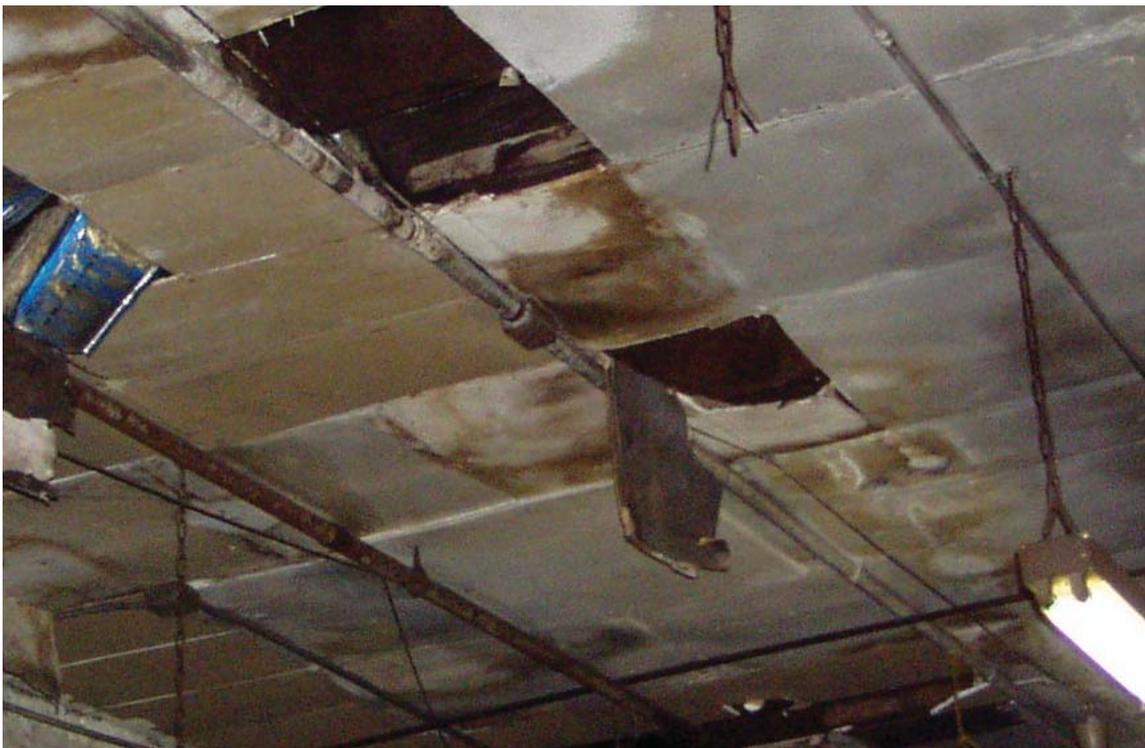
Photograph I 129-45-B

AYDC has maintained lot 45 in substantially the same condition it was in when the property was purchased in June 2005. The exterior of the building on lot 45 is in poor condition from many years of neglect. There is a large, poorly patched crack in the brickwork on the façade of the building. Graffiti marks the garage entry, window, and front doorway. Deterioration is also evident in the building's interior. There are holes in parts of the ceiling exposing electrical outlets and wiring. Elsewhere, the ceiling and walls have been seriously damaged by water, causing ceiling tiles to fall, exposing electrical wires (see Photograph B.)

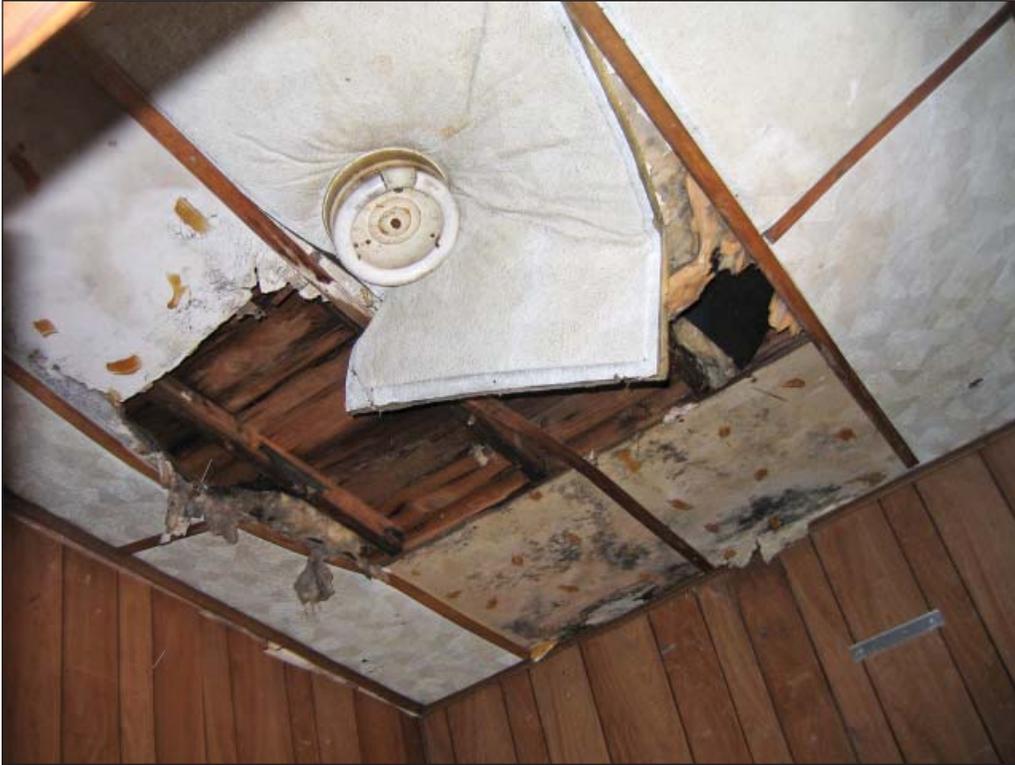
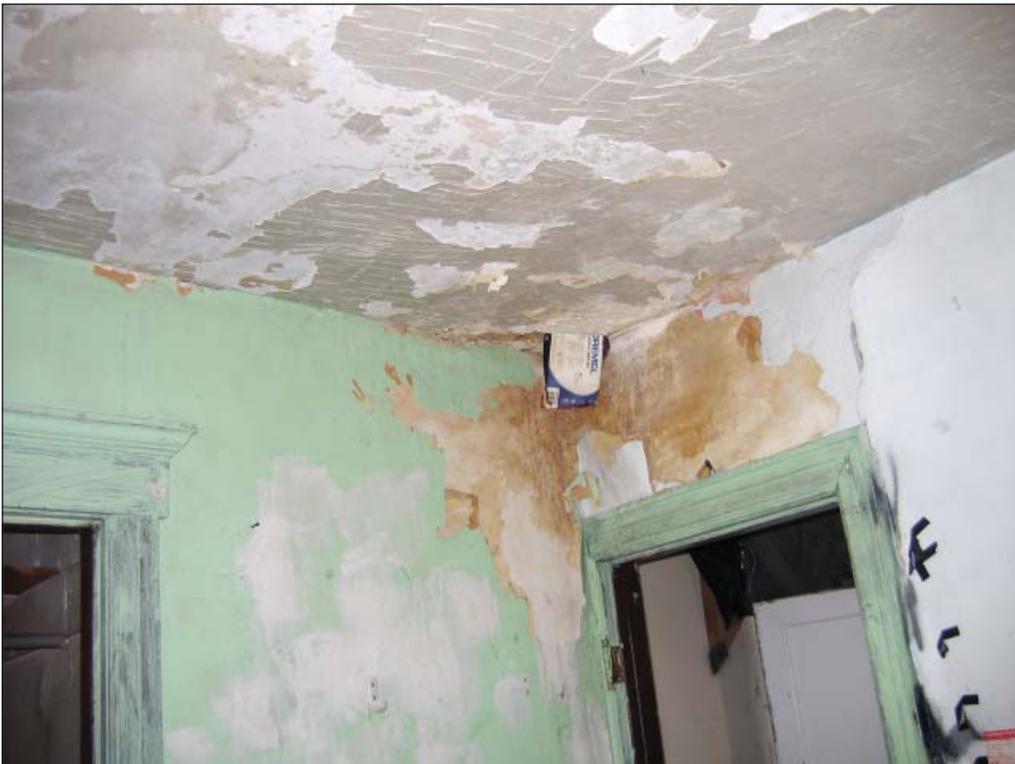
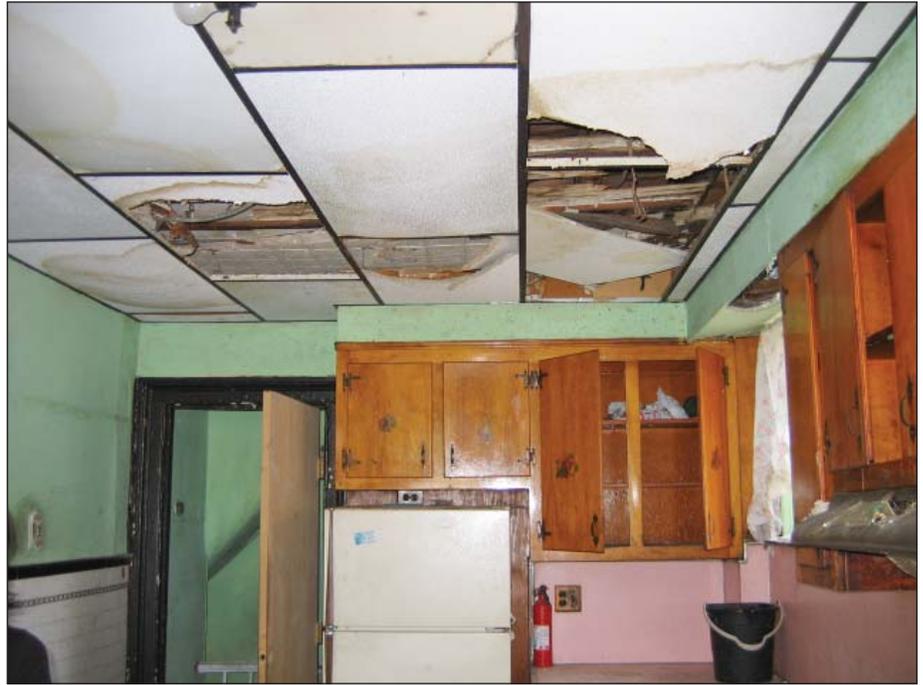
The interiors of the buildings on lot 46 are also in disrepair. As shown in Photographs G through I, the ceilings and walls in the residential building are severely damaged and insulation is falling from the ceiling in some areas. The wooden steps leading to the basement are falling down and the plaster wall in the stairwell is crumbling (see Photograph J). The basement itself is littered with debris and the walls and ceiling are in poor condition (see Photographs K and L). The second story balcony facing the northern portion of the lot is also in poor condition. As shown in Photograph M, the bricks under the window opening are crumbling and the surfacing on the brick wall on the right is cracked and has begun to fall off.

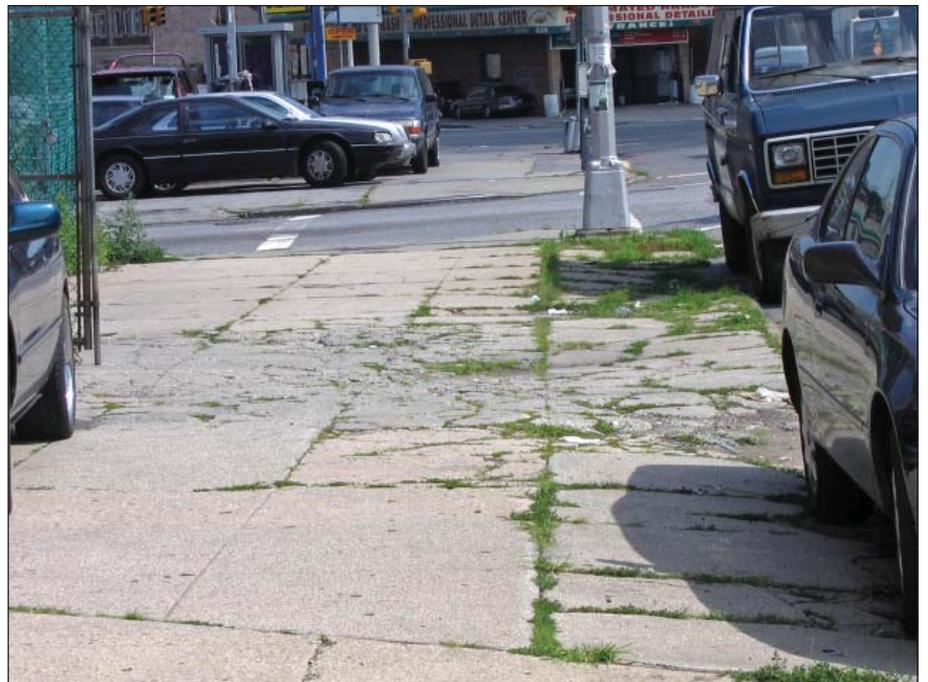
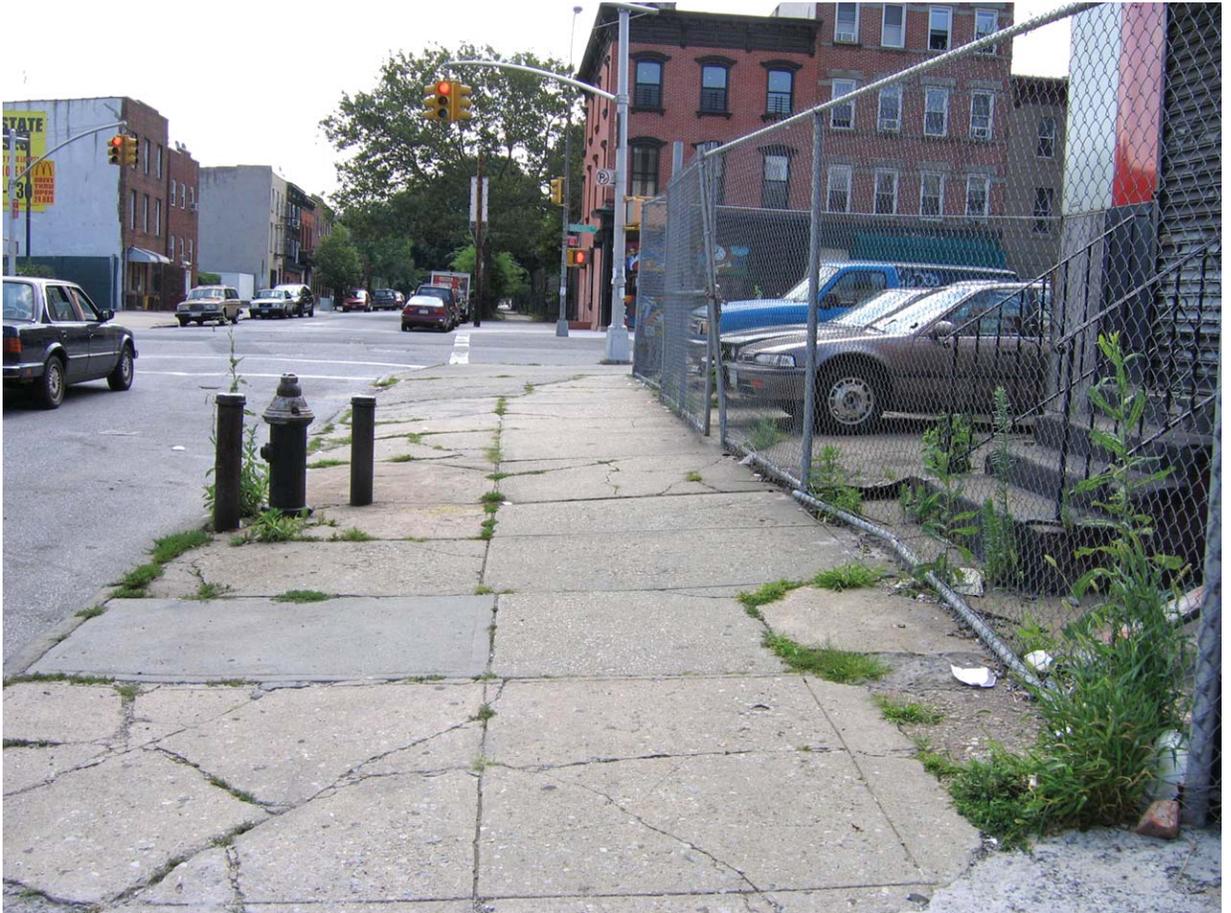
In addition to the unsafe and unsanitary conditions on the lot itself, the sidewalk surrounding the lot is also in a state of disrepair. As shown in Photographs N and O, the sidewalk is severely cracked and uneven and weeds are growing through most of the cracks.
