C. CURRENT CONDITIONS

OVERALL LOT AND INFRASTRUCTURE CONDITIONS

Manhattanville Neighborhood Conditions Study

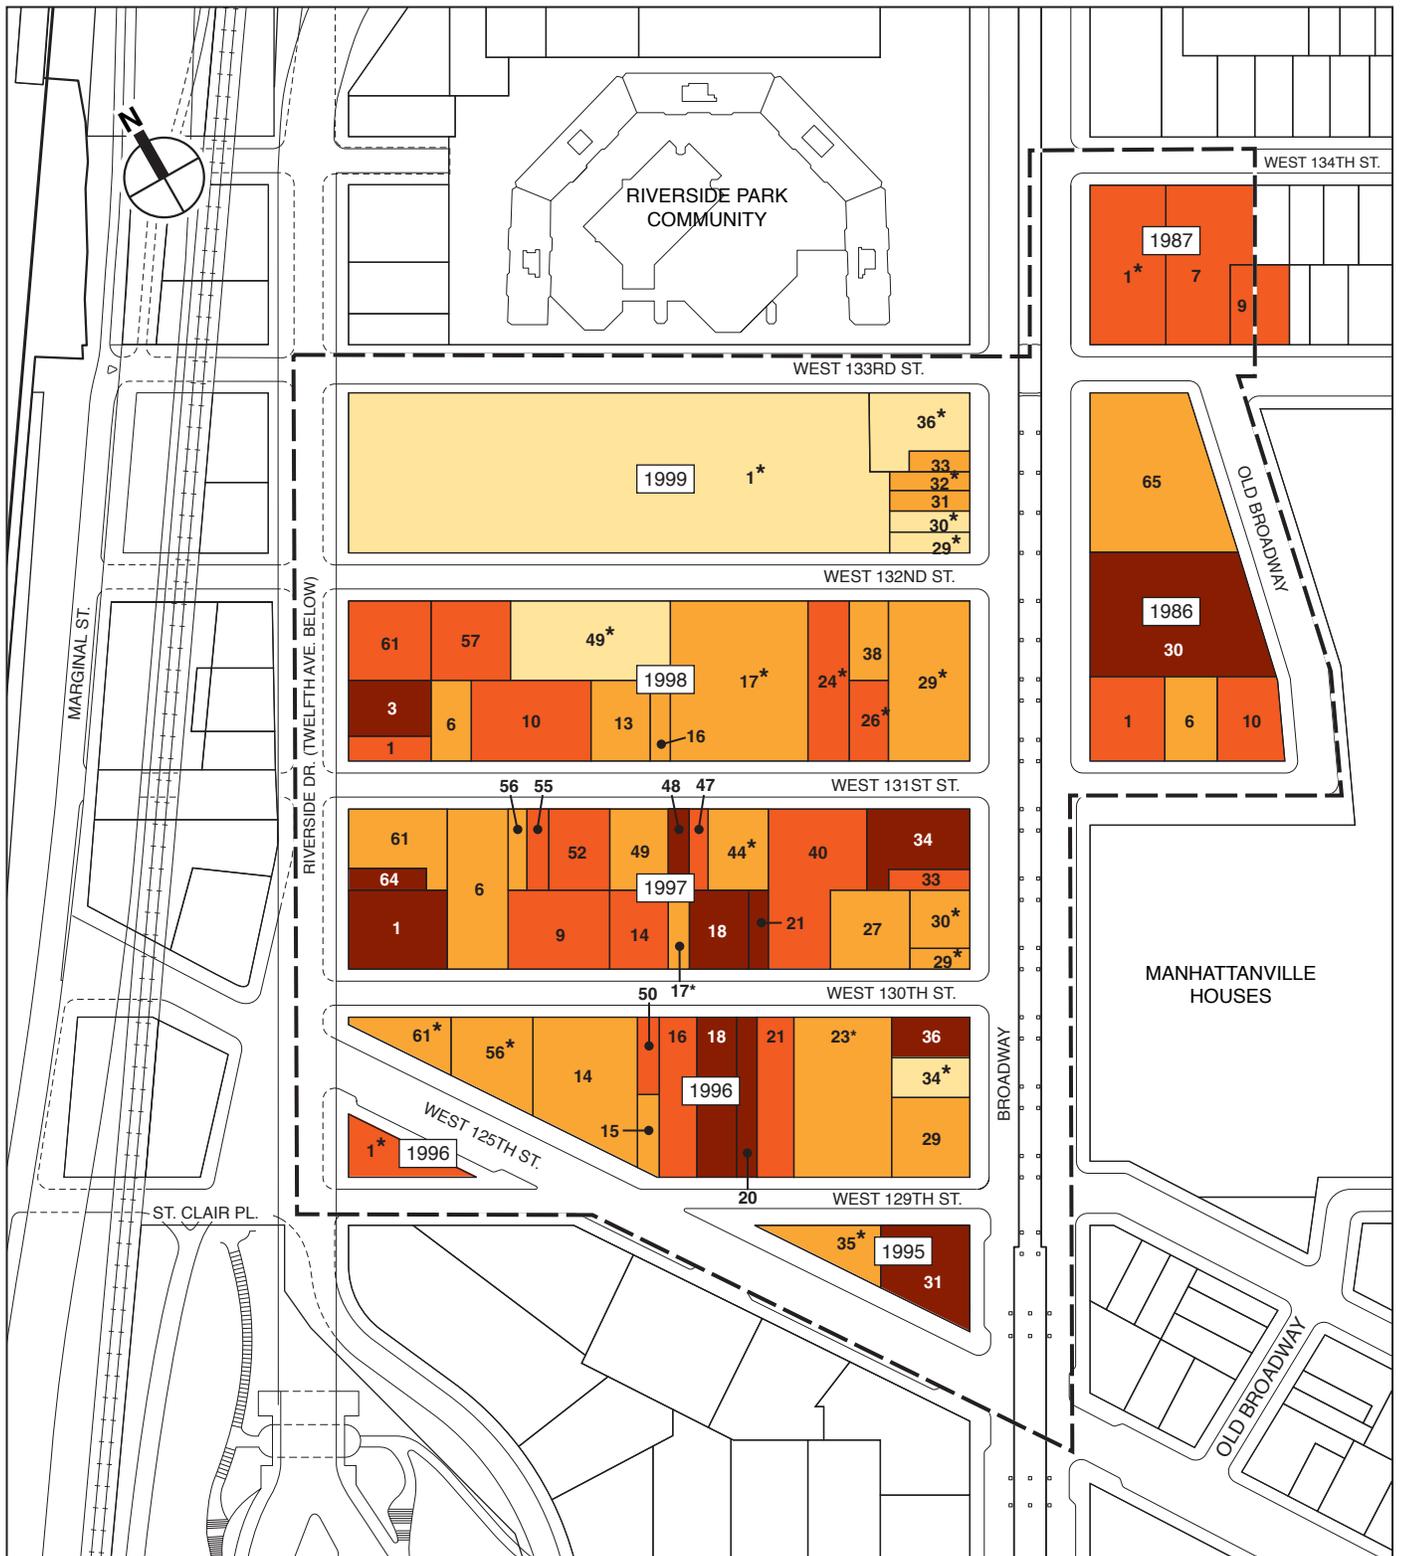
Figure 6
Lot Conditions

As illustrated in Figure 6, a widespread lack of proper building maintenance and attention to employee or public health and safety was revealed, with a majority of lots (34 lots or 51 percent) receiving a poor or critical rating. Twelve of these lots received a critical rating, due to a significant level of structural distress, ongoing maintenance problems, and hazardous health or safety conditions. Described in more detail below, the range of problems at the properties include deteriorated structural systems, sometimes critical in nature; prolonged poor roof maintenance; heavily worn interior finishes; and cracks in walls and floors. Examples of such conditions include:

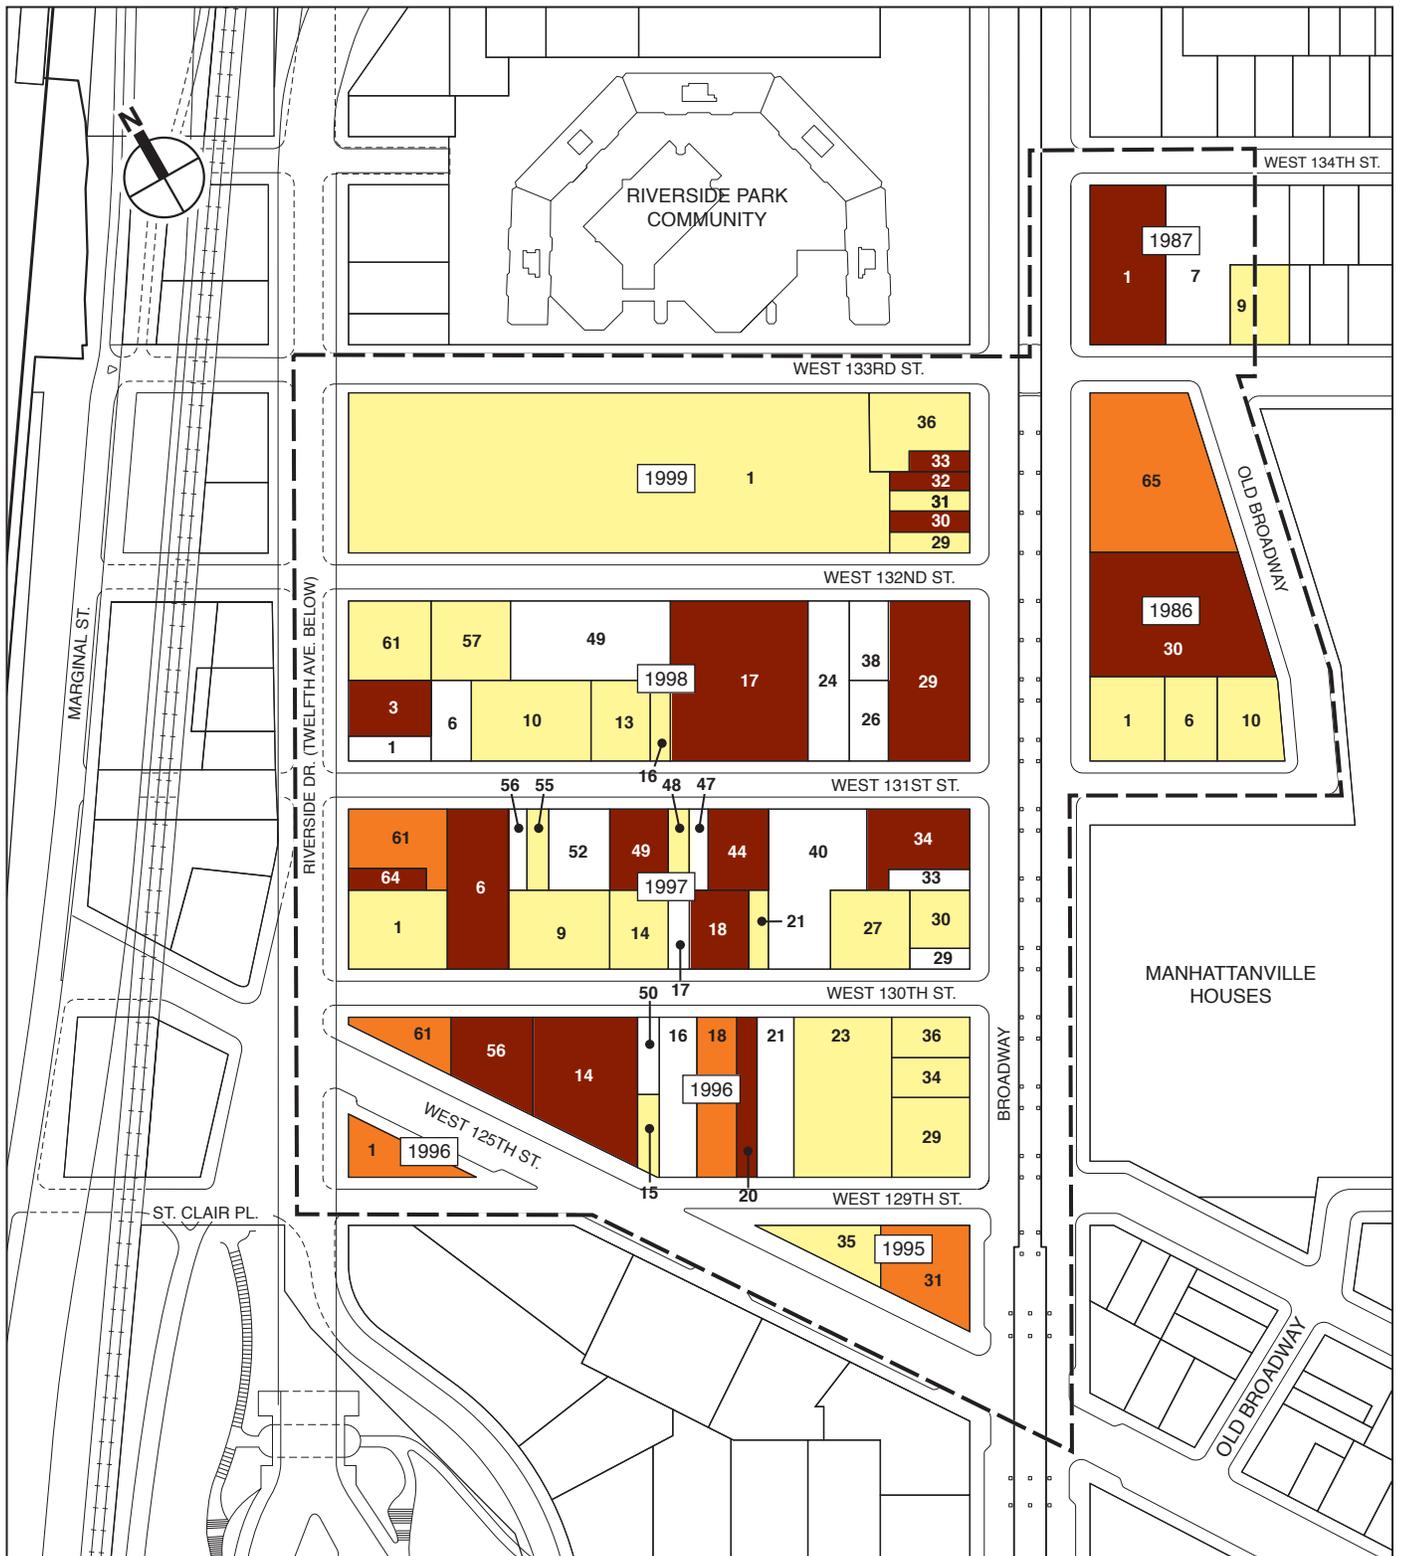
Figure 7
Open Building Code Violations

In addition to the physical deterioration discussed above, this study found that 75 percent of structures in the study area had open building code violations with the DOB and ECB as of July 2006, indicating that a large majority of structures are not being adequately maintained or are being used for purposes other than what is permitted at the site (see Figure 7). Boiler-related violations (typically citing the property’s failure to maintain the boiler) were the most prevalent (131). Violations related to elevators (119) were the second most common offense, most commonly reporting problems with “elevator safety test” or failure to maintain the elevator. Business operations not permitted by the certificate of occupancy and building alterations without a permit were also frequently cited. For example, Block 1987 Lot 1 has open violations from 1990 and 1995 for “occupancy contrary to that allowed by Certificate of Occupancy; operating a commercial business variety store without a valid C of O,” apparently referring to the current retail occupant, El Mundo Department Store.
