Block 1986 Lot 1

SITE CONDITION: POOR

Manhattanville Neighborhood Conditions Study

Block 1986 Lot 6

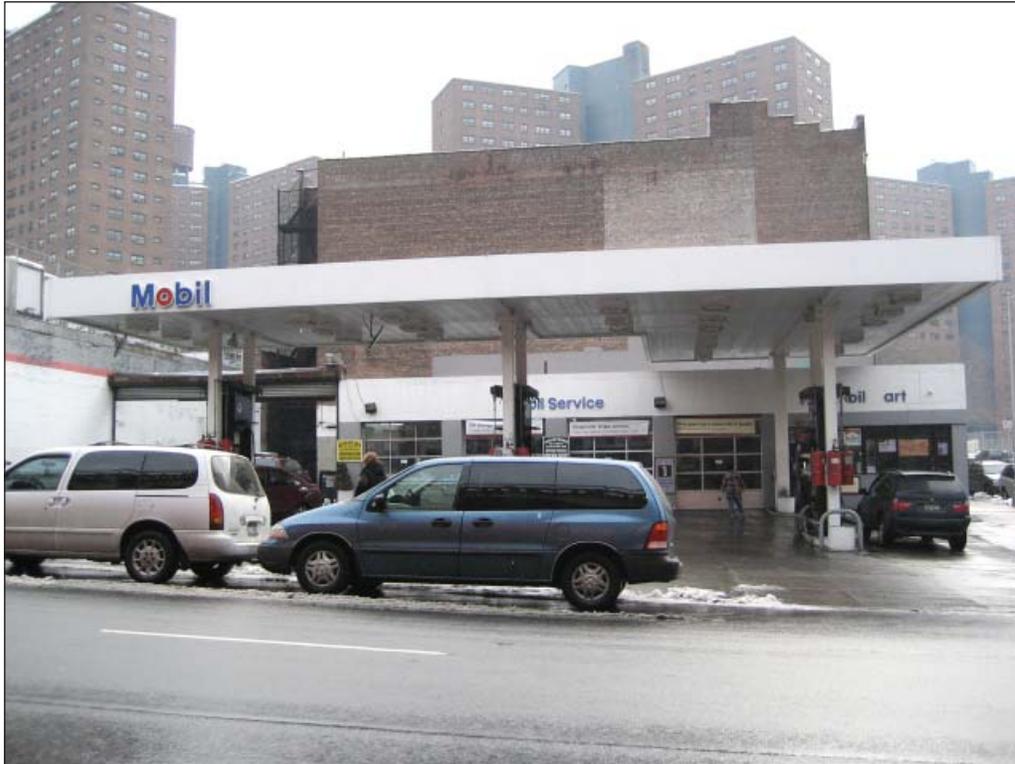
Photograph 1986-I-A

Lot 1 is located at 3260 Broadway at the northeast corner of Broadway and West 131st Street in an M1-2 zoning district. The lot, acquired by the Trustees of Columbia University on March 21, 2006, is occupied by a 1,950-gsf gas station, auto service center, and convenience store (see Photograph A). An accessory parking lot is north of the building (see Photograph B). The building was constructed in 1966; no renovations have been recorded.

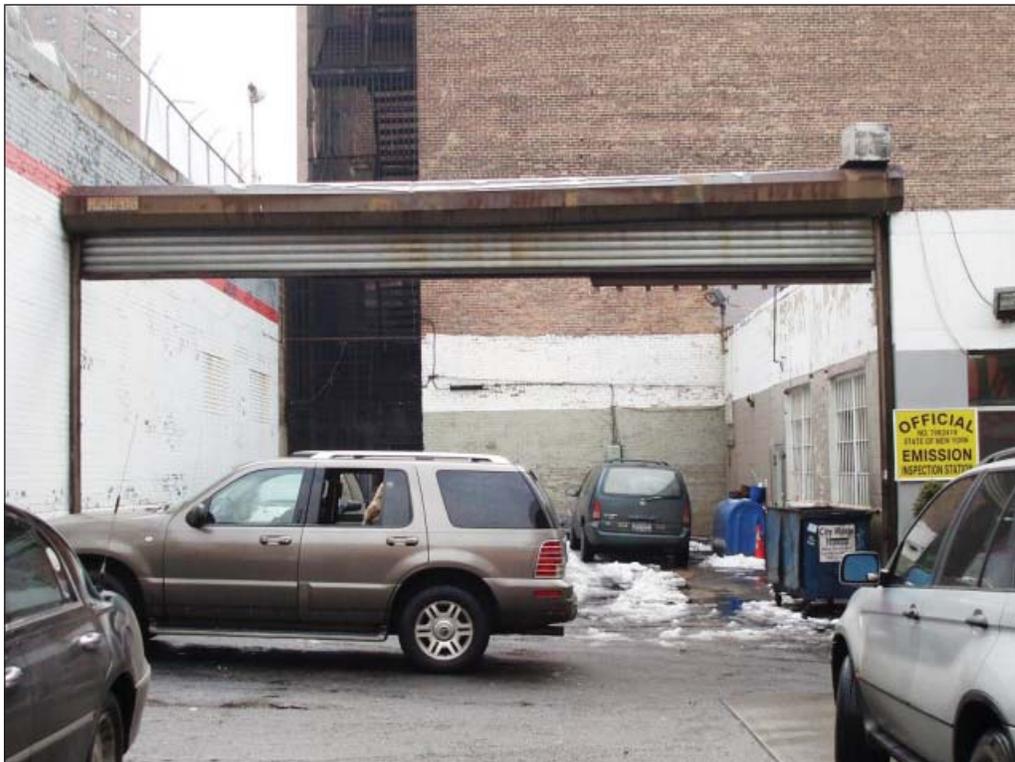
Photograph 1986-I-B

During site evaluation, some safety concerns were identified. The roll-up door on the north side of the lot is closed in the evening, blocking egress from the emergency exit from the gas station and from the adjacent building on Block 1986 Lot 6 (see Photograph B), which is an unsafe condition. In

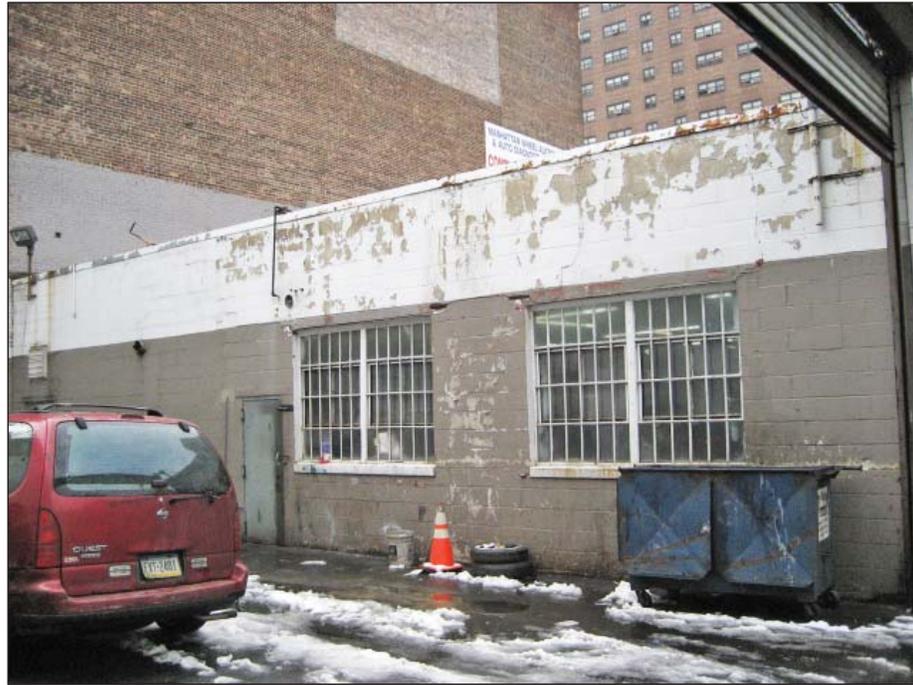
Photograph 1986-I-C

The most significant distress observed in the building is the deterioration of the exterior walls. Long-term water infiltration has caused several wide cracks on the southern façade, and cracks, corrosion of window frames and a header beam, and peeling paint on the northern façade (see Photograph C). Damage on the western façade includes loose metal cladding (see Photograph D). A wide crack in an interior wall in the automotive repair shop has likely been caused by the load of several tires stored on the other side of the wall (see Photograph E).

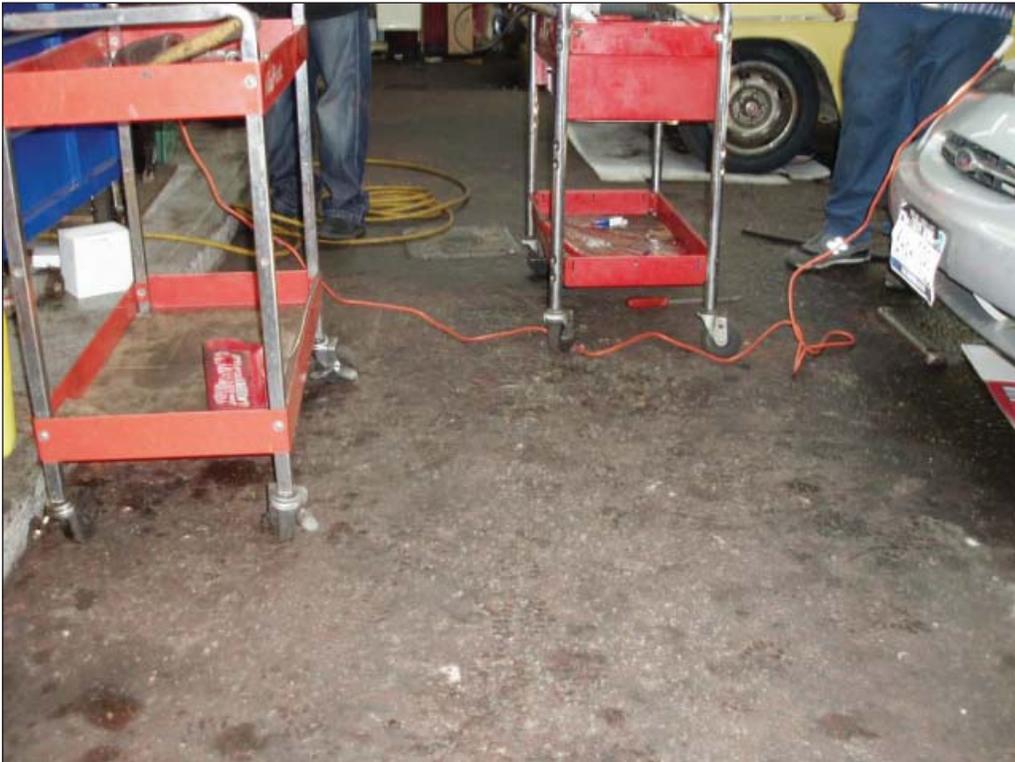
Photograph 1986-I-F

Interior and exterior slabs have several signs of damage. The interior concrete slab in the automotive service shop has cracks and chemical stains due to the nature of its long-term use (see Photograph F). The slab in the parking lot is covered with asphalt and has local spalling (see Photograph G). The sidewalks along West 131st Street and Broadway are in poor condition overall, with several wide cracks and spalling at the corner of Broadway and West 131st Street (see Photographs H and I, respectively). Curb cuts along West 131st Street and at the southwest corner appear to be in poor to critical condition with several wide cracks and spalling; however they are in fair condition near the north side of the lot along Broadway.

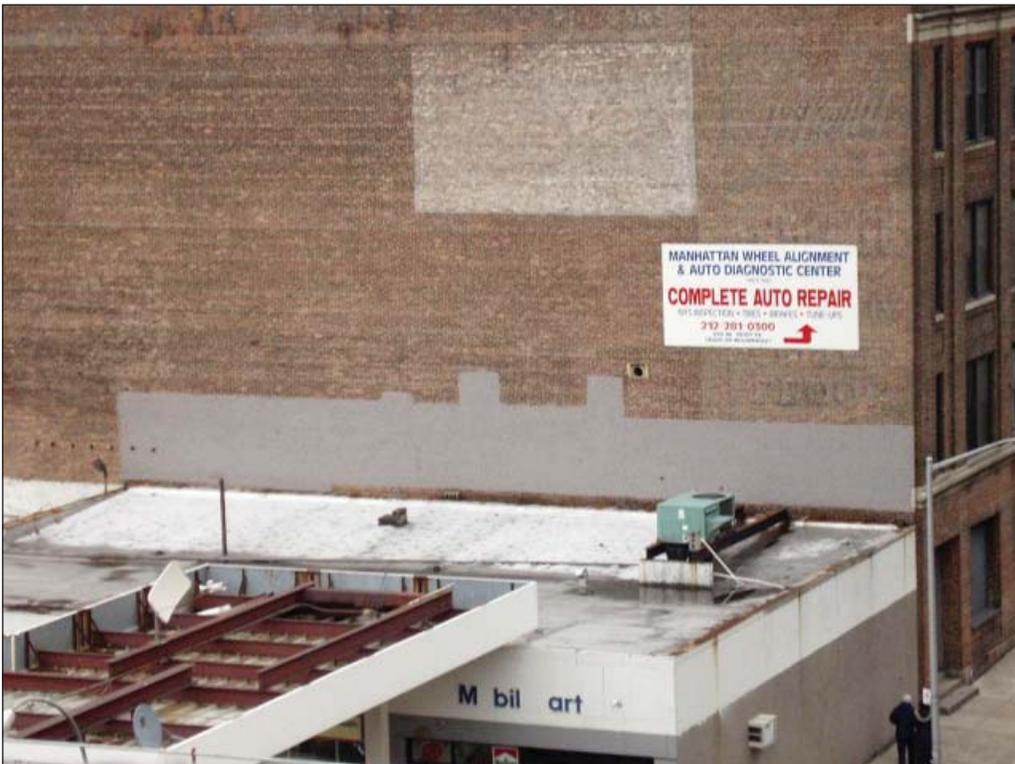
Photograph 1986-I-J

Other concerns include water stains and/or sagging ceiling panels inside the convenience store, ponding and patches of discoloration on the roof (see Photographs J and K), and corrosion stains on the canopy structure roof framing (see Photograph L).

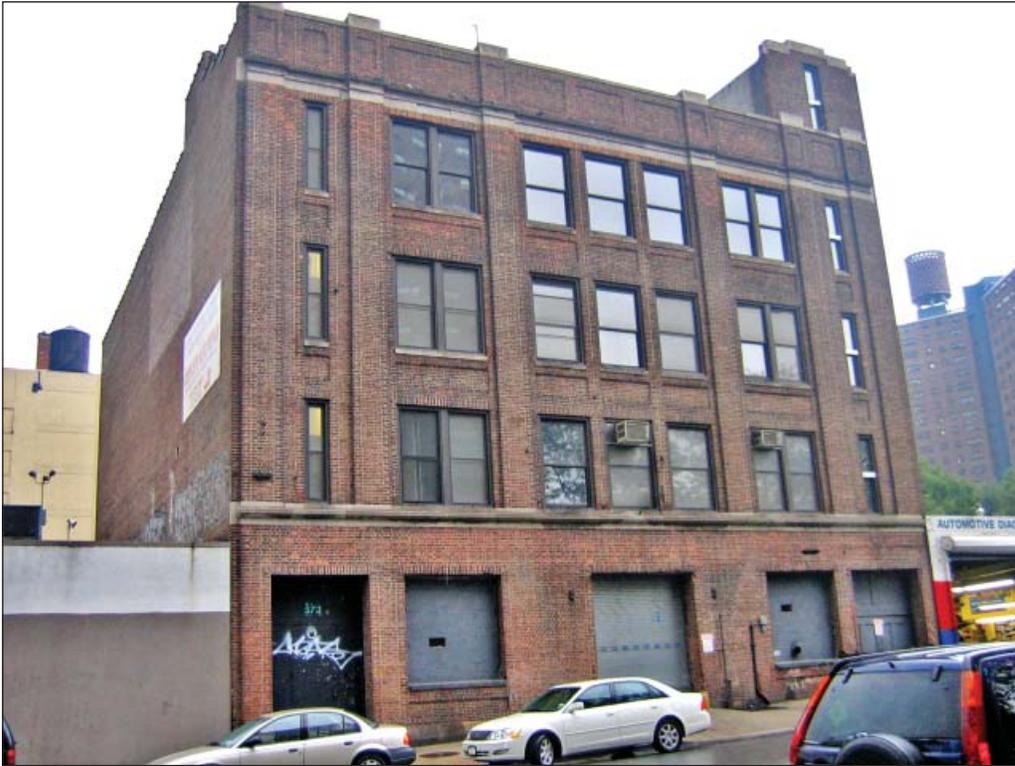
Photograph 1986-6-A

Lot 6, acquired by the Trustees of Columbia University on April 7, 2004, is located at 573 West 131st Street between Broadway and Old Broadway in an M1-2 zoning district. The lot contains 28,000-gsf, four-story brick structure that is 75 percent vacant, with vehicle storage by an adjacent auto repair shop, Manhattan Wheel Alignment, on the first floor (see Photograph A). The building was constructed circa 1917; no renovation dates are listed.

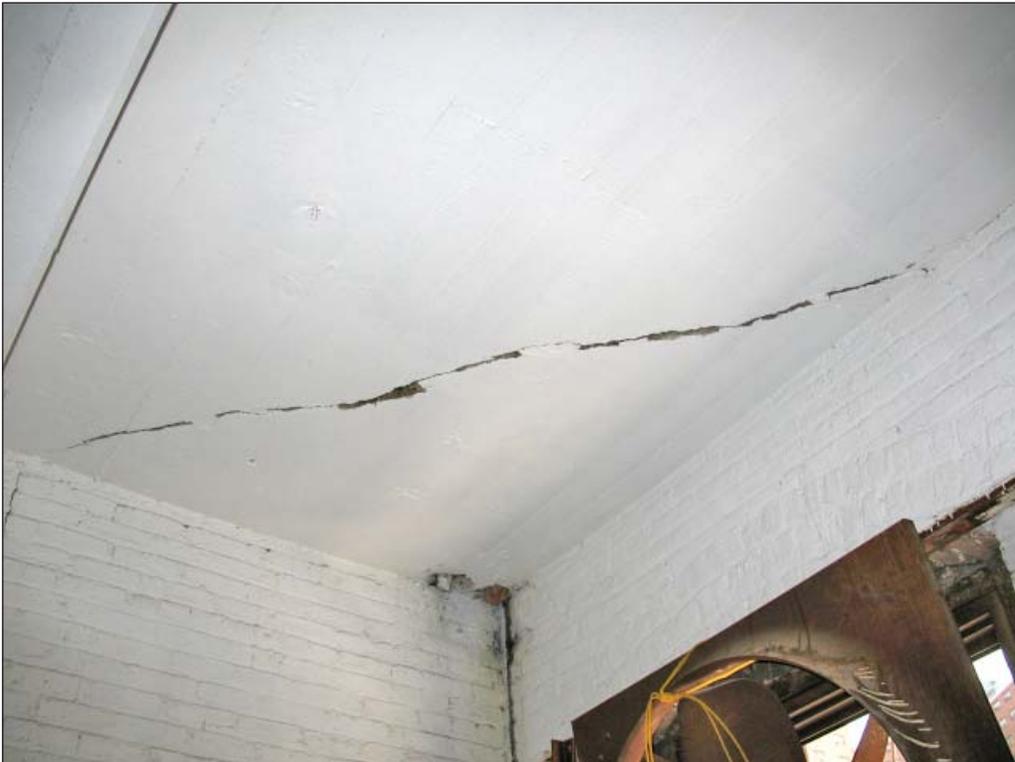
Photograph 1986-6-B

A wide diagonal crack, indicating significant structural distress, was observed in the northeast corner of the roof and floor slabs on all levels, as well as in the load-bearing exterior masonry walls, possibly the result of differential settlement of the building’s slab-on-grade (see Photographs B and C). Prolonged water infiltration has caused deterioration of the roof and floor framing (see Photographs D and E), corrosion of the façade’s steel lintels (see Photograph F), localized deterioration of brick masonry walls (see Photograph G), and microbial growth on the fourth-floor walls (see Photograph H). Portions of the building’s roofing membrane are billowing, segments of the sheet metal flashing are not properly connected (see Photograph I), and water ponding is likely a concern in the roof’s northeastern quadrant. In addition, a skylight on the roof of the elevator bulkhead is in poor condition, with broken glass panes and corroded framing (see Photograph J). As a result, signs of water intrusion from the skylight are evident on all elevator shaft walls. If left unchecked, this water intrusion will eventually lead to local failure of the skylight framing.

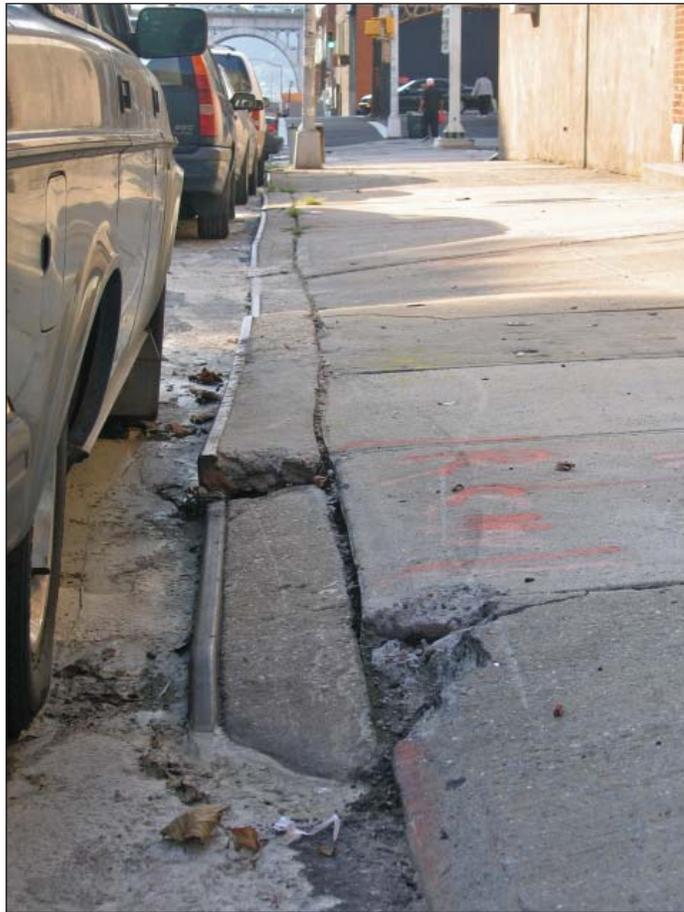
Photograph 1986-6-K

The sidewalk is in fair condition, with some cracks and an uneven construction joint, while the curb cuts are in poor condition (see Photograph K).

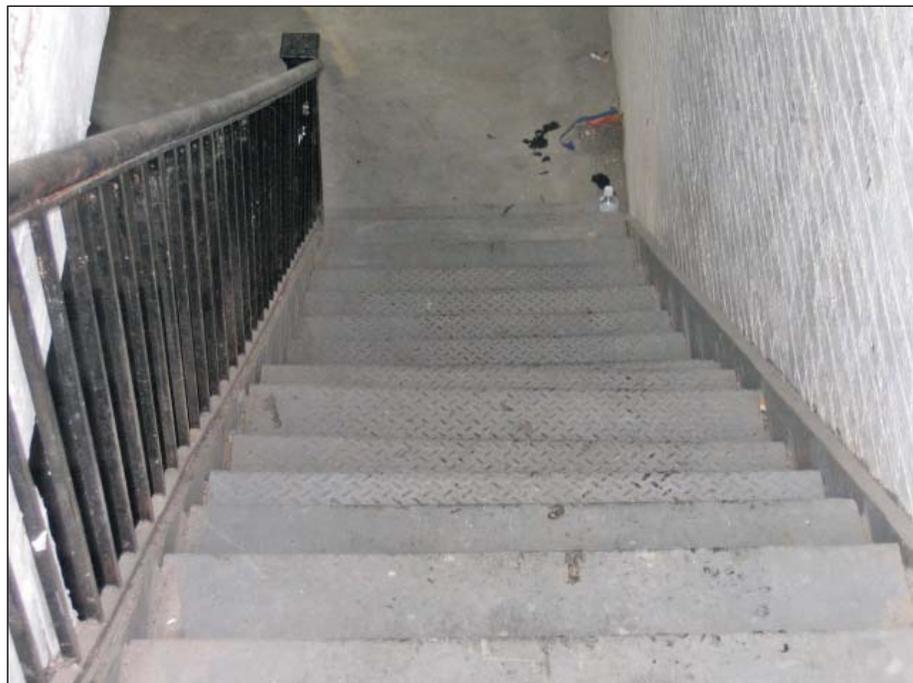
Photograph 1986-6-L

Between the fourth floor and the roof, the stair tread and riser dimensions are non-uniform, which poses a safety hazard (see Photograph L). In addition, an exit corridor along the west wall that connects the fire escape with the stairwell is blocked by storage items, creating a potential fire hazard (see Photograph M). The roll-up door on the north side of Block 1986 Lot 1 is closed in the evening, blocking egress from the emergency exit from this building and from the gas station on Block 1986 Lot 1, which is an unsafe condition (see Photograph N).
