Block 1986 Lot 10

Manhattanville Neighborhood Conditions Study

Block 1986 Lot 30

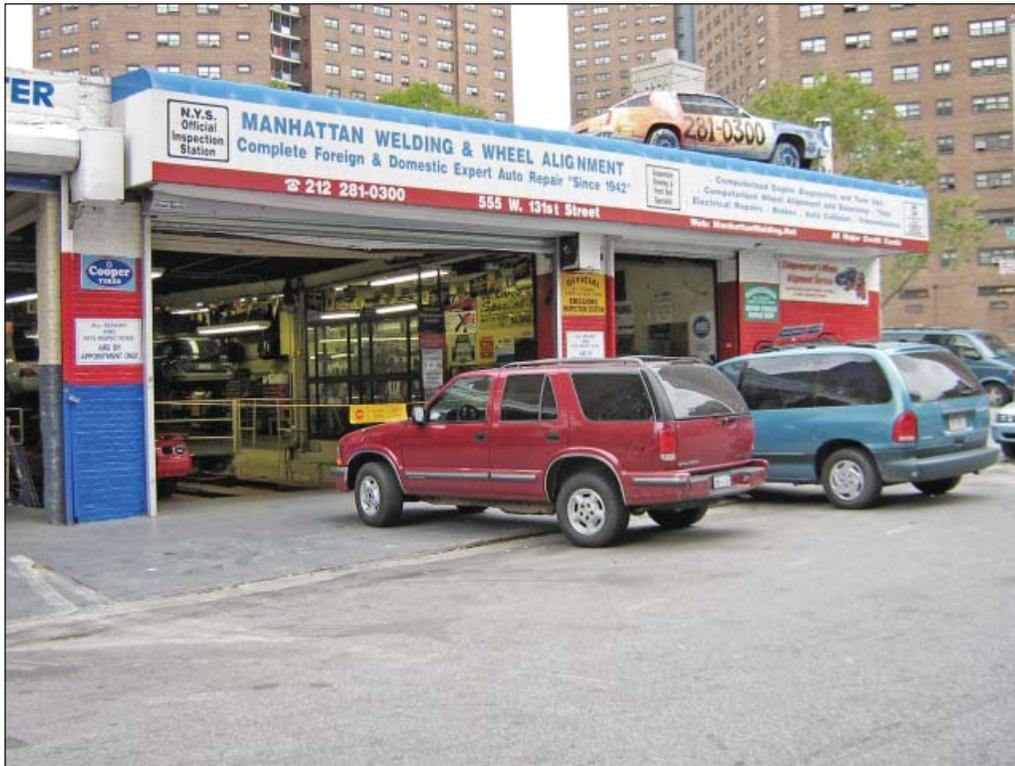
Photograph 1986-10-A

Lot 10 is located at 555 West 131st Street at the corner of West 131st Street and Old Broadway in an M1-2 zoning district. The one-story, 7,800-gsf brick building, which was acquired by the Trustees of Columbia University on July 22, 2004, is occupied by an auto repair shop (see Photograph A). It was built circa 1925; no renovations have been recorded.

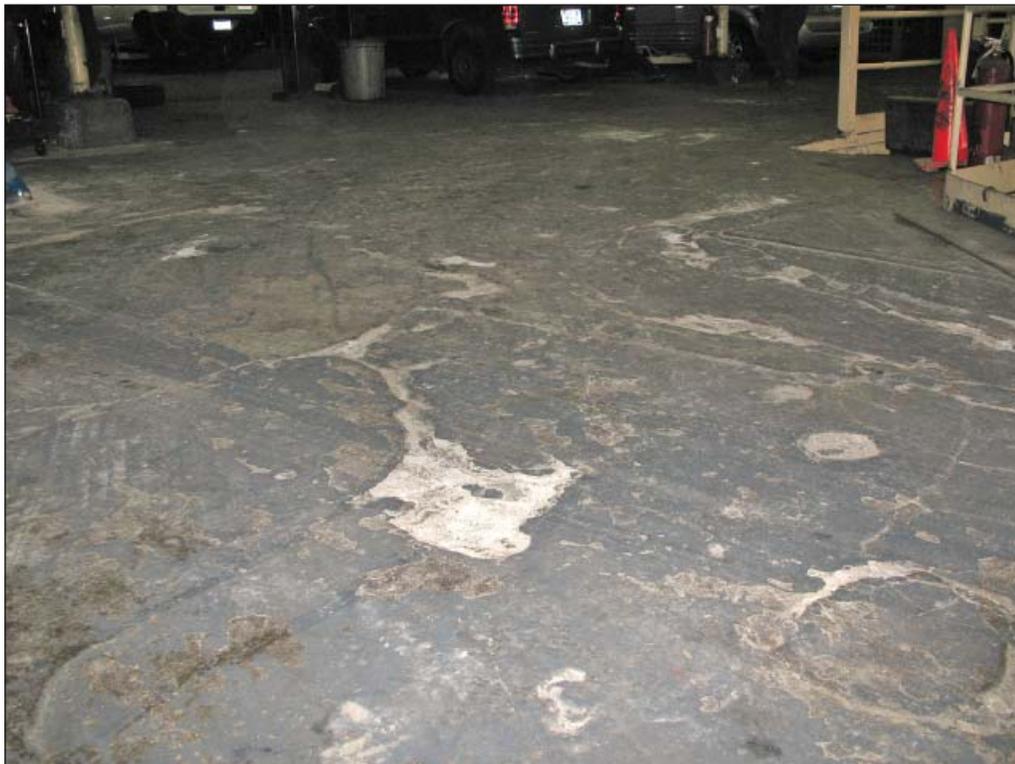
Photograph 1986-10-B

Due to localized structural distress and some substandard exterior, interior, and site conditions, this site was evaluated by Thornton Tomasetti, Inc. to be in poor condition overall. The first-floor slab-on-grade appears to be in generally poor condition, with large cracks and spalling concrete (see Photograph B). In

addition, portions of the slab are uneven as a result of differential settlement. The sagging lintel and severely cracked masonry above the center roll-up door on the south wall are indicative of significant local structural distress (see Photographs C and D) and has the potential to lead to local structural failure. Sections of the roof membrane that extend onto the parapets are damaged at various locations due to delamination and tears (see Photograph E).

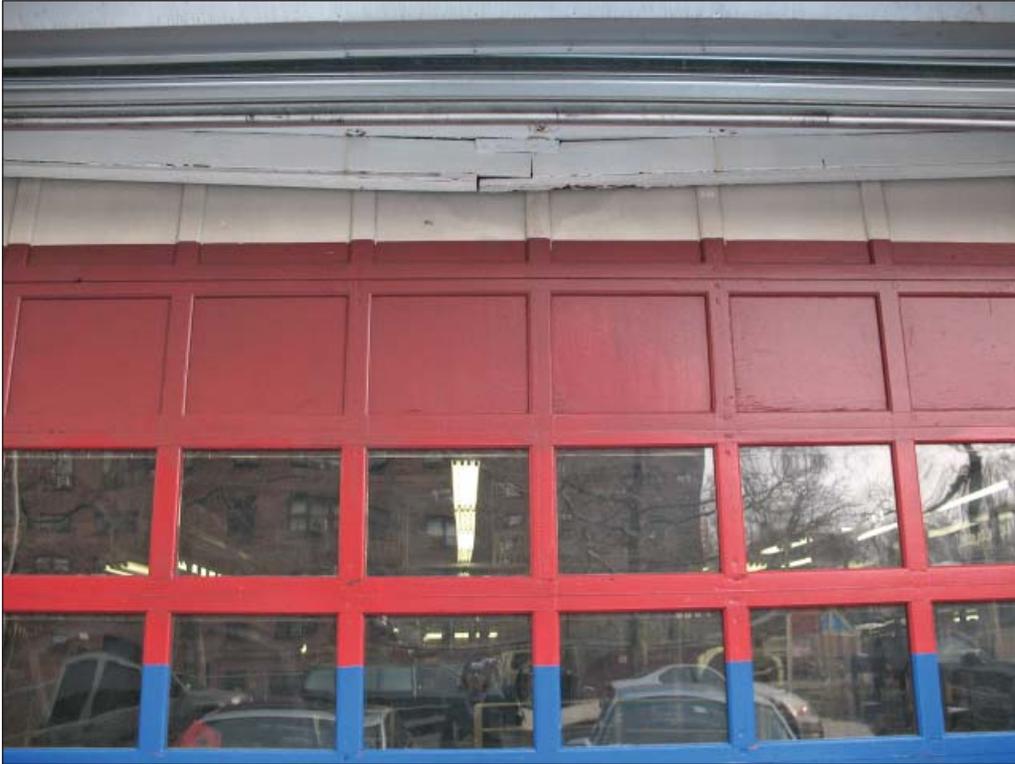
Photograph 1986-10-C

The sagging lintel and severely cracked masonry above the center roll-up door on the south wall, indicative of significant local structural distress, creates an unsafe condition because of its potential for local structural failure.

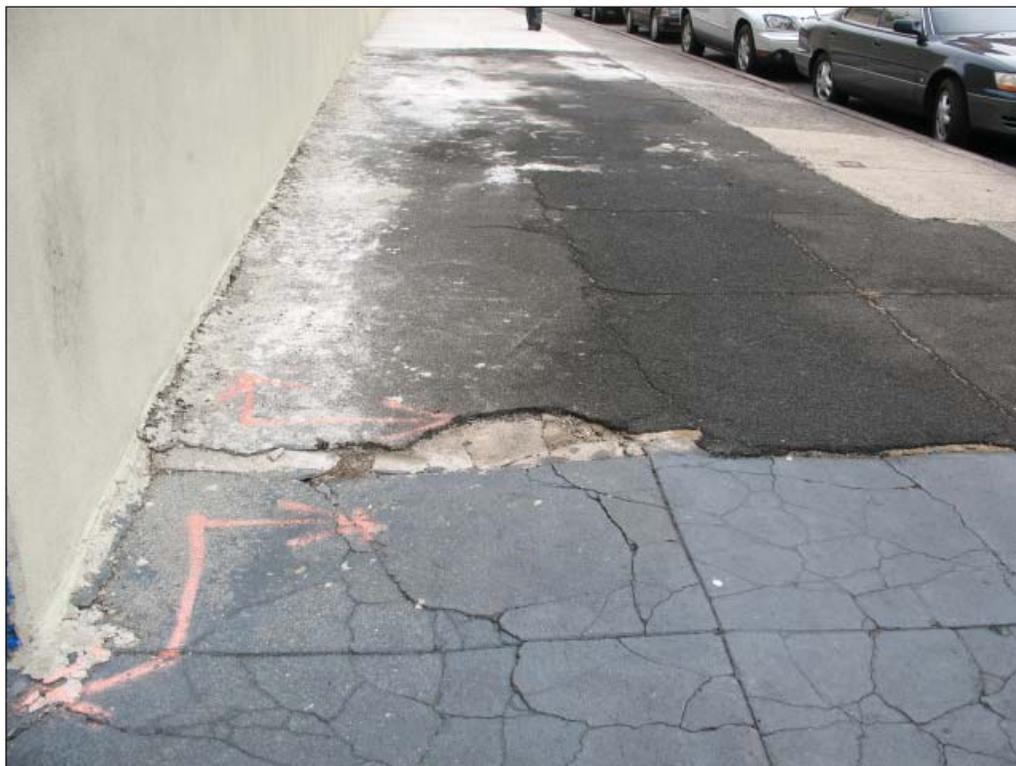
Photograph 1986-10-F

The sidewalk on the corner of Old Broadway and West 131st Street is in poor condition, with significant cracking and spalling (see Photograph F). The sidewalk and curb cuts along West 131st Street are in fair to poor condition, with some cracks and spalling present. The northern portion of the sidewalk along Old Broadway has recently been recast and is in good condition, while the southern portion of the sidewalk is asphalt and is in fair condition.

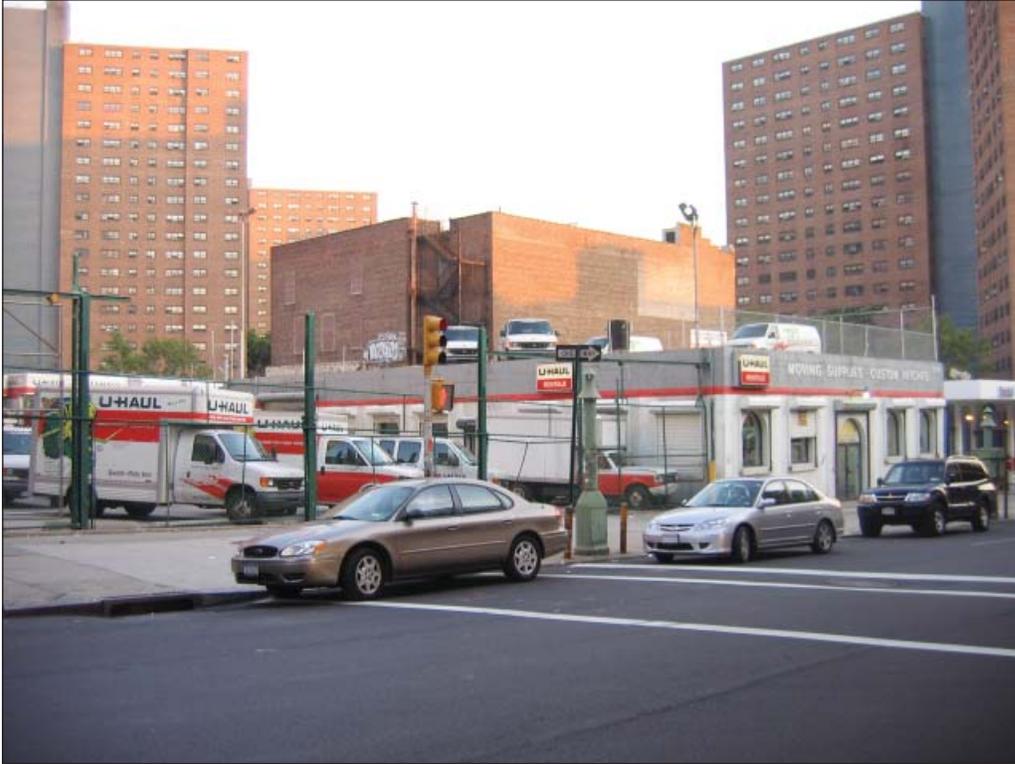
Photograph 1986-30-A

Lot 30, owned and occupied by U-Haul International, Inc., is located at 3270 Broadway with frontage on both Broadway and Old Broadway (see Photograph A). The lot contains a 6,400-gsf commercial building and a vacant garage to the rear of the building; the remainder of the lot is used for parking of the rental trucks. DOB indicates a build year of 1965. No renovations have been recorded. The property was acquired by U-Haul International, Inc. circa January 1978 and is under contract with the Trustees of Columbia University. The lot is in an M1-2 zoning district.

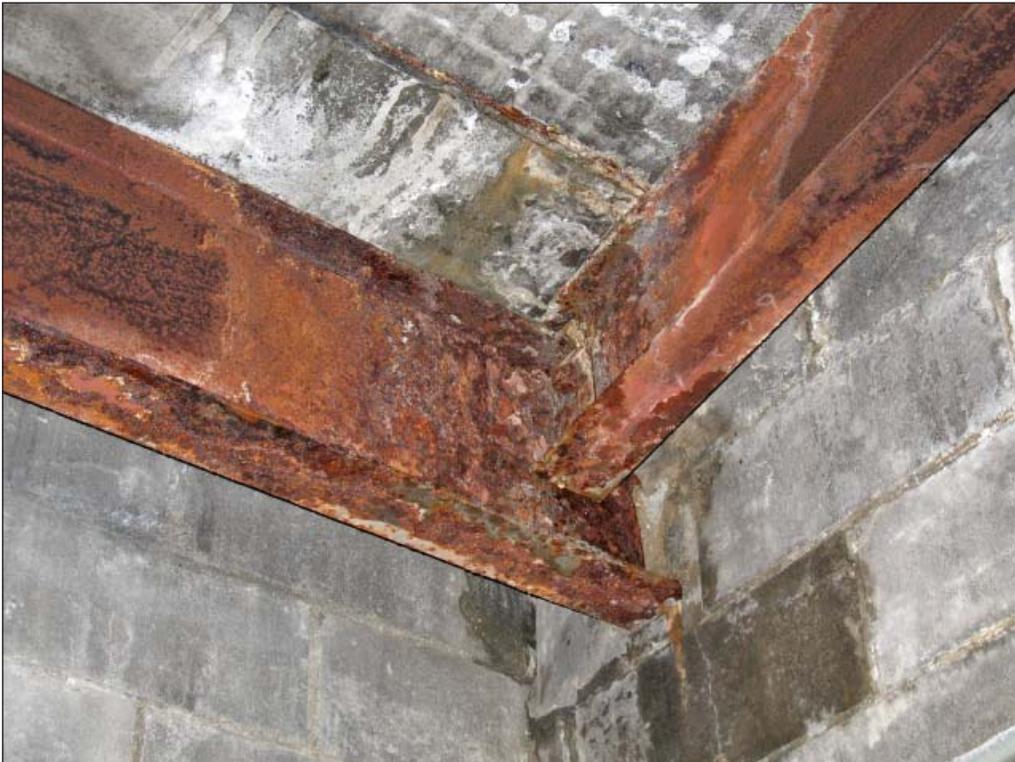
Photograph 1986-30-B

In the main commercial building, severe, ongoing water intrusion has caused localized corrosion of interior steel columns and roof framing (see Photograph B) as well as critical damage to the east concrete foundation wall (see Photograph C). The water intrusion is due to an open wall cavity at a displaced parapet masonry section on the roof (see Photograph D), deteriorated roofing adjacent to the vacant garage building, a clogged trench drain, and infiltration through the foundation wall. Water damage to the ceiling in certain locations indicates that the roof framing is subjected to water intrusion from roof leaks (see Photograph E). Water ponding observed along the southern section of the roof may be contributing to water infiltration (see Photograph F). The building's roof, used for rental vehicle parking, contains a chain-link fence along its perimeter to help prevent vehicles from driving off the edge; however, the fence is missing along the northern edge (see Photograph G).

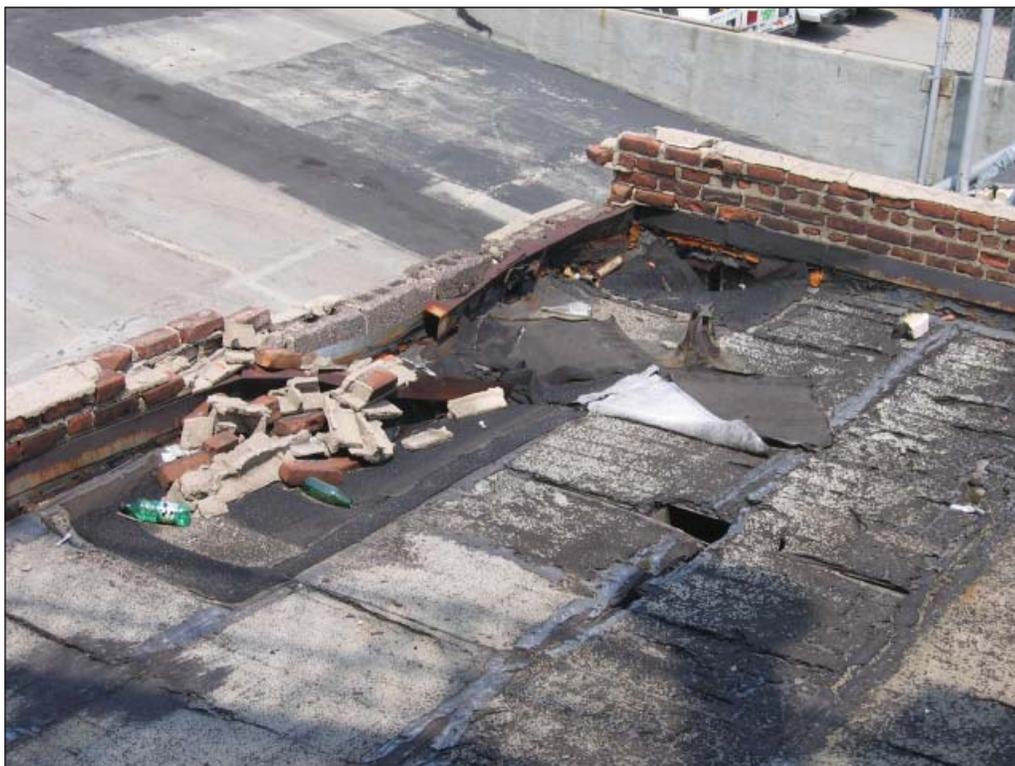
Photograph 1986-30-H

The vacant garage building is in an advanced state of disrepair due to prolonged, significant water intrusion from the roof as shown in Photograph H. Concerns include: precariously dangling pieces of the corroded metal ceiling (see Photograph I), corroded and sagging lintels, deteriorated parapets and roofing membrane, displaced masonry (see Photograph J), the absence of almost all parapet coping tiles, significant debris accumulation, and standing water inside the building. The exterior retaining wall separating the upper and lower open parking areas is in critical condition, due to a partial collapse of the northern section and the potential collapse of the southern section (which is visibly leaning), as shown in Photograph K. A significant lateral load continues to be exerted by the adjacent soil and the parked vehicles above, creating the distinct potential for a further collapse in the near future. Further, the eastern portion of the open parking area is unpaved, unkempt, and uneven, with areas of standing water, mud, and litter accumulation (see Photograph L).

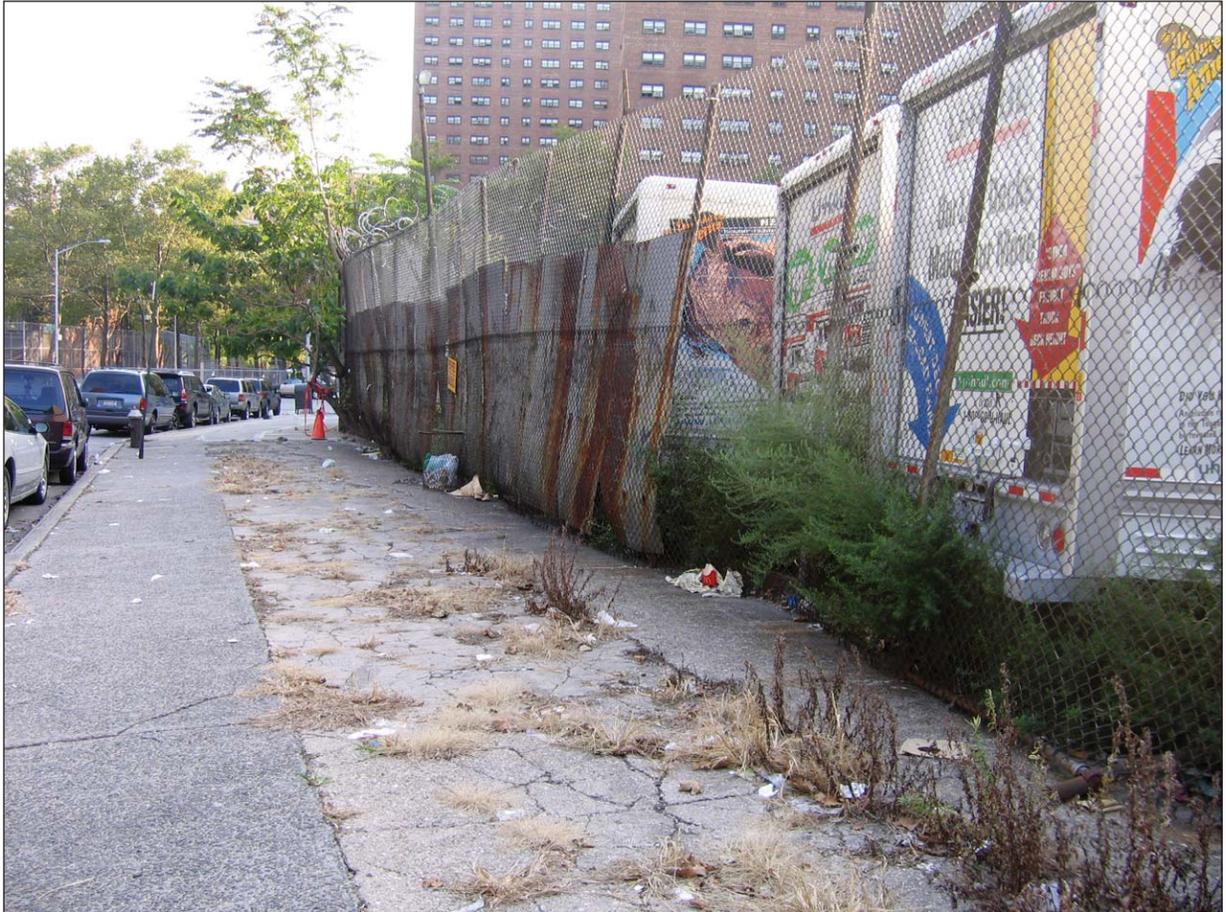
Photograph 1986-30-M

Along Old Broadway, the sidewalk is in critical condition, with significant cracking, spalling, weeds, and litter (see Photograph M). The adjacent chain-link fence is billowing and missing fence posts. The sidewalk along Broadway is in fair condition, although the curb cut is deteriorated.
