## Block 1995 Lot 31

**SITE CONDITION: CRITICAL**

Manhattanville Neighborhood Conditions Study

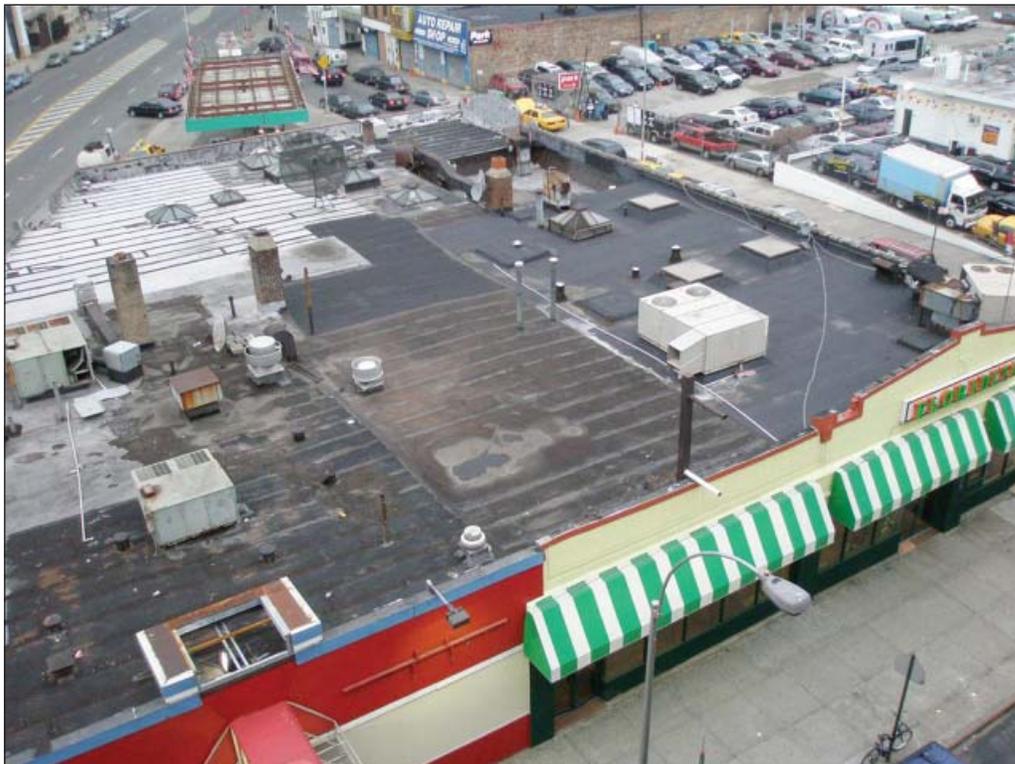
Photograph 1995-31-B

Most of the roof membrane is deteriorated and billowing, the waterproof coating on the inside face of the parapet is deteriorated, and water ponding is occurring (see Photograph B). There are signs of water intrusion from the roof around several skylights, as well as water stains on the ceiling in other areas, suggesting that there may be additional roof leaks (see Photograph J).

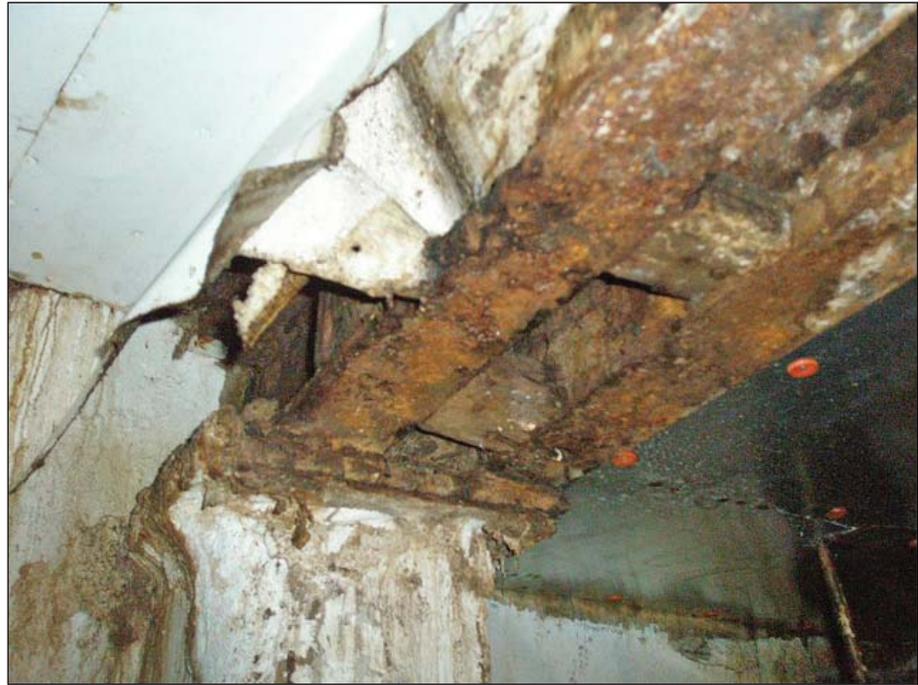
**Photograph 1995-31-C**

A significant amount of distress was observed in the building's basement including: advanced corrosion of a column/steel girder connection (see Photograph C); water intrusion and damage to portions of the stone rubble wall (see Photograph D), including an area close to electrical cabinets; exposed, deteriorated timber joists (see Photograph E); and water-induced ceiling deterioration, indicating that other structural members are experiencing some degree of structural distress in affected areas (see Photograph F). In addition, the slab-on-grade is in poor condition with widespread cracking and spalling, portions of uneven and displaced slab (see Photograph G), and an open trench in the soil below the slab in the western area (see Photograph H). Further, the first-floor framing is in critical condition in the basement under Mi Floridita Restaurant and Bakery. The framing is shored-up haphazardly in many locations, evidently to address sagging floor framing members. Some or all of the shoring beams and columns appear not to have been professionally designed and are the result of many makeshift iterations over time (see Photograph I).

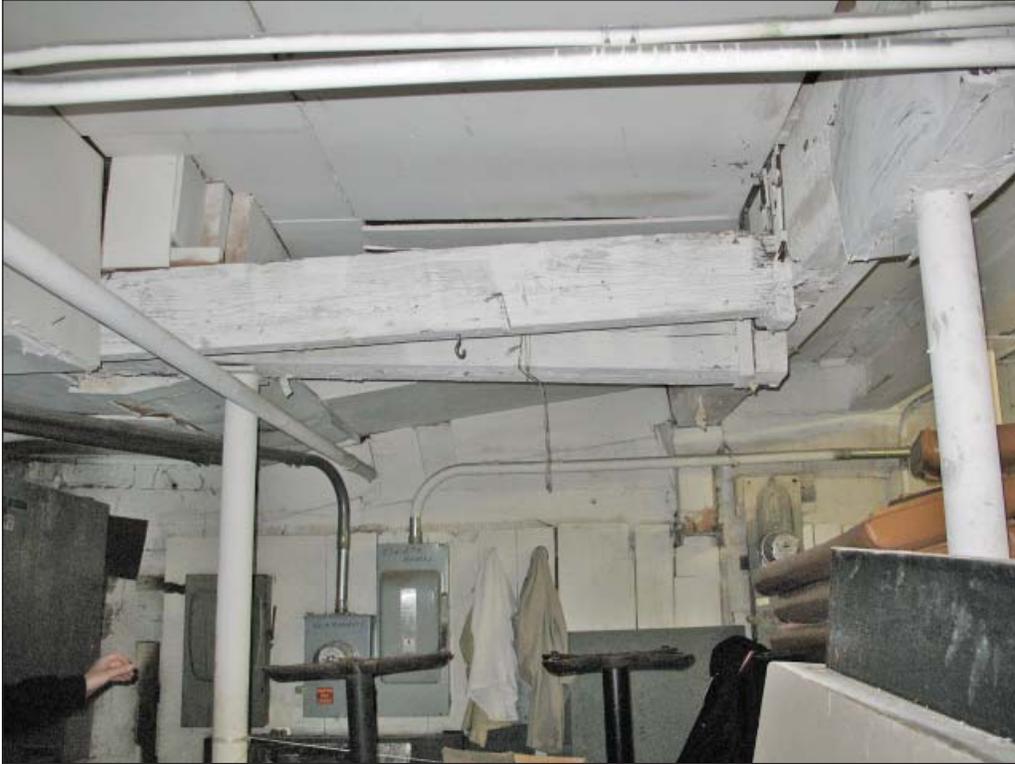
**Photograph 1995-31-I**

Further, inadequate first-floor framing members, as seen in the basement, which have been haphazardly installed over time and are subject to active water infiltration, are potentially unsafe (see Photograph I). Thornton Tomasetti, Inc., states that this water intrusion will eventually lead to local structural failure(s) if left unchecked and recommends that the condition be addressed in the short term.

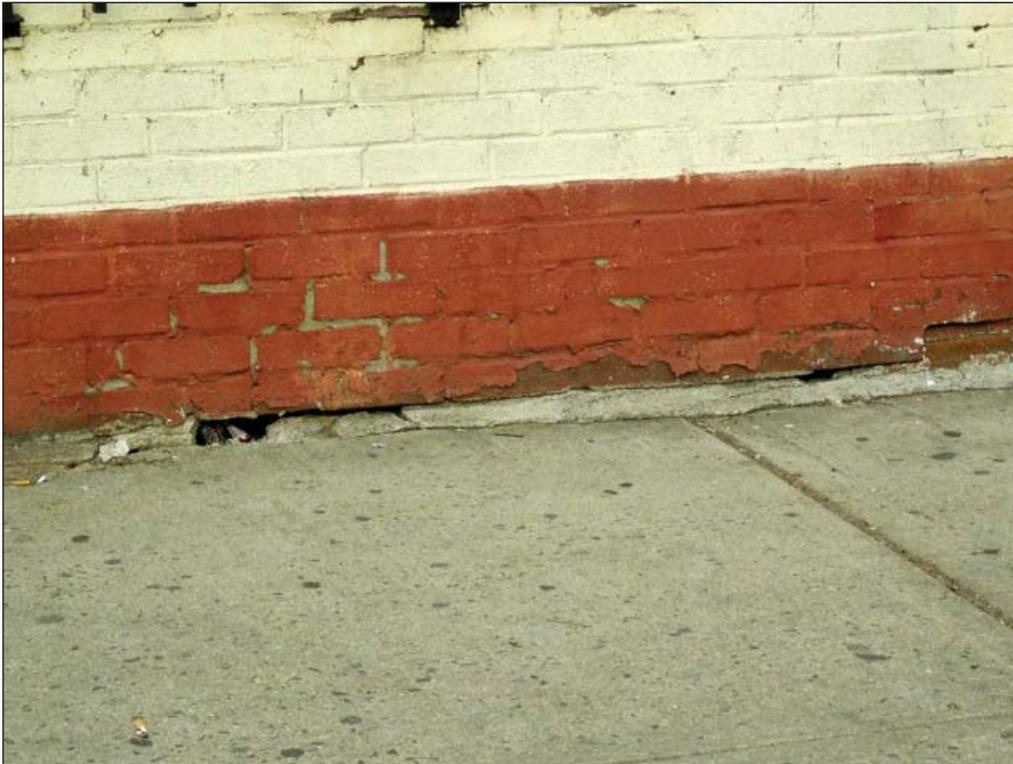
**Photograph 1995-31-K**

On the south façade, there are minor cracks, flaking paint, and open gaps where the wall meets the sidewalk (see Photograph K), which may be the source of some water infiltration. On the north façade, there is minor cracking and a section of the parapet leans inward (see Photograph L). On the

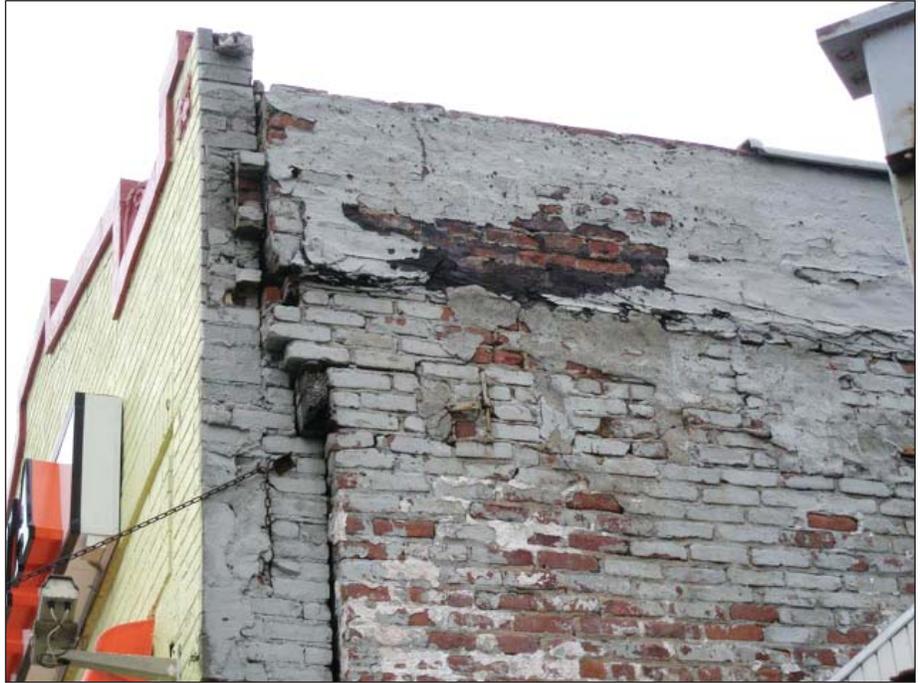
**Photograph 1995-31-M**

west façade, the masonry wall is in poor condition, with misaligned brickwork, diminished mortar joints, and flaking paint (see Photograph M).

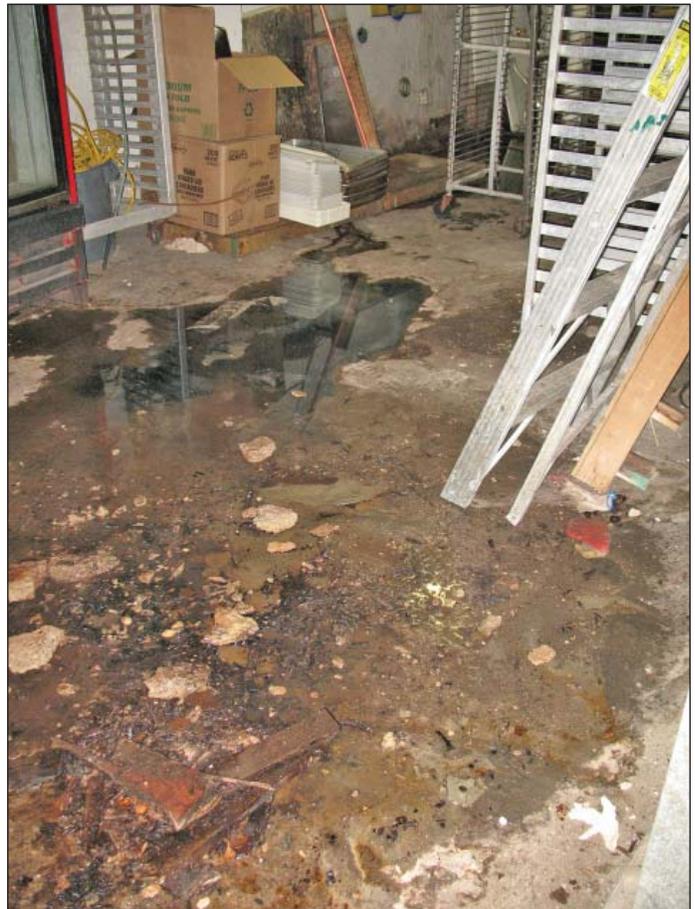
**Photograph 1995-31-N**

The property suffers from several unsanitary and unhealthy conditions which include: chemical spills from equipment and standing water in the basement in three locations (see Photograph N), water intrusion near electrical cabinets, unsafe electrical wiring, vermin infestation (see Photograph O), and microbial growth.

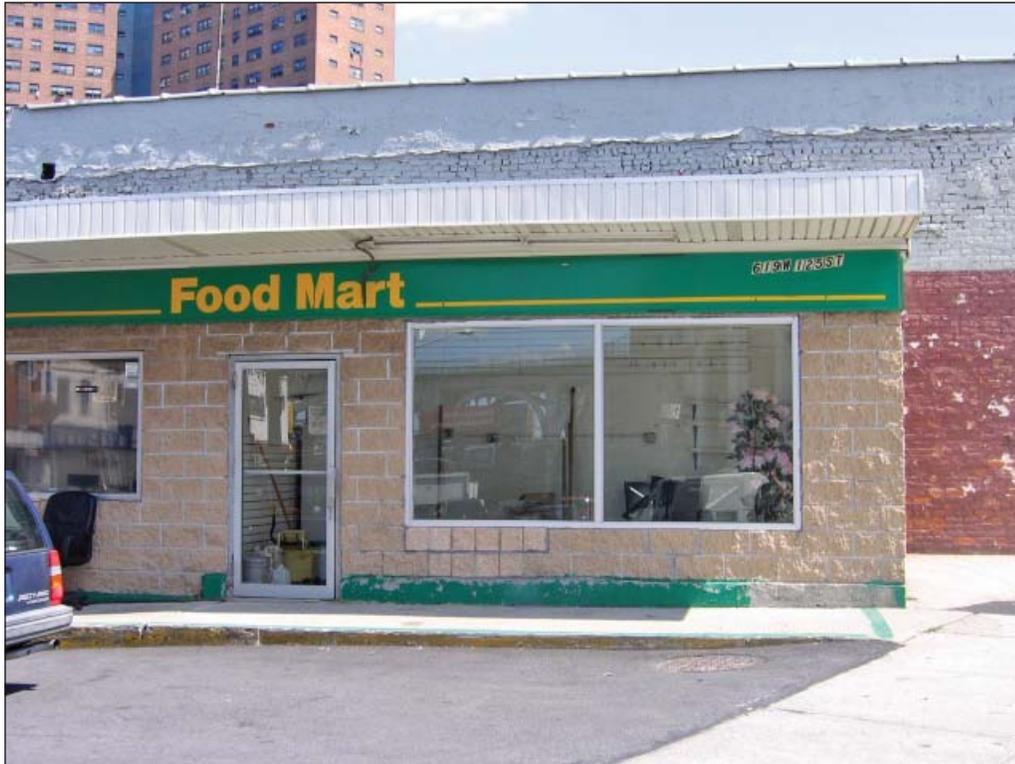
Photograph 1995-35-C

The exterior of the property was evaluated by Thornton Tomasetti, Inc. to be in fair condition overall due to some substandard conditions on the building's exterior and on the site itself<sup>1</sup>, including: a few cracks, repair patches, and peeling paint on the building's façade (see Photograph C), corrosion stains on the gas

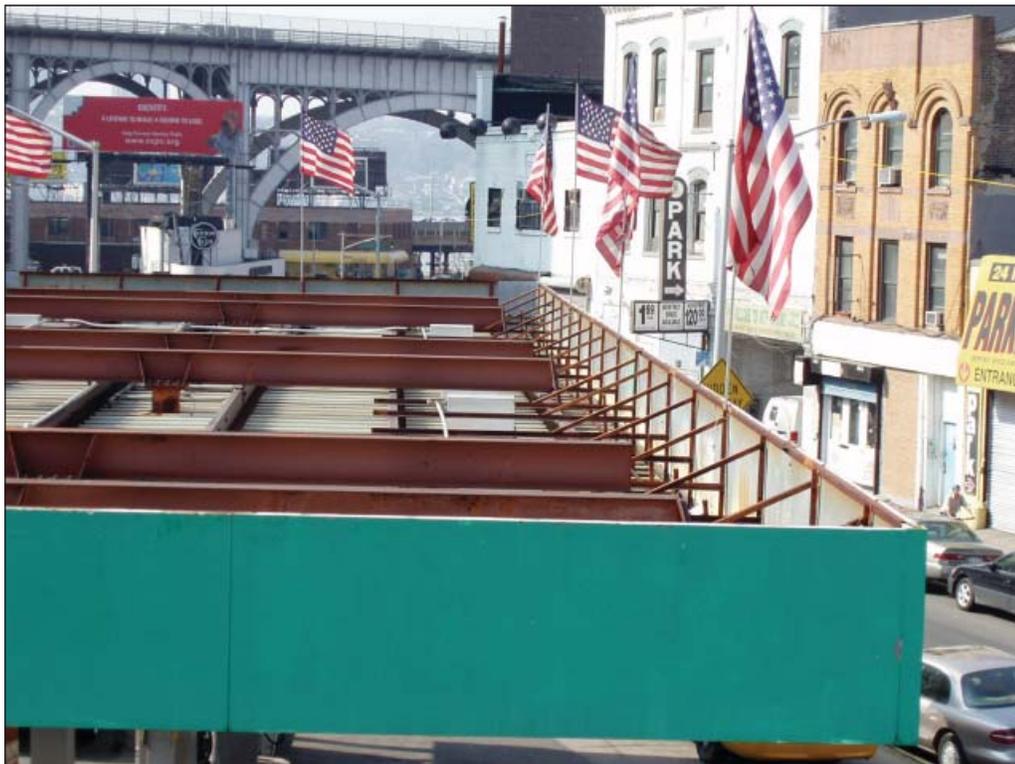
Photograph 1995-35-D

station's canopy (see Photograph D), and water stains on the eastern portion of the roof, indicating that ponding may occur in this location (see Photograph E).

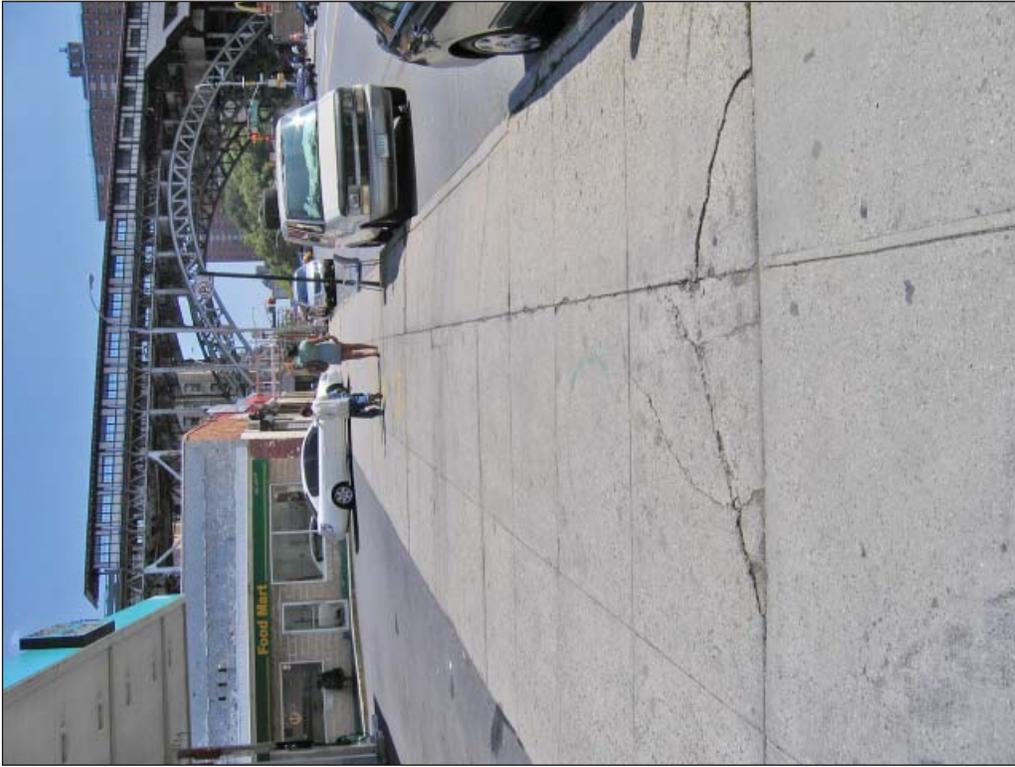
Photograph 1995-35-F

The sidewalks and curb cuts on West 125th Street and West 129th Street are in fair condition, with local spalling and cracks (see Photographs F and G, respectively). The asphalt paving is also in fair condition, with typical degradation and staining associated with gas station operations.
