## Block 1996 Lot I

SITE CONDITION: POOR

Manhattanville Neighborhood Conditions Study

## Block 1996 Lot 14

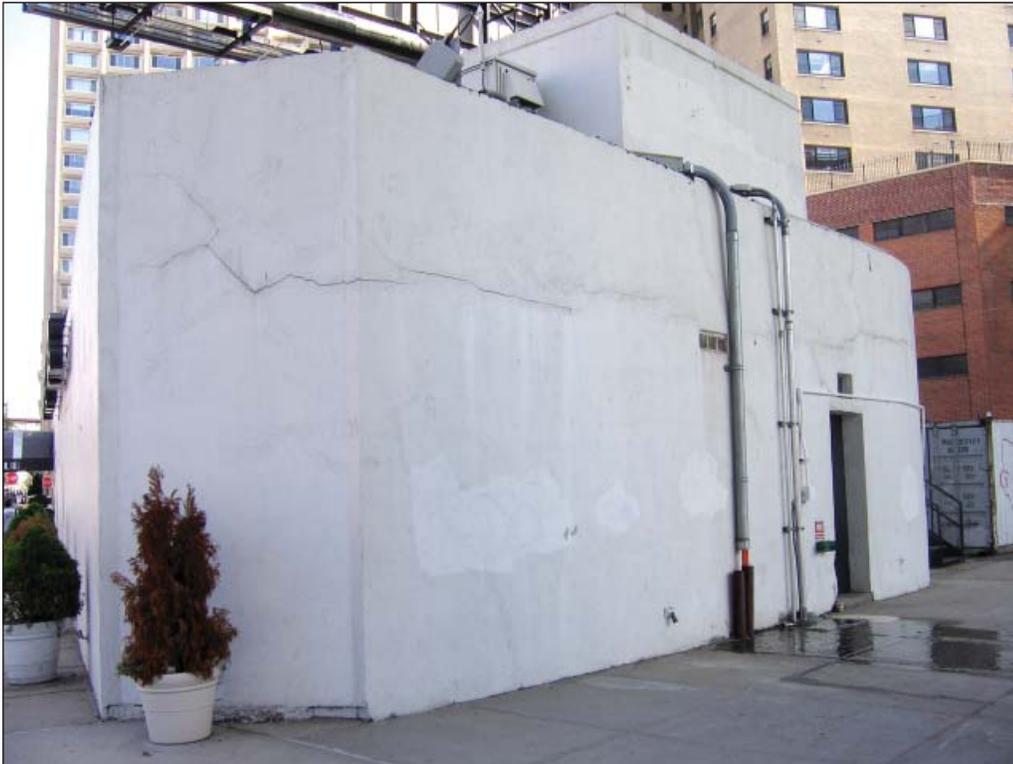
**Photograph 1996-I-C**

of the building was not accessible for observation. Distress to the building includes several wide cracks on the exterior walls around the building (see Photograph C); mold and delamination of finishes, apparently from water infiltration, on the south exterior wall under the stairs; corrosion of the header beam above the southeast door (see Photograph D); and spalled concrete at the base of the southern doors and stairs (see Photograph E).

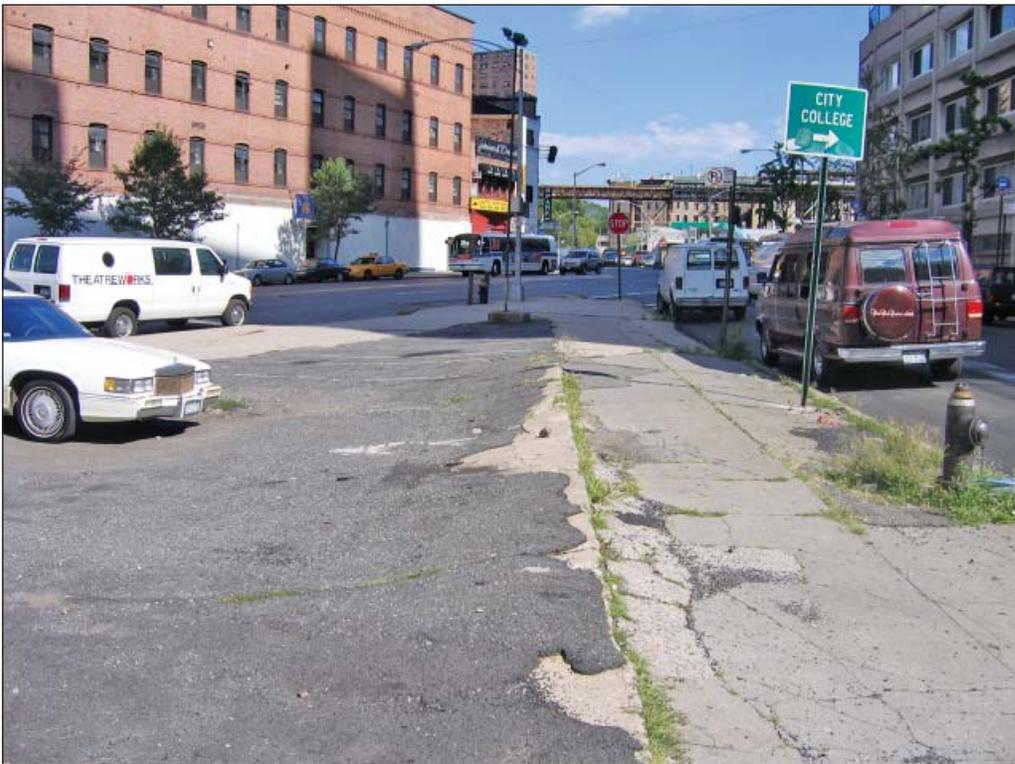
Photograph 1996-I-F

The building's rear parking lot and sidewalks along Twelfth Avenue and Claire Place are in poor condition, with significant spalling and cracks in the asphalt and concrete (see Photographs F, G and H). A grating cover located on the Twelfth Avenue sidewalk is clogged with debris and therefore cannot serve its purpose of either ventilation or drainage (see Photograph I). The sidewalk along the West 125th Street is in fair condition with few cracks observed.

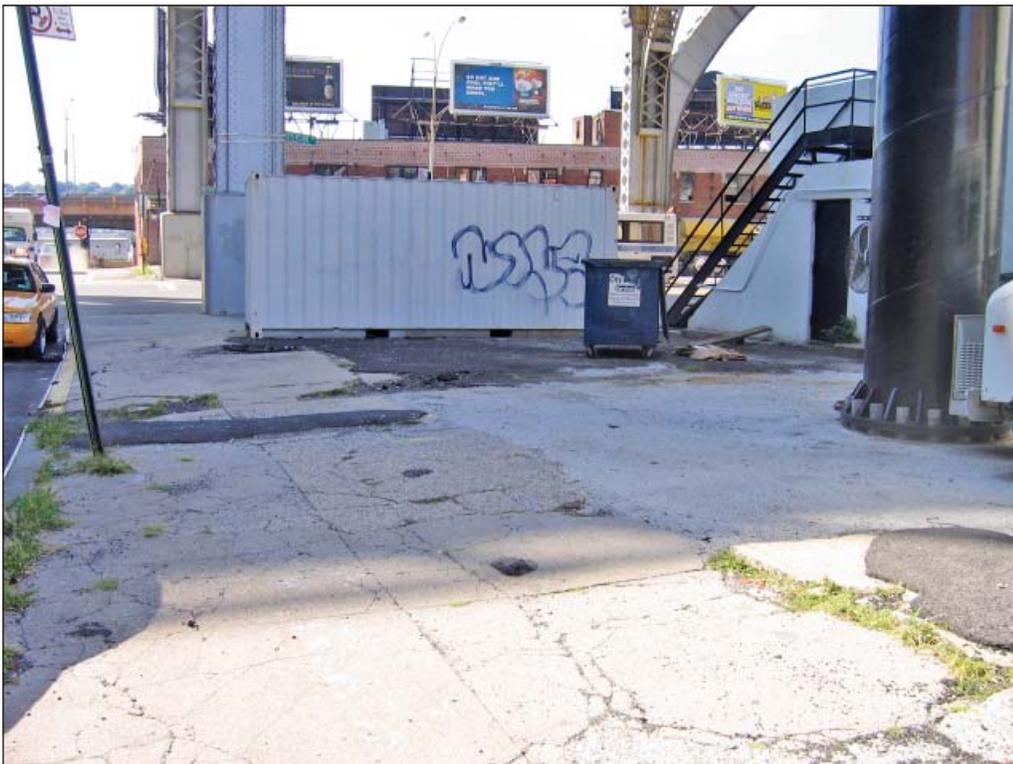
**Photograph 1996-I-H**

On the southern portion of the lot there is a large billboard. The edges of the foundation for the billboard's column are not level with the adjacent asphalt and concrete surfaces (see Photograph H). Two large metal containers with graffiti, presumably used for long-term storage, are permanently located on the lot's southwest corner and contribute to an appearance of poor maintenance along St. Claire Place and in the study area as a whole (see Photograph H and J). Also, a small, blue dumpster is present behind the building that appears to be improperly stored (see Photograph J).

The poor condition of the sidewalks along Twelfth Avenue and Claire Place, and the unevenly laid foundation for the billboard column create a safety hazard for pedestrians.

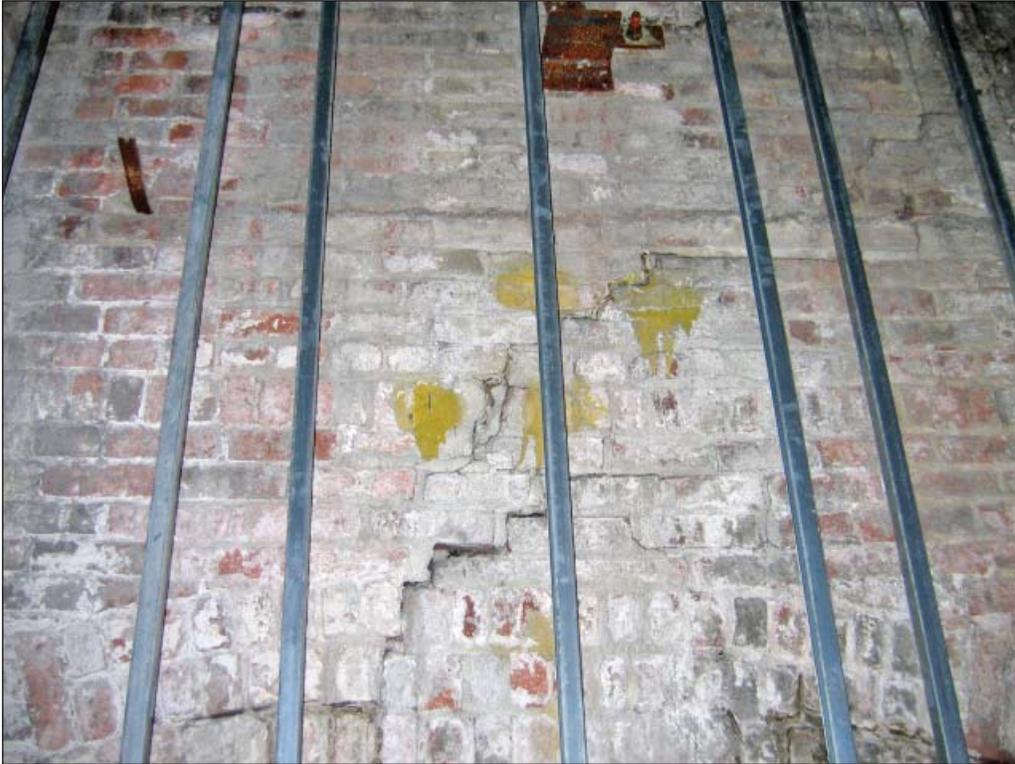
**Photograph 1996-14-C**

Water damage to the building is evident by cracks in the masonry walls (see Photograph

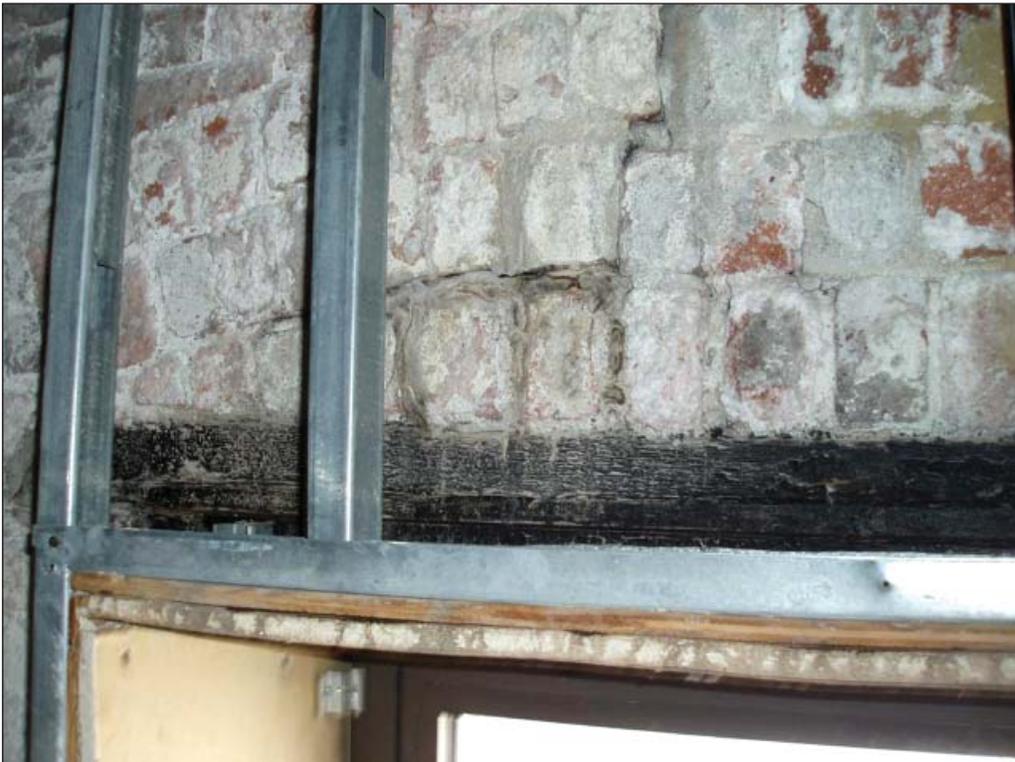
**Photograph 1996-14-D**

C), deteriorated window headers and sills (see Photograph D), cracked window glazing, corroded roof slab reinforcement (see Photograph E), spalled concrete and corrosion stains on encased steel beams (see Photograph F), and deteriorated roofing (see Photograph G). Water infiltration, causing deterioration of the roof slab and brick masonry walls above the fourth-floor window frames, could potentially lead to a localized failure of the masonry wall. Another source of localized water infiltration is holes in the north exterior wall that have been filled in with clothing and pillows (see Photographs H and I).

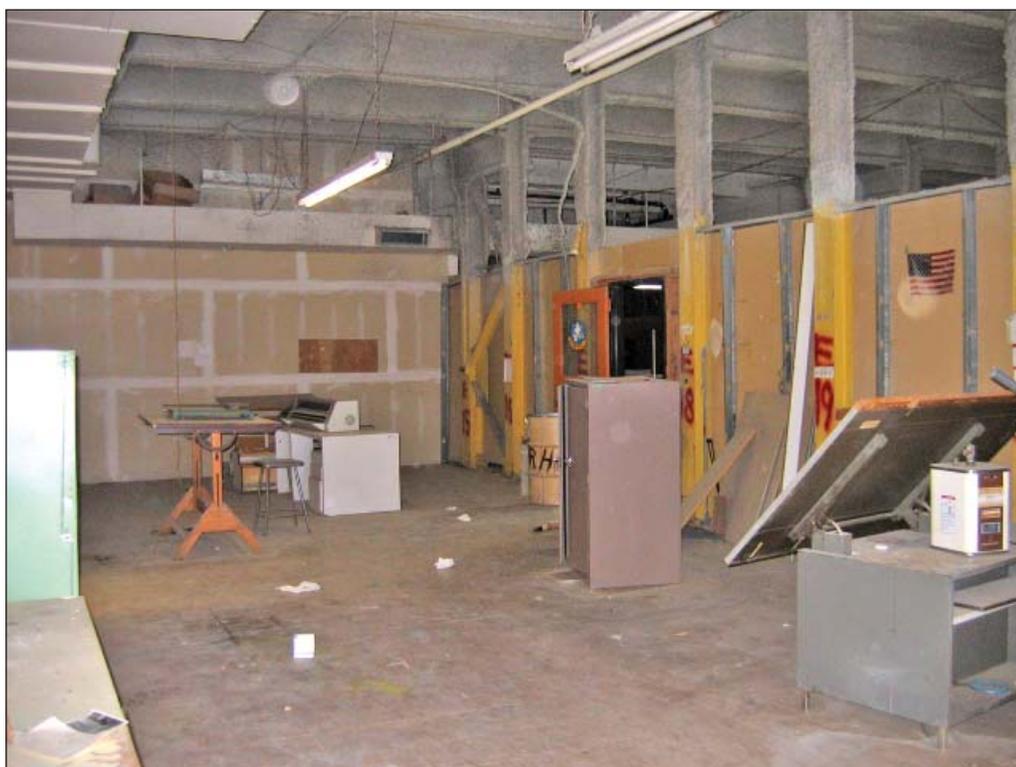
Photograph 1996-14-J

Interior spaces and partitions on portions of the first, second, and third floors and the entire fourth floor have been only partially constructed by the previous owner, and are therefore unusable in their current state, as shown in Photograph J.

Several health and safety concerns were observed during site evaluation. There are two potential fire hazards in the building. Spray-on fireproofing was only applied to partial height of several columns (see Photograph J); and steel columns and beams in the electrical room are not fireproofed. In addition, there is a drain pipe outlet above the electrical switch board, which is a safety hazard (see Photograph L). Other concerns include: mold on the ceiling and brick masonry walls, cracks at various locations on the walls, signs of vermin, and excessive debris throughout the unoccupied spaces (see Photograph M).

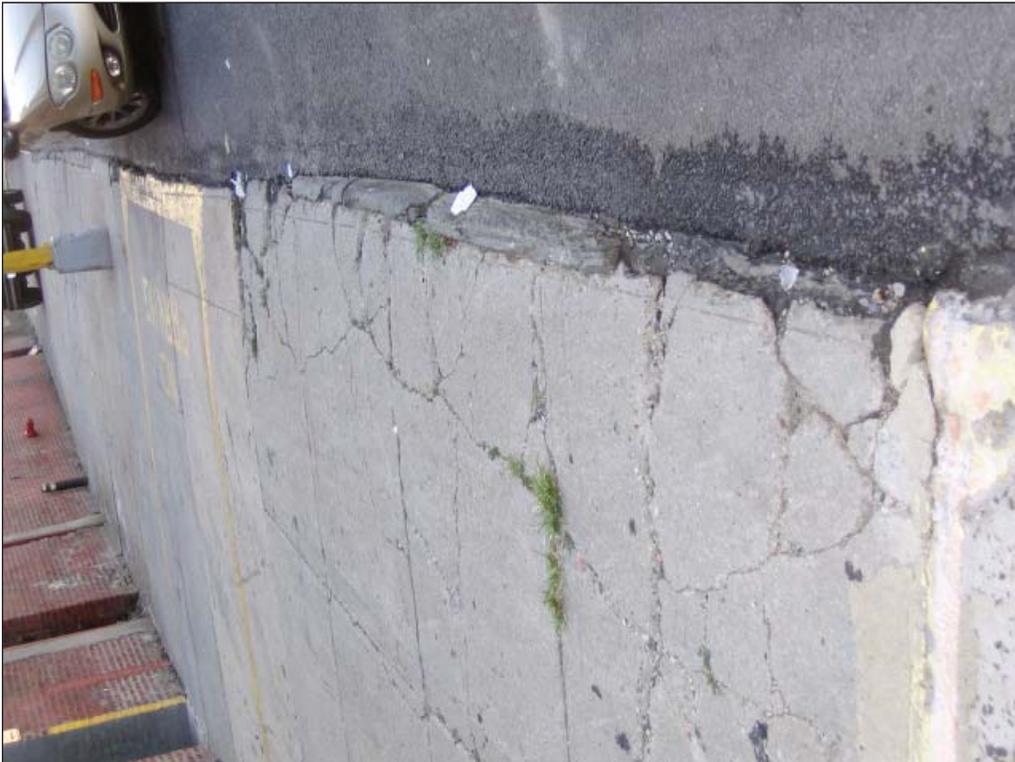
Photograph 1996-14-K

The lot's sidewalks and curb cuts are in poor condition along West 130th Street, with some wide cracks, and they are in fair condition along West 125th Street, with only minor cracks (refer to Photograph K).
