## Block 1996 Lot 18

**SITE CONDITION: CRITICAL**

Manhattanville Neighborhood Conditions Study

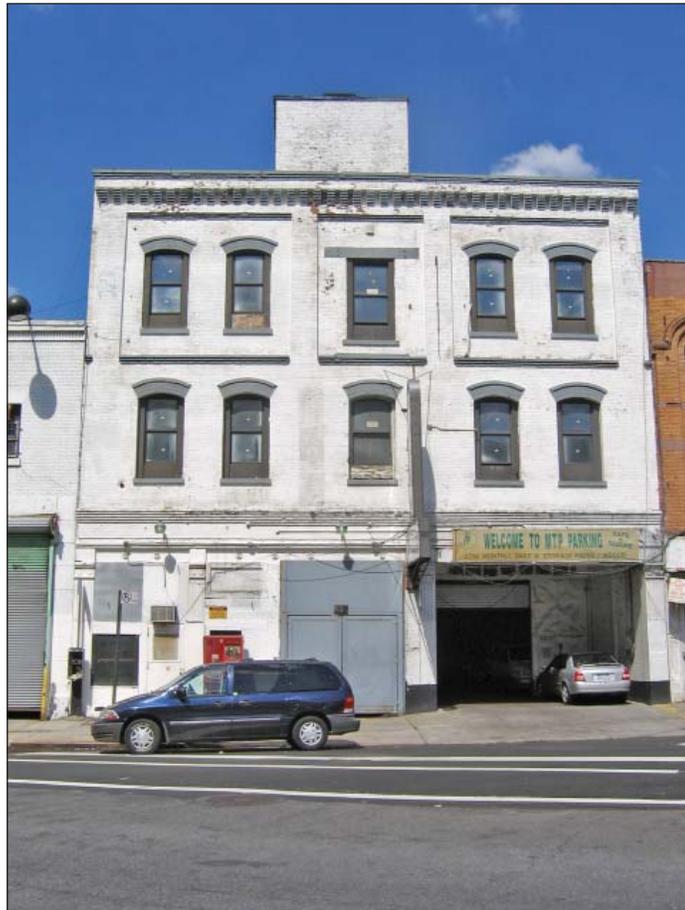
**Photograph 1996-18-A**

Lot 18 is located in an M1-2 zoning district at 627 West 129th Street between Twelfth Avenue and Broadway. Acquired by the Trustees of Columbia University on December 15, 2004, it is a three-story public parking garage with lot area fronting both West 129th and West 130th Streets (see Photographs A and B, respectively). In addition, there is an auto body shop in the northern half of the first floor. The 29,757-gsf building was constructed circa 1920. No renovations have been recorded.

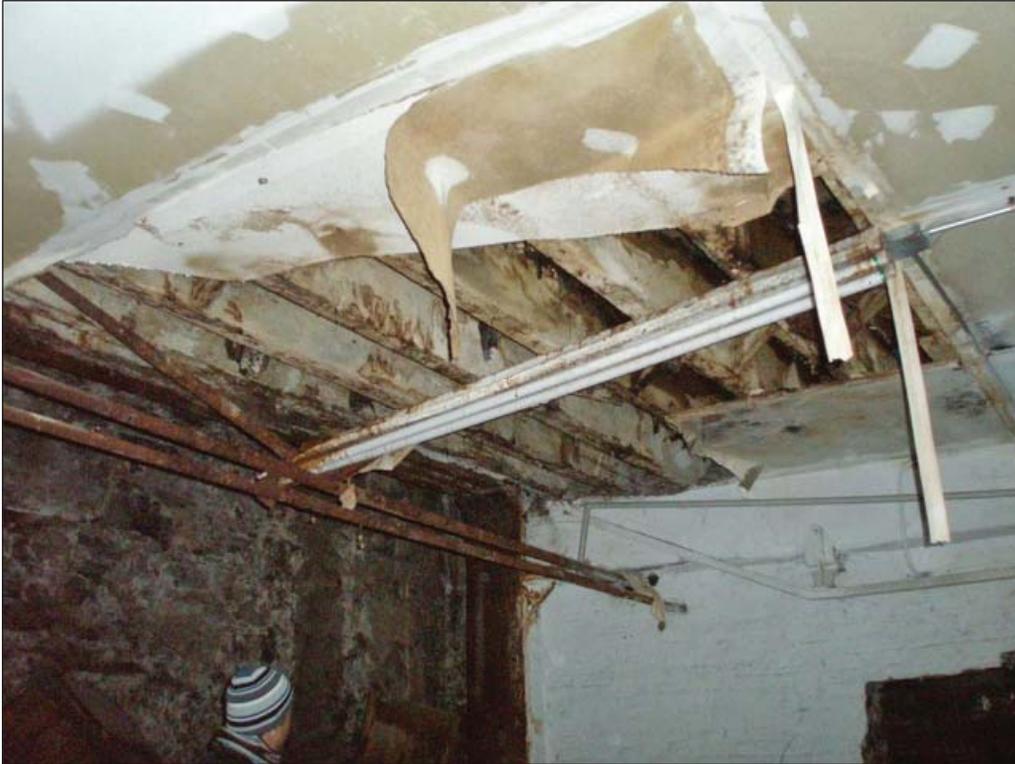
**Photograph 1996-18-C**

Long-term water infiltration is causing significant deterioration of the structural elements throughout the building. In some areas, the deterioration is critical. The timber joists and timber decking are water damaged in various locations on all levels (see Photograph C). Steel framing that supports the sidewalk and driveway slab to the auto body shop is severely corroded from water intrusion and may no longer be adequate to support the vehicular traffic for the auto paint shop above (see Photograph D). Brick masonry walls have cracks, flaking paint, and signs of water intrusion (see Photographs E and F). Significant cracks and flaking paint were also observed on the stairwell walls (see Photograph G). Additional water infiltration could be the result of corroded window frames on the north façade, a deteriorated waterproof coating on the inside face of the parapet, and cracked glass panes in the skylight.

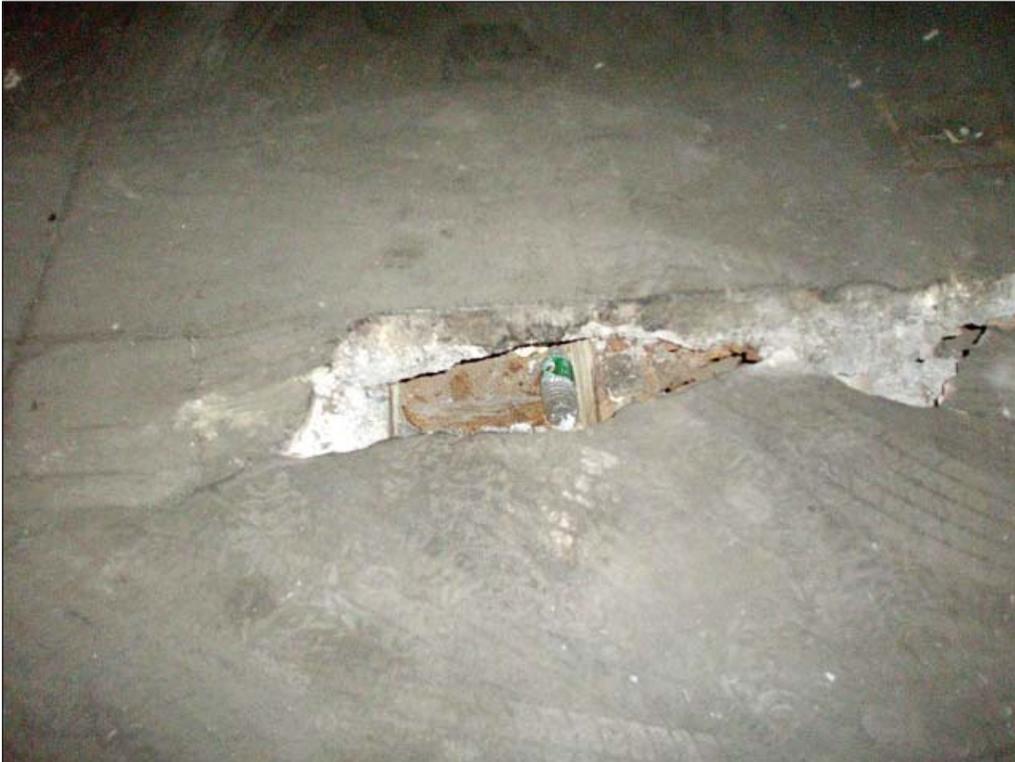
**Photograph 1996-18-H**

Vertical cogged cracks on the east and west exterior masonry walls appear to be the result of the north and south façades' separation from the rest of the building caused by either temperature-induced movement, differential settlement, or the adjacency of load-bearing and non-load-bearing building components (see Photograph H). This is evidence of structural distress occurring in the affected areas. In addition, long-term use as a parking garage and car body paint shop, and associated activities with these uses, such as exposure to vehicle exhaust, drips from motors, spray painting, and car washing operations have caused deterioration, including cracks on the concrete slabs due to vehicle access (see Photographs H and I). A large opening was created in the walls on the second floor between this building and the neighboring building on Lot 16 (see Photograph J), as a means of moving cars between the two spaces, however no structural distress was observed.

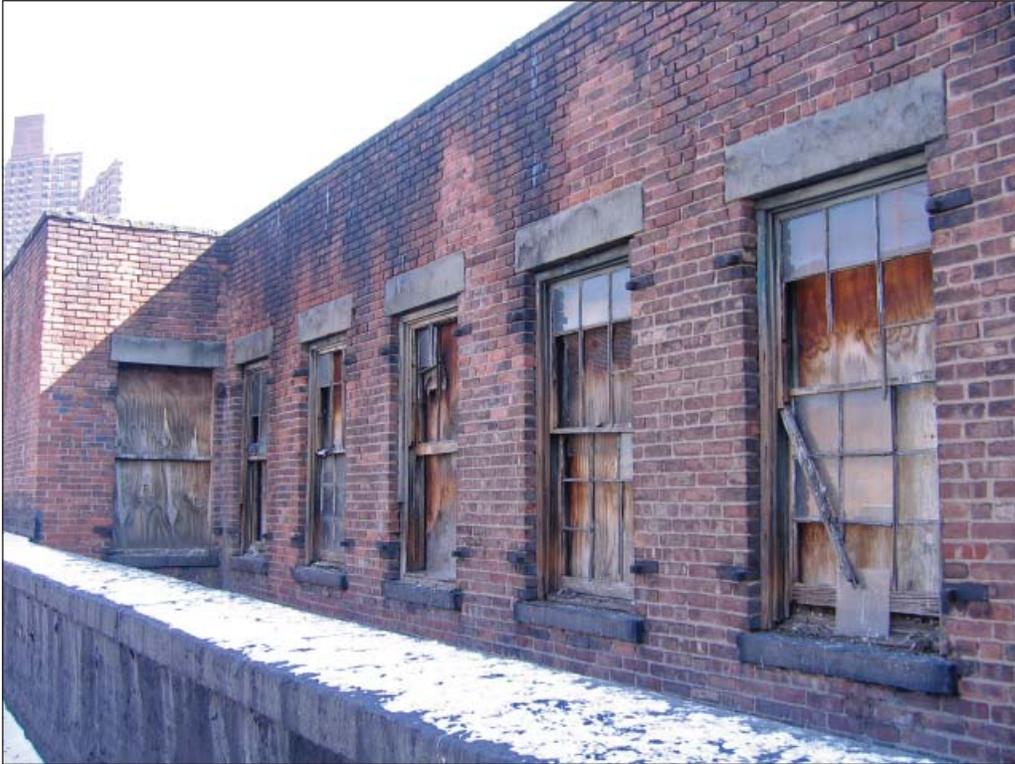
**Photograph 1996-18-K**

Other site concerns include: deteriorated window frames in the airshaft on the west side of the building (see Photograph K), the washing of cars in the building without proper drainage, and significant pigeon infestation. Long-term exposure to pigeon droppings has caused some timber joists to lose their bearing support (see Photograph L). Sidewalks and curb cuts along West 129th Street and West 130th Street are in poor condition, with cracks and uneven construction joints (see Photograph M).

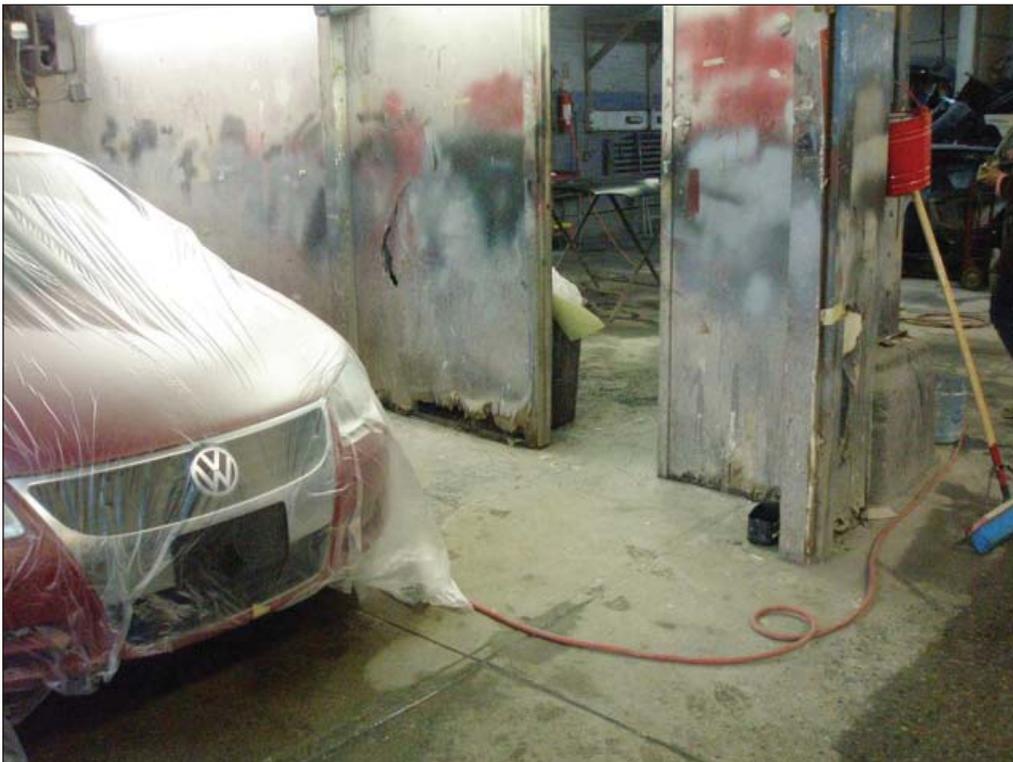
**Photograph 1996-18-N**

There are several unsafe conditions in the building, which include: a spray paint booth that does not have a proper ventilation system, as the booth walls have significant holes and an open duct leads from the booth into the rest of the first-floor space (see Photograph N); haphazard electrical wiring on the exterior of the south façade (see Photograph O); accumulation of debris and/or haphazard storage of items in the second-floor corridor to the exit stair, blocking a means of egress; severe cracking and spalling of the sidewalks; a boarded-up exit door from the stairwell to West 129th Street, rendering the means of egress non-effective and creating a fire safety hazard; and an unsafe drive-in elevator that lacks protective railings at the slab edges on all floors and has unguarded moving mechanical parts in the elevator cabin. As discussed in the next section, this elevator has three open hazardous DOB violations.
