## Block 1996 Lot 20

SITE CONDITION: CRITICAL

Manhattanville Neighborhood Conditions Study

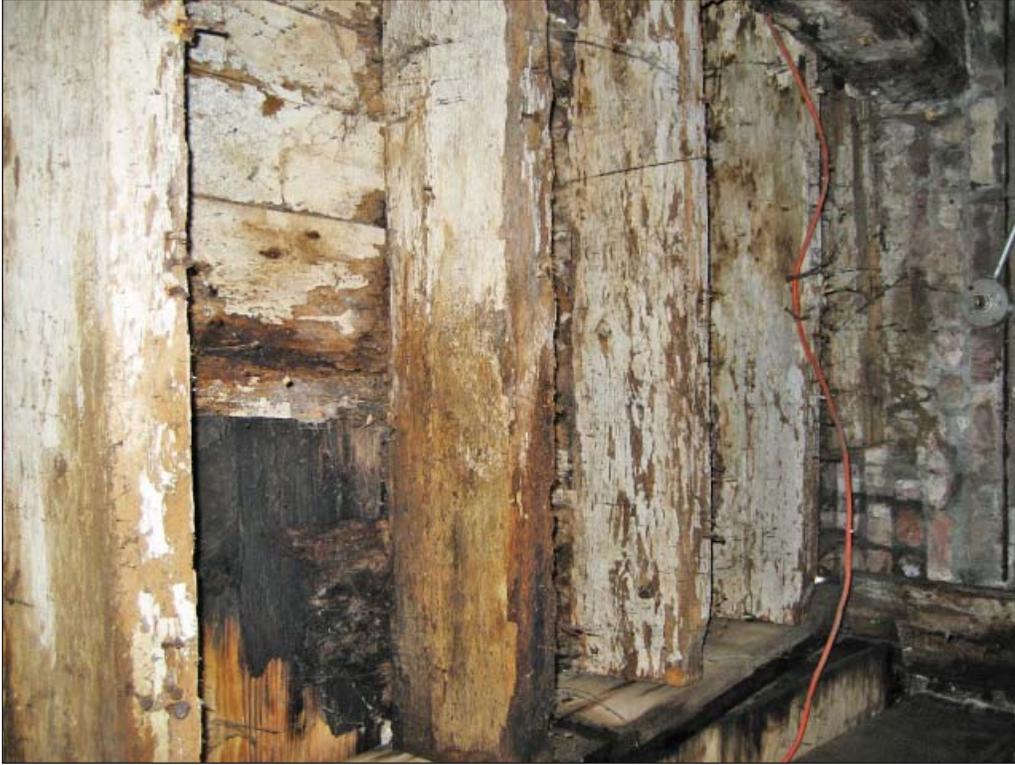
Photograph 1996-20-D

Structural concerns were observed in both buildings. In the two-story building, the timber columns have termite and water damage, with one of the columns in critical condition (see Photographs C and D). In the basement of the three-story building, additional columns were installed to support the first-floor framing and/or slab, and possibly to support the heavy equipment on the first floor (see Photograph E). According to Thornton Tomasetti, Inc. it is unclear if these columns were designed by a licensed New York State professional engineer.

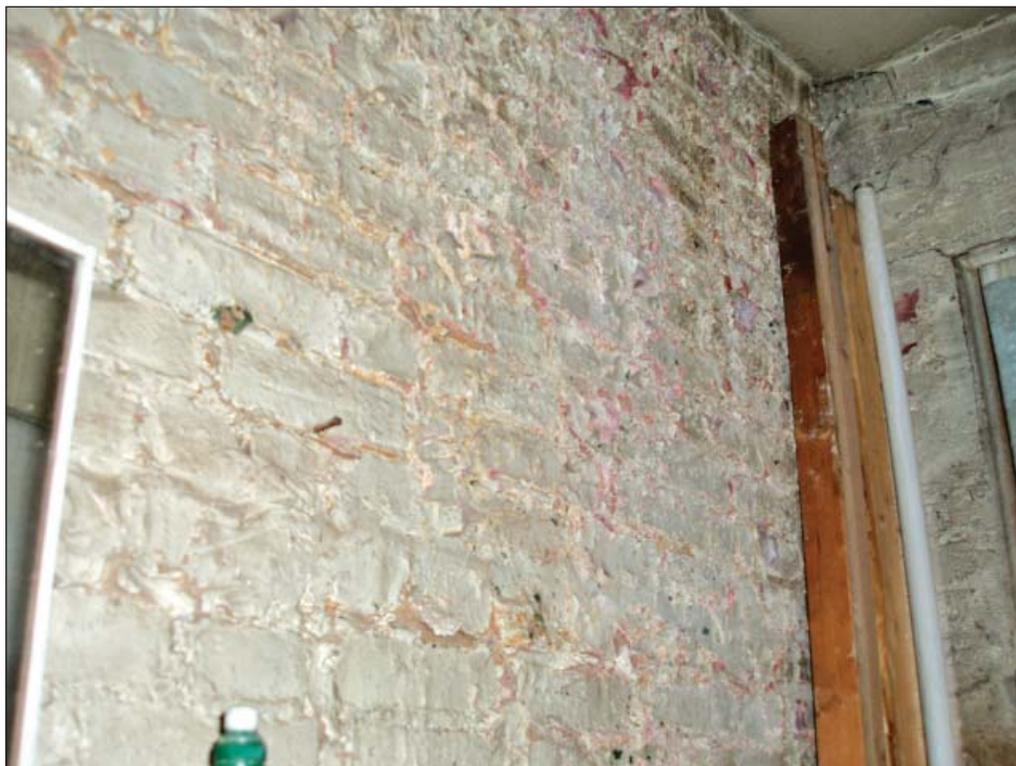
Photograph 1996-20-F

Long-term water infiltration has caused deterioration to several structural and non-structural elements in both buildings, including water stains at the door or window frames and signs of mold and efflorescence (see Photographs F and G). In the three-story building, water exposure has caused the timber framing to deteriorate near the second-floor exit (see Photograph H). Water damage was also observed at the roof access hatch, indicating potential water damage of the roof joists (see Photograph I). In the two-story building, water exposure has caused corrosion or deterioration to the following elements: the sheet metal ceiling (see Photograph J), the ceiling above the second-floor stair landing (see Photograph K), the timber members of the internal stair, and cracks on the two-story building's

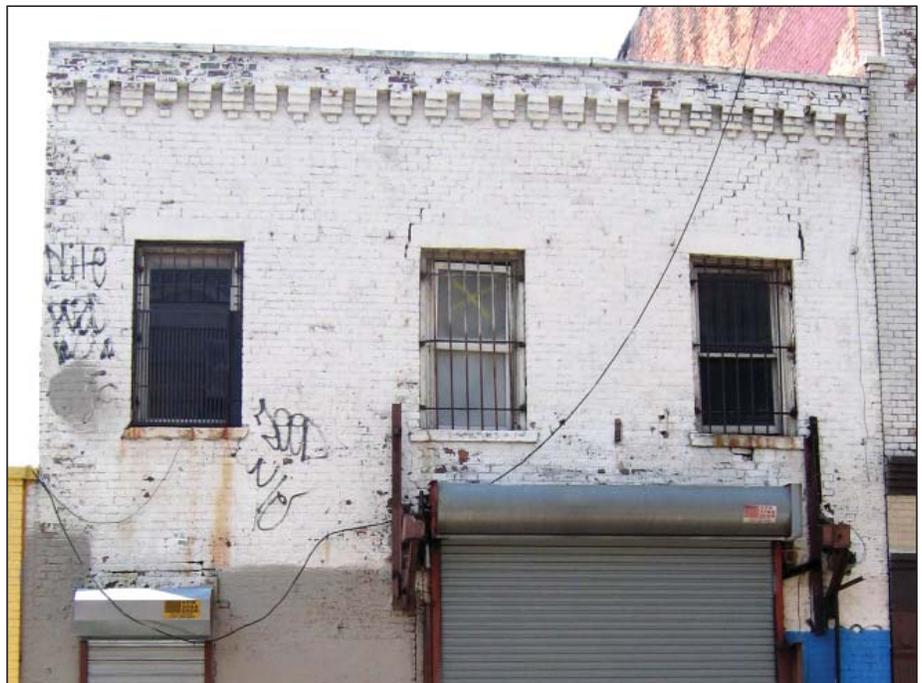
**Photograph 1996-20-L**

exterior brick masonry wall (see Photograph L). In addition, a damaged drainage pipe is likely causing water from the roof drain to fall on the exterior brick masonry wall of the three-story building, causing further damage to the exterior wall (see Photograph M).

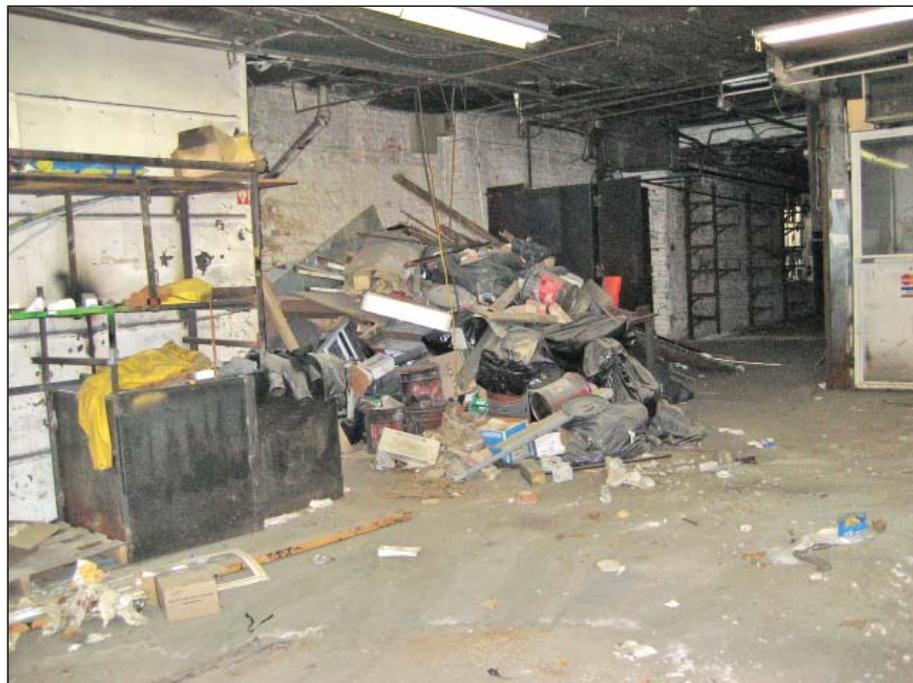
**Photograph 1996-20-N**

Other concerns and signs of poor maintenance in the two story building include: a significant amount of garbage and debris on the first floor and in the basement of the two-story building (see Photographs N and O), and cracks in the two-story building's parapet and coping stones. In the three story building further concerns include: standing water in the basement (see Photograph P), an inoperable elevator, a corroded ladder that leads to the roof (see Photograph Q), damaged coping stones on the lower roof (see Photograph R), and a clogged roof drain, causing ponding on the lower roof (see Photograph S). Although not a structural concern, there are cracks and spalled concrete at several locations on the slab-on-grade in the three-story building and local floor damage in the two-story building (see Photograph T). The sidewalk and curb cuts along West 129th Street are in poor condition, with several wide cracks and spalling concrete (see Photograph U); however the sidewalk along West 130th Street is in fair condition, with a few cracks.

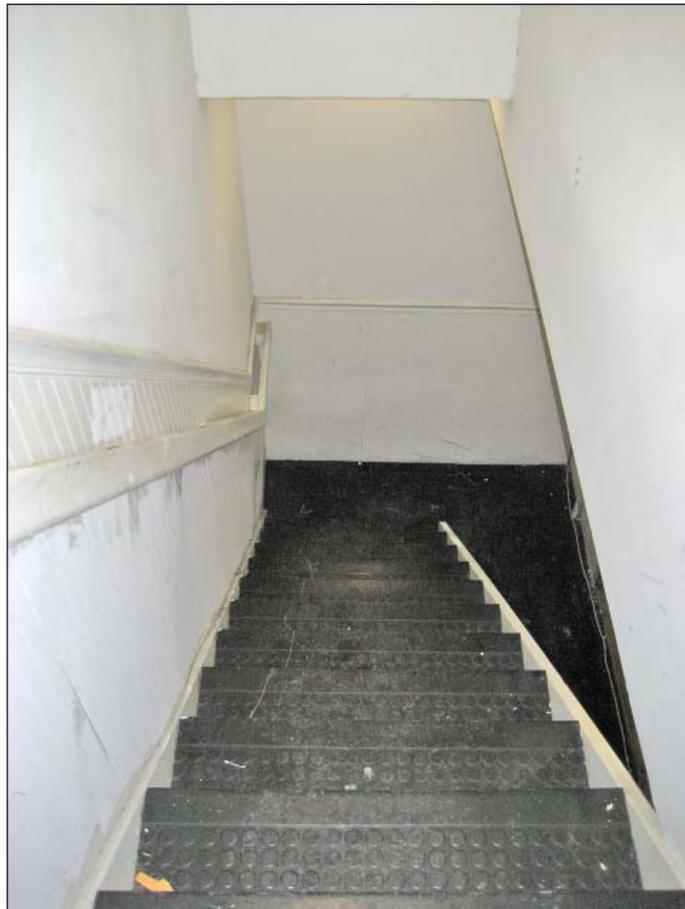
**Photograph 1996-20-V**

There are several safety concerns related to Lot 20. The three-story building's internal stair lacks handrails (see Photograph V). The exit from the second floor of the two-story building is obstructed by debris and a toilet. Other health concerns include: mold growth, standing water in the basement of the three-story building, and a significant amount of debris in the two-story building.
