Block 1996 Lot 29

SITE CONDITION: FAIR

Manhattanville Neighborhood Conditions Study

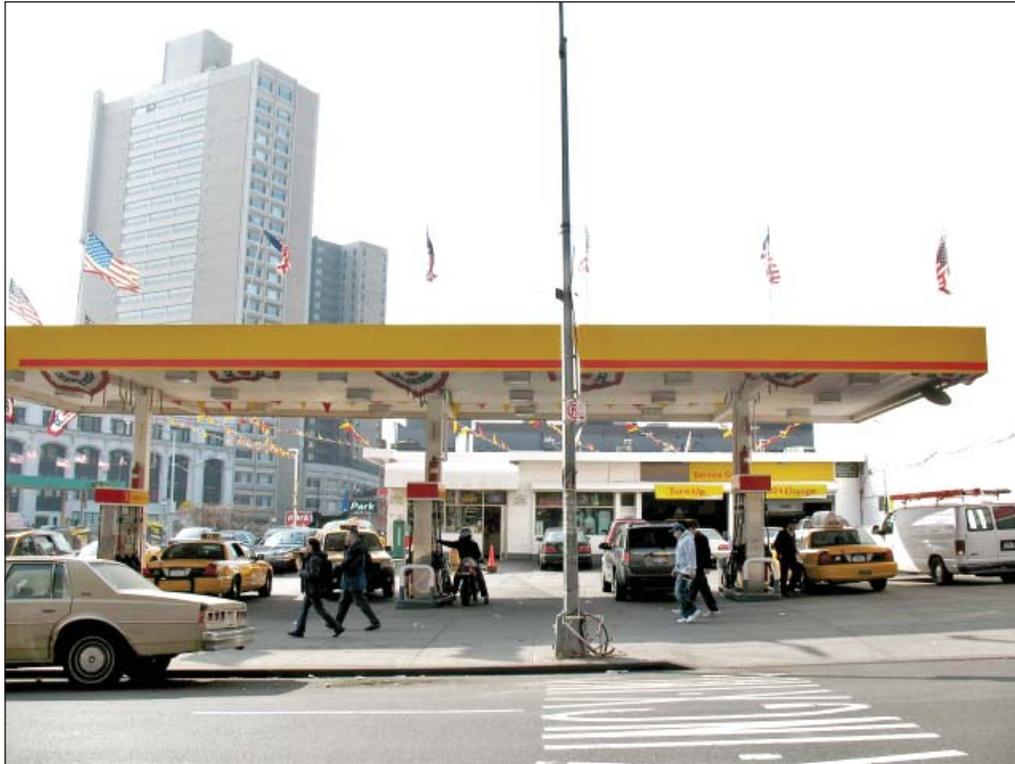
Photograph 1996-29-A

Lot 29 is located at 3221 Broadway (on the northwest corner of Broadway and West 129th Street) in an M1-2 zoning district (see Photographs A and B). Acquired by the Trustees of Columbia University on June 27, 2006, the lot is occupied by a gas station, which includes an auto repair facility and a small convenience store. The 1,845-gsf building was constructed in 1975. No renovations have been recorded.

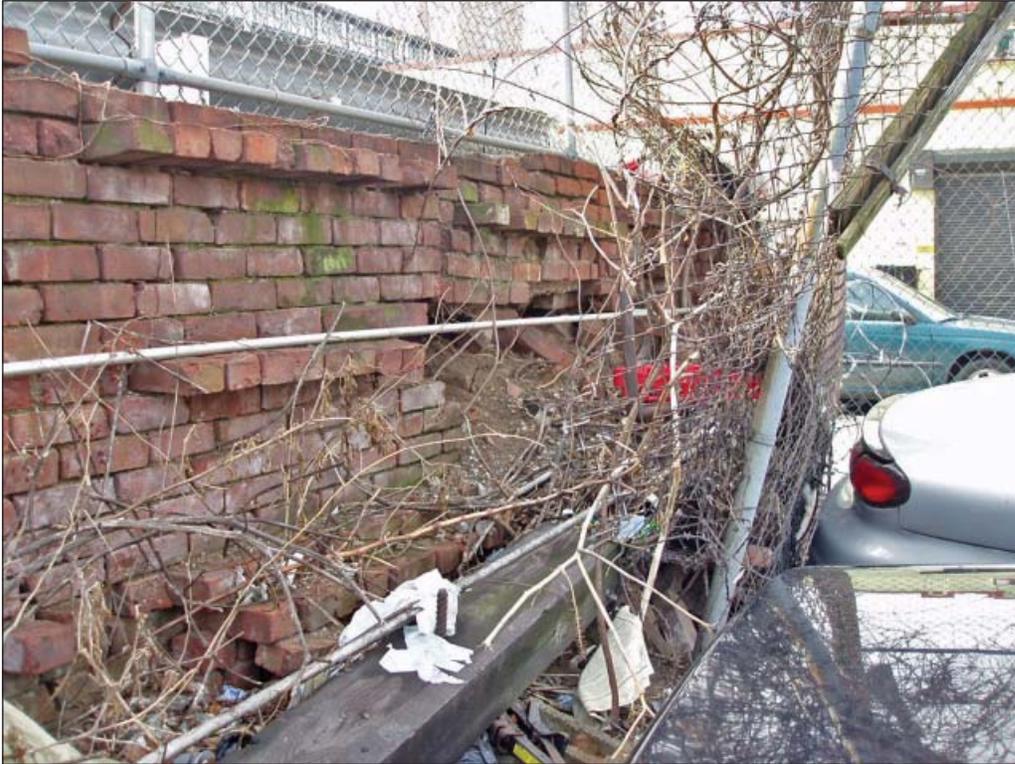
Photograph 1996-29-C

There are missing bricks at the south end of the retaining wall where loose dirt has poured through the wall, indicating that this portion of the retaining wall is likely on the verge of a collapse (see Photograph C). Also, the building's western façade is covered with a waterproof coating, however, the coating does not continue to the base of the foundation wall below. The absence of the waterproof coating in this location may cause water infiltration, which could possibly lead to structural distress of the building's foundation (see Photograph D).

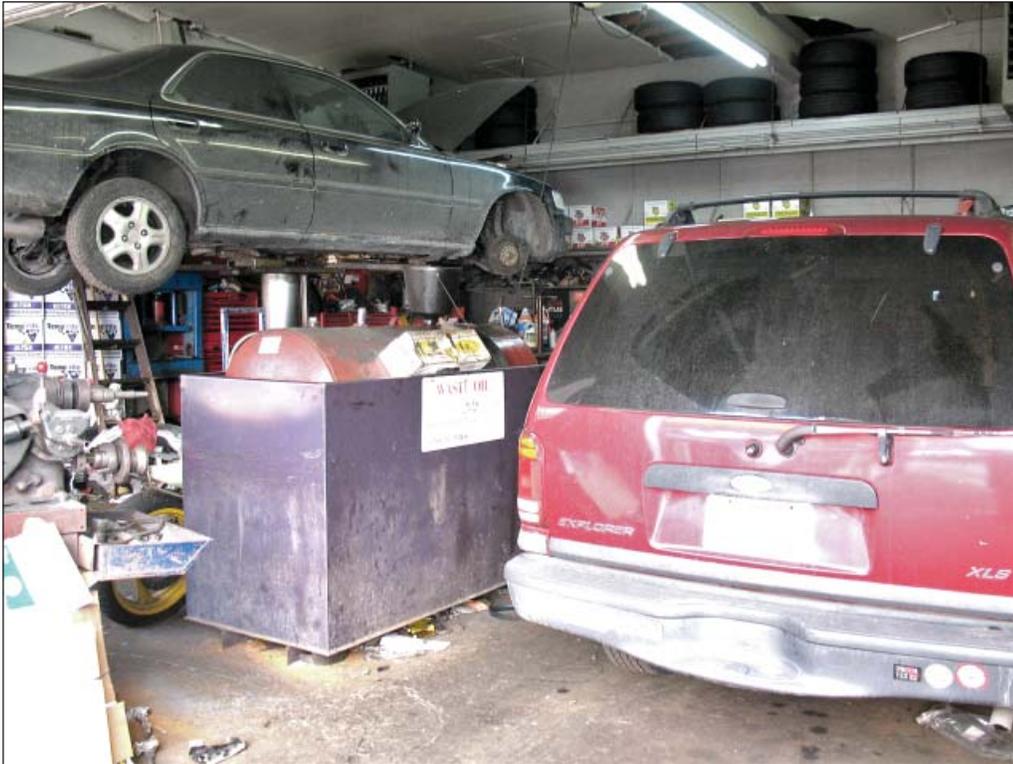
Photograph 1996-29-E

Other site concerns include chemical stains and cracks on the interior concrete slab-on-grade, which are related to the auto repair operations occurring on the site (see Photograph E); and local cracks on the concrete retaining wall south of the building (see Photograph F). The sidewalk along West 129th Street is in fair condition with several cracks (see Photograph G), although the sidewalk along Broadway is in good condition.

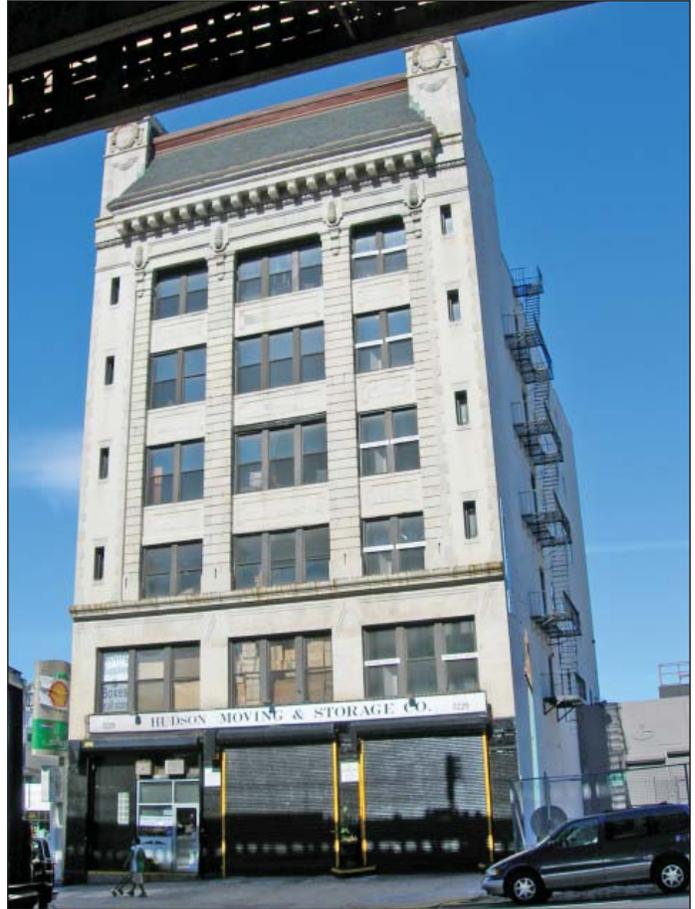
Photograph 1996-34-A

A six-story, 30,000-gsf warehouse building, acquired by Mid-Atlantic Moving and Storage circa September 1972, is located on Lot 34 at 3229 Broadway between West 129th and West 130th Streets (see Photograph A). The building, which is currently used a storage facility, was constructed in 1943; no renovation dates are listed. The lot is in an M1-2 zoning district.

ing on the north and west façades has started to peel and flake (see Photograph B and C). There is also some water staining on the east façade's upper cornice (see Photograph A). The windows are generally in good condition; however, several windows on the west façade are covered with metal sheeting (see Photograph C).

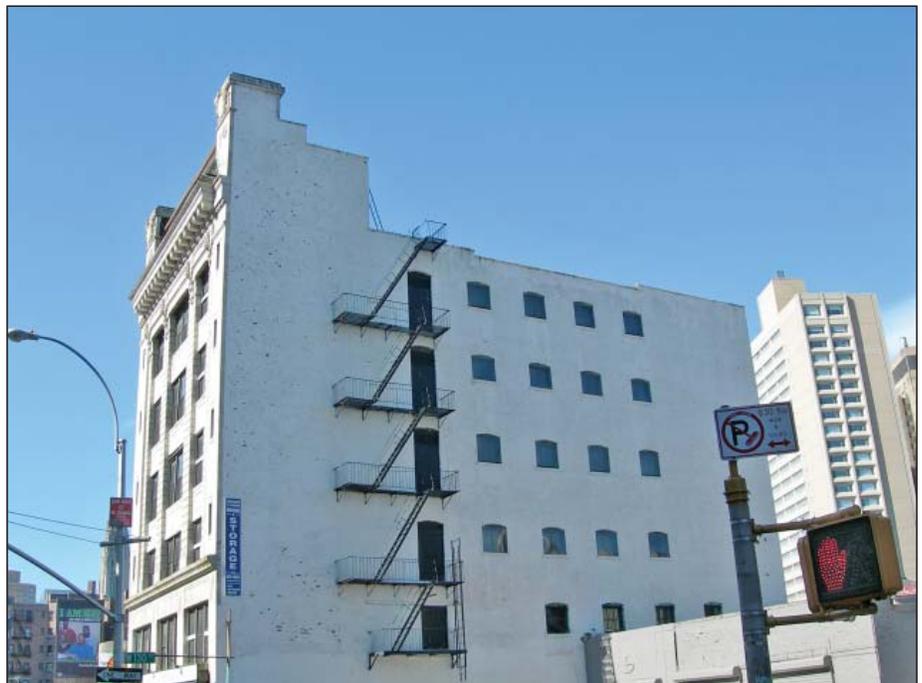
Photograph 1996-34-B

The exterior of this site was evaluated by Thornton Tomasetti, Inc. to be in good condition overall, however, the building's interior was not accessible for observation. The building's exterior, constructed of brick masonry covered with a white cementitious coating, is generally in good condition; however, the coat-

The sidewalk in front of the building is in poor condition, with cracked and spalling concrete, while the curb cuts are in good condition (see Photograph D). A fire escape leading from the roof to the ground is located on the north façade, and appears to be in good condition, as shown in Photograph B.
