Block 1997 Lot I

SITE CONDITION: CRITICAL

Manhattanville Neighborhood Conditions Study

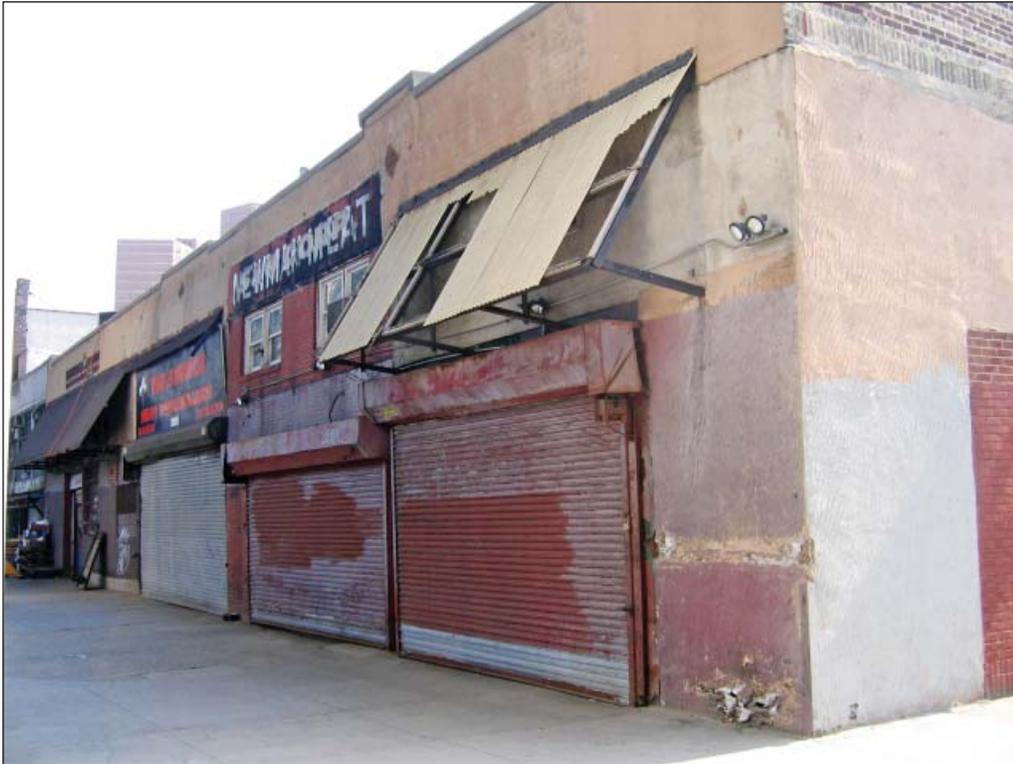
Photograph 1997-I-A

Other building concerns include: a vertical crack along the western roll-up door likely caused by vehicle impact, the poor condition of the exterior stucco coating (see Photograph A), corrosion of the steel lintels at two roll-up door openings (see Photograph P), deterioration of the first-floor concrete slab-on-grade due to exposure to auto-related chemicals (see Photograph Q), and stained ceiling tiles, indicating water infiltration.

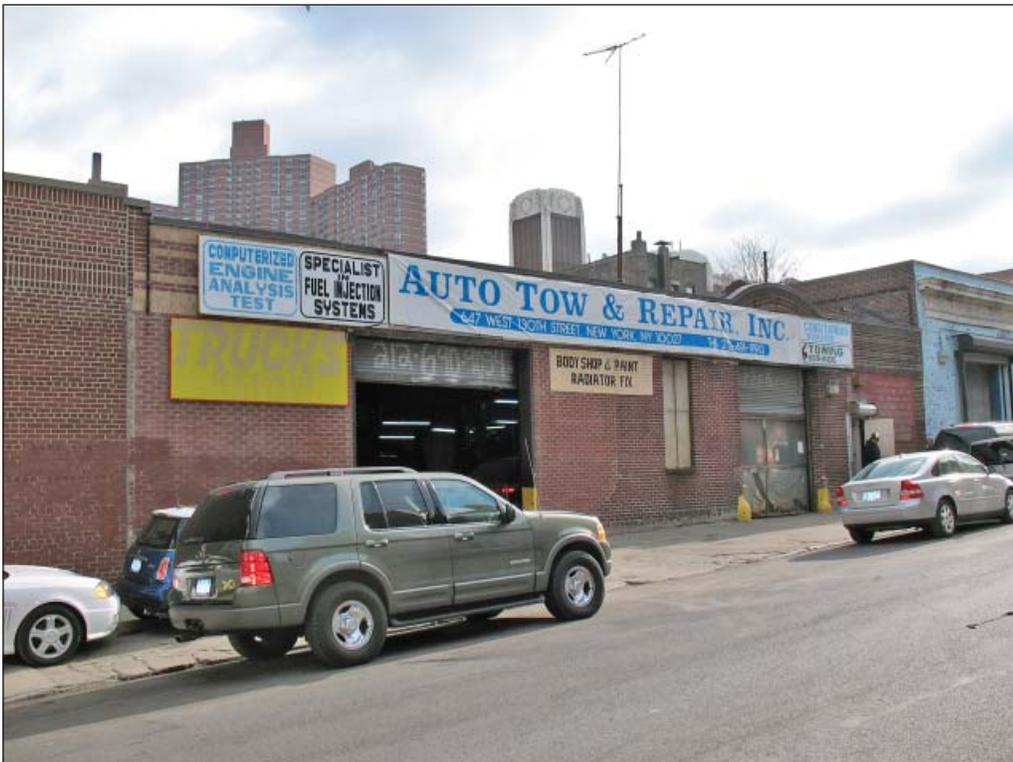
Photograph 1997-I-B

Significant structural distress is evident throughout the building, largely due to differential settlement and water infiltration. Settlement in the northwest corner of the building, likely due to periodic flooding and erosion below the first-floor slab, has resulted in shifting, cracking, and wide separation gaps in the exterior walls (see Photograph C), interior mezzanine walls (see Photographs D and E), mezzanine flooring, and windows (see Photograph F), as well as uneven and sunken slab sections (see Photograph G). Water infiltration has caused a partial collapse of roof joists in the northeast corner of the building (see Photograph H). Further, there is a diminished section of the center masonry pier, which may be structurally compromised (see Photograph I); a portion of the masonry wall along West 130th Street is bulging (see Photograph J); and the west parapet along Twelfth Avenue is leaning out (see Photograph K).

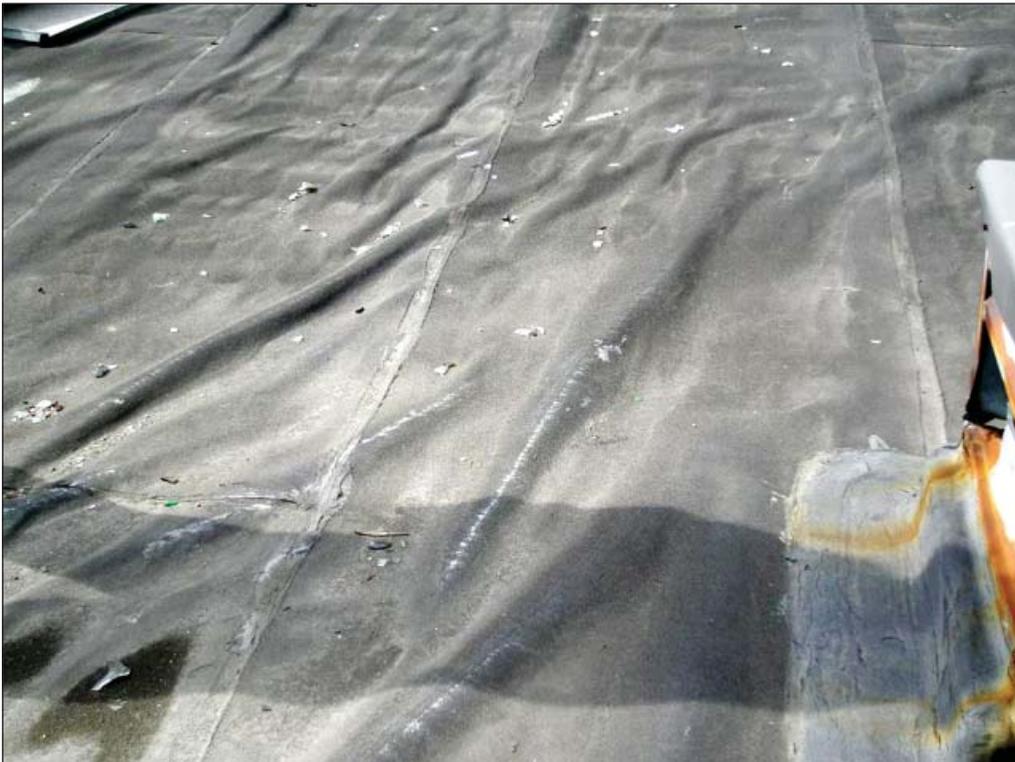
Photograph 1997-I-L

The building's roof and skylights are in generally poor condition, as portions of the roof membrane are delaminated and billowing (see Photograph L), the membrane flashing is partially displaced (see Photograph M), various sections of the parapet's waterproof coating is compromised, several skylight glass panes are cracked and flashing is deteriorated, and accumulated floating debris around the roof drains indicate that water ponding is occurring (see Photograph N). In addition, three windows of the adjacent building are partially hidden behind the north parapet—a poor design practice, as it allows water to accumulate and may lead to structural deterioration (see Photograph O).

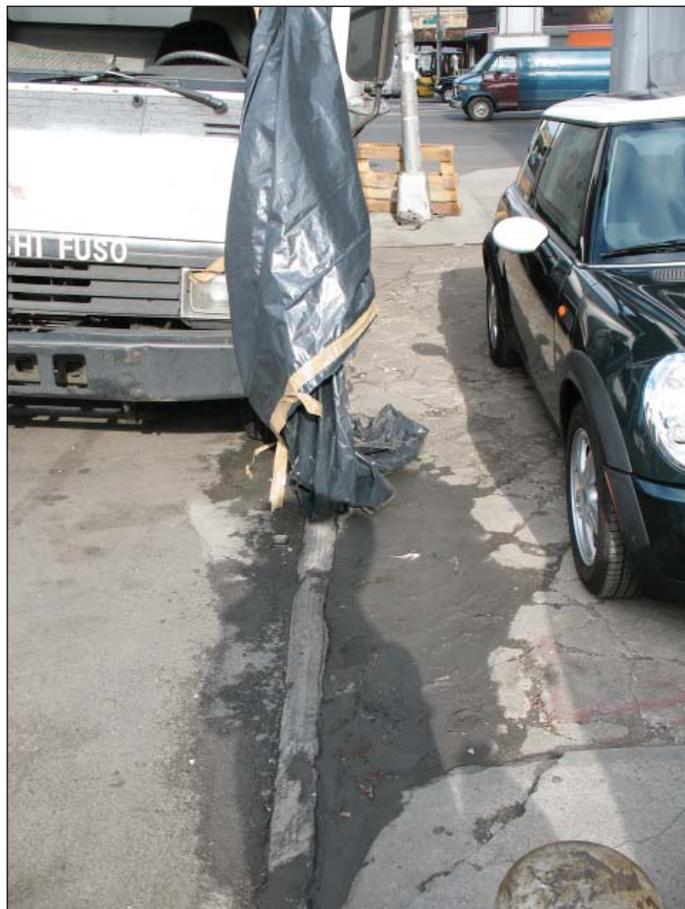
Photograph 1997-I-R

The sidewalks and curb cuts on Twelfth Avenue and West 130th Street are in critical condition, with significant cracks in various locations (see Photograph R), which are likely exacerbated by the auto repair business' practice of parking cars on the West 130th Street sidewalk.
