## Block 1997 Lot 6

SITE CONDITION: FAIR

Manhattanville Neighborhood Conditions Study

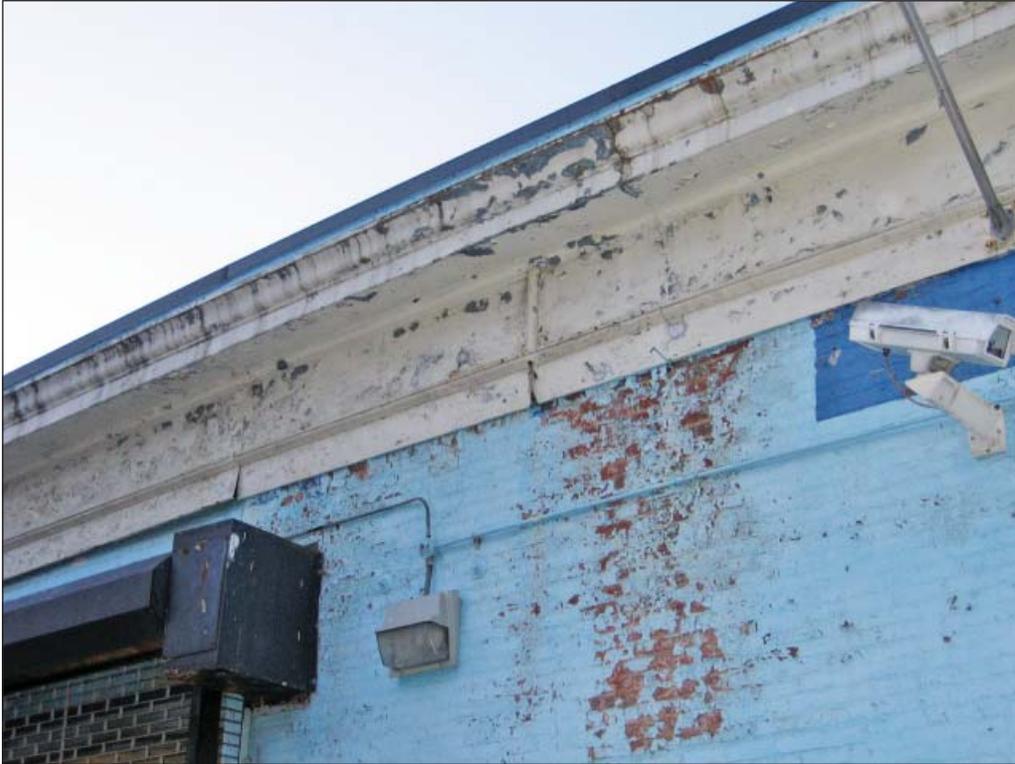
**Photograph 1997-6-C**

This site was evaluated by Thornton Tomasetti, Inc. to be in fair condition overall due to localized structural distress and some substandard exterior and site conditions. Water infiltration and/or moisture is likely causing peeling paint on the north and south façades (see Photograph C). Another sign of water damage is a

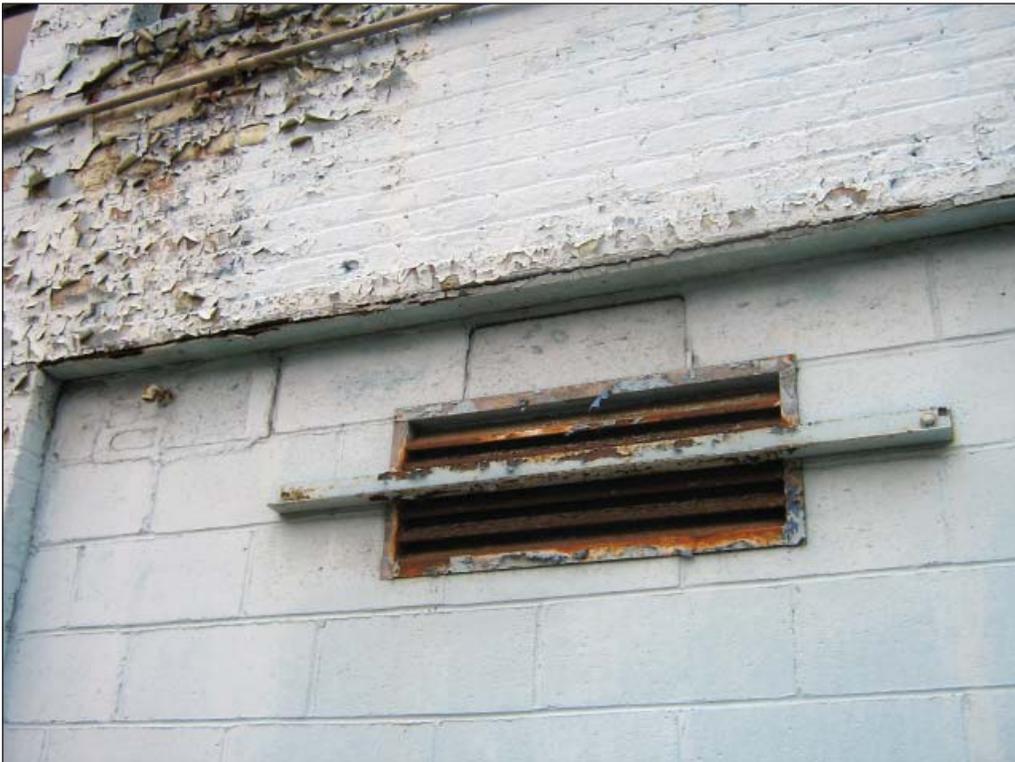
**Photograph 1997-6-D**

corroded header beam above a former window that was blocked off with concrete masonry units (see Photograph D).

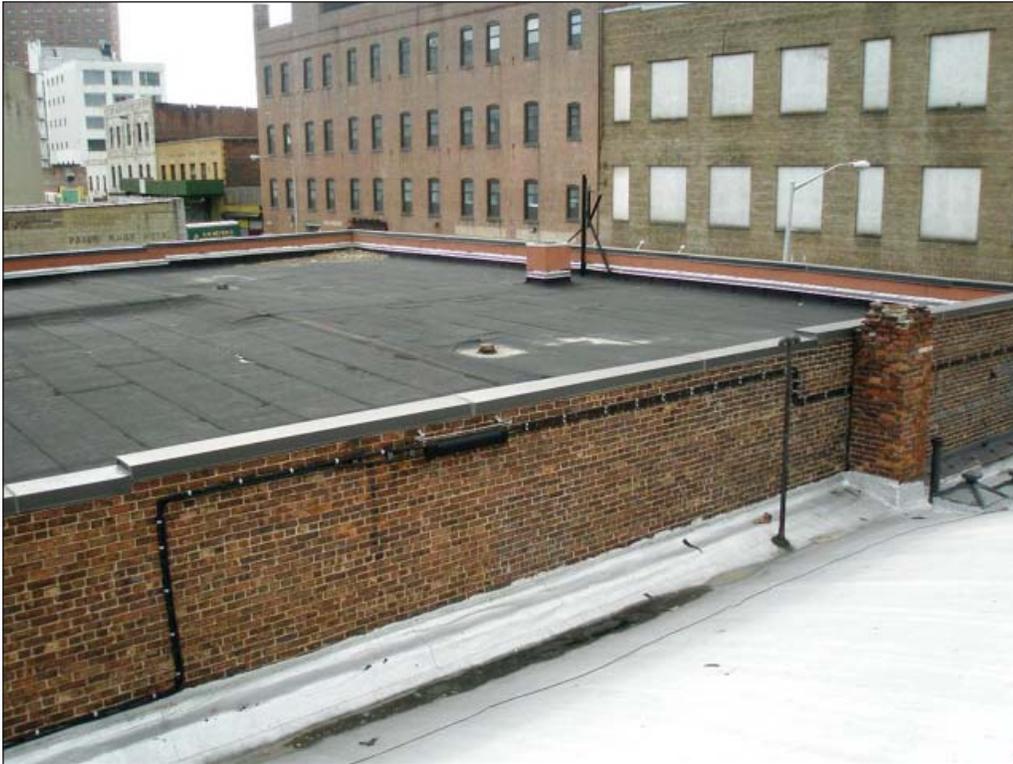
**Photograph 1997-6-E**

Although the roofing membrane is in fair condition, there are a few air pockets. Also, debris has accumulated on the southeast corner of the roof, which may be a potential area for ponding (see Photograph E).

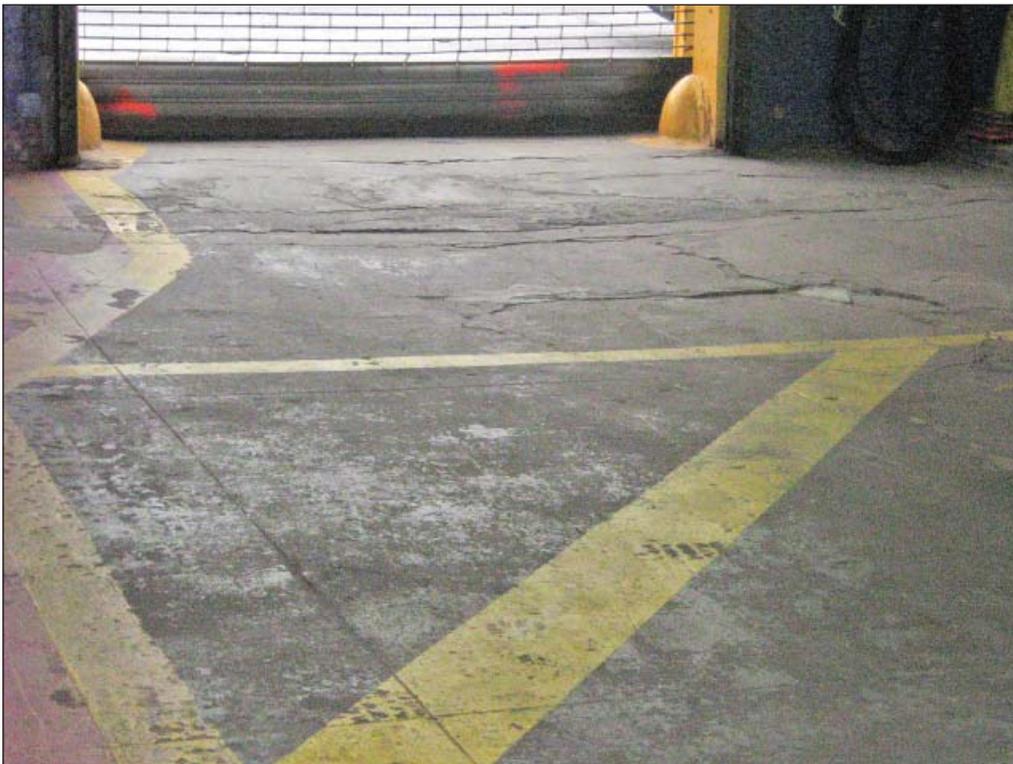
**Photograph 1997-6-F**

In general, the interior of the building is in fair condition, with some local cracks in the concrete slab-on-grade and interior wall on the first floor (see Photographs F and G). The wear and tear observed on the slab-on-grade is indicative of the long-term use of forklifts and other vehicles in the building (see Photograph H).

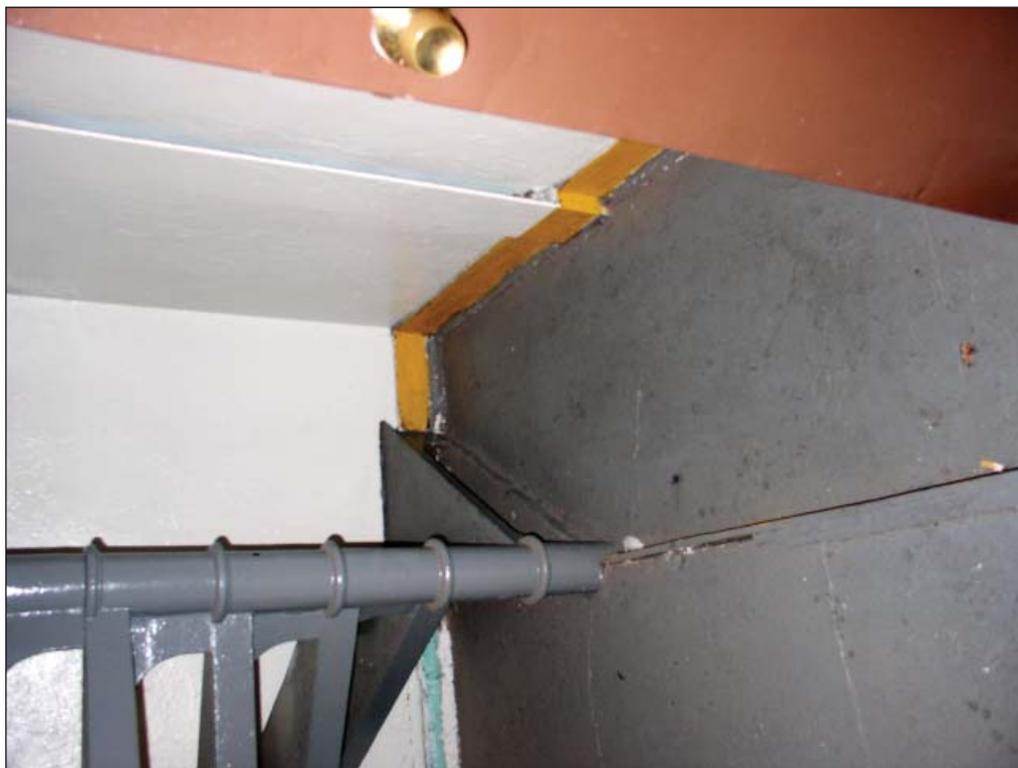
Photograph 1997-6-J

A staircase inside the building has a step down portion at the base, which is a potential tripping hazard due to its location in a blind spot (see Photograph J).

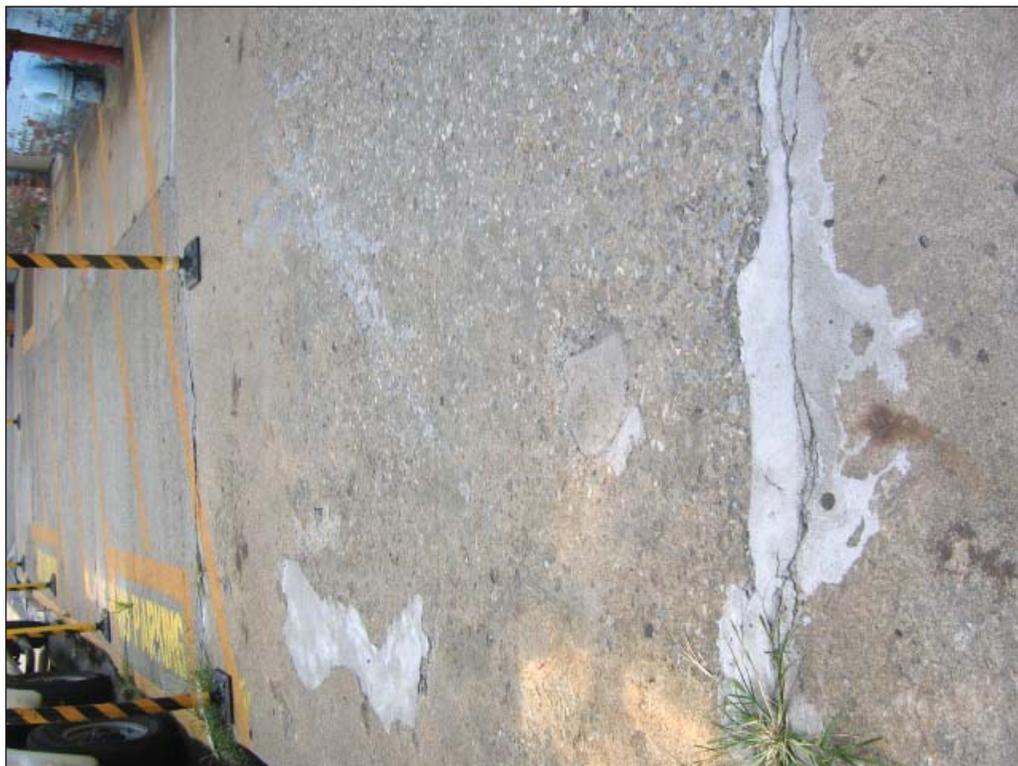
Photograph 1997-6-I

The sidewalks and curb cuts on West 130th and West 131st Streets are in fair condition with minor spalling and cracks observed (see Photograph I).
