## Block 1997 Lot 9

SITE CONDITION: POOR

### LOCATION, USE, ZONING, AND OWNERSHIP

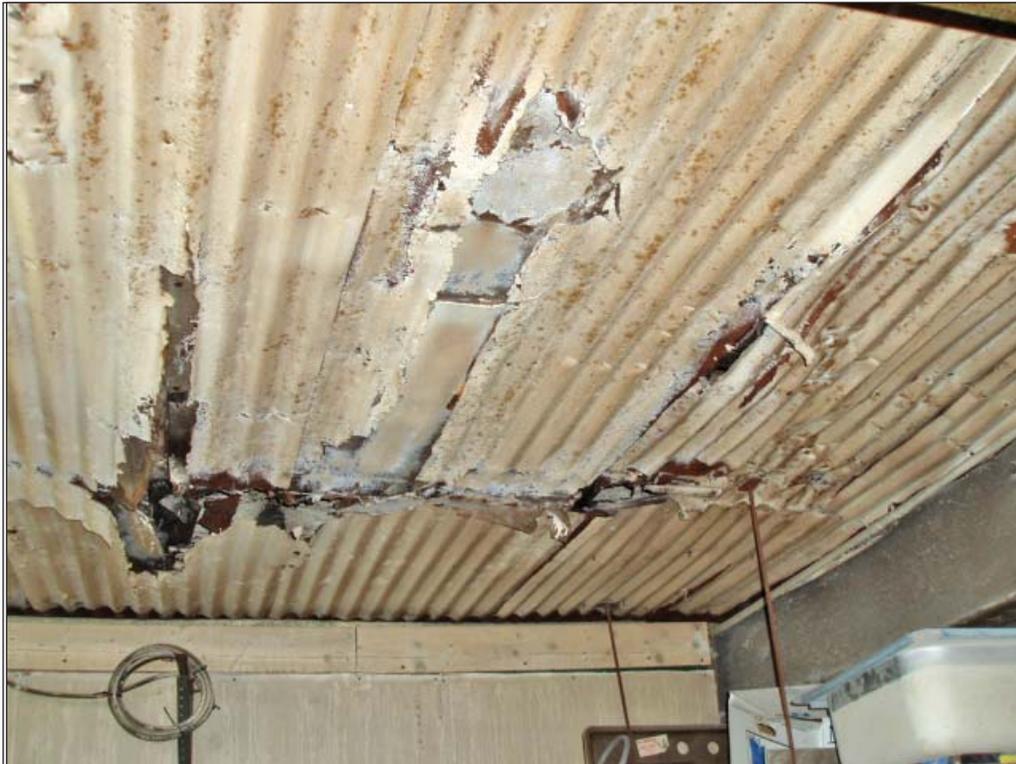
**Photograph 1997-9-C**

Long-term water infiltration has caused the wood and steel framing and masonry walls to deteriorate. There are several signs of corrosion throughout the building, such as a corroded sheet metal ceiling on the first floor of the north building (see Photograph C) and corroded steel beams in the west building (see Photograph D). The north building's timber joists are in poor condition, with widespread signs of termite damage, discoloration, deterioration due to water damage, and some warped and sagging members (see Photograph E). The timber roof joists in the east and west buildings also have signs of water damage (see Photographs D and F). There are signs of efflorescence on the north and south walls of the west building. Also, there are several repair patches on the interior face of the exterior walls of the west building, with cracks visible on some of the repair patches (see Photograph G). Water damage is also evident on the exterior walls, which have wide cracks (see Photographs H and I).

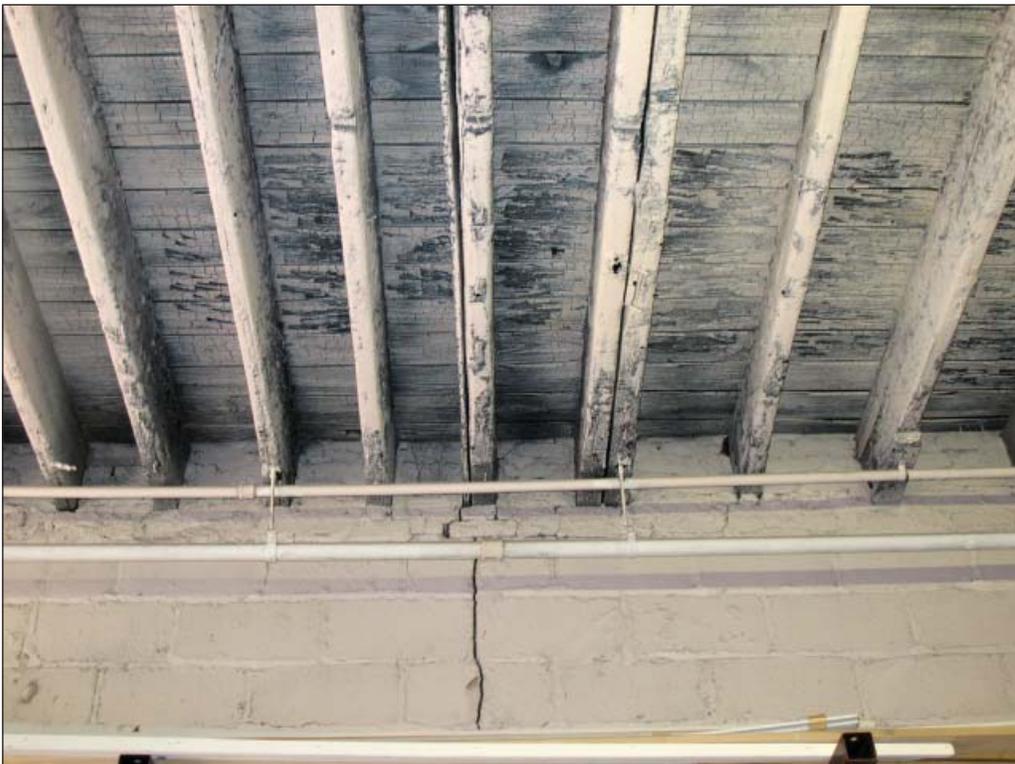
**Photograph 1997-9-F**

Other damage includes: spalling and wide cracks around the roll-up door of the east building (see Photograph N), and possible fire damage on the timber roof joists and planks in the east building (see

Photograph F) and on a timber column on the second floor of the north building (see Photograph O). The concrete slab-on-grade in the front yard has several large cracks and spalling concrete (see Photograph P). On the western portion of the lot, there are corrosion stains, flaking paint, and spalling on the roll-up doors in front of the parking lot (see Photograph B) and the asphalt surface is badly deteriorated, with spalling and numerous cracks (see Photograph Q). The sidewalks and curb cuts along West 130th Street are in fair condition, with minor cracking and spalling.

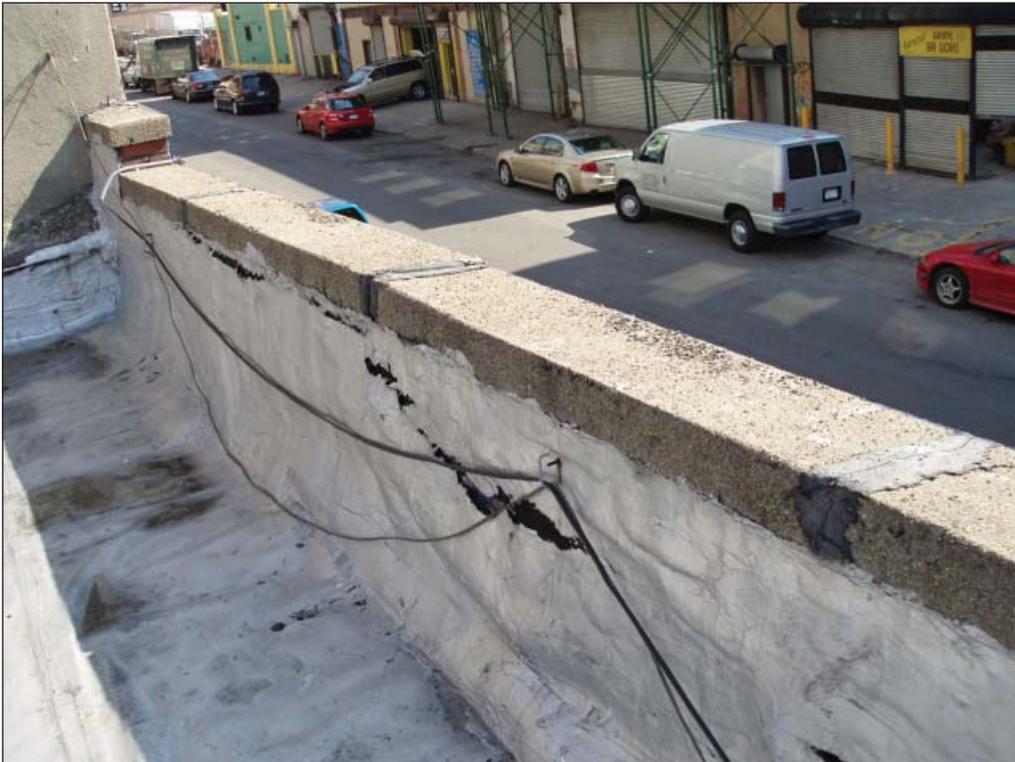
**Photograph 1997-9-J**

On all three buildings, there are tears in the roofing membrane on the inner face of the parapet (see Photographs J and K). Water ponding is occurring on the roofs of the east and west buildings (see Photograph L), and water stains and accumulated debris in a corner of the north building indicate that ponding may be occurring there as well. In addition, several coping stones on the north and east buildings' roofs are uneven and poorly secured, as shown in Photograph M.
