Block 1997 Lot 14

SITE CONDITION: POOR

Manhattanville Neighborhood Conditions Study

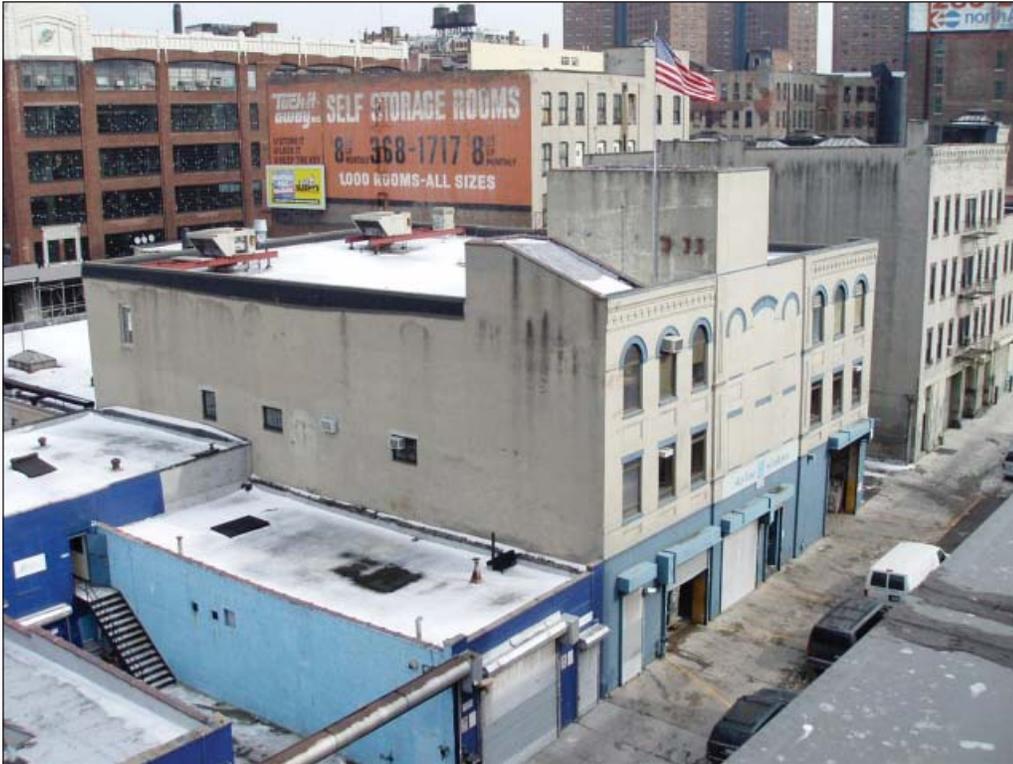
Photograph 1997-14-A

Located in an M1-2 zoning district at 625 West 130th Street between Twelfth Avenue and Broadway, Lot 14 contains a 21,437-gsf three-story brick masonry building that is occupied by a window manufacturer (see Photograph A). There is also a small one-story extension on the building's northeast side. It was acquired by Cigon LLC in January 2004 and is under contract by the Trustees of Columbia University. The structure was constructed in 1920 and was renovated in 1988.

The building has several health and safety concerns. There is a spray-painting booth with improper ventilation in the basement (see Photograph T). During several site visits, the roll-up door in front of the emergency exit door in the west stair was closed, blocking egress through this door (see Photograph A), which is an unsafe condition. Egress to the roof on the east side of the building is also blocked by a padlocked access hatch. Potential safety concerns for pedestrians include a severely damaged portion of the sidewalk and sidewalk parking (see Photographs R and S).

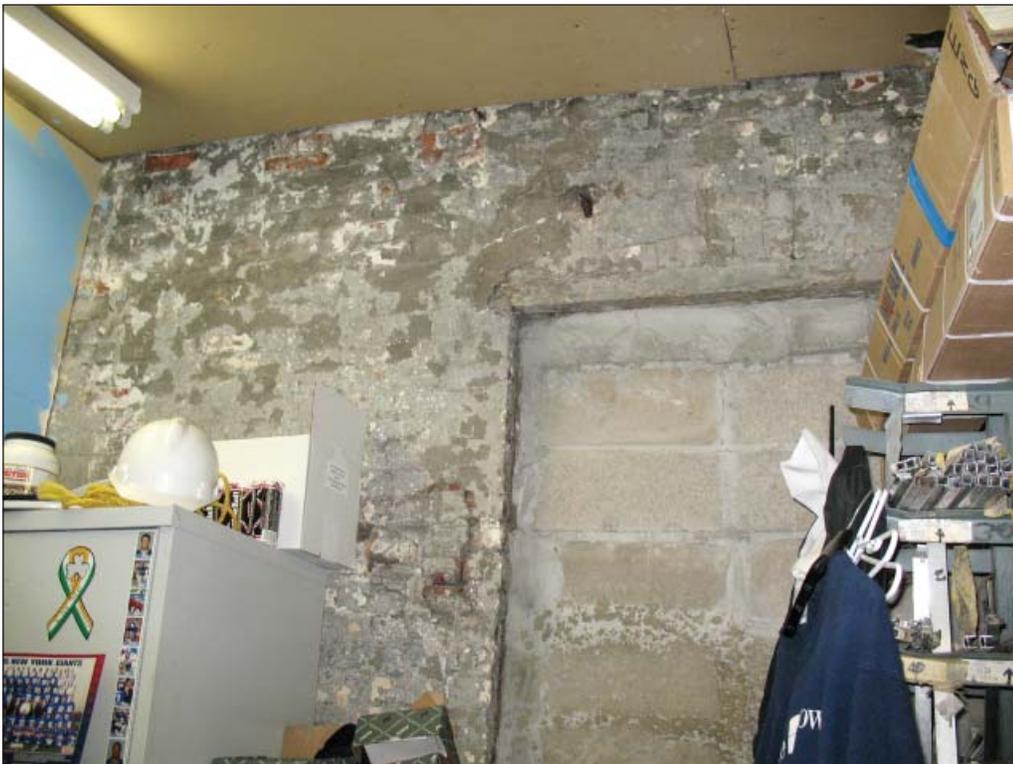
Photograph 1997-14-B

Long-term water infiltration has caused damage to the building's structural and non-structural components, including signs of efflorescence and wide cracks on the brick masonry walls (see Photographs B-D); cracks and spalling on the underside of the concrete slab (see Photograph E); signs of corrosion on the exposed reinforcement bars (see Photograph F); a corroded sheet metal ceiling (see Photograph G); and water stains on other ceilings (see Photograph H). Potential sources of water infiltration include ineffective roof drains, as they are higher than the roof (see Photograph I); a deteriorated and torn waterproofing membrane on the parapet; and cracks and spalled stucco on the chimney (see Photograph J).

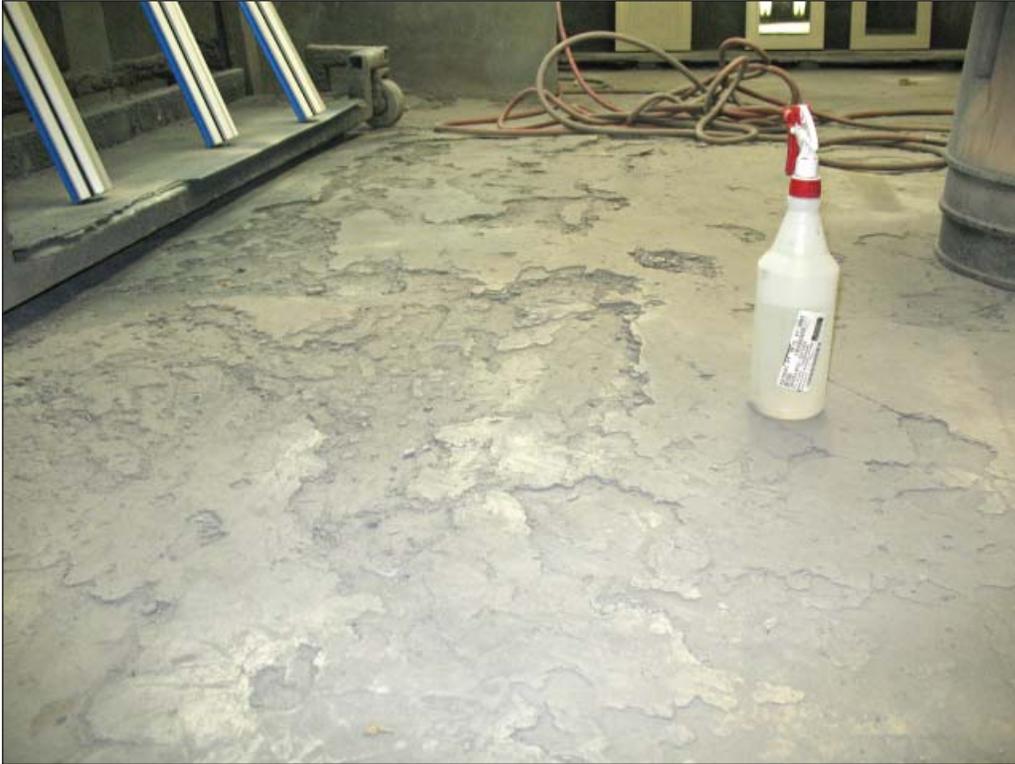
Photograph 1997-14-K

Distress is evident on the basement floor, which is in poor condition with numerous cracks (see Photograph K) and exposed wire mesh in a few locations (see Photograph L). Steel plates have been placed directly on the slab in front of the freight elevator in the basement and on the first floor possibly to protect the slab from being damaged by heavy items being dropped (see Photographs M and N).

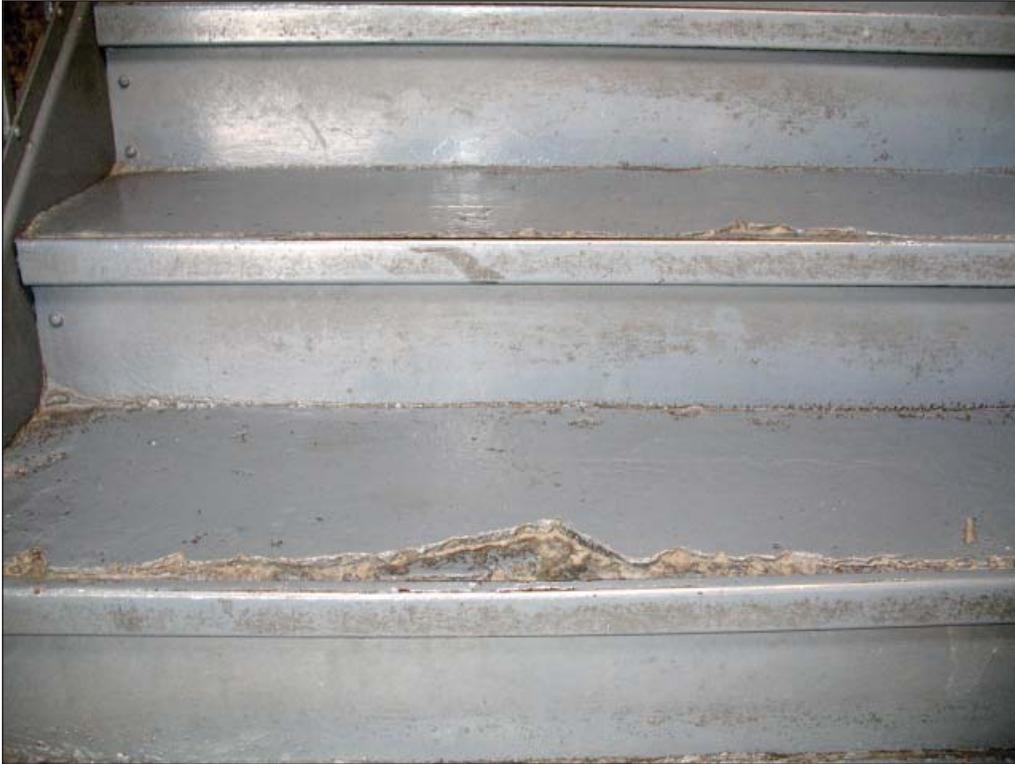
Photograph 1997-14-O

Other concerns include widespread cracks and spalling on the west stair's concrete treads (see Photograph O) and water stains on the roof, indicating a history of ponding (see Photograph P). Also, the lower roof is in poor condition and is covered with moss (see Photograph Q). Also, as shown in Photograph Q, there are patches of missing stucco on the wall adjacent to this lower roof, which appears to be a potential location for water infiltration. Although a portion of the sidewalk in front of the loading area is deteriorated (see Photograph R), the sidewalks and curb cuts along West 130th Street are in fair condition overall. However, trucks park on the sidewalk, which is likely exacerbating the cracks in the sidewalk (see Photograph S).
