Block 1997 Lot 18

SITE CONDITION: CRITICAL

Manhattanville Neighborhood Conditions Study

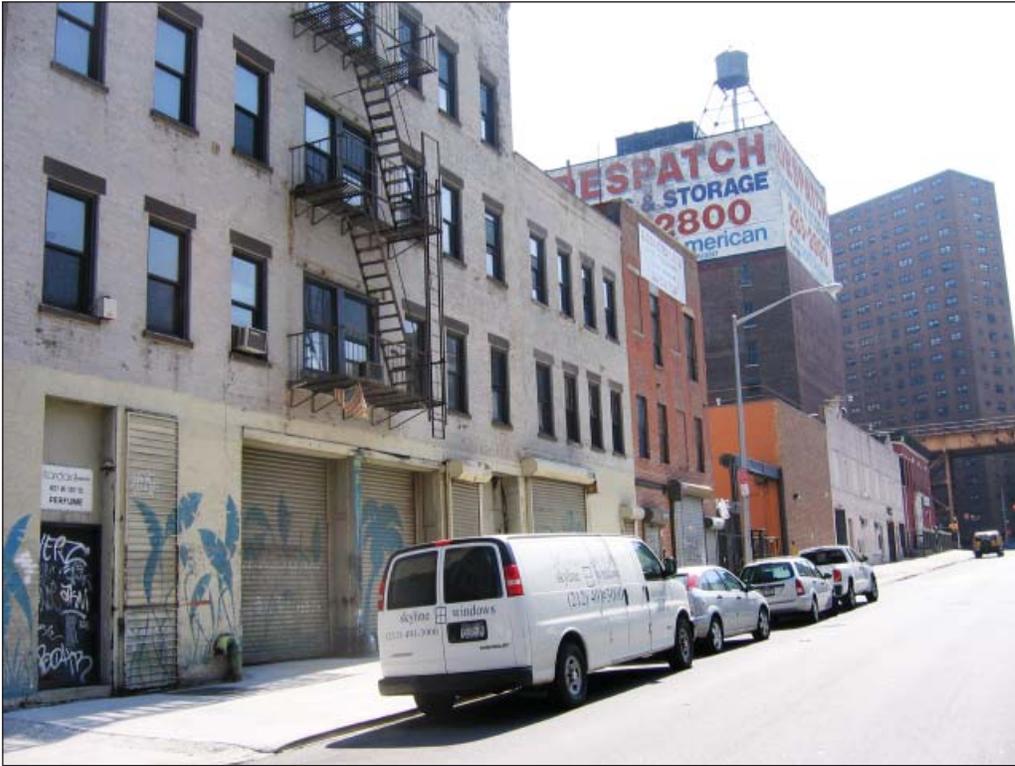
Photograph 1997-18-A

Lot 18, acquired by the Trustees of Columbia University on August 27, 2003, is located in an M1-2 zoning district at 617-621 West 130th Street between Twelfth Avenue and Broadway. The lot contains two buildings that are currently vacant (see Photograph A). The western portion of the lot has a four-story building with a one-story section that extends farther north than the rest of the building. The eastern portion of the lot has a three-story building. DOB's records indicate a build year of circa 1920 for this property, although the 1893 Sanborn map shows the four-story building, indicating that it was likely constructed prior to 1893. It was renovated in 1985.

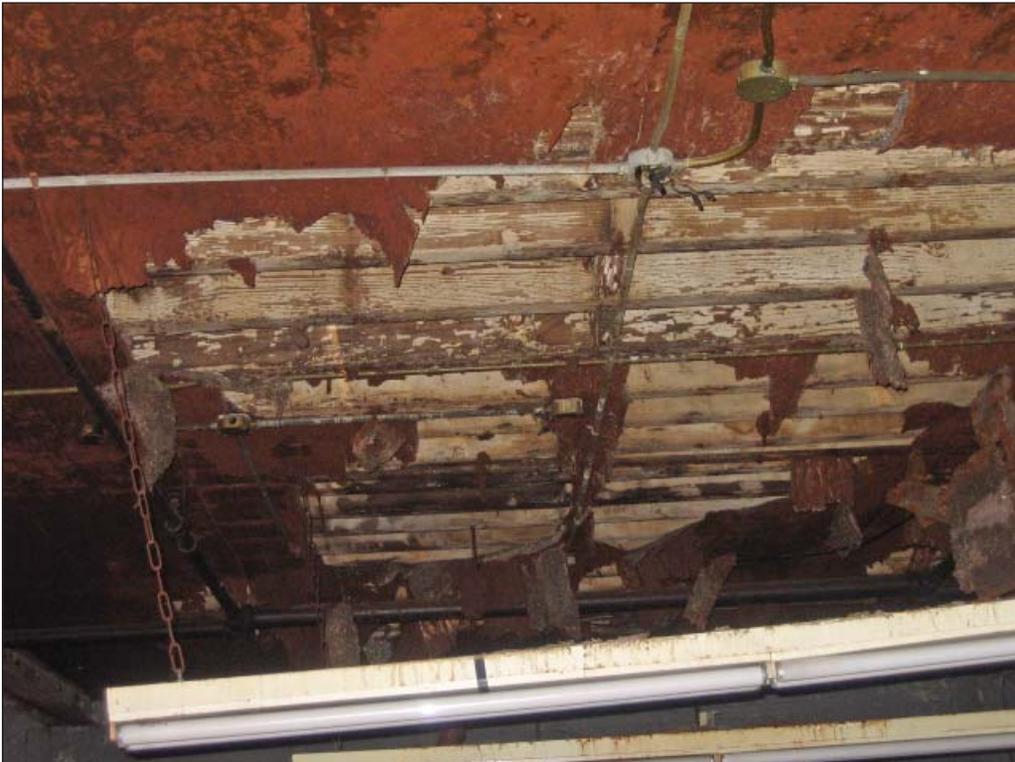
Photograph 1997-18-B

Widespread, long-term water infiltration has caused deterioration to several of both buildings' structural and non-structural components, including deteriorated wood planks and timber joists (see Photograph B), delaminated and warped floor tiles (see Photograph C), corroded steel girders, damaged window sills and headers, corroded sheet metal ceiling (see Photograph D), severely corroded slab reinforcements (see Photograph E), and missing mortar on the brick masonry walls (see Photograph F). In addition, the foundation walls have minor cracks, signs of efflorescence, and fungus infestation (see Photograph G). The deteriorated roofing membranes on both buildings are potential causes of water intrusion (see Photographs H and I). In addition, a previous fire in the three-story building that damaged a branch line of the building's sprinkler system likely exacerbated water damage in many areas of the building. Structural deterioration is also evident in a severely damaged concrete column with exposed steel reinforcement bars, although the cause is unknown (see Photograph J).

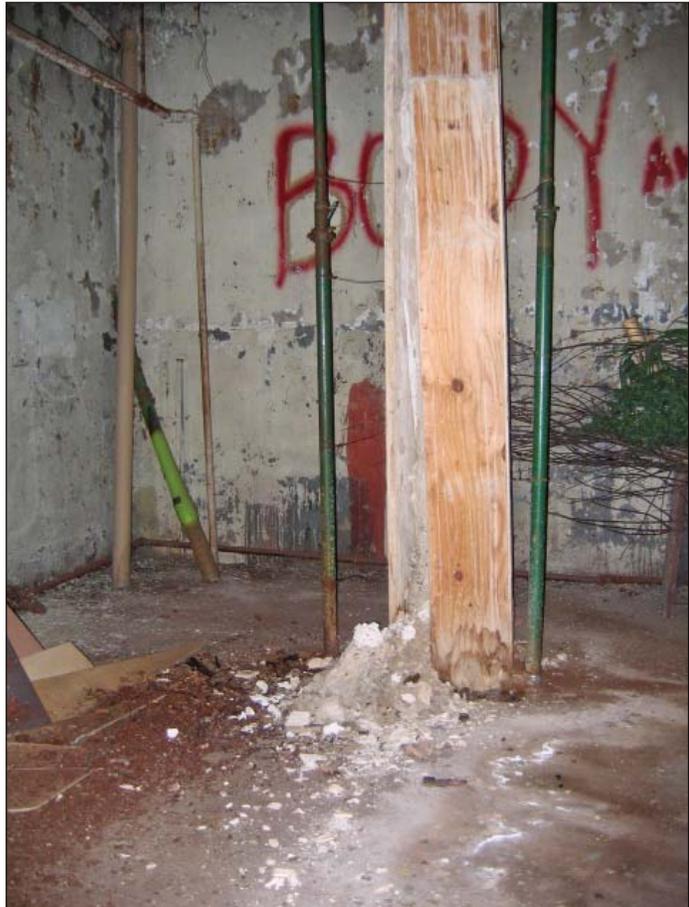
Photograph 1997-18-J

On the first floor of the four-story building there is a severely damaged concrete column with exposed steel reinforcement bars. Thornton Tomasetti, Inc. concluded that the structure supported by this column is unsafe (see Photograph J). In addition, fungus infestation, mold, and efflorescence on the walls of the building are a health concern. Stair treads are also not anchored to steel stair stringers, which is a safety hazard. As noted below, the elevator appears to be in need of crucial maintenance. Overall the health and safety concerns associated with this property make it essentially unusable in its
