## Block 1997 Lot 21

**SITE CONDITION: CRITICAL**

### LOCATION, USE, ZONING, AND OWNERSHIP

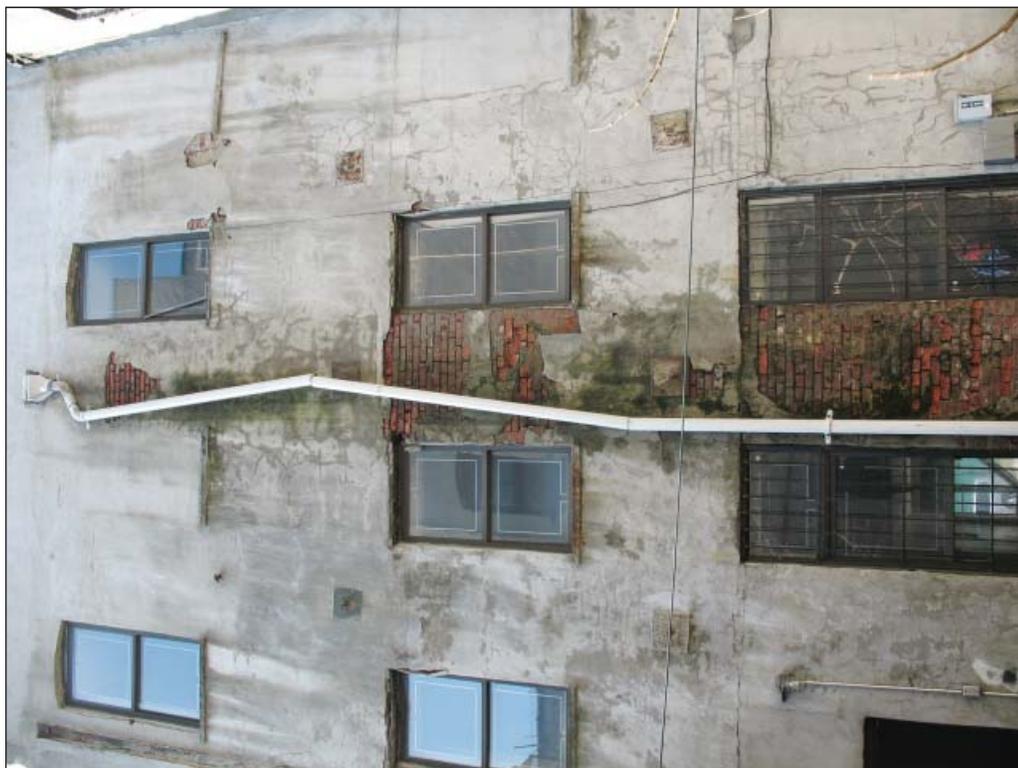
Photograph 1997-21-B

Long-term water infiltration has caused deterioration of the reinforcement and masonry system. Water damage on the north exterior wall is extensive, with cracked stucco, mold, and cracks at window openings (see Photograph B). The detachment of a roof drain, which is connected to the north façade, has likely caused further cracking in the stucco wall. Water damage is evident throughout the building, as indicated by mold growth on the first floor's north wall and on the walls in the stairwell (see Photographs C and D, respectively), warped floor tiles (see Photographs E and F), corrosion on a metal door and piping in the basement (see Photograph G), and corrosion stains on the underside of concrete floor beams and concrete slab (see Photographs G and H). Water infiltration has also likely caused partial collapse of the first-floor ceiling (see Photograph I). Although the roofing membrane is in fair condition overall, local damage—such as air pockets and cracks/gaps in the roof flashing (see Photograph J)—is likely contributing to the water infiltration into the structure below.

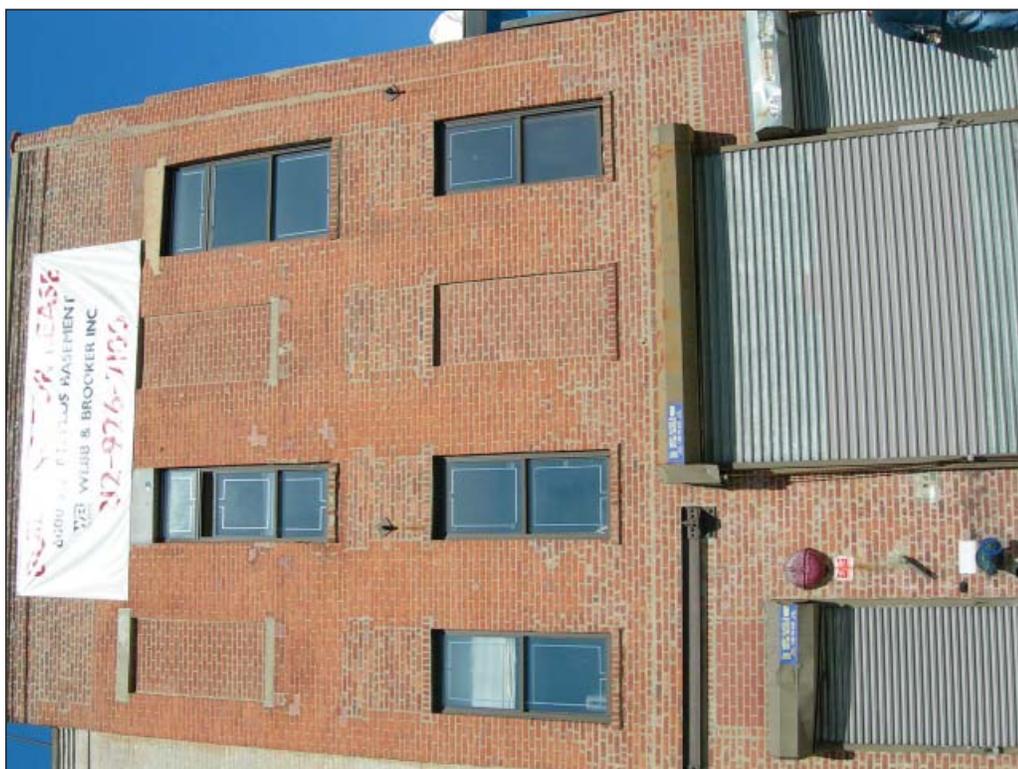
Photograph 1997-21-A

Lot 21 is located at 615 West 130th Street, between Twelfth Avenue and Broadway, in an M1-2 zoning district. A three-story brick masonry building, built circa 1920 and renovated in 1995 is on the lot (see Photograph A). The 12,400-gsf building is currently vacant, but it had been occupied by a real estate agency. Lot 21 was acquired by the Trustees of Columbia University on October 4, 2004.

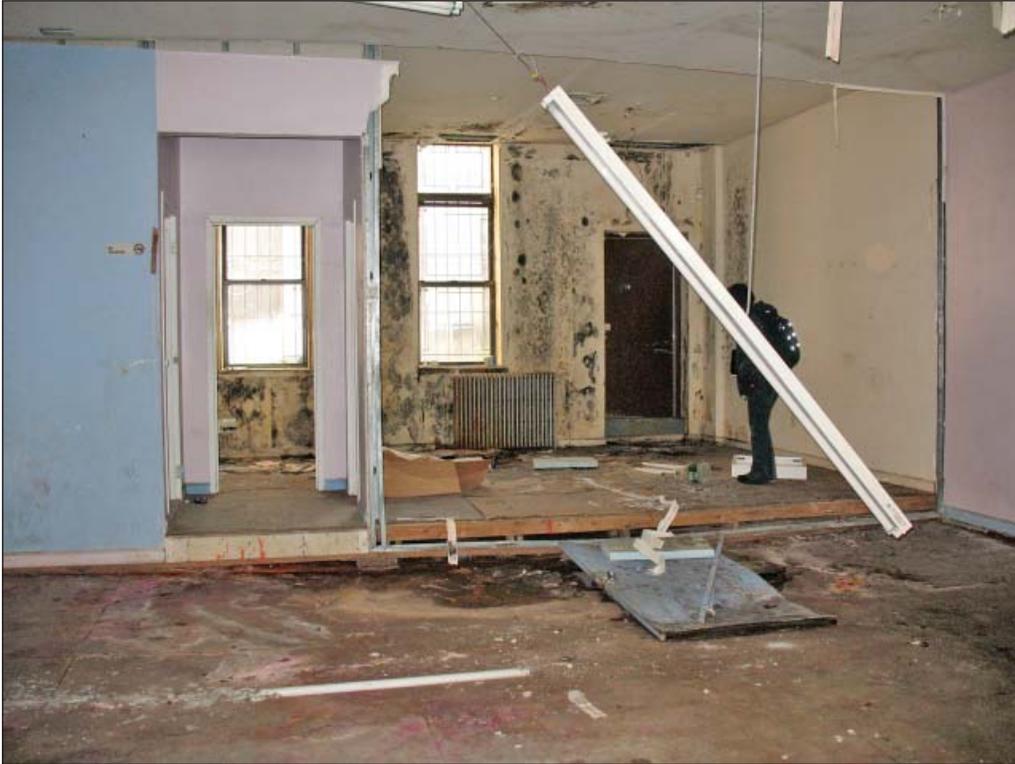
**Photograph 1997-21-C**

A significant amount of mold was observed throughout the building, covering the first floor's north wall and the walls in the stairwell, which is a health concern (see Photographs C-F). North of the yard, there is an approximately 4'-0" gap between the edge of the yard and the exterior wall of the building

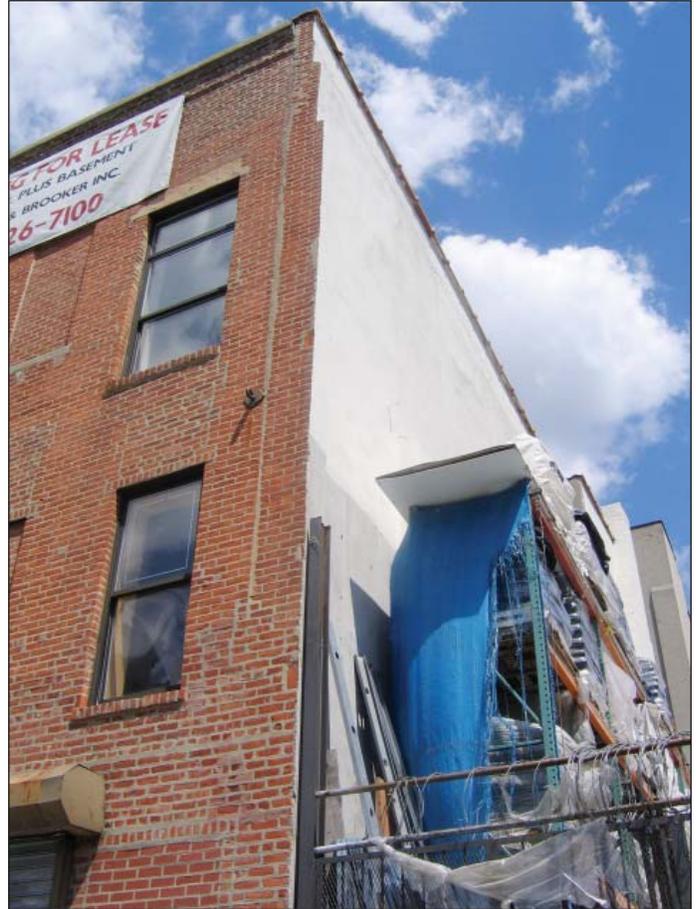
**Photograph 1997-21-K**

Further damage includes deteriorated window headers and sills, broken window glazing, and a vertical crack along the east side of the south brick masonry wall (see Photograph K). In the basement, there is a water line and debris on the walls approximately a foot above the floor, indicating a history of flooding at this property (see Photograph L). The concrete slab-on-grade in the yard, located north of the building, is in poor condition, with several wide cracks (see Photograph M). The sidewalk along West 130th Street is in fair condition.

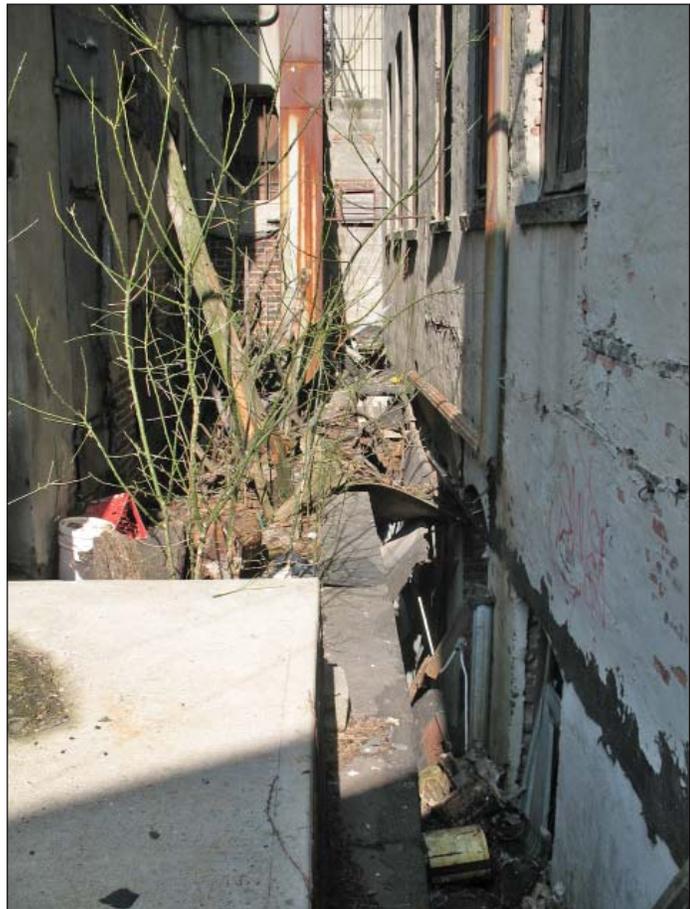
**Photograph 1997-21-N**

to the north. This gap, though part of Lot 44, presents an unsafe condition for those in the yard as there is no barrier between the yard and the gap (see Photograph N). Overall the health and safety concerns associated with this property make it essentially unusable in its current condition. These health and safety concerns should be addressed if the building should become occupied.
