Block 1997 Lot 27

SITE CONDITION: FAIR

Manhattanville Neighborhood Conditions Study

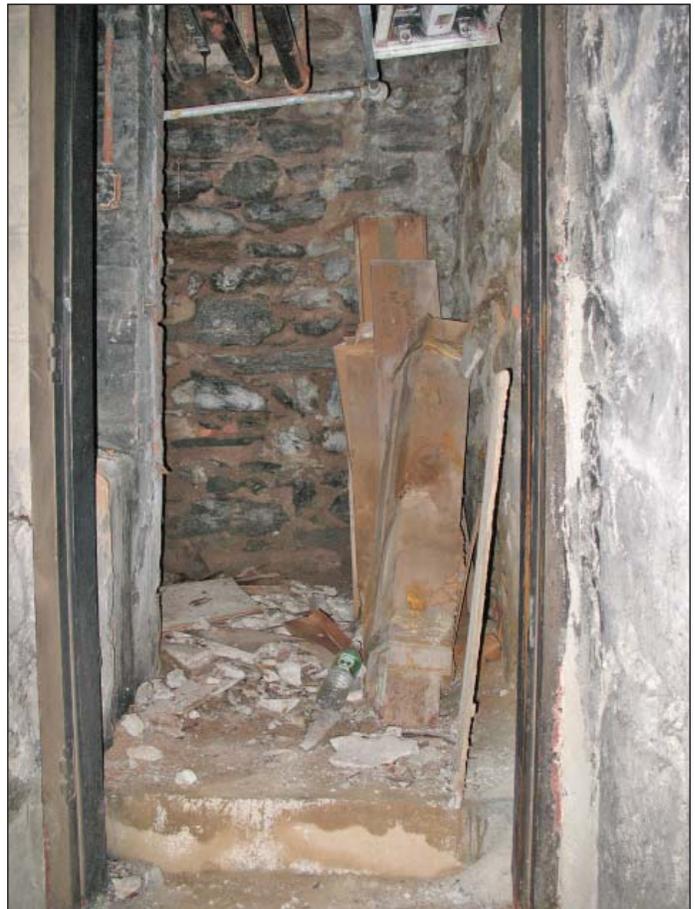
Photograph 1997-27-B

Signs of limited but prolonged water infiltration are apparent in several portions of the building. In the basement, the stone rubble sidewalk vaults show signs of water intrusion (see Photograph B) and deterioration of an interior column's concrete encasement was observed (see Photograph C). Water intrusion along the top of the south basement wall is causing deterioration to steel lintels above the openings to the sidewalk vaults (see Photograph D) and to mechanical/electrical/plumbing (MEP) and telephone equipment located along this wall (see Photograph E). There is also a significant horizontal crack in the first-floor north masonry wall, as shown in Photograph F, and signs of water damage on the east masonry wall (see Photograph G).

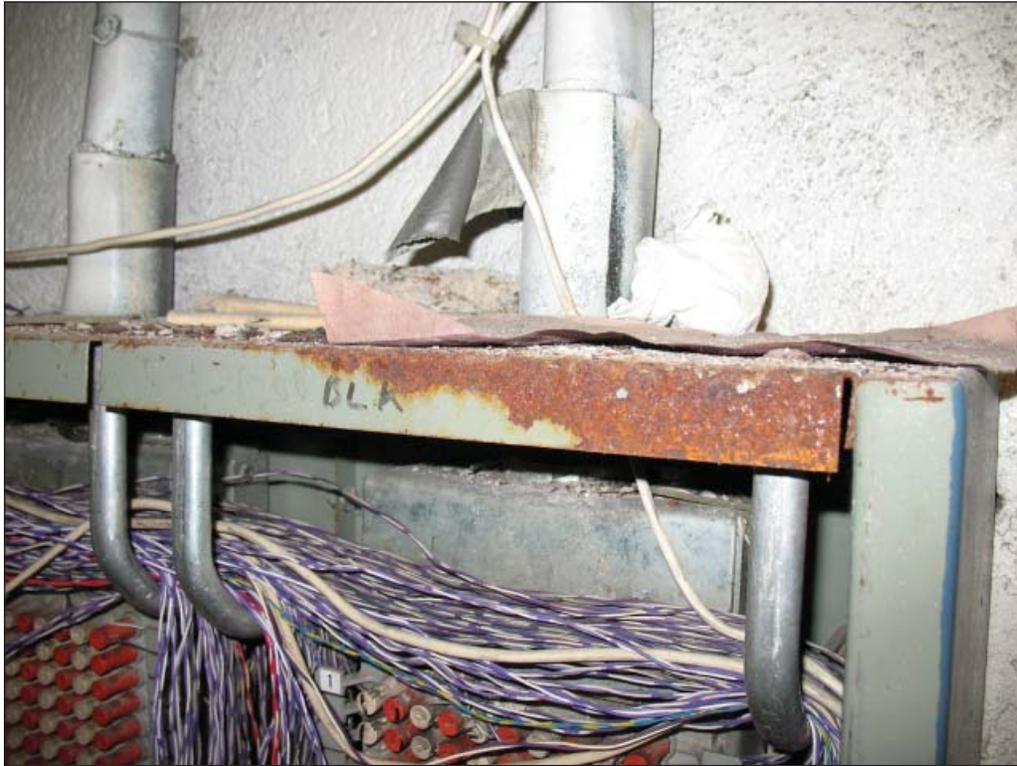
Photograph 1997-27-E

Water intrusion, which is occurring along the top of the south basement wall, is causing deterioration to MEP and telephone equipment located along this wall—a potential fire hazard (see Photograph E). In addition, the electrical systems in the first-floor locker room spaces appear to be unsafe in some locations (see Photograph M).

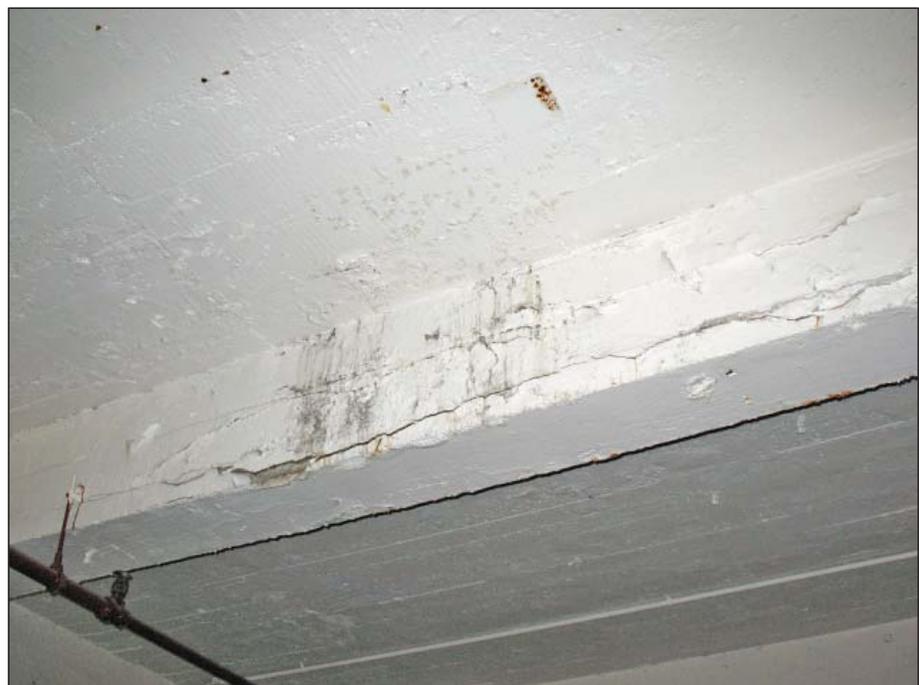
Photograph 1997-27-H

Where visible, the roof framing and first- and second-floor slabs are in fair condition, although there is cracking and spalling in a few locations (see Photograph H) and signs of corrosion and flaking paint on the metal ceiling below the roof framing and slab, potentially signifying that there is water damage affecting the concealed roof framing members. Ponding on the roof appears to be a longstanding problem; repairs were made to the membrane relatively recently, likely as a result of deterioration due to this issue (see Photograph I). The waterproof coating on the inside face of the south parapet is in poor condition and partially displaced, allowing water to infiltrate the roof, as shown in Photograph J.

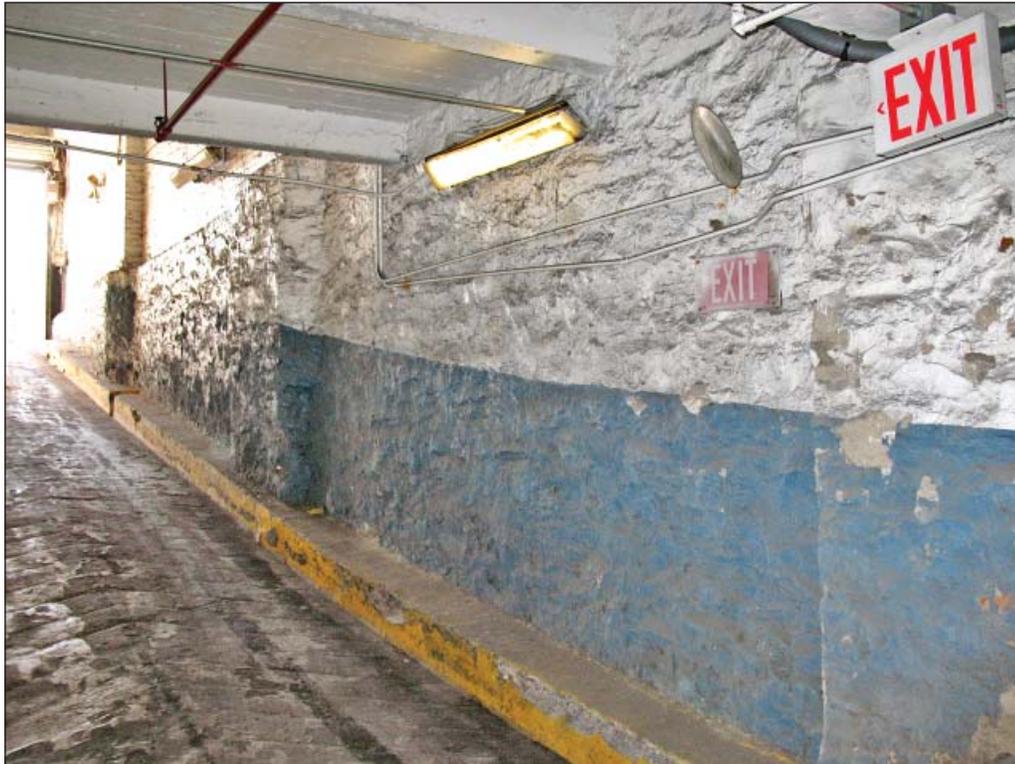
Photograph 1997-27-K

In addition, the vehicular ramp from the basement to the sidewalk is in poor condition, with significant spalling of the ramp surface and curb (see Photograph K). In general, the conditions in the building reflect its long-term use as parking garage, as evidenced by signs of associated degradation from vehicles entering and exiting the building and exposure to vehicle exhaust and motor drips (see

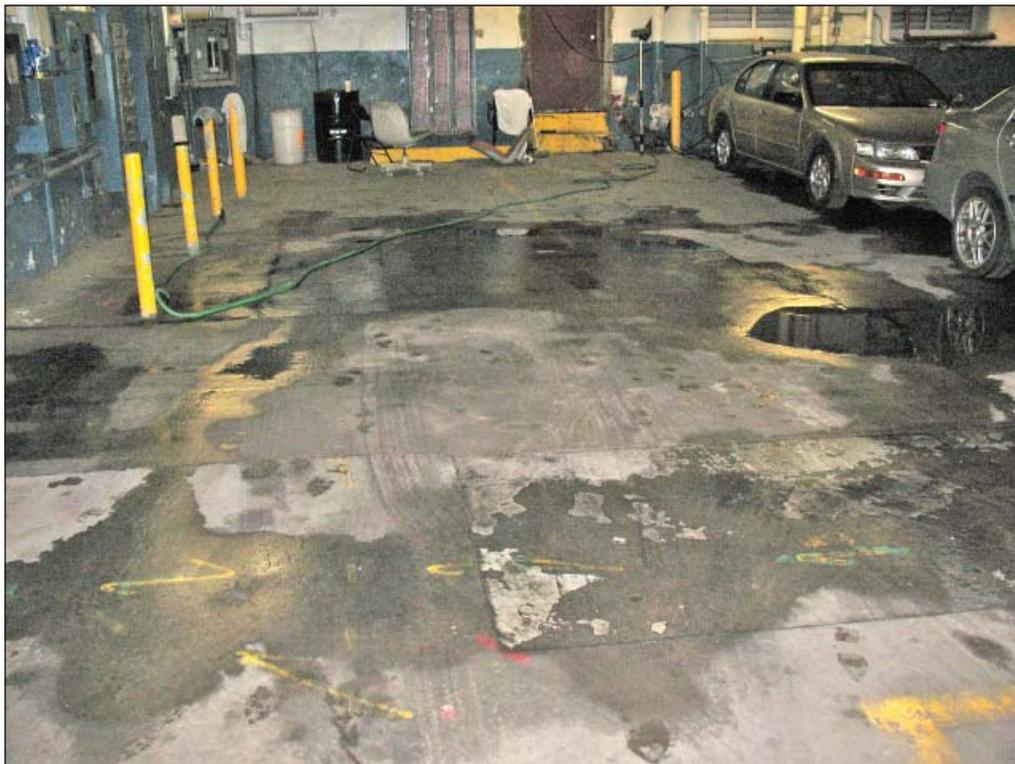
Photograph 1997-27-L

Photograph L). The sidewalk is in fair condition, with some cracking and spalling, although the curb cut is in poor condition.
