## Block 1997 Lot 33

SITE CONDITION: POOR

Manhattanville Neighborhood Conditions Study

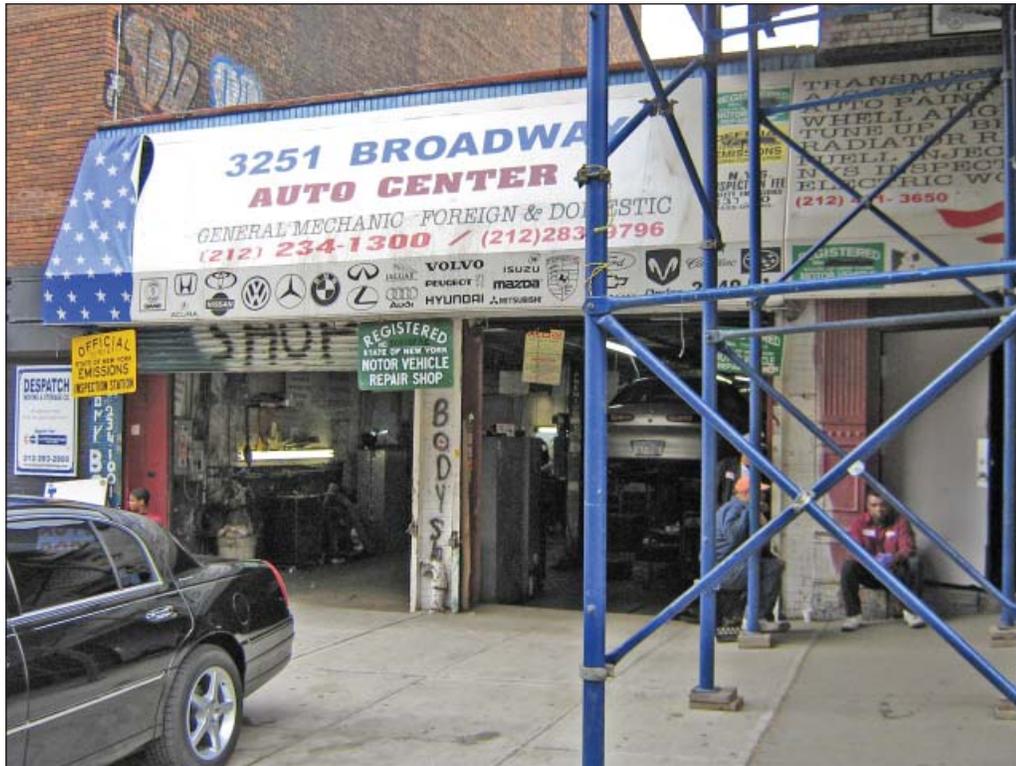
Photograph 1997-33-A

Acquired by the Trustees of Columbia University on December 15, 2004, Lot 33 is located at 3249 Broadway between West 130th and West 131st Streets. The lot, which is in an M1-2 zoning district, hosts a one-story, brick masonry building that is currently being used as an auto repair shop (see Photograph A). The 2,500-gsf structure has an estimated build year of 1930 by the DOB and has no renovation dates listed.

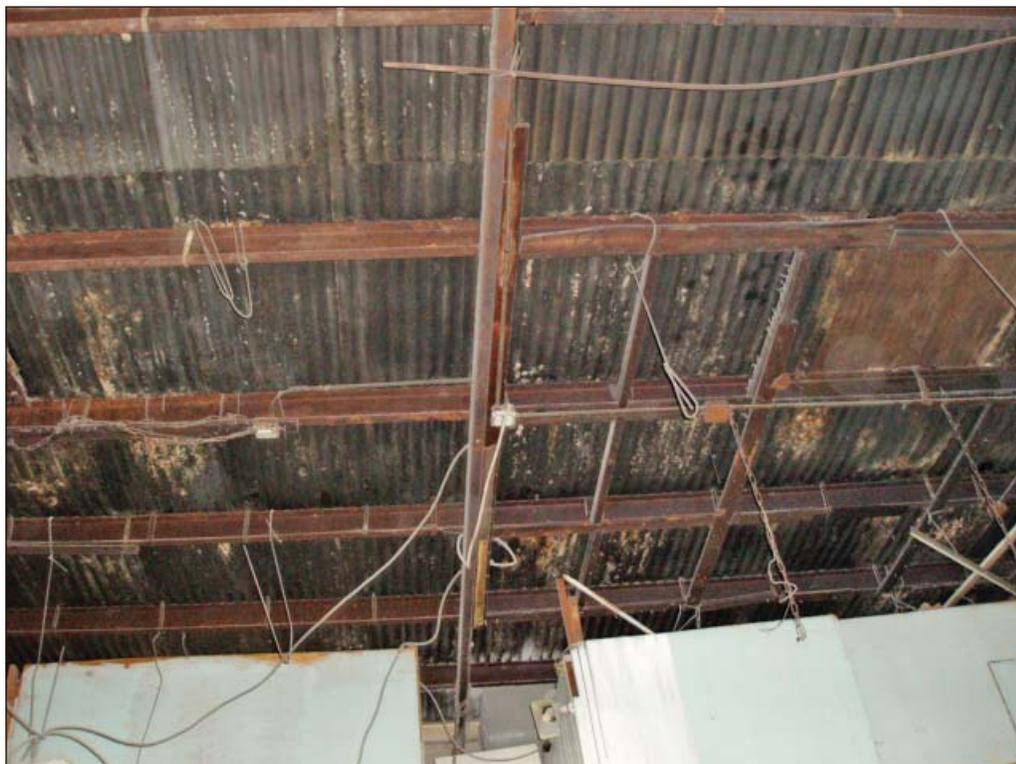
Photograph 1997-33-B

Most of the building's structural distress is the result of water infiltration that is causing the timber roof system to deteriorate. Water damage is evident by the corroded steel beams and metal deck (see Photographs B and C), wide cracks in the concrete and masonry walls (see Photographs D and E), and deteriorated timber roof joists (see Photograph F). The building's ceiling is generally in poor condition, with portions that are missing or corroded (see Photograph G).

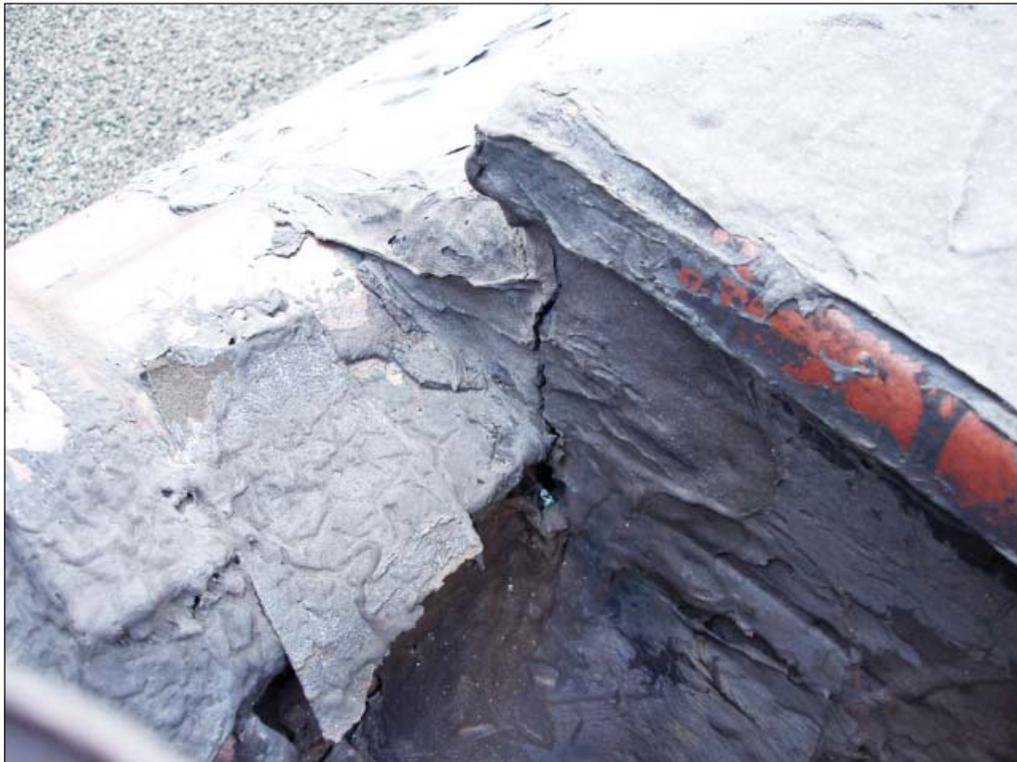
**Photograph 1997-33-H**

The roof shows numerous signs of deterioration, including cracks in the membrane (see Photograph H), delamination at the edges and along the parapet (see Photograph I), cracks around makeshift roof ducts (see Photograph J), and damage to the coping stones. Accumulated debris and water stains near south side of the roof indicate ponding is an issue (see Photograph K), which causes deterioration of the roofing membrane. The brick masonry parapet along Broadway is in poor condition, with a wide crack observed near northeast corner of the building and deteriorated or missing mortar under the coping stone (see Photograph L). A large amount of garbage and debris was also observed in the northeast corner of the roof (see Photograph M). These numerous points of water infiltration in the roof membrane and parapet are likely causing water damage to the roof structure, ceiling and masonry walls below.

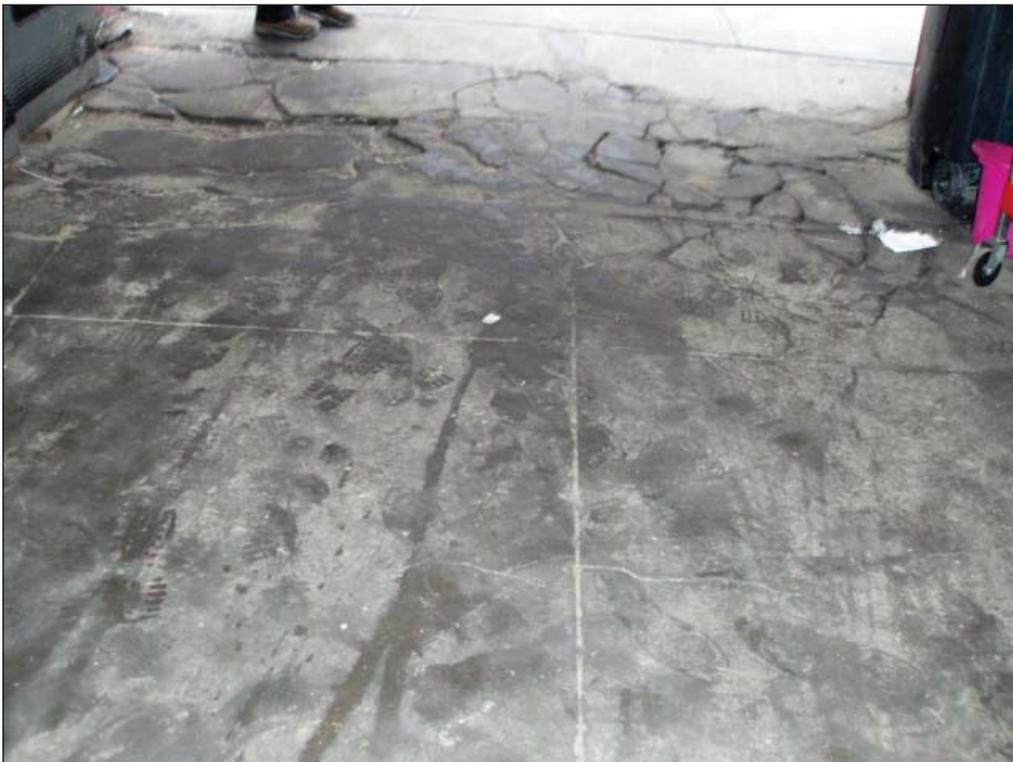
**Photograph 1997-33-N**

As shown in Photograph N, the floor is concrete slab-on-grade and is generally in poor condition, with several wide cracks and spalling, exhibiting widespread evidence of degradation associated with long-term automotive repair shop operations, such as exposure to motor oil, fuel, and other chemicals.

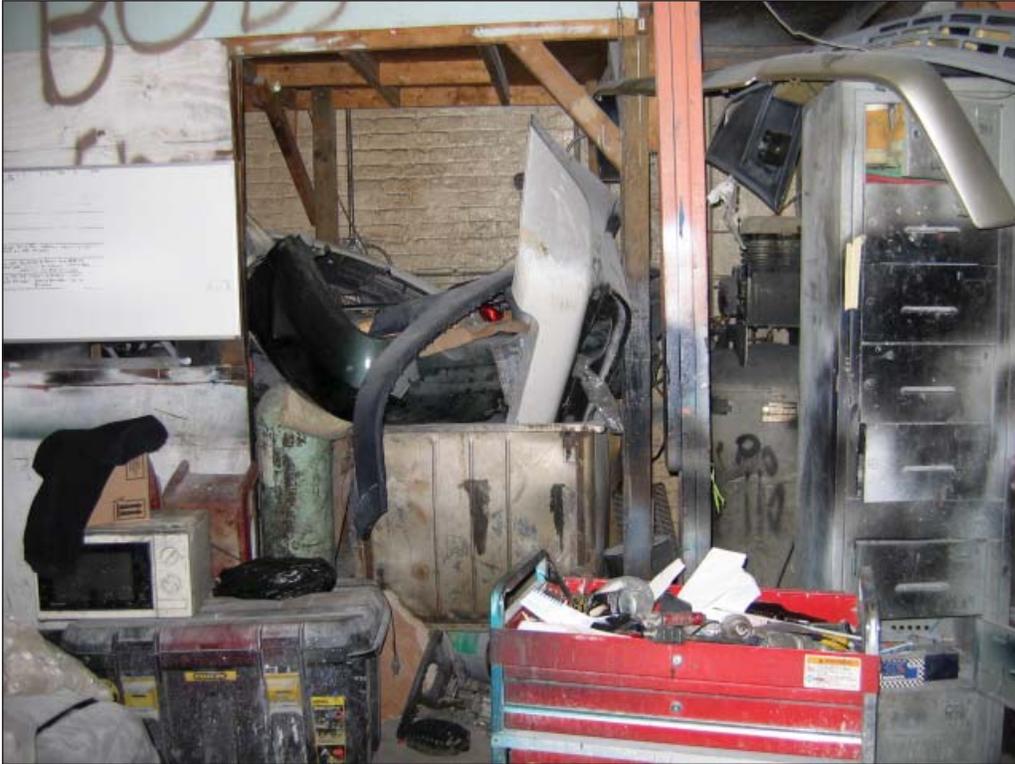
**Photograph 1997-33-O**

A wide crack was observed near in the brick masonry parapet along Broadway, as well as deteriorated or missing mortar under coping stone, which together create a potential safety hazard for pedestrians on the sidewalk below. Unsanitary conditions include: excessive, improperly stored waste and debris throughout the building (see Photograph O) and standing water and/or chemicals in the eastern portion of the building (see Photograph P).
