## Block 1997 Lot 34

SITE CONDITION: CRITICAL

Manhattanville Neighborhood Conditions Study

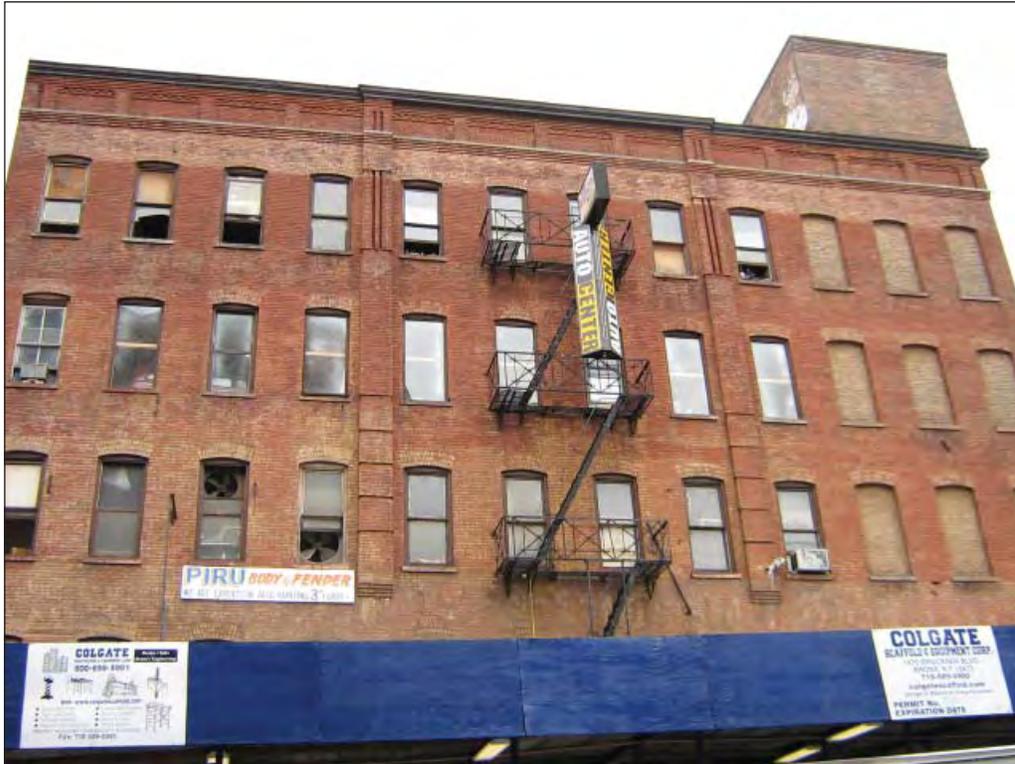
Photograph 1997-34-A

Within an M1-2 zoning district, Lot 34 is located at 3251 Broadway at the corner of Broadway and West 131st Street (see Photographs A and B). The lot, which was acquired by the Trustees of Columbia University on January 23, 2006, contains three structures primarily occupied by auto-related tenants. The main building is a five-story brick structure. There are also two smaller, one-story brick buildings: one south of the main building fronting Broadway and the other west of the main building fronting West 131st Street. The total building area on the lot is 43,600 gsf. DOB records list the buildings' construction year as 1910; however, the three buildings' construction type and their presence on a historic Sanborn map from 1893 indicate that they were likely constructed prior to 1893.

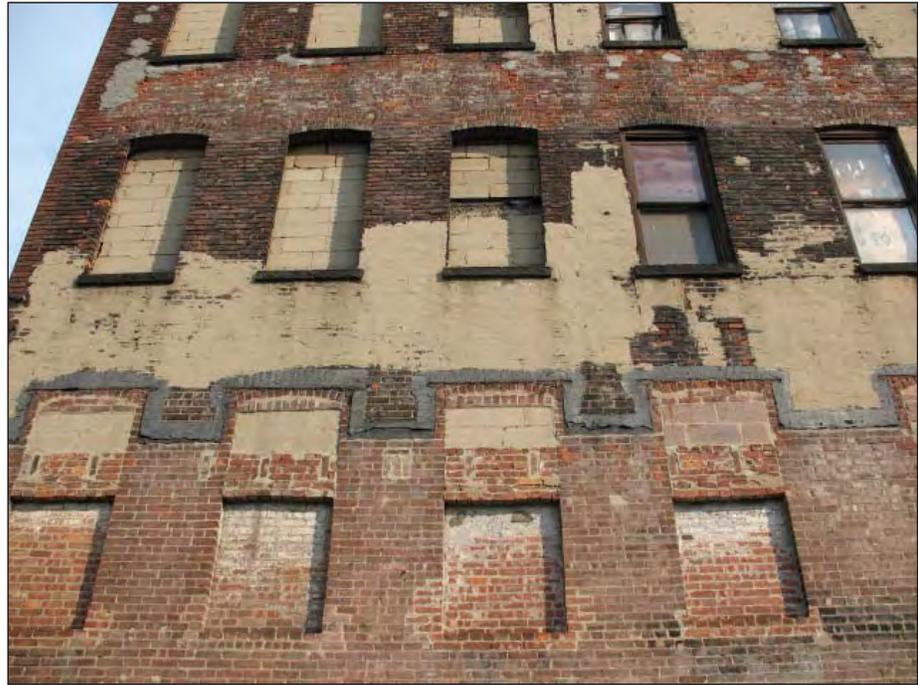
**Photograph 1997-34-C**

Structural distress in the five-story building is significant and widespread. As shown in Photographs C and D, there are several wide cracks and signs of deterioration on the exterior masonry walls. In the south exterior wall, wide cracks are evidence that the structure is deteriorating and that local failure of the masonry bearing wall could occur (see Photograph E). Additional distress in the building includes water damage to the timber joists, masonry walls, and window headers and sills (see Photographs F, G, and H, respectively); a rotting timber column (see Photograph I); corroded steel beams (see Photograph J); and cracked, spalling, and deflecting floor slabs (see Photograph K). Deterioration of the timber joists has already caused local collapses of the floor slab in several locations (see Photograph L). In addition, ceilings throughout the building are corroded and, in some cases, have collapsed (see Photographs M and N). Structural distress is likely worsening due to continued water infiltration through the damaged roof membrane (see Photograph O), cracks in the exterior walls, improperly sealed windows (see Photographs A, B, and P), and a deteriorated door. Also, cars are washed inside the building without an adequate drainage system, which is likely causing water infiltration to the timber joists below and has likely caused or exacerbated the deterioration of the timber joists (see Photographs P and Q). If not addressed, this water infiltration will eventually lead to local collapses of the timber floor and roof joists systems.

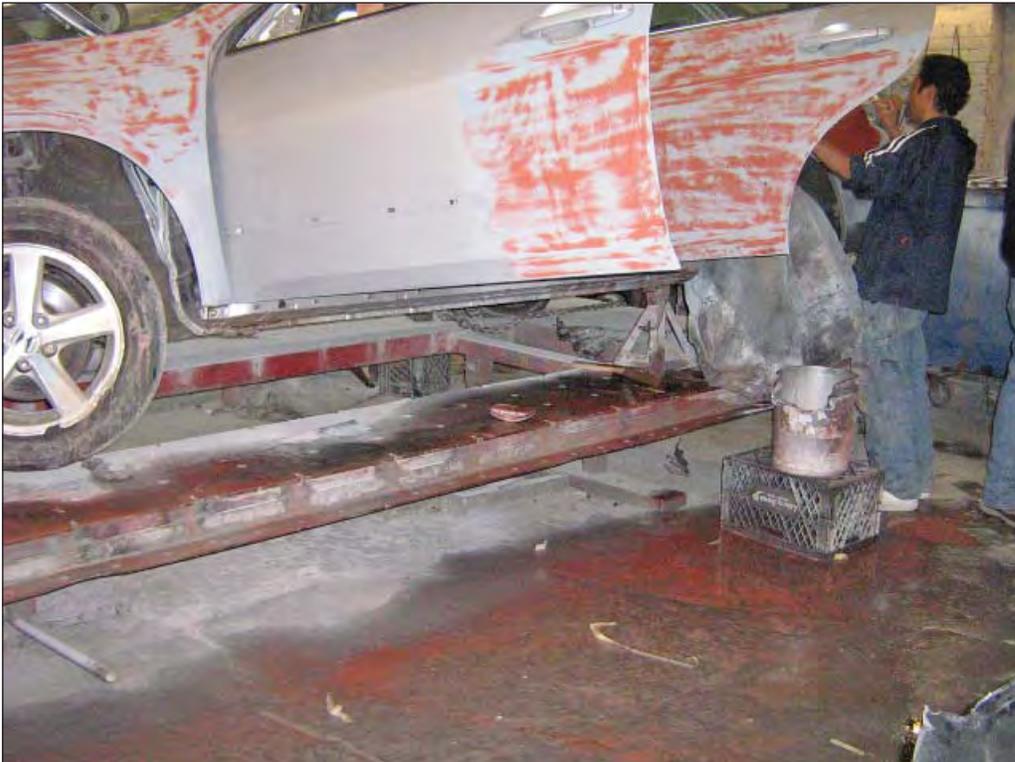
**Photograph 1997-34-R**

The one-story building fronting West 131st Street is generally in poor condition, with cracking and spalling of the floor slab in several locations (see Photograph R), cracks in the interior walls, and local

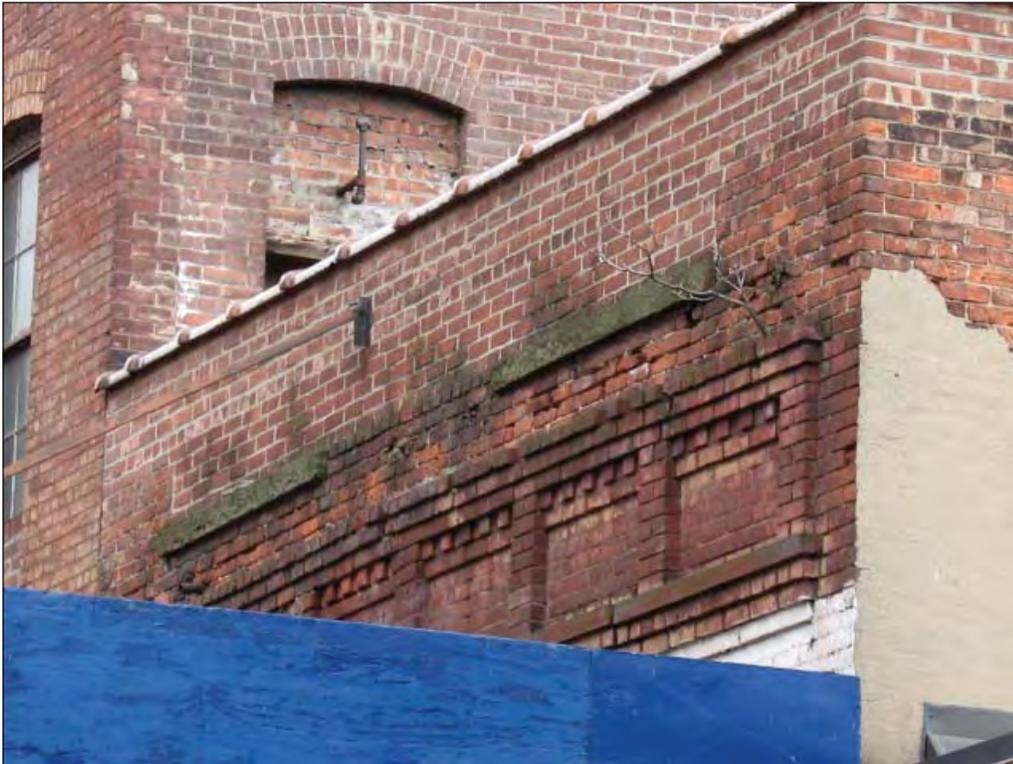
**Photograph 1997-34-S**

corrosion stains visible on a portion of the ceiling. The interior roof structure is concealed and could not be observed; however, it is likely that the roof structure is constructed of timber joists and is deteriorating from water infiltration, as signaled by the ceiling corrosion. As shown in Photograph S, the exterior north wall has deteriorated bricks and missing mortar, and vegetation is growing through the masonry, signaling likely water infiltration through the exterior wall. The wooden garage door is in poor condition as a result of water damage. The roof membrane appears to be in poor condition, with signs of deterioration observed.

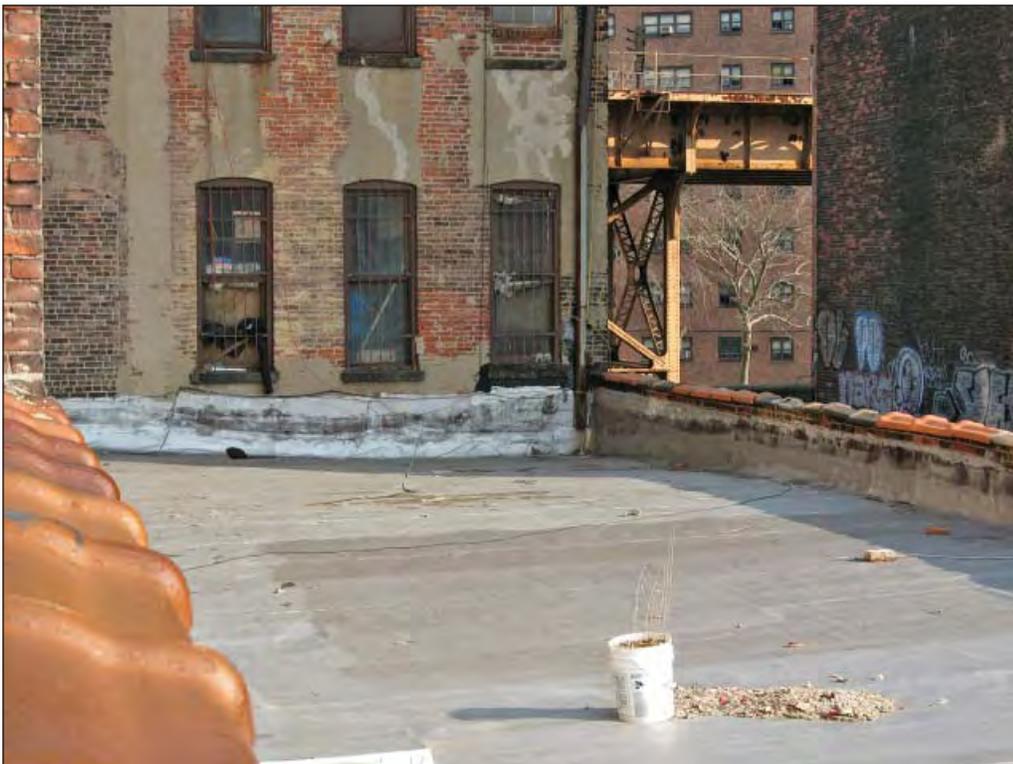
**Photograph 1997-34-T**

The condition of the one-story south building fronting Broadway appears to be fair, with minor cracks in the floor slab, exterior masonry, and interior walls, which are likely the consequence of water infiltration. The roof structure itself is concealed and could not be observed, although it has likely deteriorated from water infiltration as well. The roof membrane appears to be in fair condition, with no signs of major damage (see Photograph T).

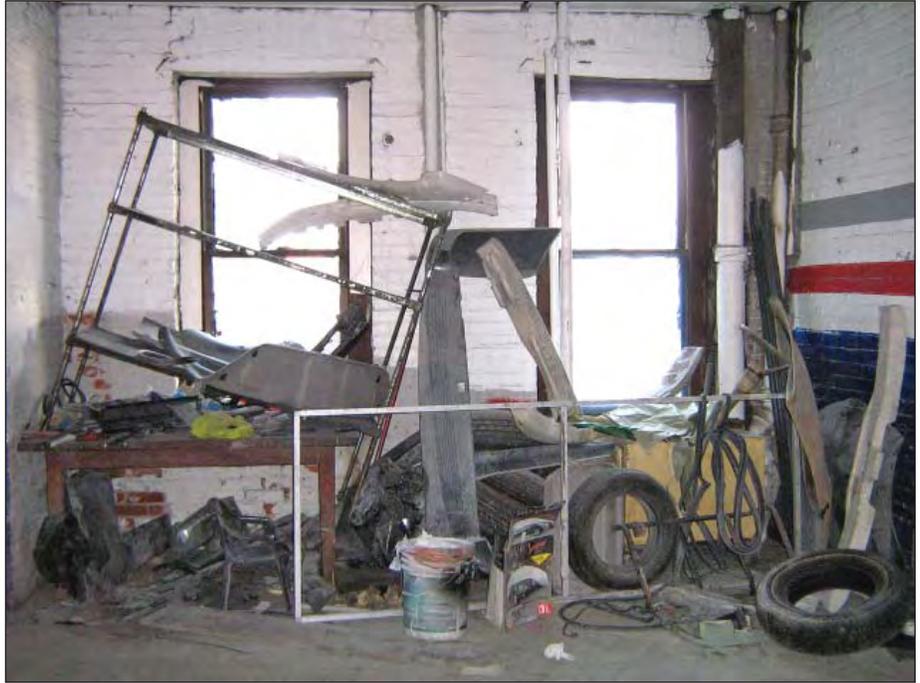
**Photograph 1997-34-Y**

There are several health and safety items that create an unsafe environment for tenants and/or customers in the five-story building, most notably the hazardous condition of the freight elevator, which is used to transport cars and people to all five floors and the basement. The elevator is out of alignment with the floor planes, as shown in Photograph U, and the elevator shaft masonry has several cracks (see Photographs V and W). The elevator currently has several open building code violations, as detailed in the next section. Other safety concerns include auto-painting materials that are sprayed in the building without proper ventilation systems and are stored improperly (see Photograph X); haphazardly stored garbage and debris throughout the five-story building, presenting a safety hazard to workers (see Photograph Y); and some evidence of vermin in the stairwell.

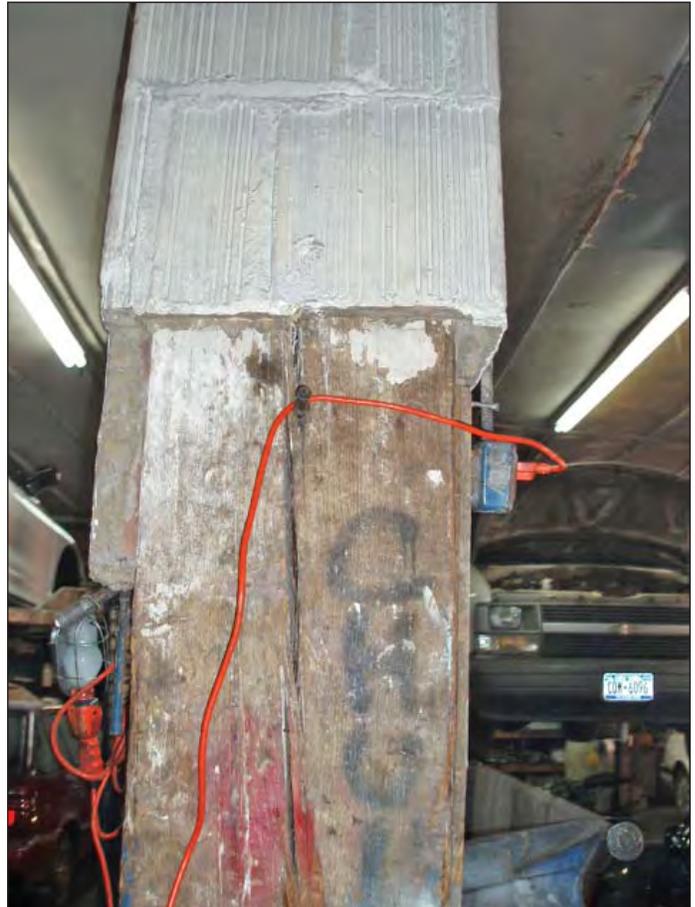
**Photograph 1997-34-Z**

Fire safety is of particular concern in the five-story building. Concrete encasing, necessary to fireproof the building's structural system, is missing from a portion of three second-floor timber columns and from several steel floor beams on the first level (see Photographs Z and AA). In addition, auto body and auto repair tenants throughout the building use paints and solvents and collect waste oil that could accelerate a potential fire in the building. Further, a portion of the building's southeast emergency stairway is an exposed timber structure without fireproofing, and the timber roof joists and stair risers are deteriorated from water infiltration. A fire stair on the western side of the building has heavily corroded stair treads (see Photograph BB), a severely deteriorated second-floor exit door with the potential for debris to fall from the lintel (see Photograph CC), and a significant amount of dog feces, which, in addition to being an unsanitary condition, presents a slipping hazard (see Photograph DD). The first-floor exit door from this western stairwell was blocked by a piece of wood during the site visit and the gate in a chain-linked fence leading to the street from this egress route was padlocked. In addition, means of egress via the fire escape on the east façade is restricted by the presence of plexiglass and plywood in windows leading to the fire escape, as well as numerous cars parked in close proximity to the exit windows (see Photograph EE).
