**Block 1997 Lot 40**SITE CONDITION: **POOR**

Manhattanville Neighborhood Conditions Study

Block 1997 Lot 40

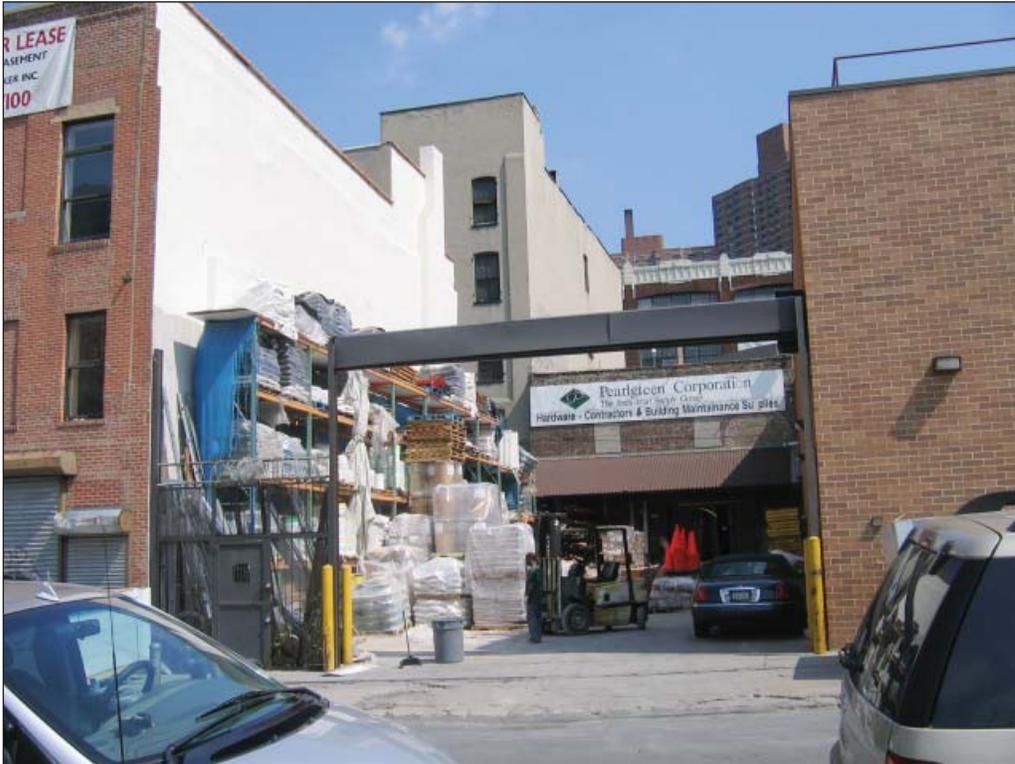
Photograph 1997-40-A

Lot 40 is located at 604 West 131st Street in an M1-2 zoning district, with lot area fronting West 130th and West 131st Streets (as shown in Photographs A and B, respectively). There are three interconnected buildings on this lot, with a total building area of 22,465 gsf. The main building is two stories, and two one-story buildings are to the east and south. There is also a paved yard used as a storage and loading/unloading area on the lot's southwest portion. The main structure was built circa 1940 and renovated in 2000. The lot was acquired by Danmike, LLC, circa July 2005 and is currently occupied by a provider of building maintenance and contractor supplies. It is currently under contract by the Trustees of Columbia University.

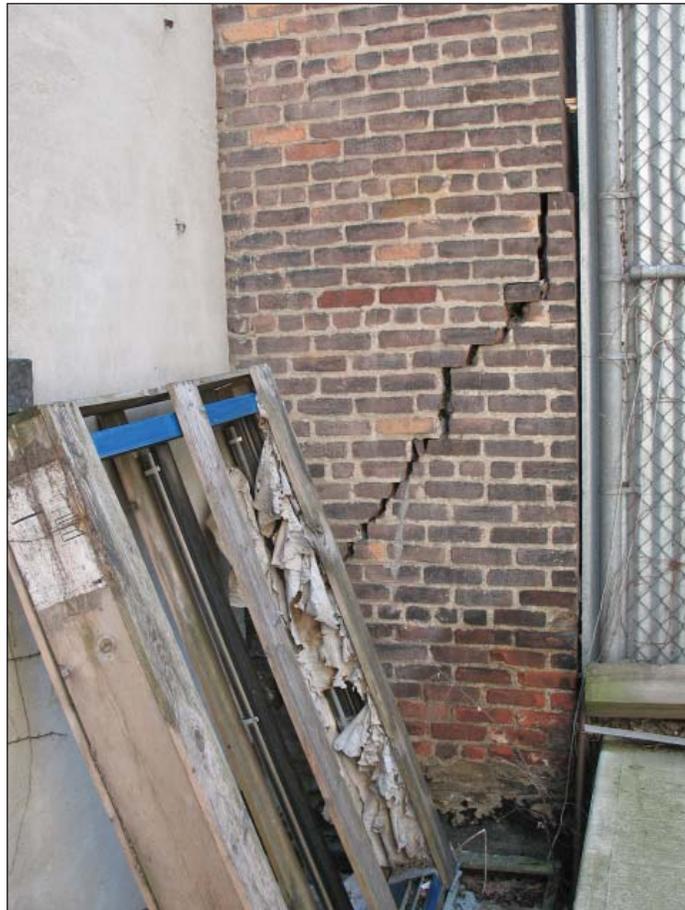
**Photograph 1997-40-C**

Long-term water infiltration has caused deterioration to the main building's concrete and steel framing and masonry walls. There are cracks in several locations, including on the exterior faces of the west and south walls (see Photographs C and D, respectively). Significant cracks were also observed inside the building, including on an interior wall above the ramp in the northeastern portion of the building, above the conveyor belt in the southwestern portion of the building, and on the first floor's western wall (see Photographs E-G, respectively). Water infiltration has also caused peeling paint, mold, and efflorescence on the east brick masonry wall (see Photograph H) and on the stair penthouse ceiling (see Photograph I). Signs of water infiltration and corrosion were observed on the masonry wall (see Photograph J) and on a window header in the northeastern portion of the main building. Steel beams are corroded, causing cracked and spalling concrete encasements (see Photographs K and L). Corrosion stains—likely from the sheet metal ceiling—are on the wall above the conveyor belt (see Photograph F).

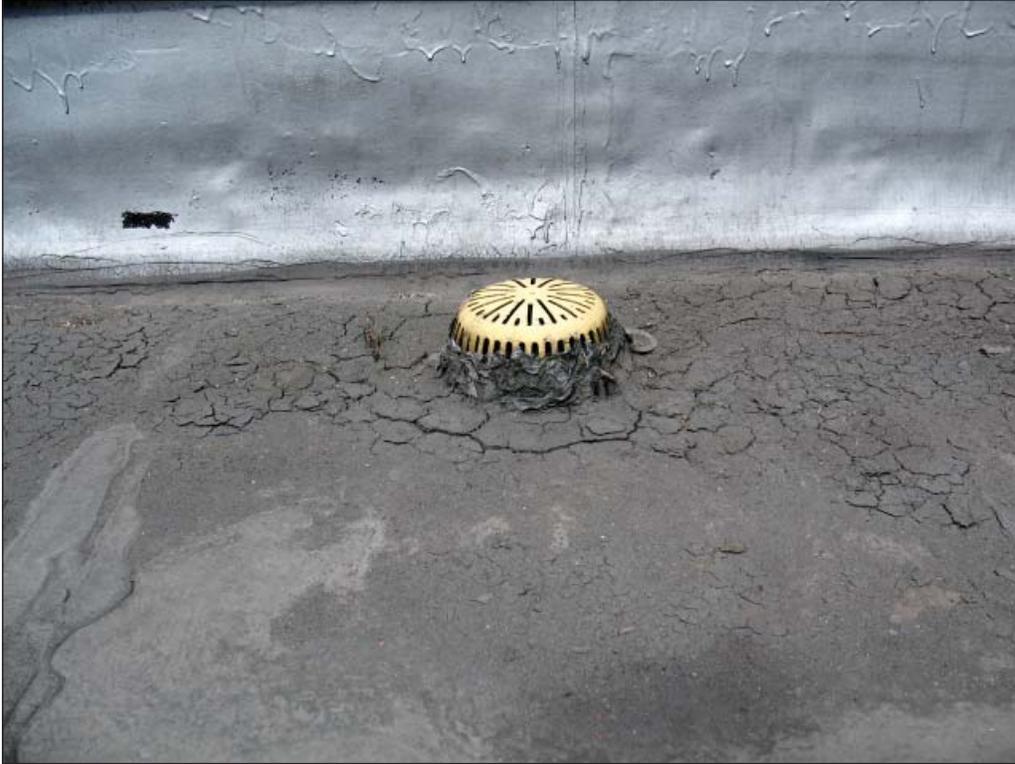
**Photograph 1997-40-M**

Although the roofs of the three structures are in fair condition overall, several potential sources of water infiltration were identified. Drains on all roofs have accumulated debris, indicating the potential for water ponding (see Photograph M). Damage on the main roof includes tears and signs of deterioration on the roofing membrane on the inside face of the parapet (see Photographs N and O), missing or damaged coping stones (see Photograph P), and a wide crack in the chimney (see Photograph Q). On the east building, there is a gap between the aluminum flashing and the roofing membrane, another potential point for water infiltration (see Photograph R).

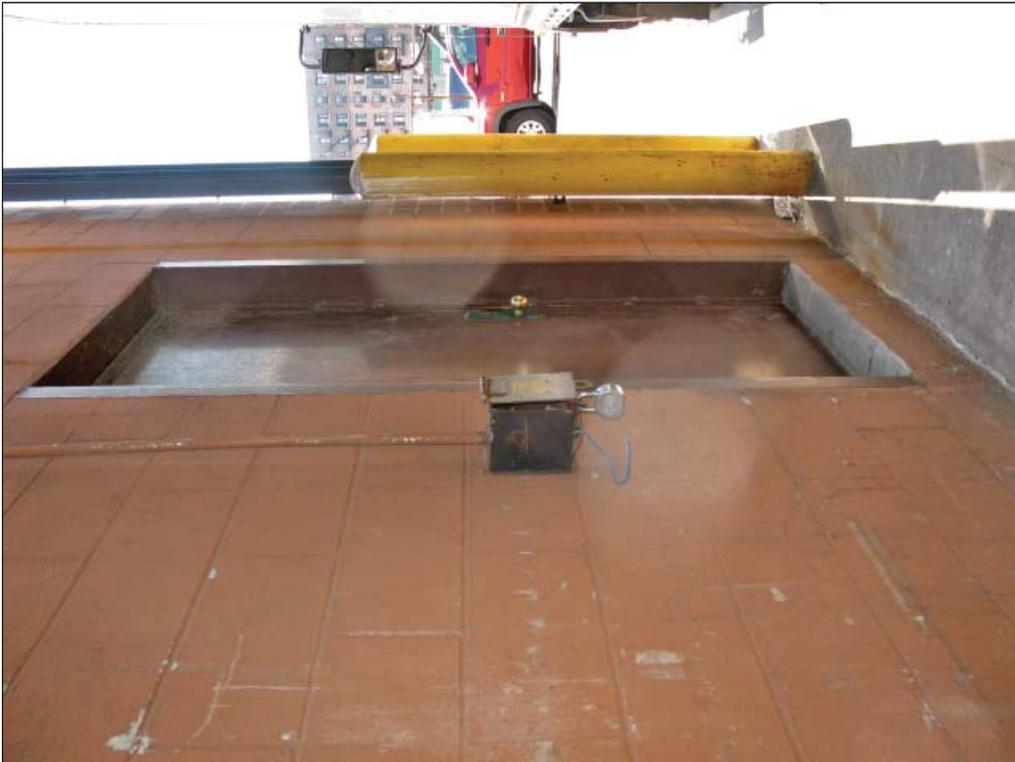
Photograph 1997-40-U

Lot 40 has several unsafe conditions. The floor inside the emergency exit door on the west façade of the south building is higher than the surface of the yard, where the door opens. The lack of warning signs for this height difference is a tripping hazard (see Photograph U). Another safety concern is the storage of materials in front of the door in the southwest corner of the yard on West 130th Street, blocking egress through this emergency exit (see Photograph V). Further, this emergency exit was padlocked from the outside during a site visit. If this lock is not removed when the adjacent roll-down gate is closed (see Photograph A), the means of egress would be obstructed. Also, trucks park on the sidewalk, which is a pedestrian safety issue.
