Block 1997 Lot 47

SITE CONDITION: POOR

Manhattanville Neighborhood Conditions Study

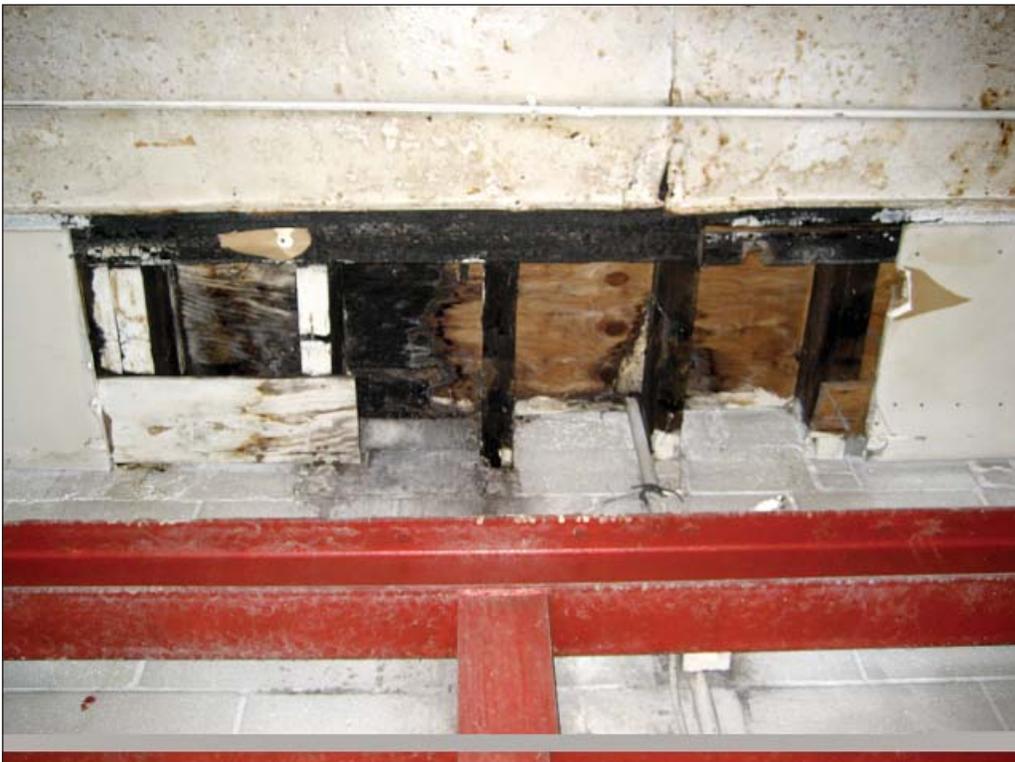
Photograph 1997-47-B

Water infiltration has caused structural distress to the timber roof joists (see Photograph B). In addition to water damage, the color and texture of the timber roof joists suggests that they have suffered fire damage, which has likely lessened their structural capacity. Additional water damage could be occurring in the building as a result of cracks in the exterior brick masonry wall (see Photographs C and D). Besides water damage, the north masonry wall has been further stressed by the attached awning of the adjacent property, which has caused wide horizontal cracks (see Photograph D).

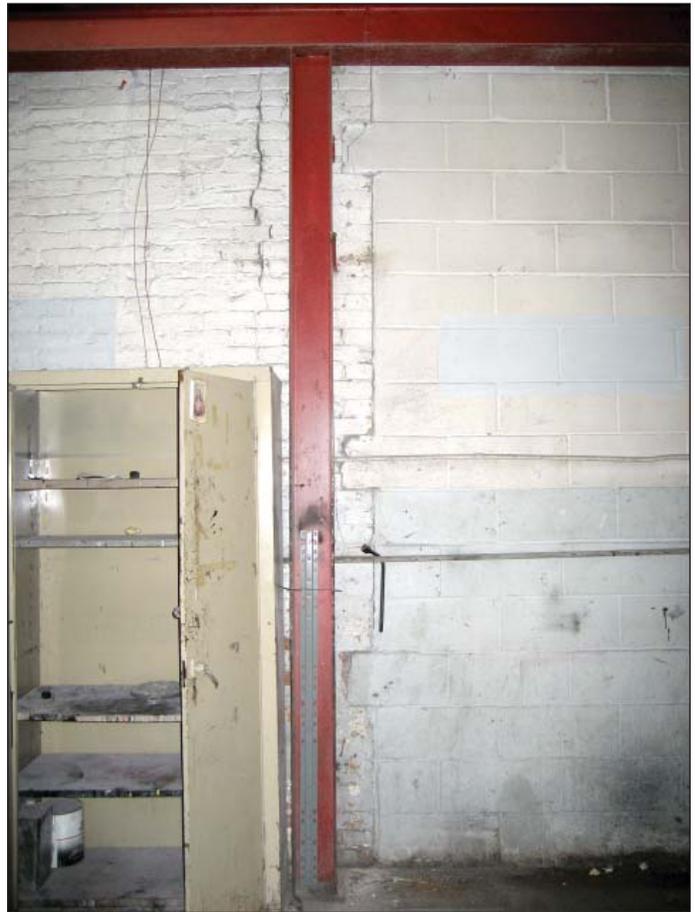
Photograph 1997-47-E

Other site concerns include cracks in the masonry wall (see Photograph E), corrosion of the sheet metal ceiling (see Photograph F), and minor cracks in the concrete slab-on-grade. The sidewalk and curb cuts along West 131st Street are in poor condition, with wide cracks and spalling concrete (see Photograph G).
