Block 1997 Lot 49

SITE CONDITION:	FAIR
------------------------	-------------

Manhattanville Neighborhood Conditions Study

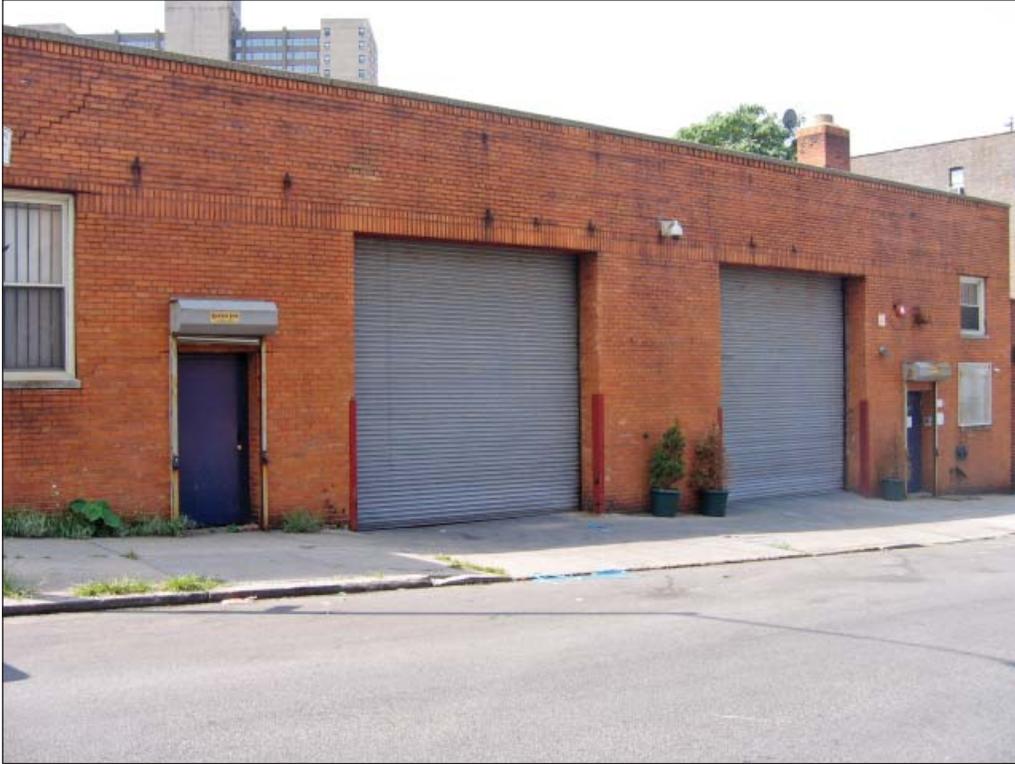
Photograph 1997-49-A

Block 1997 Lot 49, occupied by a building contractor, is located at 624 West 131st Street between Twelfth Avenue and Broadway (see Photograph A). The lot accommodates a one-story 7,494-gsf brick structure with a partial basement in an M1-2 zoning district. The building was constructed circa 1951; no renovations have been recorded. Lot 49 was acquired by the Trustees of Columbia University on March 28, 2000.

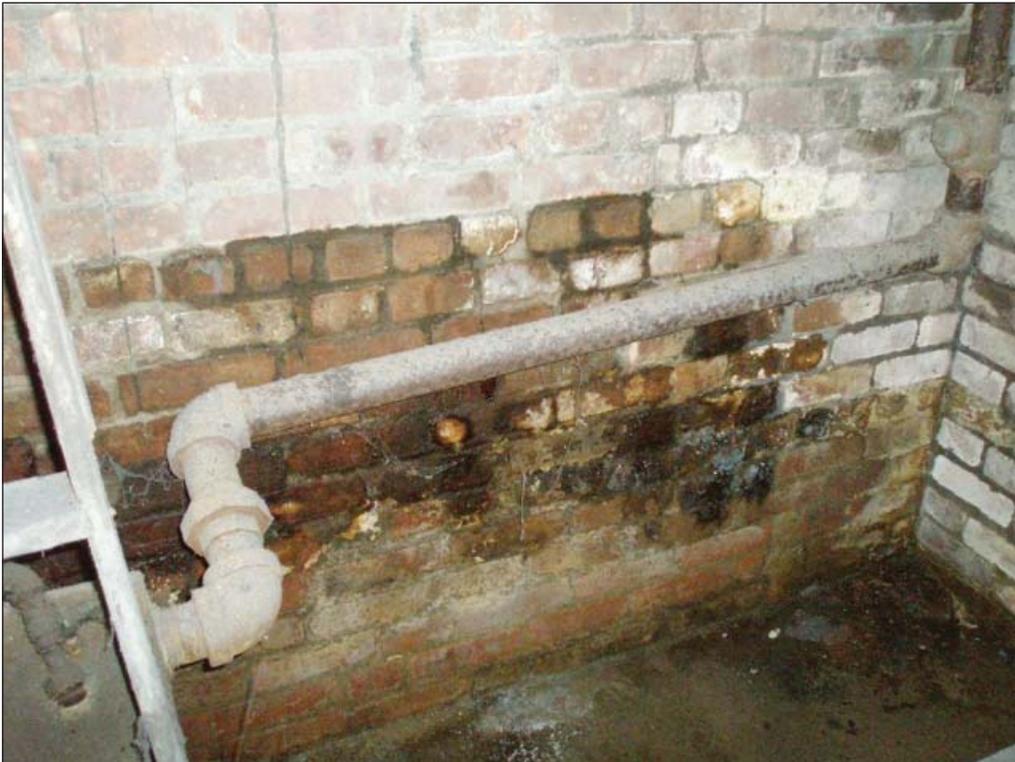
Photograph 1997-49-B

The partial basement is in poor condition, with water-stained walls, standing water on the floor (see Photograph B), and a severely corroded lintel at the basement entrance (see Photograph C), likely attributable to water infiltration from the disconnected boiler chimney. The concrete-encased steel beams have large cracks, and the exposed steel shows signs of corrosion and expansion. Timber is temporarily being used to shore up one of the concrete encased beams (see Photograph D).

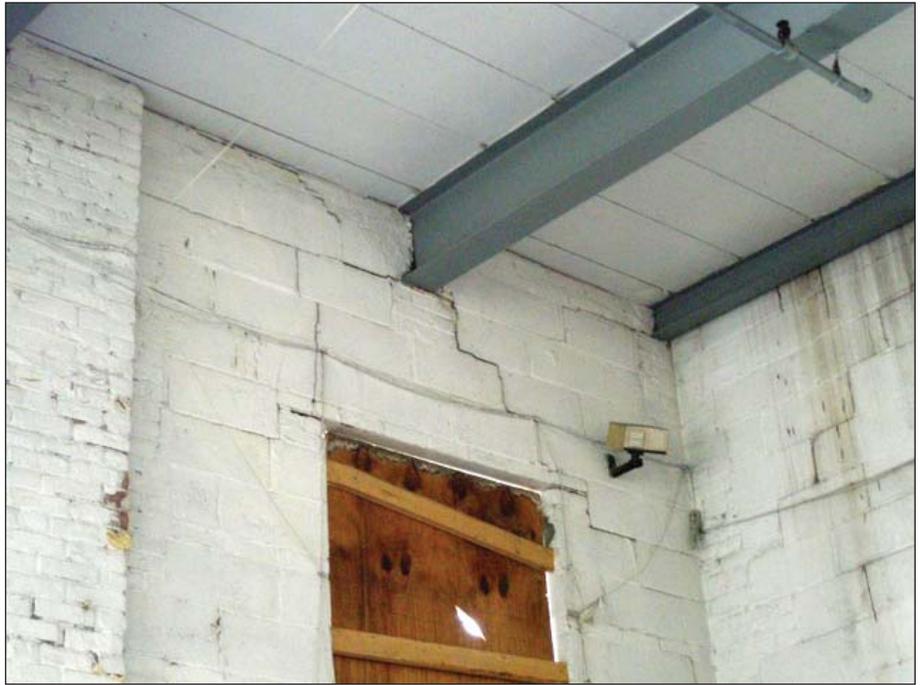
Photograph 1997-49-E

At the northern wall of the building, there are cracks that originate at the beam seats (see Photograph E); signs of water intrusion at the northwest corner, which appear to originate from the roof; cracks in the exterior wall, which are likely due to differential settlement (see Photograph F); and corrosion and sagging of the steel lintel headers around the door and window openings (see Photograph G). Along the south masonry wall, some of the concrete masonry unit blocks on the exterior wall are dislodged and protrude into the air shaft (see Photograph H), potentially compromising the structural integrity of the load-bearing wall. Minor cracking and spalling of the concrete slab-on-grade floor was also observed.

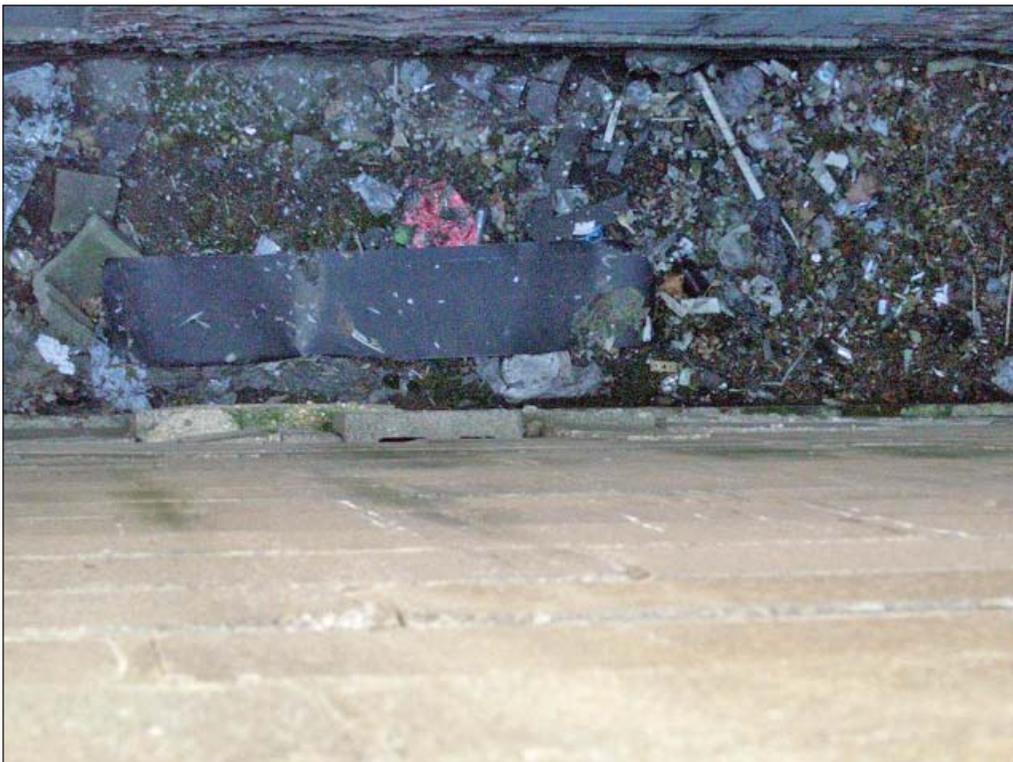
Photograph 1997-49-H

As mentioned above and shown in Photograph H, there are dislodged CMU blocks on the exterior wall, which Thornton Tomasetti, Inc. recommends be addressed in the short term. This condition is a

safety concern, as it may have the potential to compromise the structural capacity of this load-bearing wall.

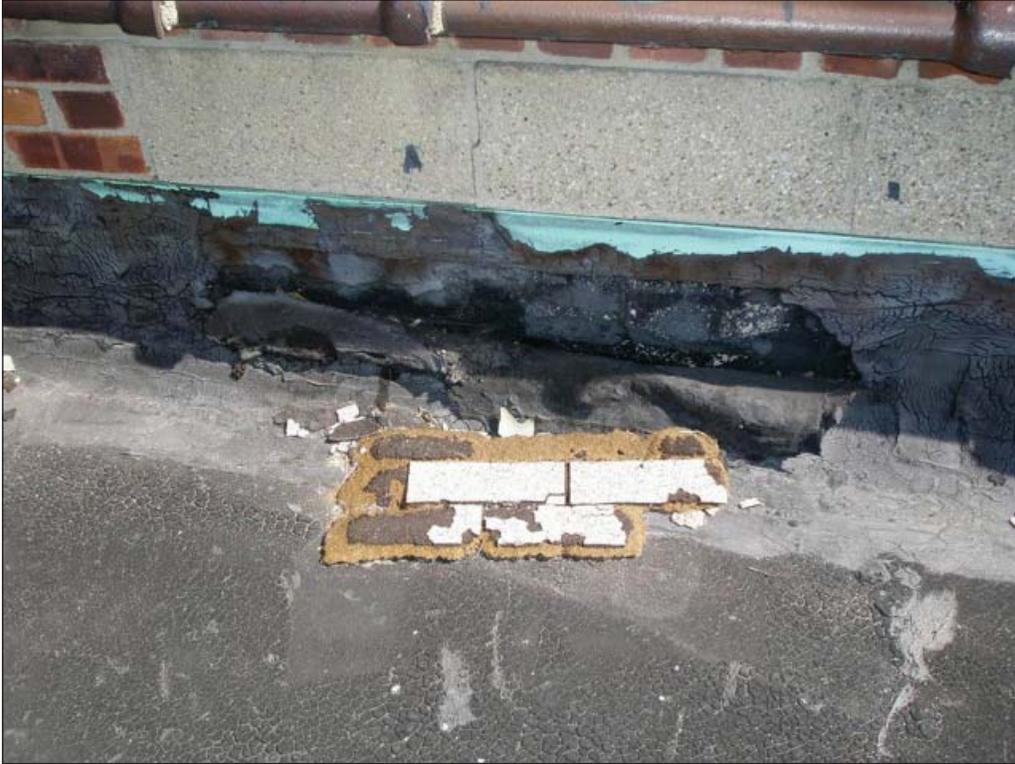
Photograph 1997-49-I

Tears in the roof membrane along the parapet (see Photograph I), several cracked skylight glass panes (see Photograph J), and inadequate repairs to the membrane may be causing water infiltration in the building.

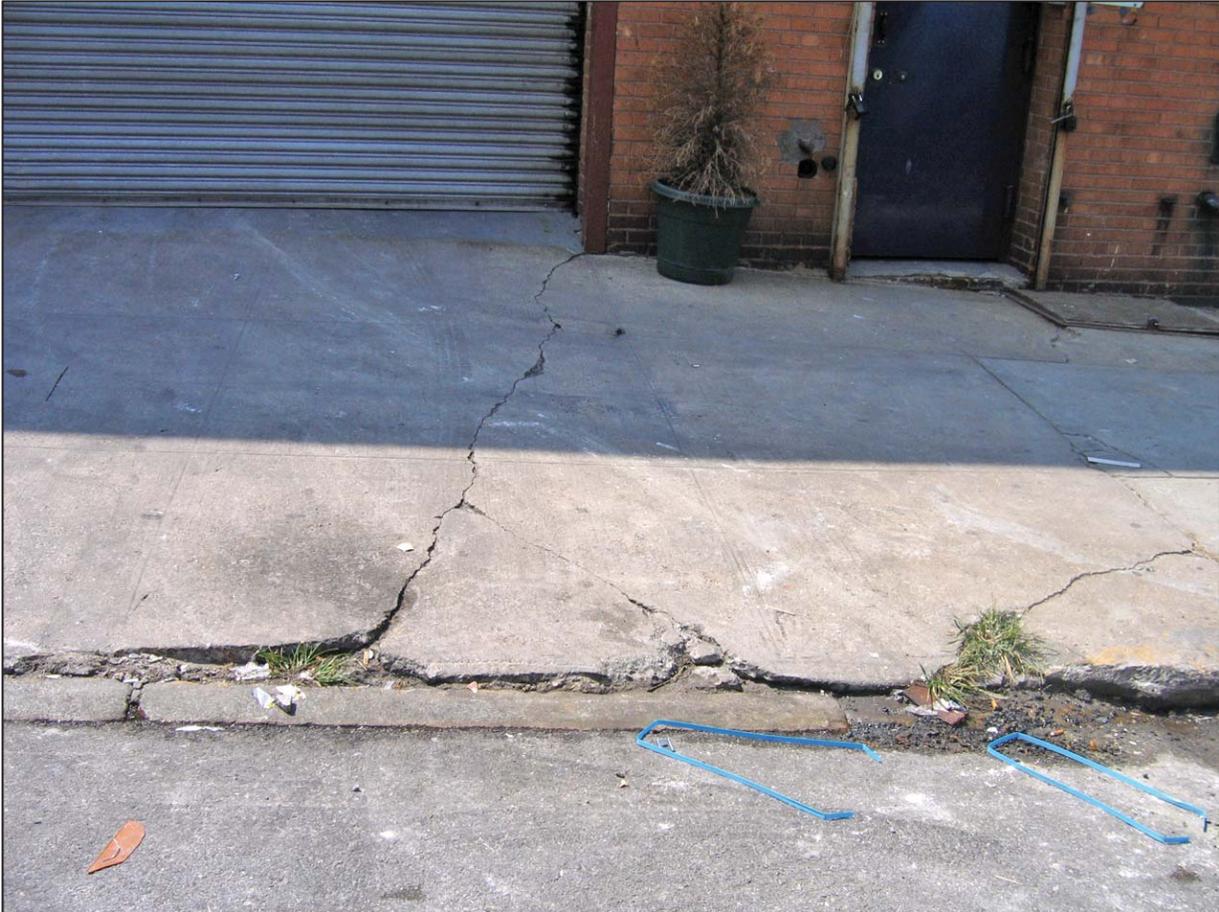
Photograph 1997-49-K

The sidewalk along West 131st Street is in fair condition, with cracking and small spalls observed; however, the curb cuts are in poor condition due to large chips and cracks (see Photograph K).
