Block 1997 Lot 55

SITE CONDITION: POOR

Manhattanville Neighborhood Conditions Study

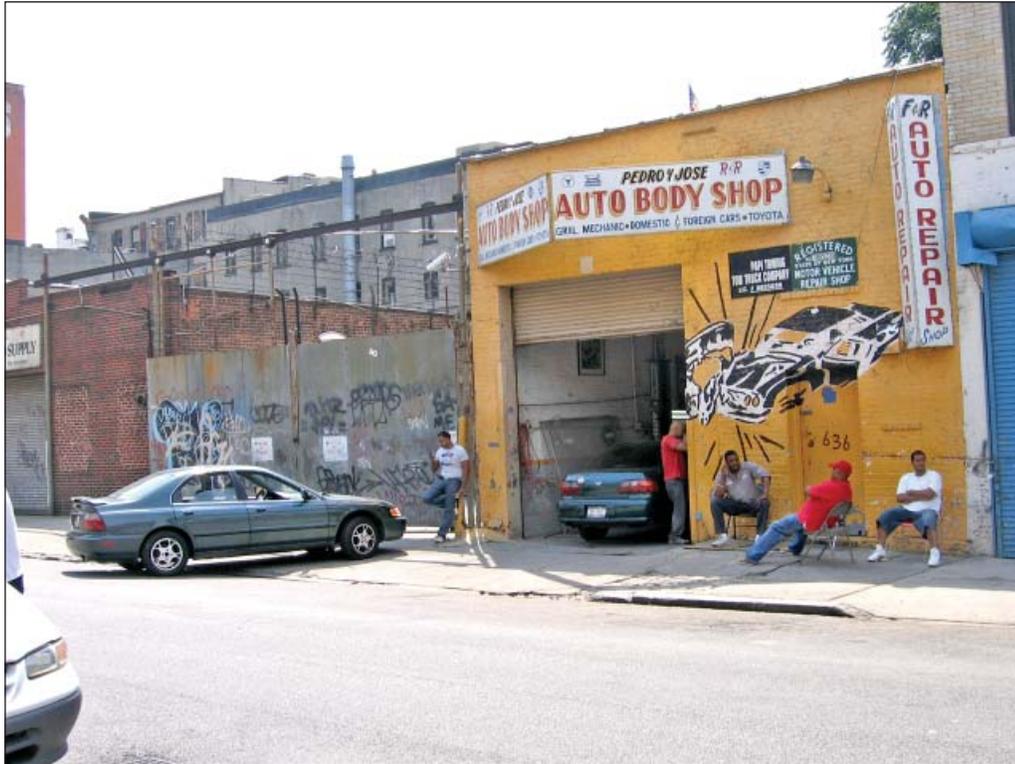
Photograph 1997-55-A

Lot 55, which was acquired by the Trustees of Columbia University on January 31, 2005, is located at 636 West 131st Street between Twelfth Avenue and Broadway in an M1-2 zoning district. The one-story, 2,373 gsf brick masonry building is occupied by an auto repair shop (see Photograph A). The structure was constructed in 1920. No renovations have been recorded.

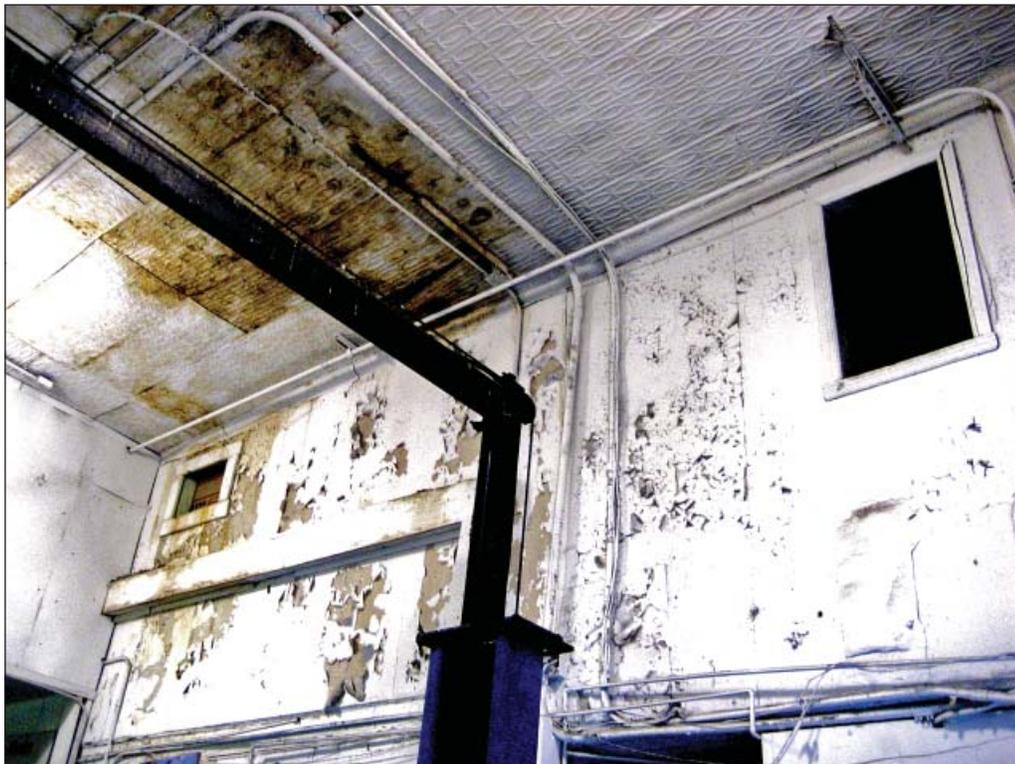
Photograph 1997-55-B

Long-term water infiltration has caused deterioration of the building's structural and

non-structural components, including corrosion of the sheet metal ceiling (see Photograph B) and widespread cracks in interior and exterior walls (see Photographs C-E). Water damage to the building has likely been caused by a deteriorated roof membrane (see Photograph F). Active water infiltration observed on the first floor and mezzanine level is causing further structural damage to the building (see Photograph G).

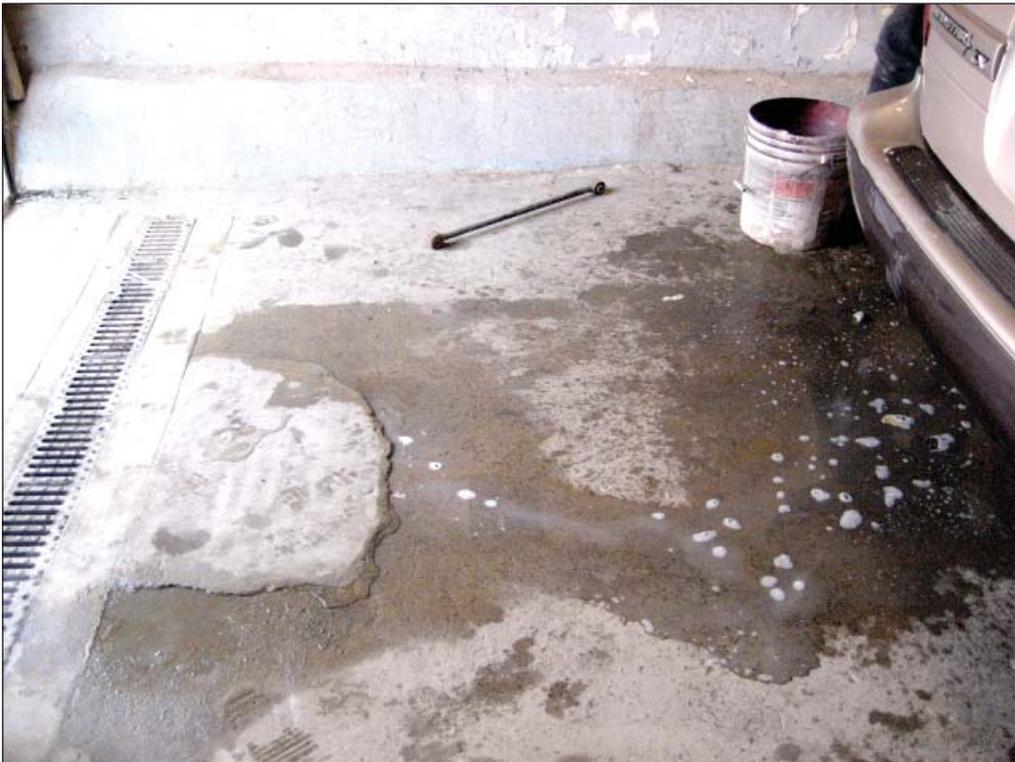
Photograph 1997-55-H

Long-term exposure to auto-related activity has caused cracks in the concrete floor (see Photograph H). Damage to the floor has also likely resulted from cars being washed in the building. The sidewalks are in poor condition due to severe cracking and spalling of two panels in front of the entrance (see Photograph I). As shown in Photograph J, the structure has a limited capacity, forcing cars to be serviced or stored on the sidewalk.

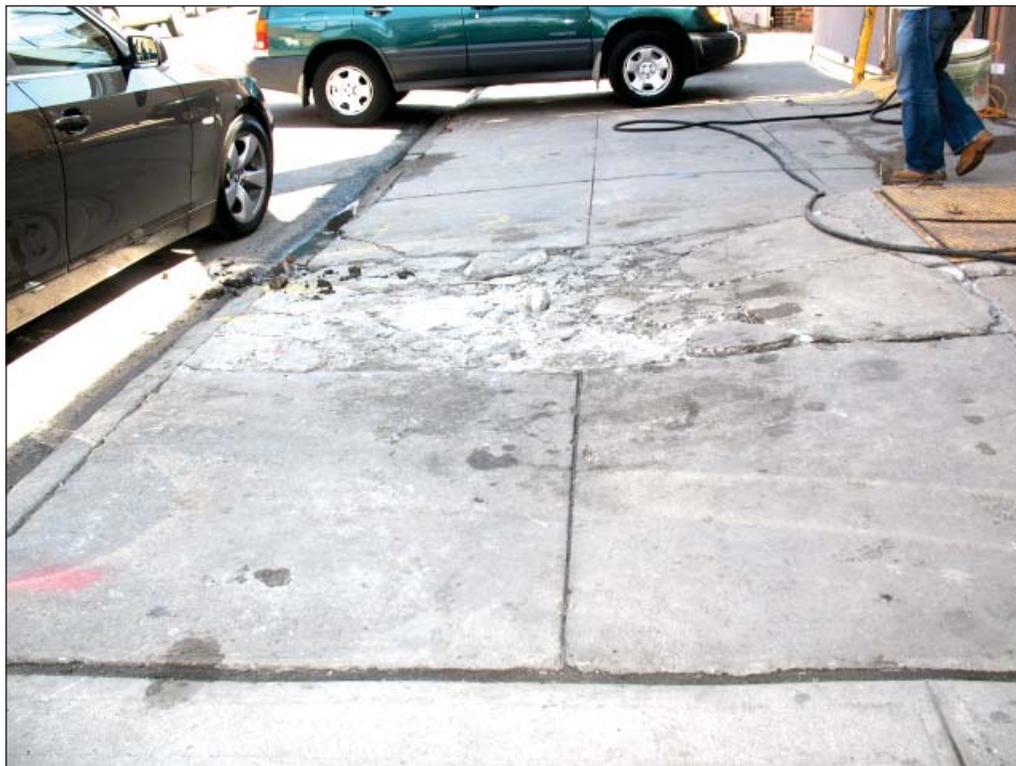
Photograph 1997-55-I

There are several health and safety concerns at this site. The exit door on the south wall of the building opens to a fenced-in area filled with discarded auto parts, obstructing egress through this door (see Photograph K). Mold is growing on walls in the sidewalk vault (see Photograph L). Auto-painting equipment and chemicals are used in the building without proper ventilation systems (see Photograph M). The sidewalk has several cracks and spalling concrete, and is a tripping hazard (see Photograph I). In addition, the parking of cars on the sidewalk creates a safety hazard for pedestrians.
