## Block 1997 Lot 61

SITE CONDITION: FAIR

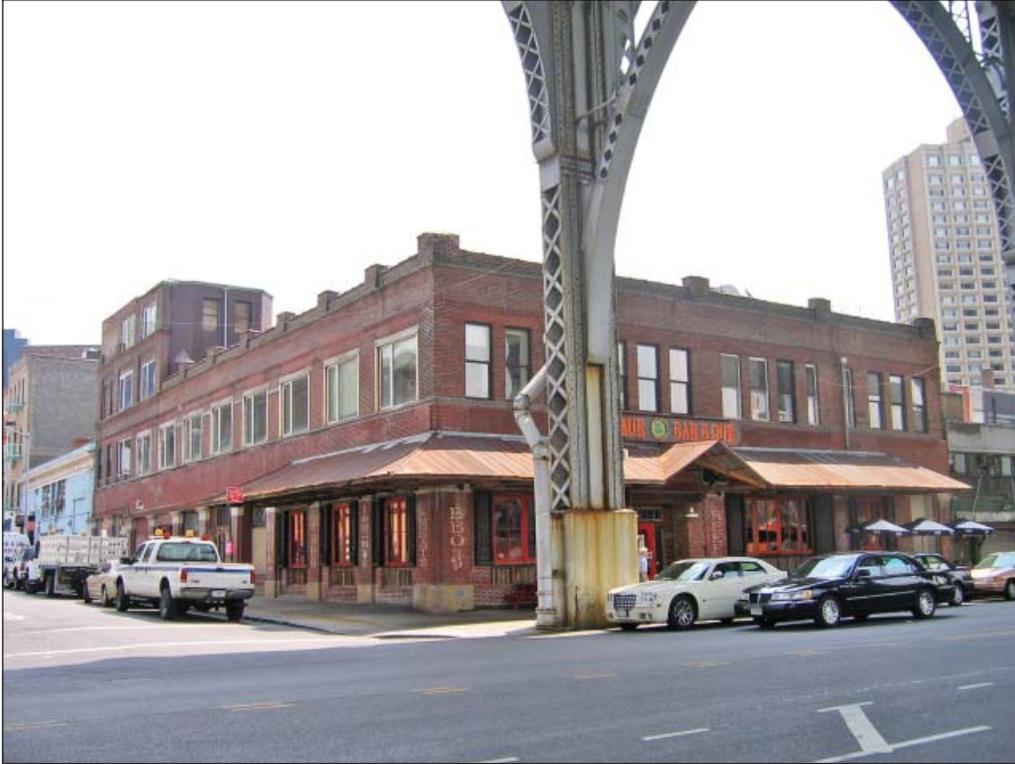
**Photograph 1997-61-A**

Lot 61 is located at 2293 Twelfth Avenue (on the southeast corner of West 131st Street and Twelfth Avenue) in an M2-3 zoning district (see Photograph A). The two-story, 22,100-gsf, brick, commercial building was built circa 1925 and renovated in 2002 and again in 2005. The property, occupied by a restaurant, production company, architecture firm, and other commercial tenants, was acquired by GHC NY Corporation circa October 1999 and is under contract by the Trustees of Columbia University.

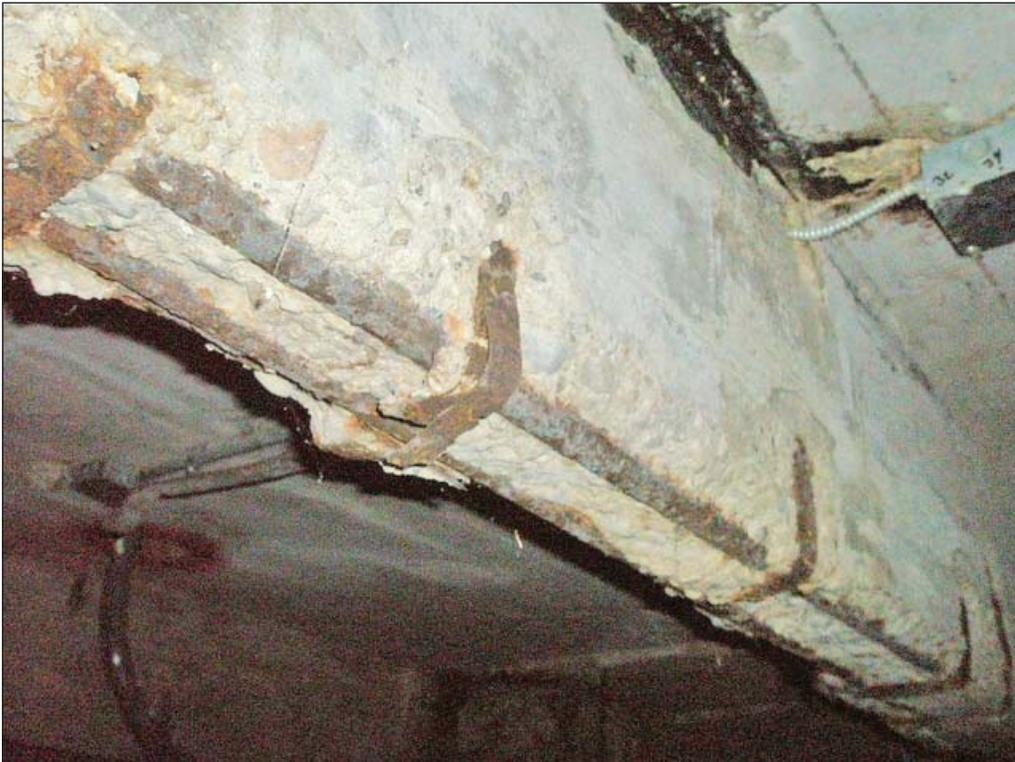
**Photograph 1997-61-B**

Most of the structural distress in the building is due to long-term neglect and water infiltration in the basement. These factors have resulted in compromised first-floor framing girders and beams, as evidenced by severe spalling at the underside of the beams and girders, and exposed and significantly corroded reinforcing bars (see Photographs B). In the basement mechanical vault, significant corrosion to one of the steel framing members has been caused by water intrusion from above (see Photograph C) and there are missing sections of the concrete slab-on-grade (see Photograph D). Although not a longstanding problem, water intrusion in the basement is currently caused by defective plumbing in the restaurant above (see Photograph E). There are signs of water intrusion on the underside of the first-floor (see Photograph F) and third-floor slabs (see Photograph G).

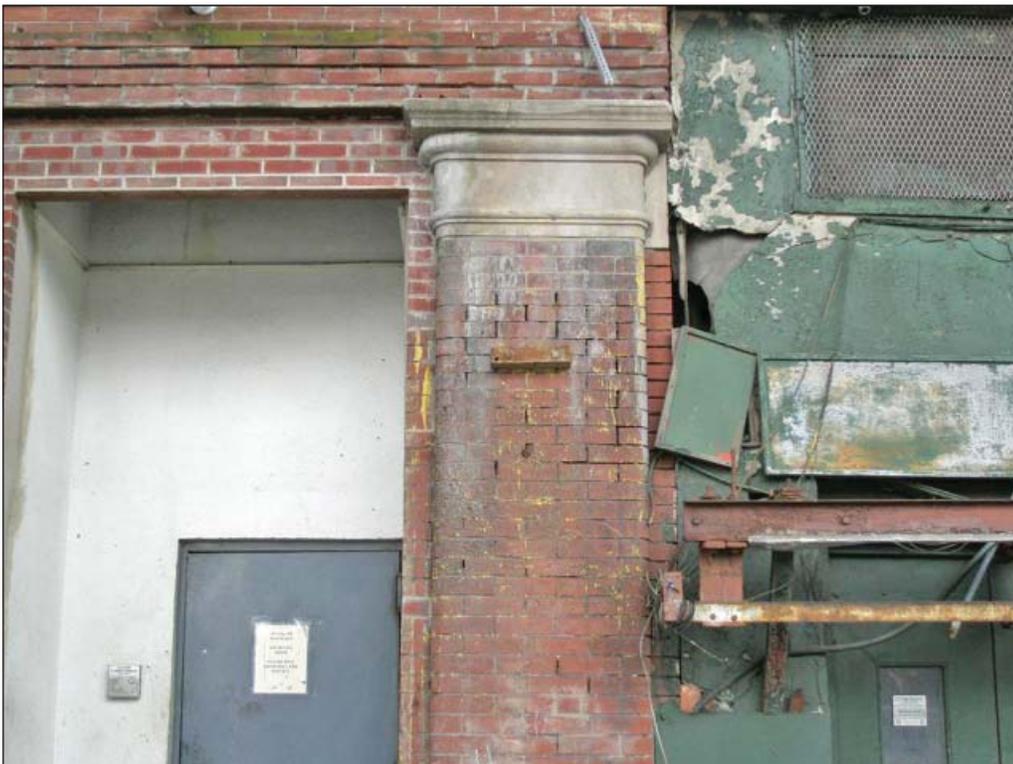
**Photograph 1997-61-H**

The brick masonry on the north and west façades of the building, is in fair condition overall, though some of the masonry piers are cracked and deteriorated (see Photograph H). In addition, as shown in Photograph H, there is efflorescence and moss growth on the brick façade. On the south façade, there are areas with missing stucco. Also, an area that previously abutted the adjacent building is now exposed because portions of the adjacent building's roof collapsed. This condition allows water intrusion into the south wall because flashing is no longer in place (see Photograph I).

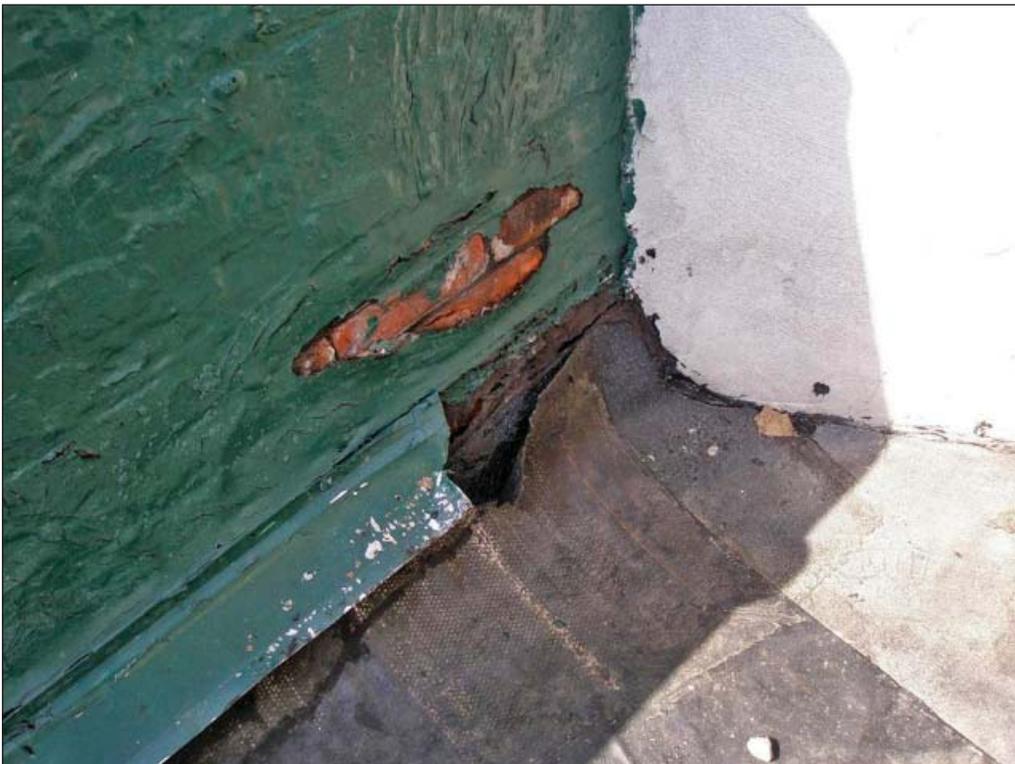
**Photograph 1997-61-J**

On the roof, there are several patched areas and evidence of standing water in various locations. The waterproof coating on the inside of the parapets is compromised in a few locations, and the flashing along the bottom of the west wall of the higher eastern building portion is partially displaced (see Photograph J). It appears that the west parapet along Twelfth Avenue is leaning inward slightly, possibly as a result of over-tightened bracing rods. Some cracks in the masonry were observed around the rod attachments to the parapet, although they do not indicate significant structural distress.

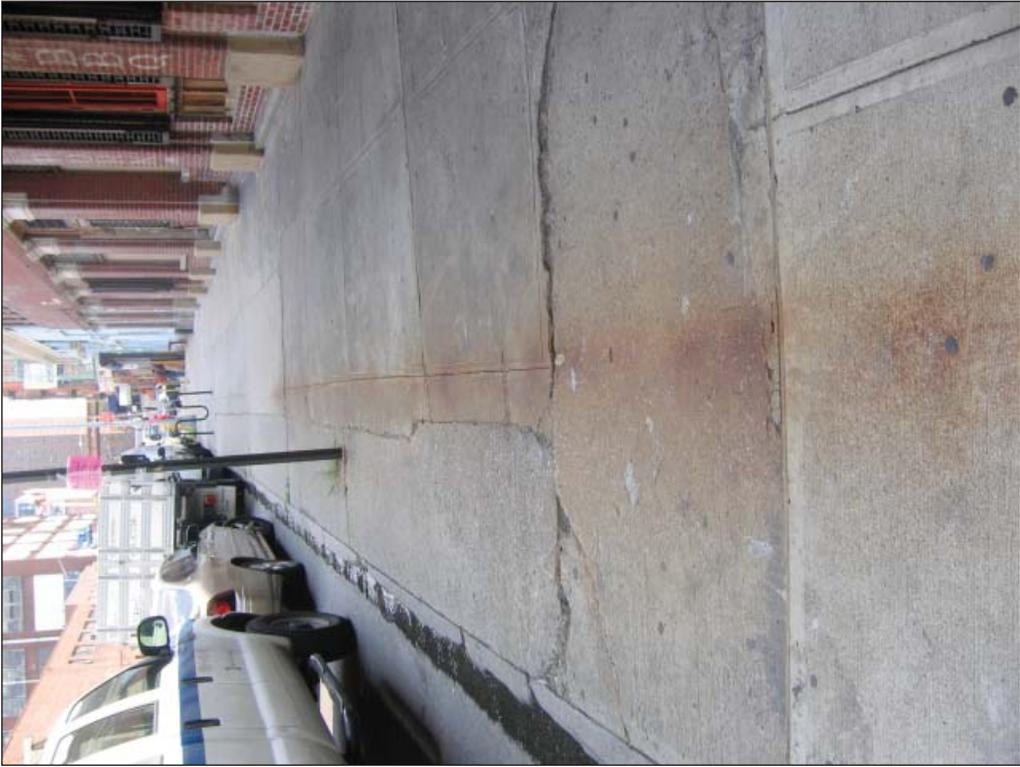
Photograph 1997-61-L

There is a moderate amount of cracking and spalling on the sidewalk along West 131st Street (see Photograph L); however, the sidewalk along Twelfth Avenue is in good condition. There are no curb cuts along either sidewalk.

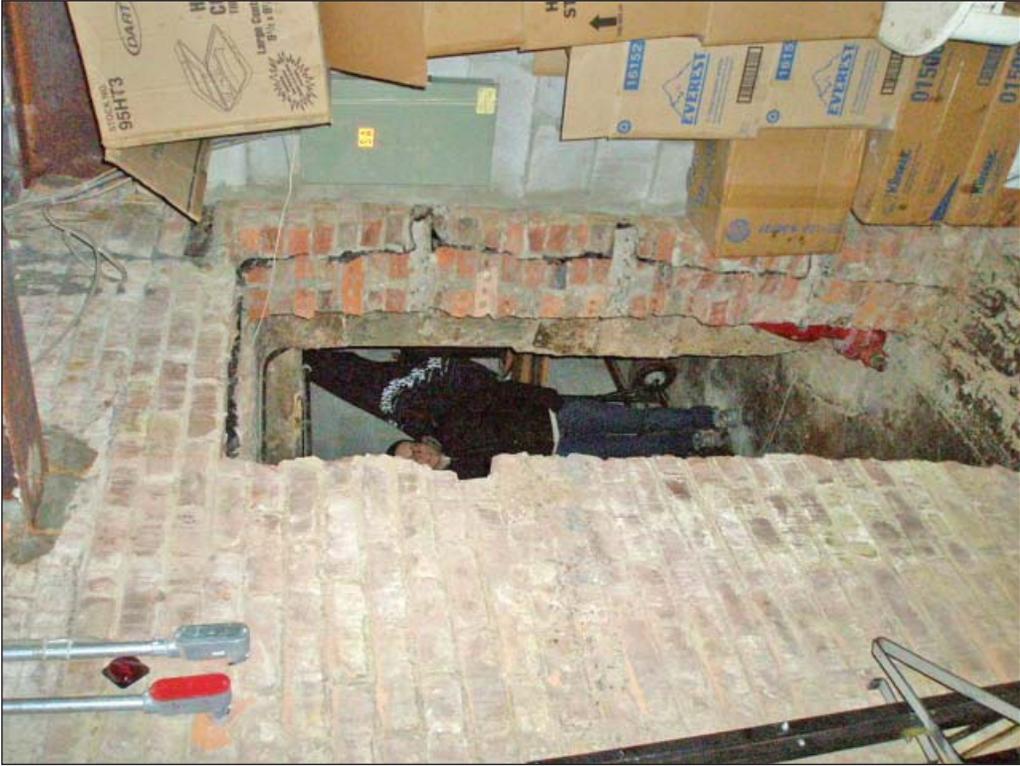
Photograph 1997-61-K

An opening without a door frame or lintel was observed in a demising wall in the basement, indicating that the masonry above the opening is not adequately supported (see Photograph K).

The absence of a lintel above the opening in the demising wall, discussed above, is a safety hazard, as the masonry above the opening is not adequately supported and bricks could potentially become loose and fall down.
