## Block 1997 Lot 64

SITE CONDITION: CRITICAL

Manhattanville Neighborhood Conditions Study

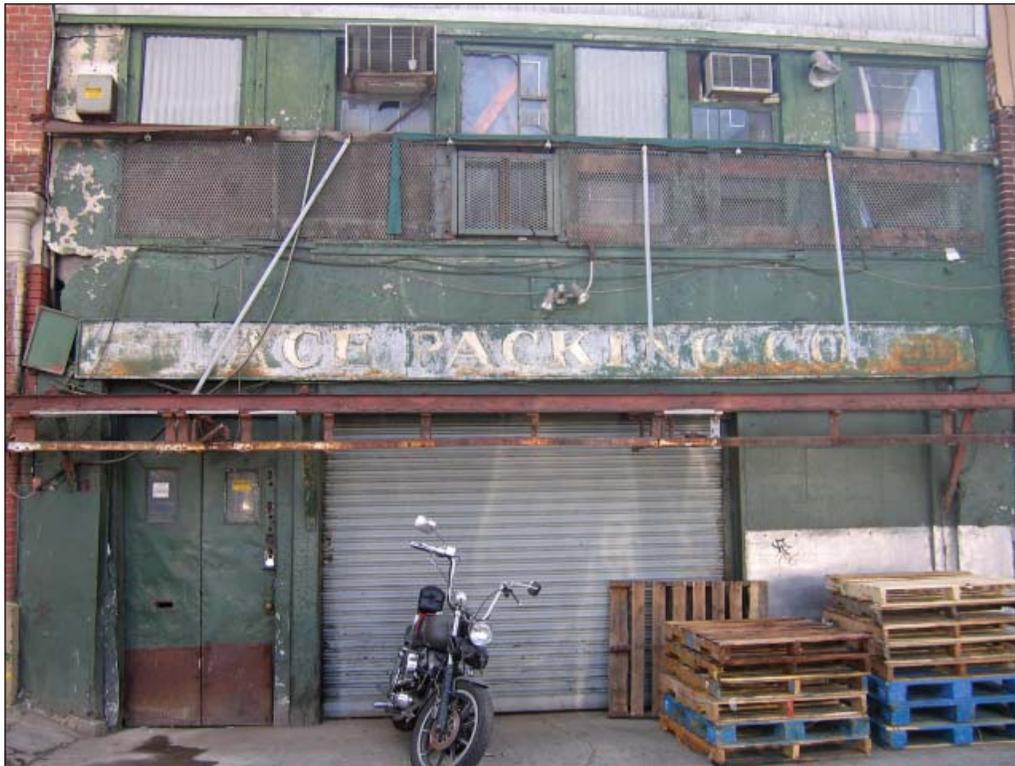
Photograph 1997-64-A

Lot 64 is located at 2291 Twelfth Avenue between West 130th and West 131st Streets in an M2-3 zoning district. The 3,425 gsf, two-story building, previously occupied by a meat wholesale company, is now used by a nearby meat wholesaler for dry-goods storage (see Photograph A). It is currently owned by 2291 Twelfth Avenue<sup>1</sup>, Inc. and is under contract for purchase by the Trustees of Columbia University. The historic Sanborn Map from 1893 indicates that the building was likely built before that year.

As shown in Photographs A and Q, the west façade of the building along Twelfth Avenue is in poor condition with a deteriorated and delaminated stucco coating, windows blocked off by plywood, broken window glazing, peeling paint, and a corroded meat conveyer belt that runs the length of the facade.

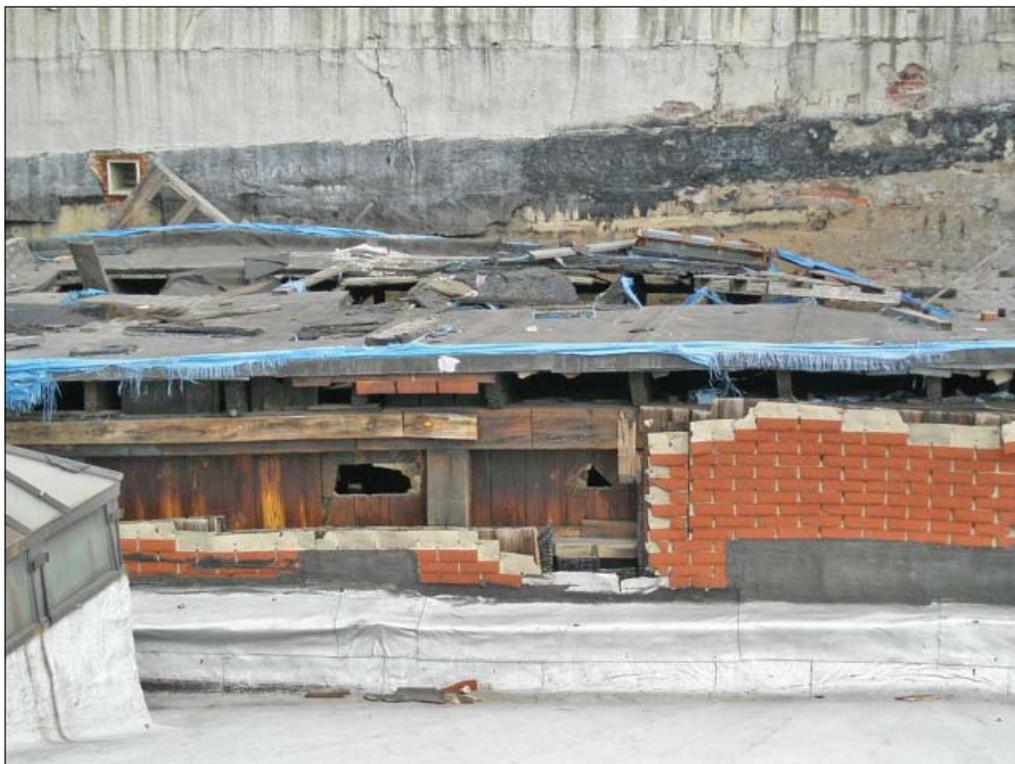
Photograph 1997-64-B

Prolonged water infiltration, likely from periodic flooding and substandard building conditions, has caused severe structural distress throughout the building. A fire occurred in August of 2000 that caused substantial damage to the rear roof and exterior wall structures (see Photographs B and C). This damage has not yet been repaired, likely significantly exacerbating the deterioration of the building's structural and non-structural components. The eastern portion of the building, where the fire occurred, was not available for observation on either floor due to safety concerns. In the western portion of the building extensive water infiltration was evident by: the severe sagging of the second floor ceiling (see Photograph D), partial ceiling collapses (see Photographs E and F), shoring of a damaged wood plank deck and tar that has dripped through a gap(s) in the roof components (see Photograph G), corrosion of the meat conveyor belt steel support system (see Photographs H and I), active roof leaks (see Photograph J), and mold infestation in the first floor walk-in refrigerator (see Photograph K). In addition, the second-floor timber structure appears to be unsafe, as evident by the warped and delaminated plywood flooring (see Photograph L). Periodic flooding, reported by business owners and staff at adjacent properties to be a longstanding problem along Twelfth Avenue, is likely a problem in this building as well, as water damage was observed along the lower portion of first-floor walls and doors (see Photographs M and N).

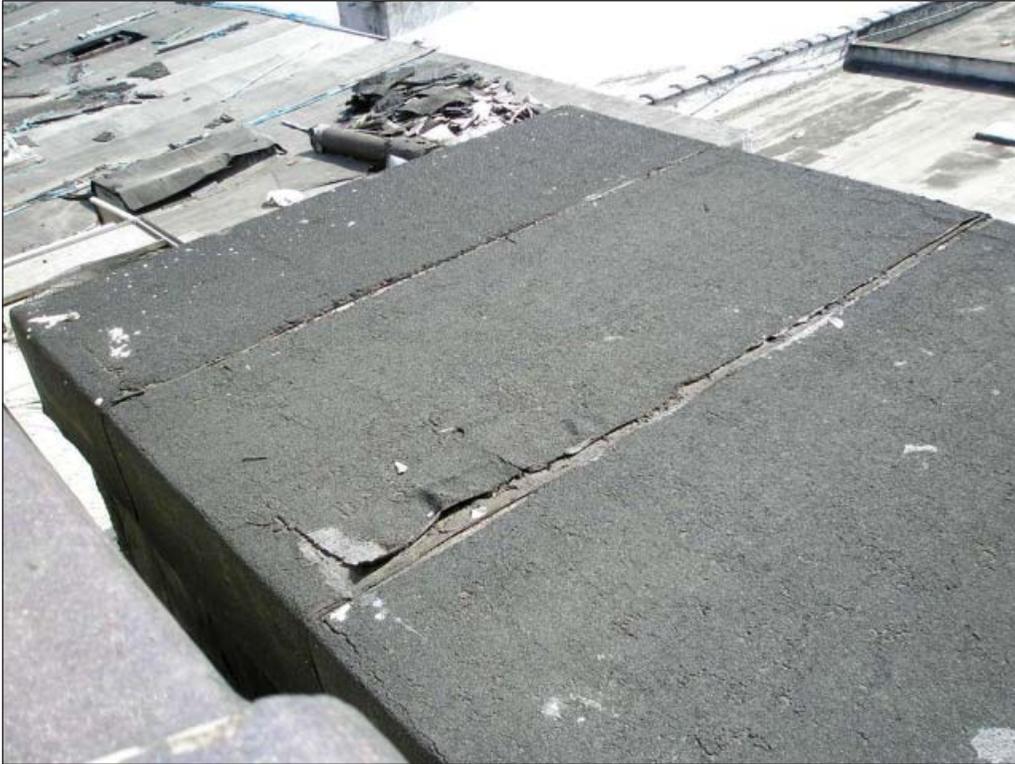
**Photograph 1997-64-O**

The western section of the roof, which is still intact, is in critical condition. The roofing membrane shows signs of deterioration, such as delaminated edges (see Photograph O), and portions of the

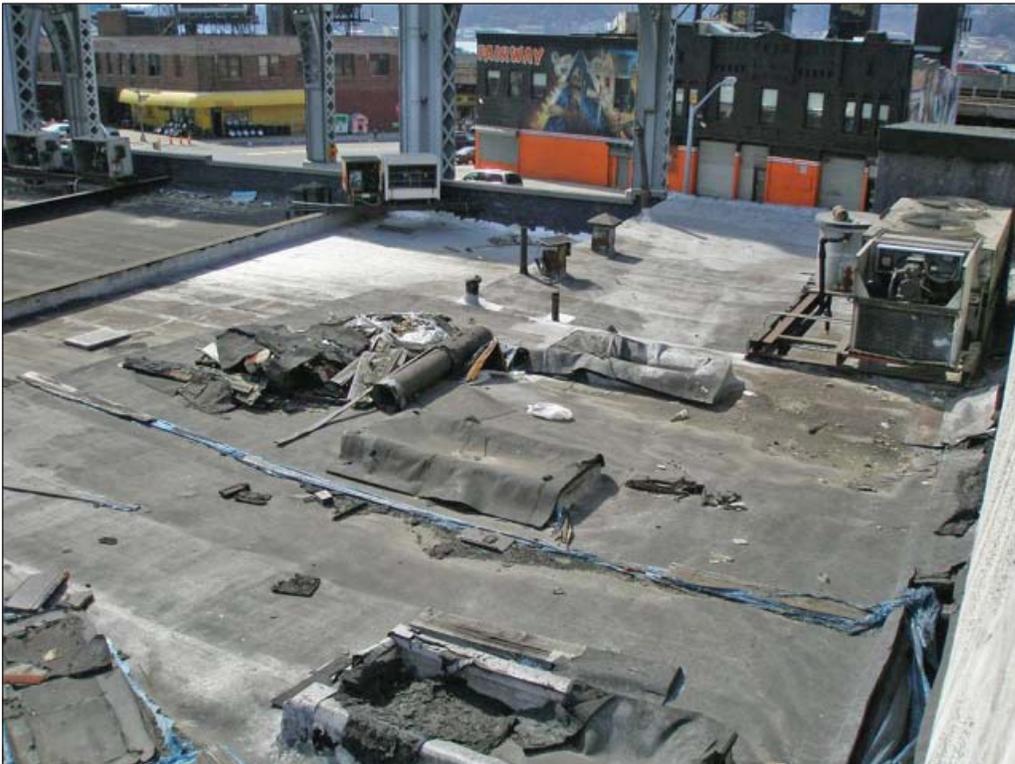
**Photograph 1997-64-P**

membrane have been ripped off entirely (see Photograph P). Ponding was also observed along the north side of the roof.

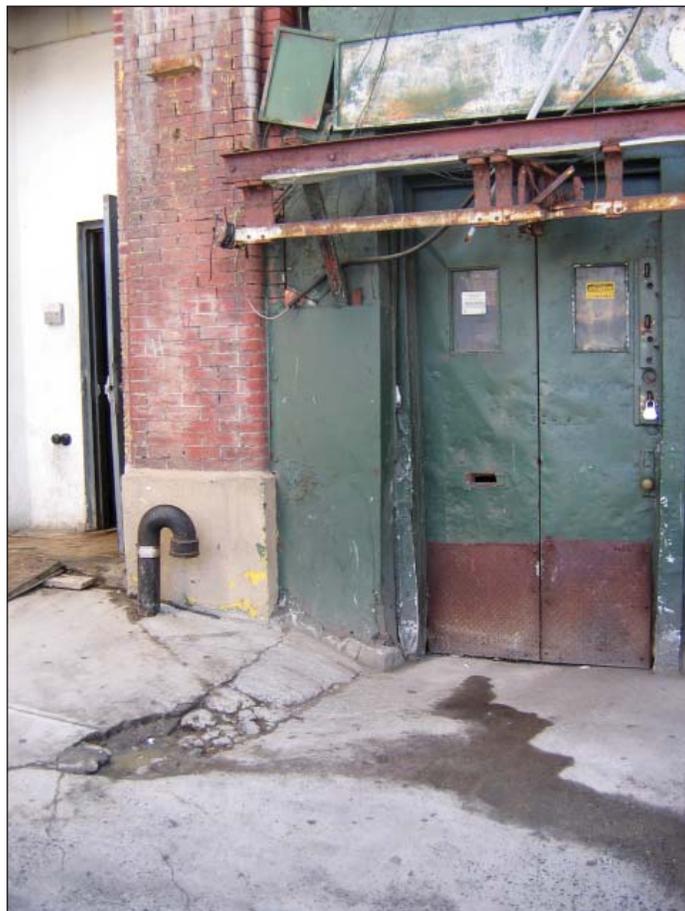
**Photograph 1997-64-R**

The sidewalk and curb are in poor to critical condition, with widespread cracking and a large patch of spalled concrete (See Photograph R).

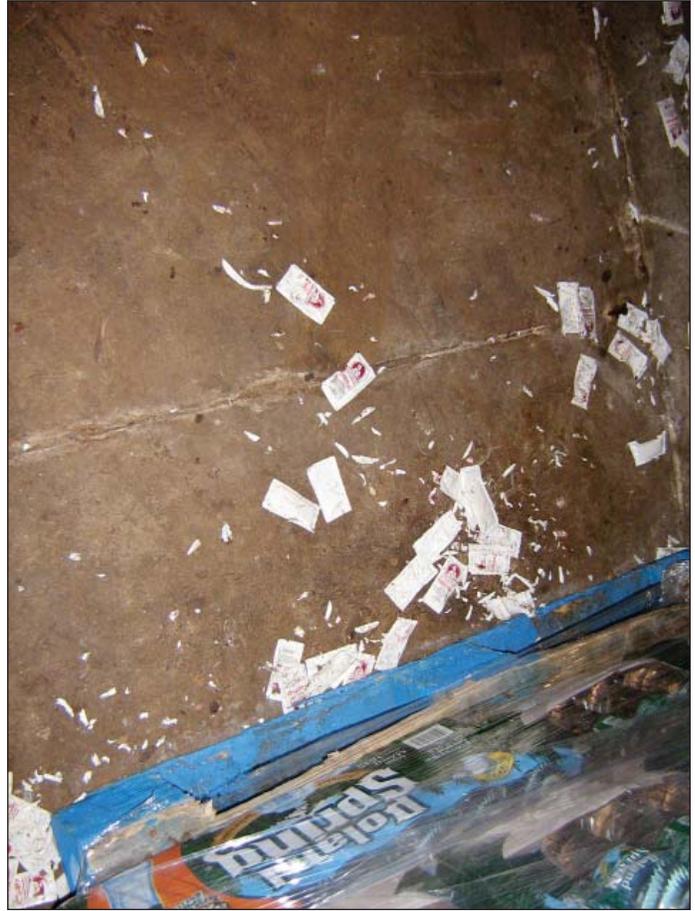
**Photograph 1997-64-S**

Though no longer used for meat wholesaling, the first floor of the building is used for dry goods storage despite many indications of unhealthy and unsanitary conditions. Vermin infestations was evident by gnawed-through ketchup packets littered on the first floor near the dry goods storage area (see Photograph S). The eastern wall of the walk-in refrigerator room is mold-infested and currently has an active water leak (see Photograph K). The interior of the building is generally filthy and unkempt, with cigarette butts, old tires, and other trash strewn throughout the building. In addition, the failure to address these structural and sanitary issues, like vermin infestation, is likely having a negative effect on the adjacent buildings to the north and south, which both have vermin problems. In addition, the missing portions of the roof and the south exterior wall are likely causing water infiltration into these neighboring buildings.

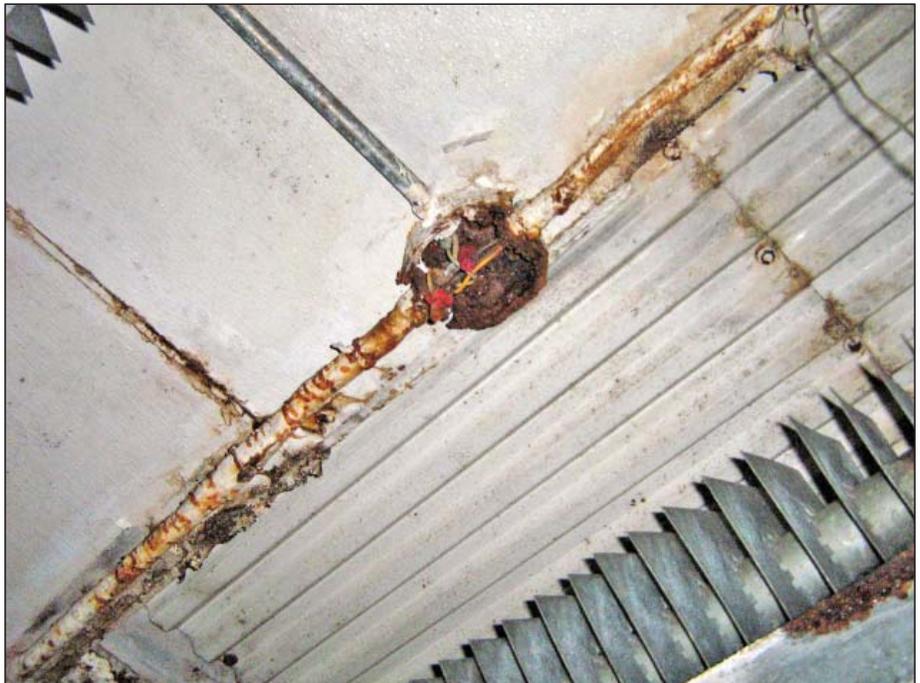
**Photograph 1997-64-T**

Electrical hazards are also present in the building. Pipes with electrical wiring are severely corroded (see Photograph T) and a lighting fixture has a standing pool of water and mold (see Photograph U).
