Block 1998 Lot I

SITE CONDITION:	POOR
-----------------	------

Manhattanville Neighborhood Conditions Study

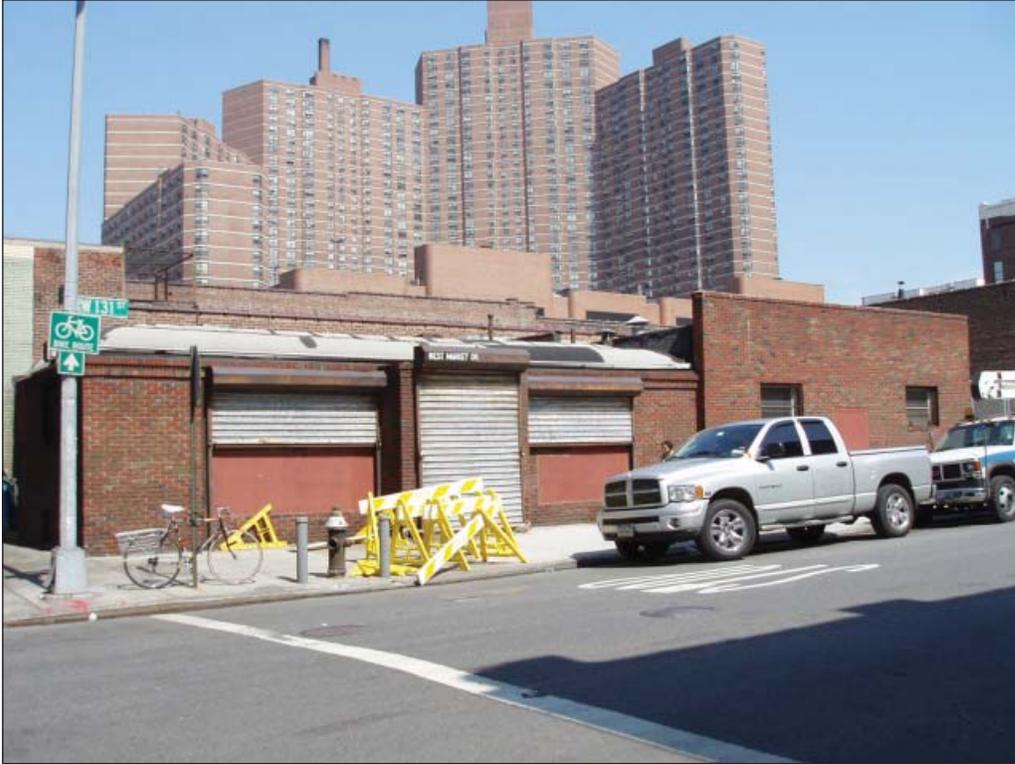
Photograph 1998-I-A

Lot 1 is located at 2301 Twelfth Avenue in an M2-3 zoning district. The lot includes a 1,110-gsf, one-story vacant structure at the corner of West 131st Street and Twelfth Avenue (see Photographs A and B) and a parking lot east of the building (see Photograph C). The building is made up of three portions: a railroad car on the northwest portion of the lot, a diner car on the southwest portion, and a masonry building east of the railroad car and diner car. The Trustees of Columbia University purchased the property on June 30, 2003. According to the New York City Department of Buildings, the structure was built circa 1960. However, according to Columbia University personnel the railroad car and diner car were brought to the property circa 1948 and around this time the masonry building was added to the east.

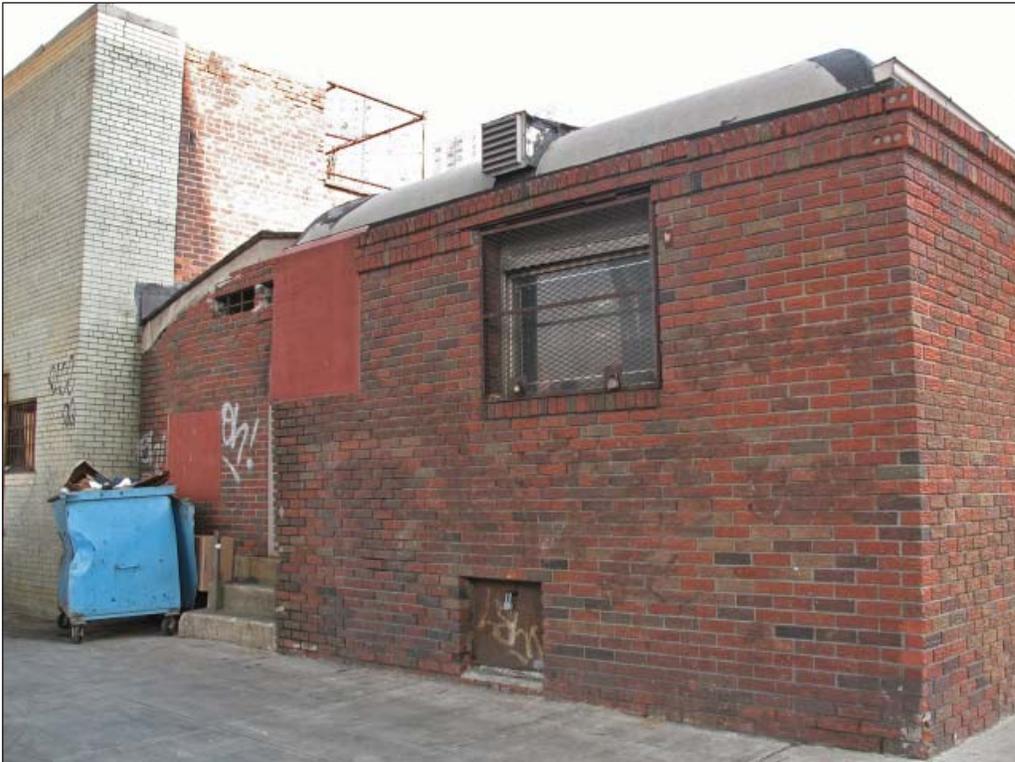
Photograph 1998-I-B

Other site concerns include severe delamination¹ of the concrete slab-on-grade in the parking lot (see Photograph H), damaged concrete and masonry at the exterior steps (see Photograph I), and the long-term presence in front of the building of a dumpster, which appears to be used by an adjacent business (see Photograph B).

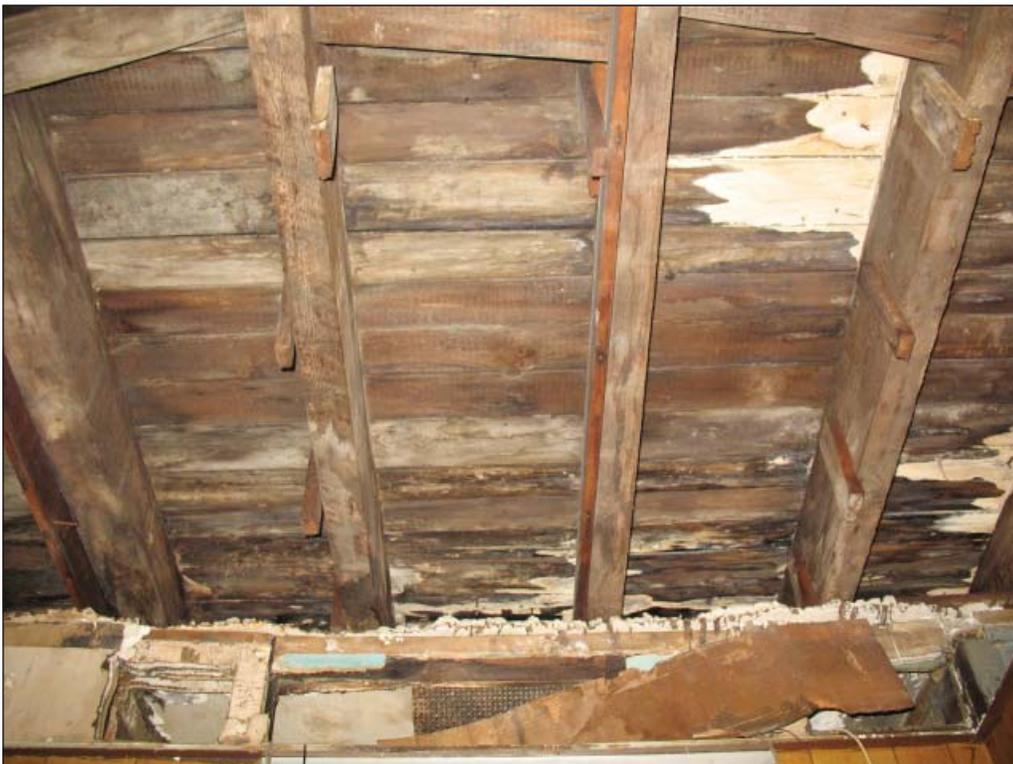
Photograph 1998-I-D

Long-term water infiltration has caused deterioration of the building's structural and non-structural components and finishes. There are widespread water stains on the timber roof joists and wood planked deck in the masonry building (see Photograph D). Although a portion of the roof framing has been repaired, water stains indicate continued water damage. Further water damage could be caused by a deteriorated roofing membrane on the diner car (see Photograph E), wide vertical cracks in the exterior concrete masonry unit wall (see Photograph F), and a cracked and spalling repair patch on the west façade's exterior wall (see Photograph G).

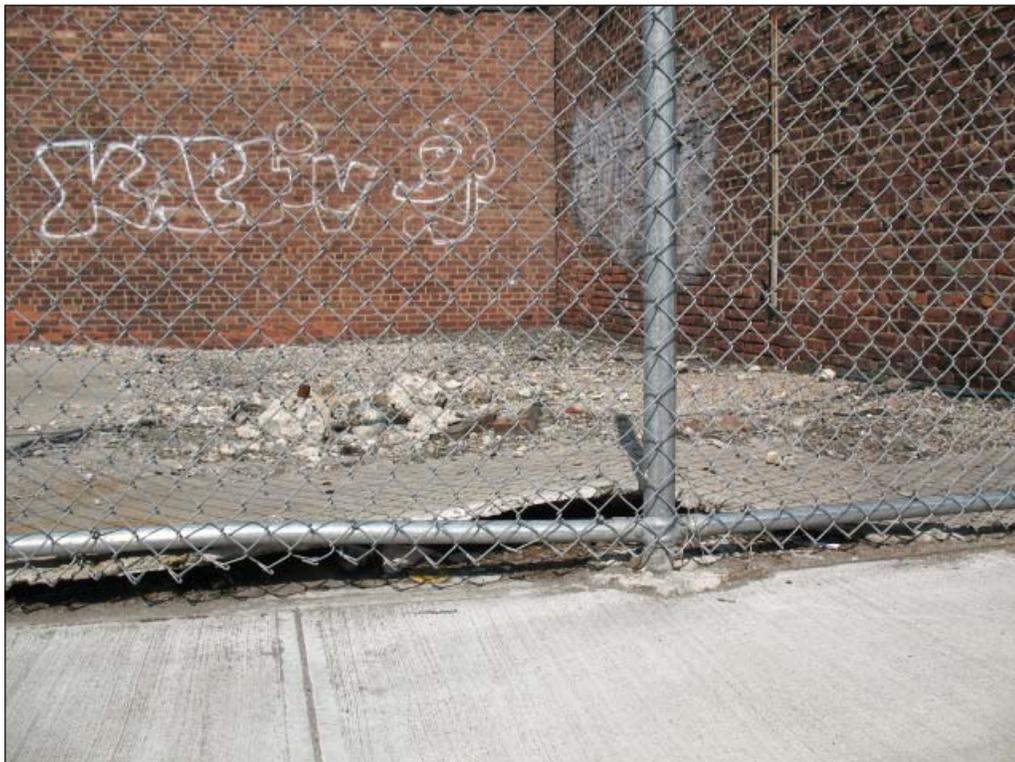
Photograph 1998-I-H

¹ According to the National Ready Mixed Concrete Association, delamination of concrete surfaces results from premature and improper finishing, which causes the top 1/8 to 1/4 inch to separate from the base slab by a thin layer of air or water.

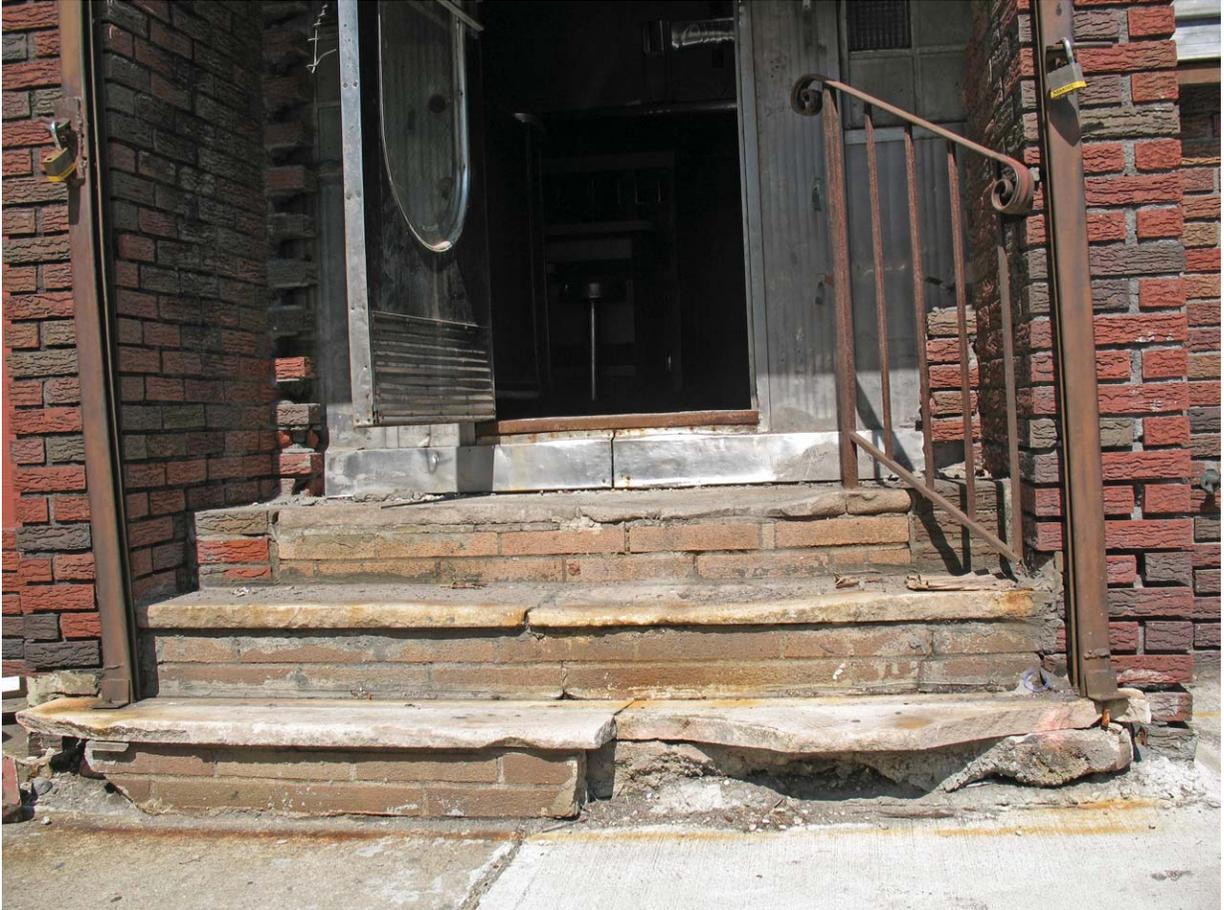
Photograph 1998-1-1

Health and safety concerns include: an unsafe entrance with damaged steps, and mold on the ceiling and walls of the restrooms in the masonry building. These health and safety concerns will need to be addressed if the building becomes occupied.
