## Block 1998 Lot 3

**SITE CONDITION: CRITICAL**

Manhattanville Neighborhood Conditions Study

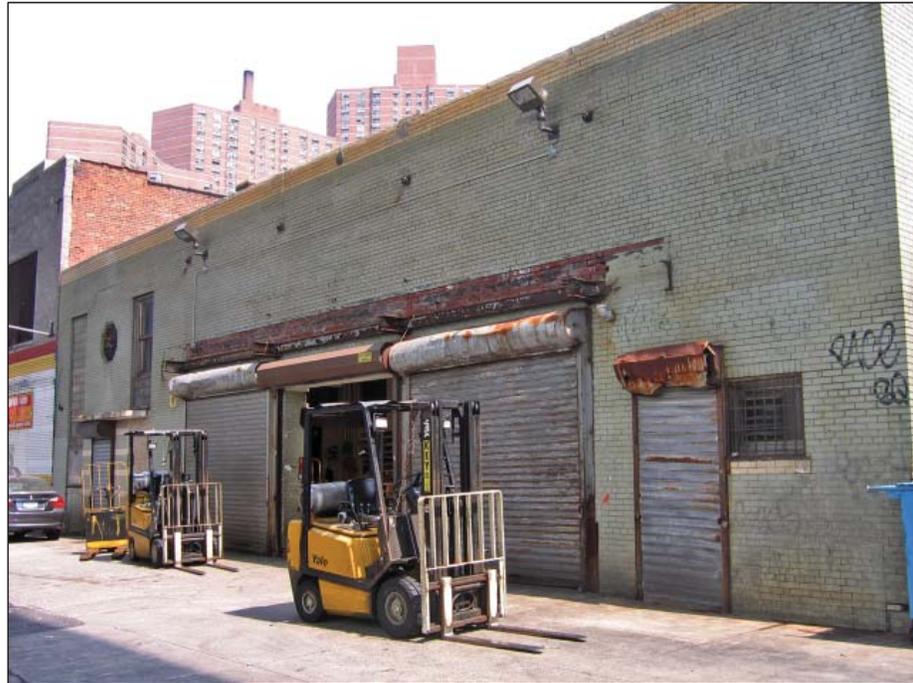
**Photograph 1998-3-A**

Long-term water intrusion has caused the following damage to several structural and non-structural components and finishes: water stains and corrosion (see Photographs A and B), flaking paint (see Photograph C), and a cracked cementitious coating at the top of the columns (see Photograph D). As shown in Photograph E, the skylights are corroded, and the waterproof coating on the inside face of the parapet is severely deteriorated. In the mechanical/electrical room in the building's northwest portion, the boiler, several pipes, and electrical panel enclosures on the south wall have been significantly corroded by water damage (see Photographs F and G). In addition, the concrete slab-on-grade in this room has significant spalling (see Photograph H).

Several potential hazardous conditions were observed at the site. In the southwest corner of the first floor, there are cooling compressors, which appeared to be leaking chemicals onto the concrete slab. In addition, as shown in Photograph R, there are several automotive-type batteries that are leaking battery fluid onto the floor. Standing water was observed in the northwest corner of the main refrigeration space, indicating that the floor may not be adequately sloped toward the floor drains (see Photograph S). On the day of the site visit, there was a strong odor outside the building that resembled decaying organic waste, and a large quantity of organic growth on the column in the main refrigeration space (see Photograph I) was observed. Moisture and corrosion near active electrical equipment in the mechanical/electrical room is a safety concern (see Photographs F and G). A potentially unsafe condition includes a padlocked hatch to the roof from the second floor (see Photograph T). The door on the north side of the building’s west façade provides emergency egress from the second floor via a stairway; however, the roll-up shutter in front of this emergency exit door was closed on the day of the site visit, thereby preventing egress and creating an unsafe condition for employees (see Photograph A).

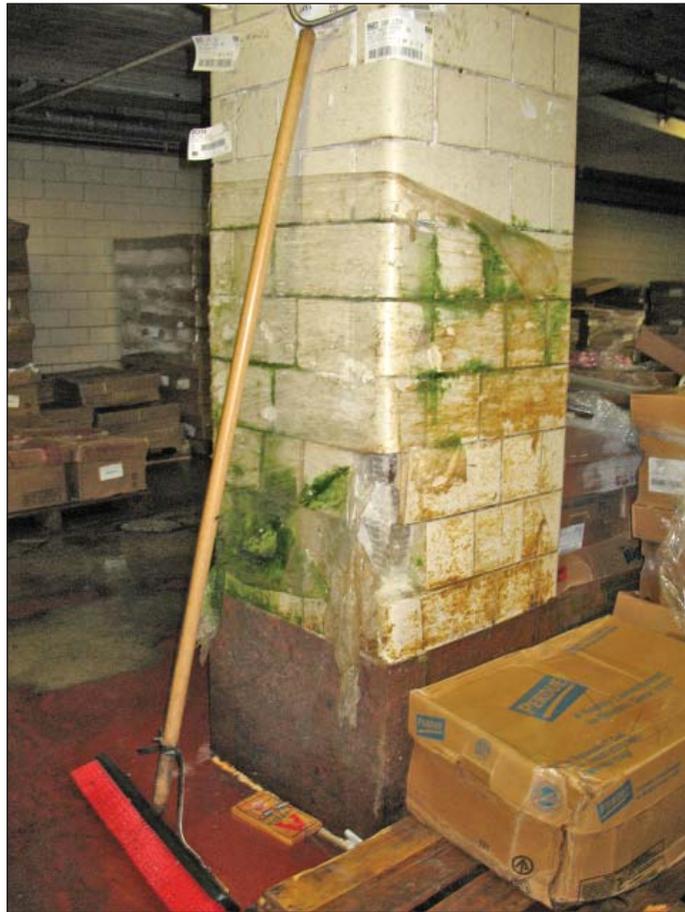
**Photograph 1998-3-I**

Long-term occupancy of a poultry packing business and its associated operations, such as forklift and pallet jack traffic and wash-down cleaning, has resulted in damaged columns and door jambs from repeated vehicle impacts (see Photograph I), displaced red-colored top coating on the slab-on-grade in one of the refrigeration rooms (see Photograph J), and spalling concrete on the exposed slab (see Photograph K).

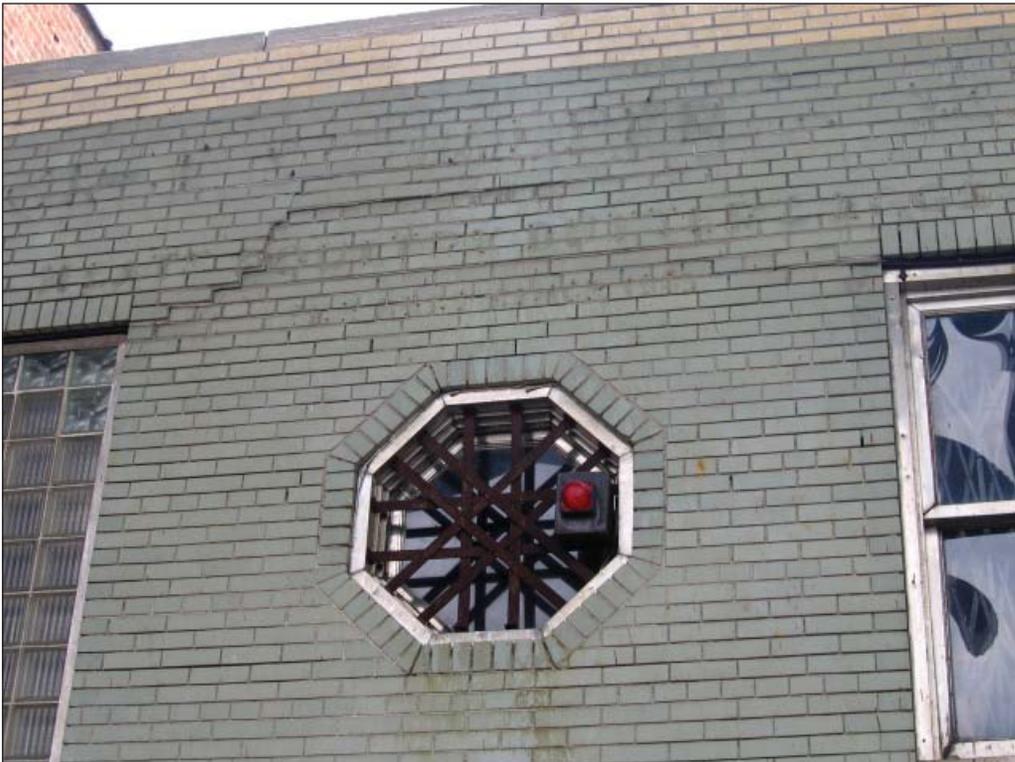
**Photograph 1998-3-L**

Damage on the exterior masonry walls includes: cracks and misaligned brickwork on the exterior façade (see Photograph L), and diminished mortar joints and potentially loose bricks on the façade and a portion of the south parapet (see Photographs M and N). There is also a significant stepped crack on a non-load-bearing interior wall (see Photograph O); however this is not indicative of major structural distress.

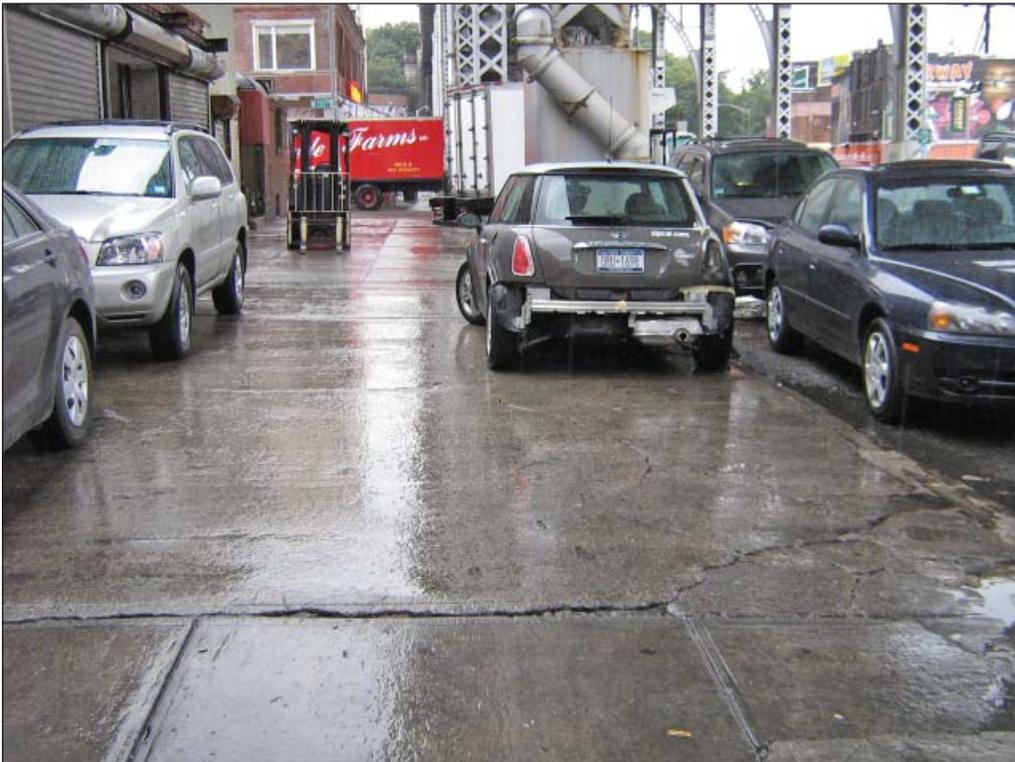
**Photograph 1998-3-P**

The sidewalk along Twelfth Avenue is in fair condition overall, with moderate cracking and spalling. However, there is an area in poor condition (see Photograph P). Also, puddles of brackish standing water were observed along the curb in front of the building on the day of a site visit. The day was dry, indicating that areas of the street or sidewalk are not properly drained by the storm sewer system (see Photograph Q).
