## Block 1998 Lot 10

SITE CONDITION: POOR

Manhattanville Neighborhood Conditions Study

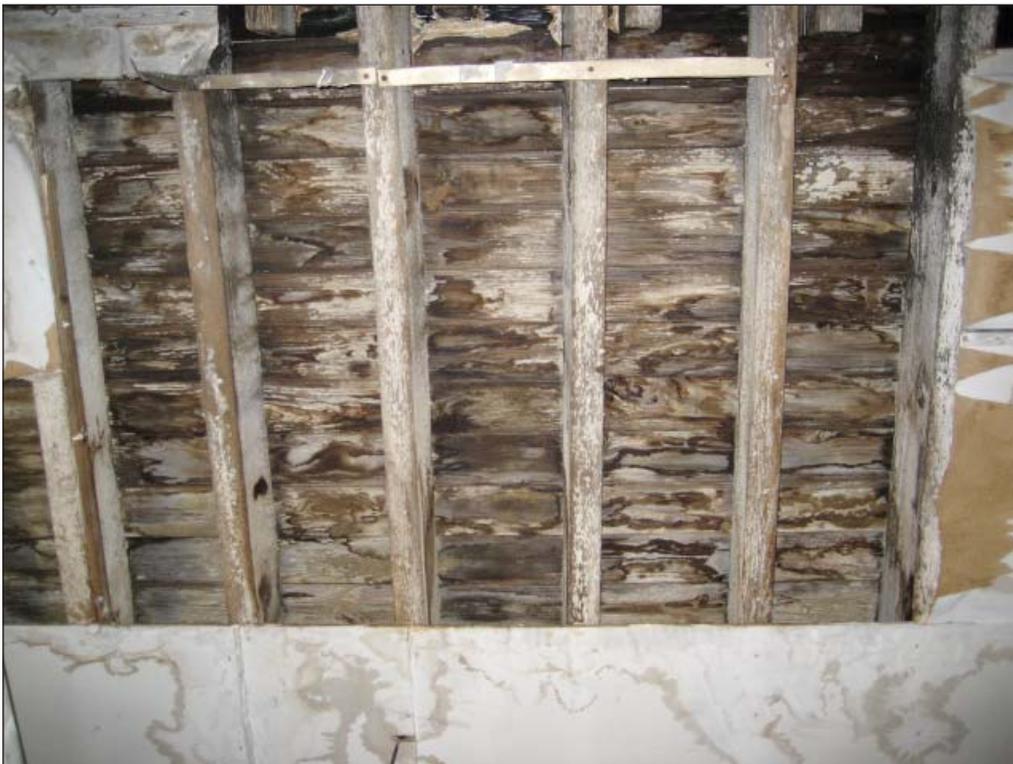
**Photograph 1998-10-B**

Damage caused by long-term water and/or moisture infiltration includes deterioration of the timber joists and roof framing (see Photograph B); and water stains and deteriorated portions of the ceiling (see Photograph C and D). The interior faces of the brick masonry walls have several cracks, and signs of efflorescence and mold (see Photographs C-G). Cracks were also observed on the south façade as shown in Photograph H. Water-related damage to the timber roof framing and brick masonry walls was likely caused by damage on the roof, including signs of deterioration on the roofing membrane (see Photograph I), damaged flashing (see Photograph J), and ponding (see Photograph K). Also, a few coping stones on the southern portion of the building have local damage.

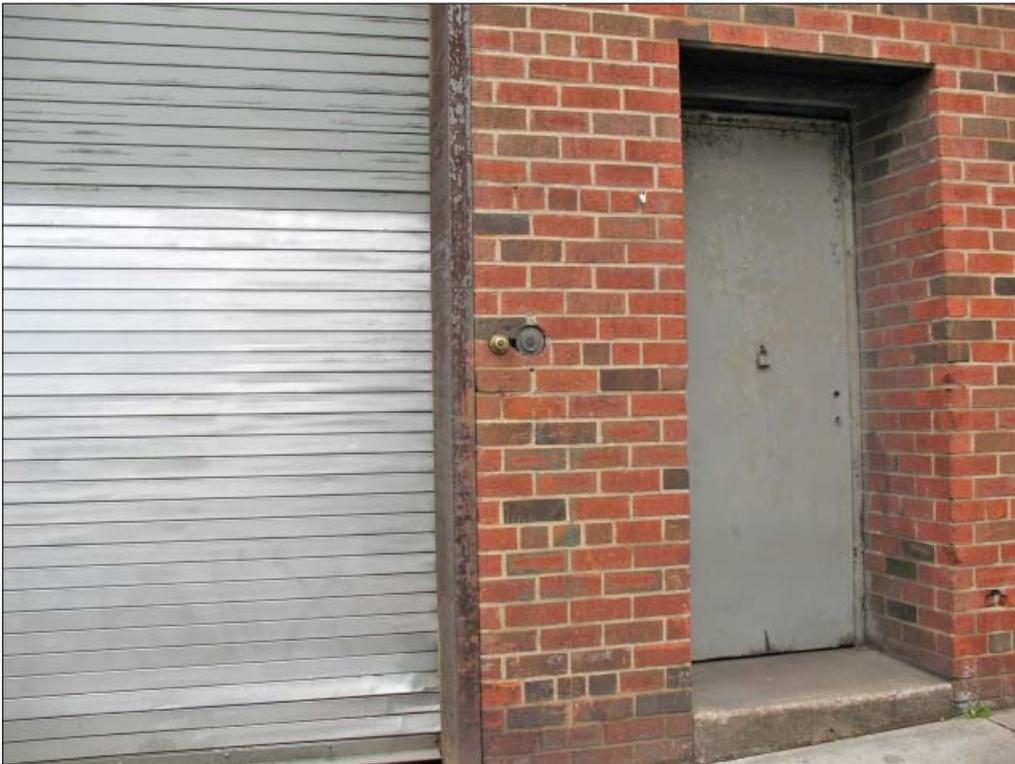
**Photograph 1998-10-L**

Other concerns in the building include: minor corrosion stains on the roll-up door's frame (see Photograph L), uneven metal stair treads to the mezzanine level (see Photograph M), smoke stains throughout the sidewalk vault (see Photograph N), and cracks in the concrete slab and in the rubble foundation wall (see Photograph O). Although the sidewalks and curb cuts are in fair condition, there are cracks and spalling concrete around the sidewalk vault (see Photograph P).

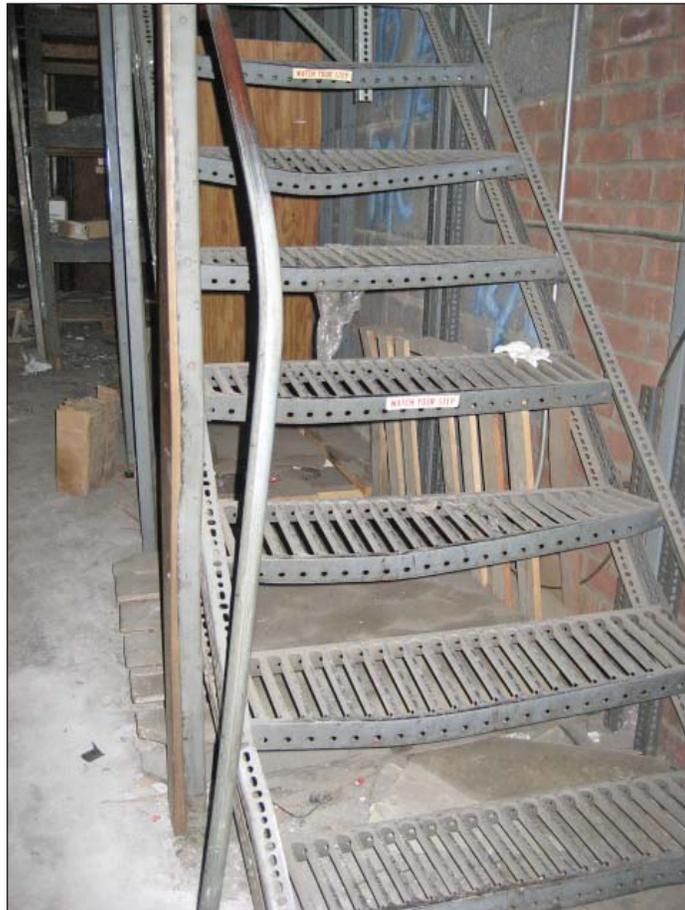
**Photograph 1998-10-M**

Mold was observed on the building's masonry walls, which is a health concern. Safety concerns include: uneven stair treads to the mezzanine level (see Photograph M) and a damaged railing on an internal stair (see Photograph Q). These health and safety concerns should be addressed prior to occupancy.

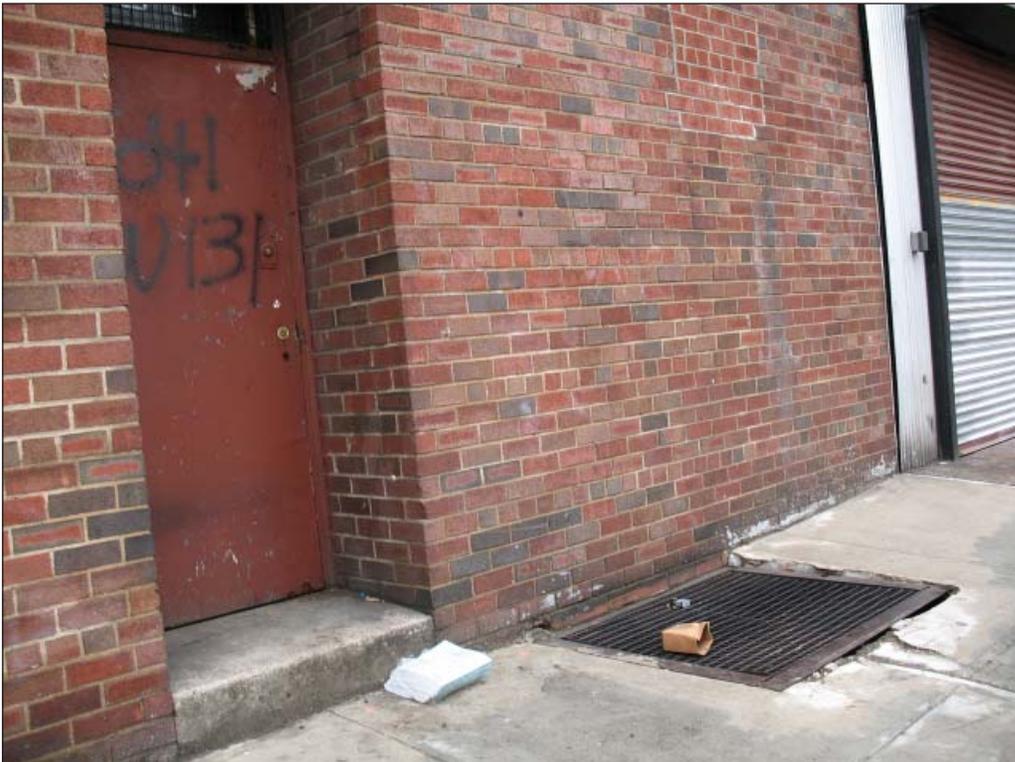
**Photograph 1998-10-P**

In addition, as shown in Photograph P, the concrete around the access hatch to the sidewalk vault is cracked and spalling, and is a potential unsafe condition for pedestrians.
