## Block 1998 Lot 13

SITE CONDITION: FAIR

Manhattanville Neighborhood Conditions Study

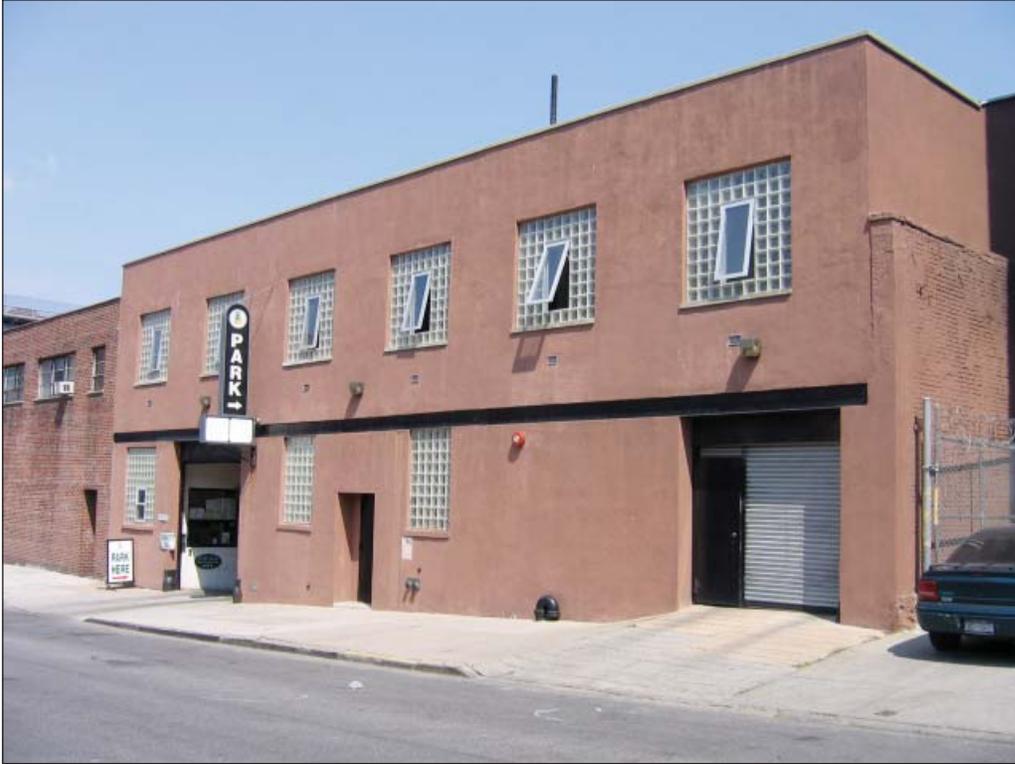
**Photograph 1998-13-A**

Lot 13 is located at 635 West 131st Street between Twelfth Avenue and Broadway in an M1-2 zoning district. The two-story, 16,000-gsf building is currently being used as a public parking garage (see Photograph A). The structure, which was built circa 1940 and renovated in 2002, was acquired by 635 West 131st Street LLC circa November 1999. Lot 13 is under contract by the Trustees of Columbia University.

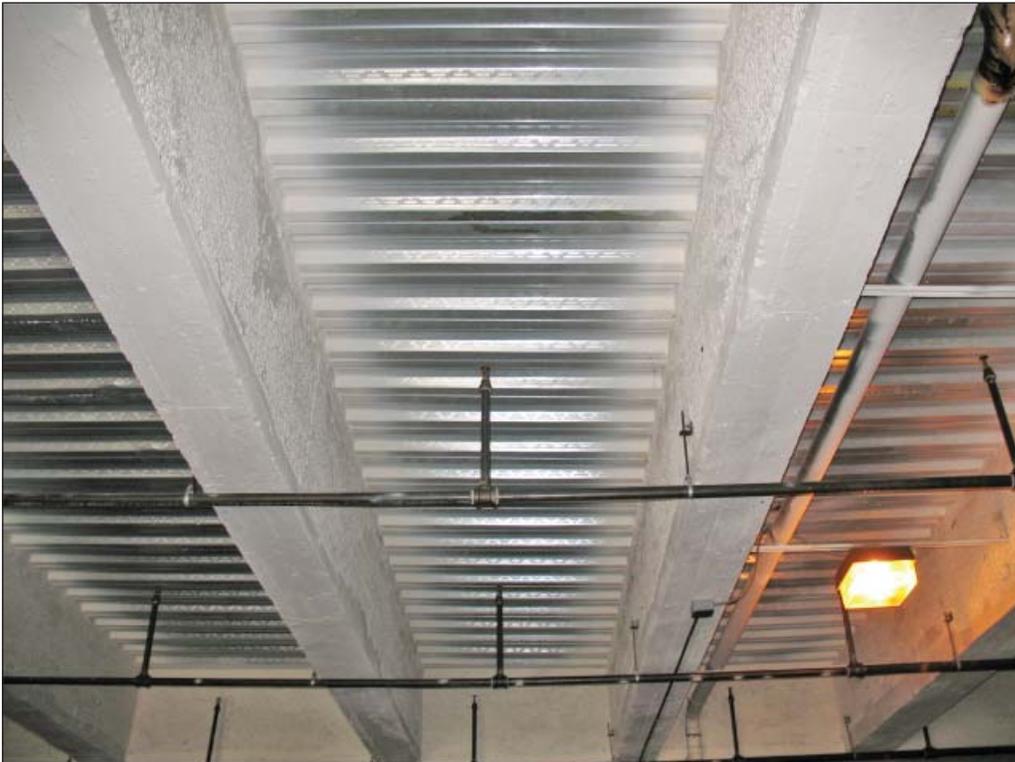
**Photograph 1998-13-B**

The second-floor concrete-encased steel framing is generally in fair condition, however there is honeycombing of the concrete encasement, minor cracking, and spalling in a few locations (see Photograph B). The first-floor concrete slab-on-grade is in fair condition, with some cracking and spalling (see Photograph C). There is also significant spalling in an area of the second-floor concrete slab where it meets the top surface of the vehicular ramp (see Photograph D). Fluid from the second-floor hydraulic vehicle lifts is leaking through to the underside of the second-floor slab in two locations, which has the potential to deteriorate the local structural framing (see Photograph E). There are also signs of water intrusion and efflorescence at the east and west interior masonry walls, as shown in Photograph F.

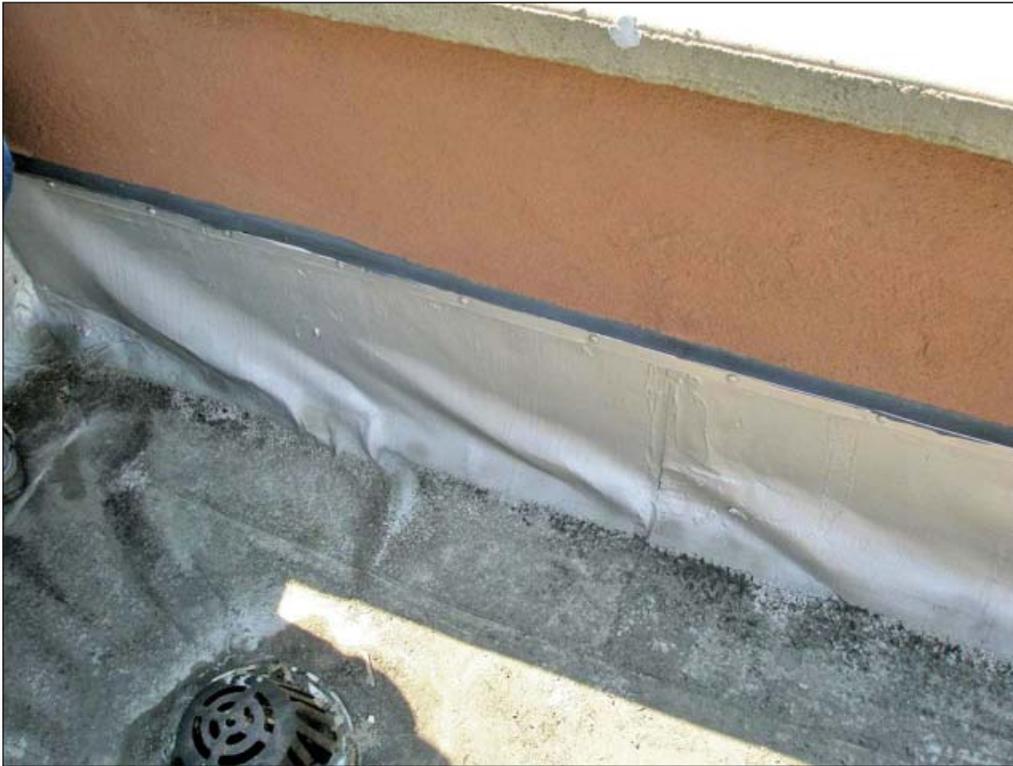
**Photograph 1998-13-G**

The roof membrane is in good condition, except for an area at the southeast corner where portions of the membrane inside the parapet are billowing (see Photograph G). There is also residue on the roof, indicating past episodes of standing water (see Photograph H), which may have been caused by a clogged roof drain in the southeast corner of the roof. Further, the roof slope is likely not in accordance with recognized good design practices since the roof does not slope toward the roof drains.

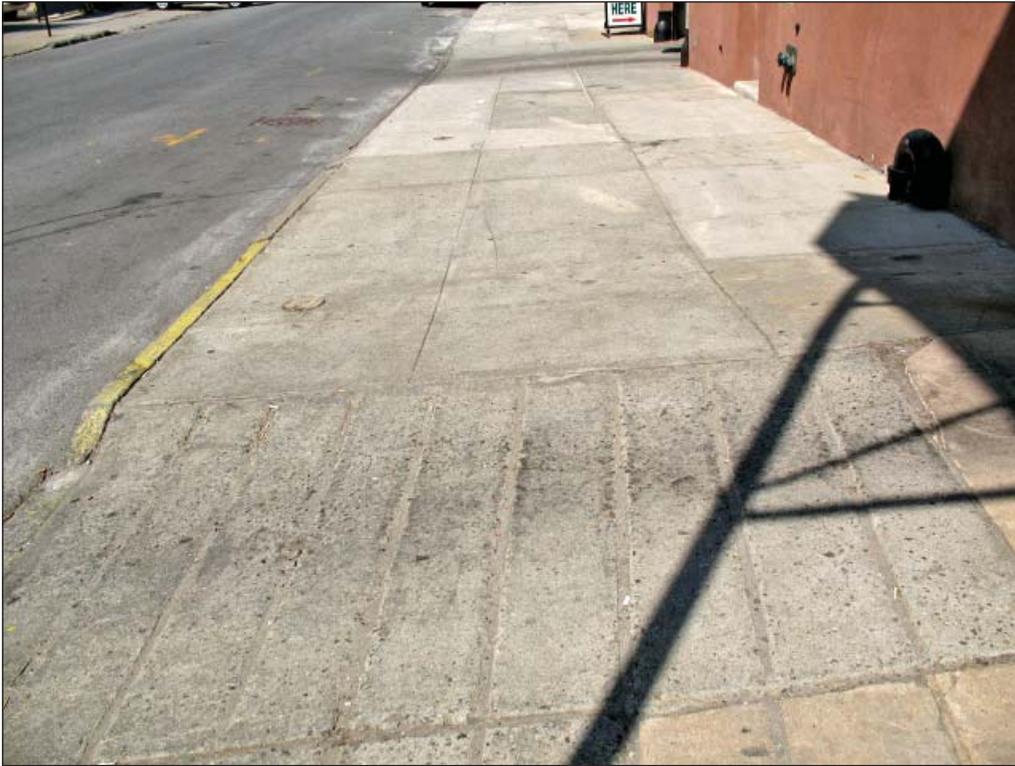
Photograph 1998-13-I

The sidewalk and curb cuts along West 131st Street are in fair condition with minor cracking and spalling (see Photograph I). However, there is more significant spalling in the area adjacent to the ramp.

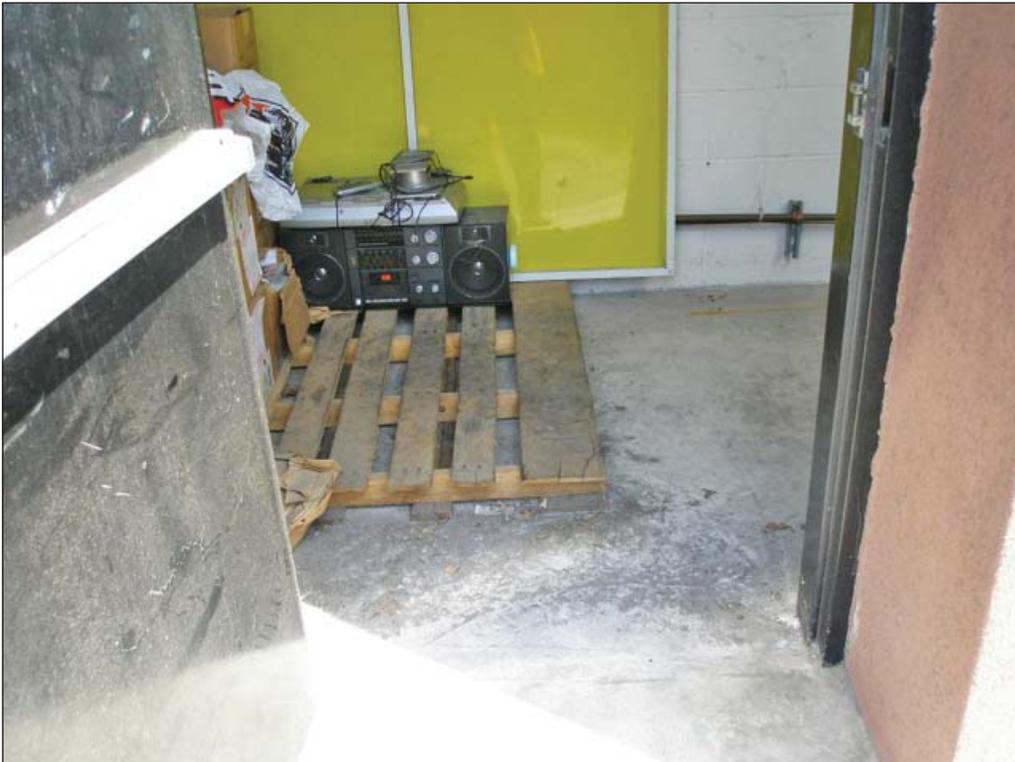
Photograph 1998-13-J

Items stored between a flight of stairs and the door to West 131st Street are obstructing a means of egress, and pose a tripping hazard (see Photograph J). On the second floor, tightly-parked vehicles directly adjacent to the fire exit door would interfere with proper egress from the building (see Photograph K). In addition, as stated below, the occupancy of the building is contrary to that allowed by the Certificate of Occupancy, which is a safety concern.
