Block 1998 Lot 24

SITE CONDITION: POOR

Manhattanville Neighborhood Conditions Study

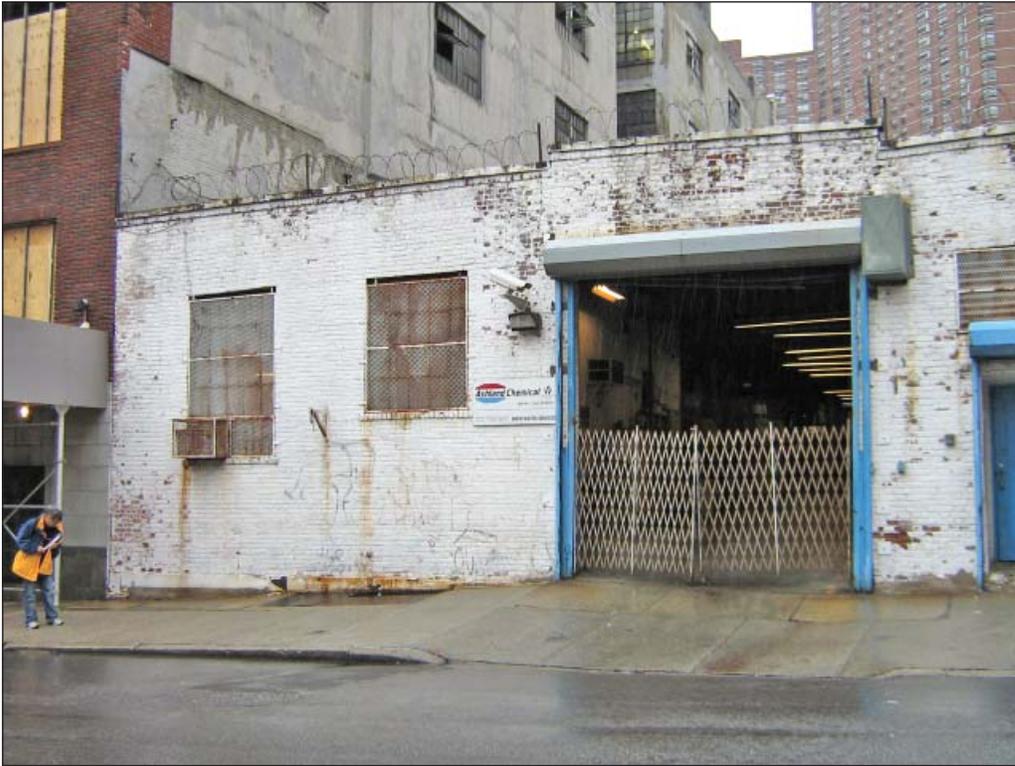
Photograph 1998-24-A

Lot 24 is located at 609 West 131st Street in an M1-2 zoning district, with lot area fronting West 131st and West 132nd Streets (see Photographs A and B, respectively). The one-story 9,992-gsf building was acquired by Ashland Chemical, Inc. circa September 1990, which currently occupies the property as well. The property is currently under contract by the Trustees of Columbia University. DOB records list the build year as 1910; however, the building's presence on a historic Sanborn map from 1909 indicates that it was likely constructed prior to 1909. No renovations have been recorded.

The building's exterior walls along both West 131st and West 132nd Streets are in poor condition, with chipping paint, numerous cracks, and graffiti (see Photographs A, B, and C). There are two large cracks in the stucco adjacent to the personnel door on the south façade—a wide, horizontal crack above the entrance and a wide, vertical crack on the left side of the entrance (see Photograph D)—as well as cracks and spalling above the exterior step (see Photograph E). Further, the south façade wall appears to have settled on both the east and west sides of the roll-up door (see Photograph A), although the cause of the settlement could not be determined. There are corrosion stains on the windows and metal grates on the south façade (see Photograph F), and there is ponding water and debris on the roof (see Photograph G).

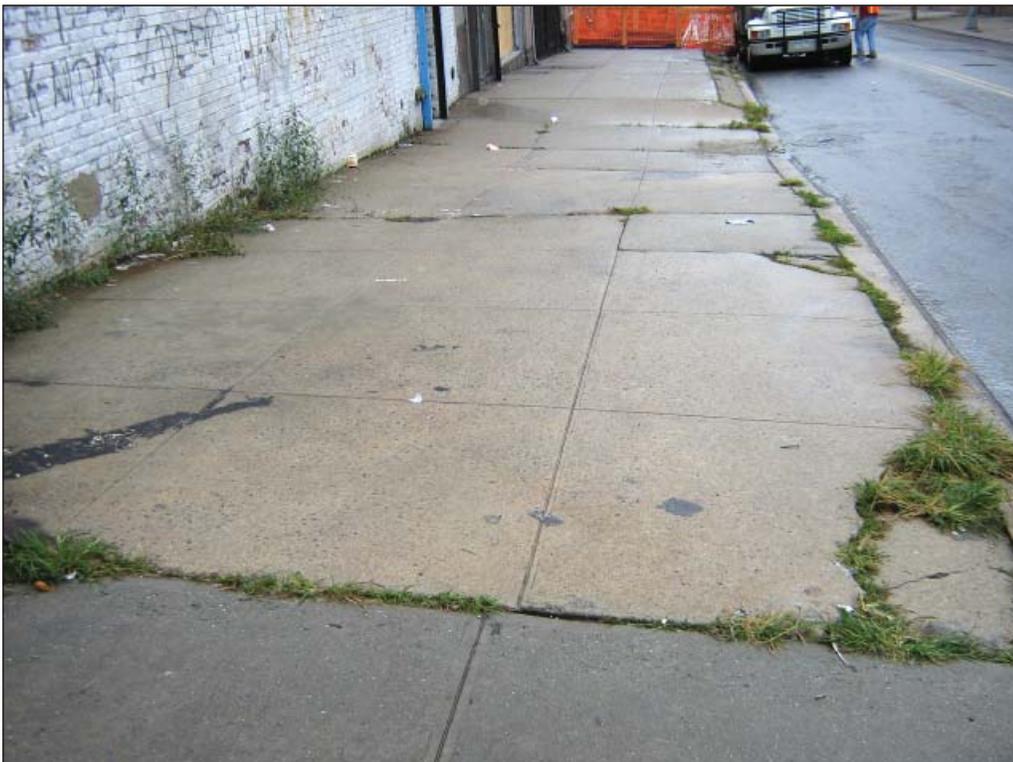
Photograph 1998-24-H

The sidewalks along both West 131st and West 132nd Streets are in poor condition, with several wide cracks, spalling, and weeds observed (see Photograph H). The curbs cuts are in fair condition, with minor damage.
