## Block 1998 Lot 61

SITE CONDITION: POOR

Manhattanville Neighborhood Conditions Study

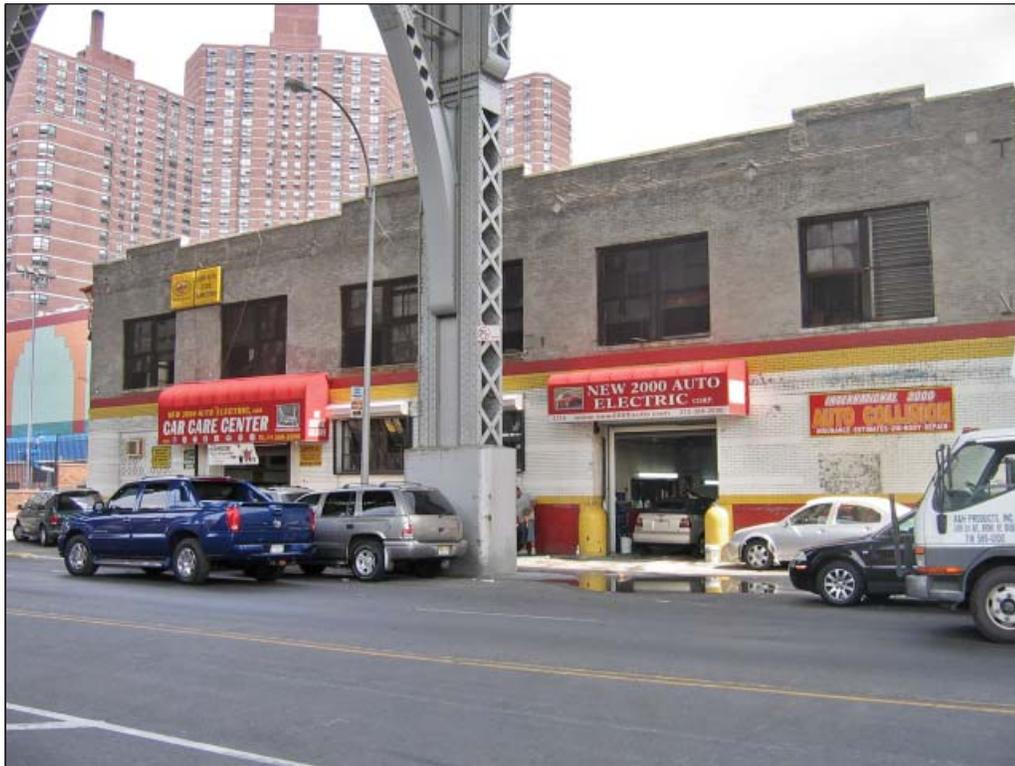
Photograph 1998-61-A

Lot 61 is located at 2311 Twelfth Avenue at the southeast corner of West 132nd Street and Twelfth Avenue in an M2-3 zoning district (see Photographs A and B). The two-story, 19,984-gsf building is used as an auto-repair and auto body shop on the first floor and as a parking garage for a utility company's service vehicles on the second floor, which is internally connected to the building on Block 1998 Lot 57. It was built in 1912; no renovations have been recorded. Lot 61 was acquired by Tikva Ofek circa June 1982 and is under contract by the Trustees of Columbia University.

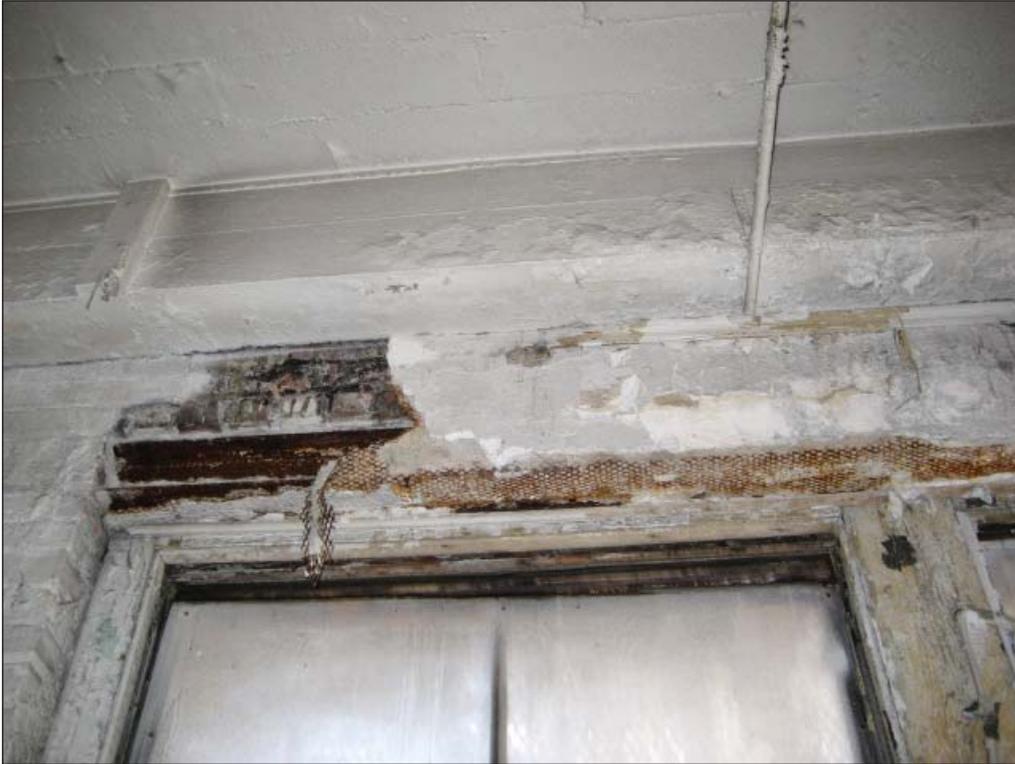
**Photograph 1998-61-C**

Long-term water infiltration has caused deterioration to several of the building's structural and non-structural components and finishes, such as efflorescence and cracks on the roof beams on the second floor (see Photograph C), cracks in the second-floor slab (see Photograph D), peeling paint on the ceiling above the interior ramp (see Photograph E), and corrosion stains on the lintel beams (see Photograph F). Further water damage to the building could have been caused by infiltration from the second-floor windows, which are in poor condition, with deteriorated window frames and sills (see Photographs C and G), and by damaged waterproofing and tears on the membrane lining the parapets (see Photograph H).

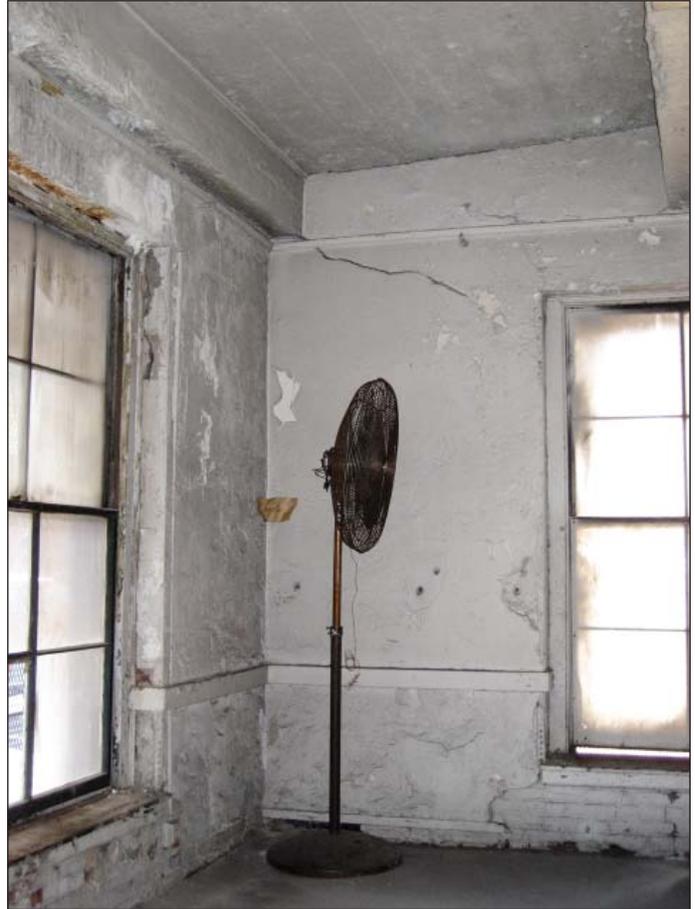
**Photograph 1998-61-G**

Other site concerns include wide cracks in the brick masonry walls (see Photographs G, I, and J), wide cracks and spalling in the concrete encasement of the steel beams (see Photograph K), and the washing of cars inside the building without a proper drainage system. Although the sidewalks and curb cuts along Twelfth Avenue and West 132nd Street are in fair condition, there are minor cracks likely due to cars driving and parking on the sidewalks (see Photograph L).

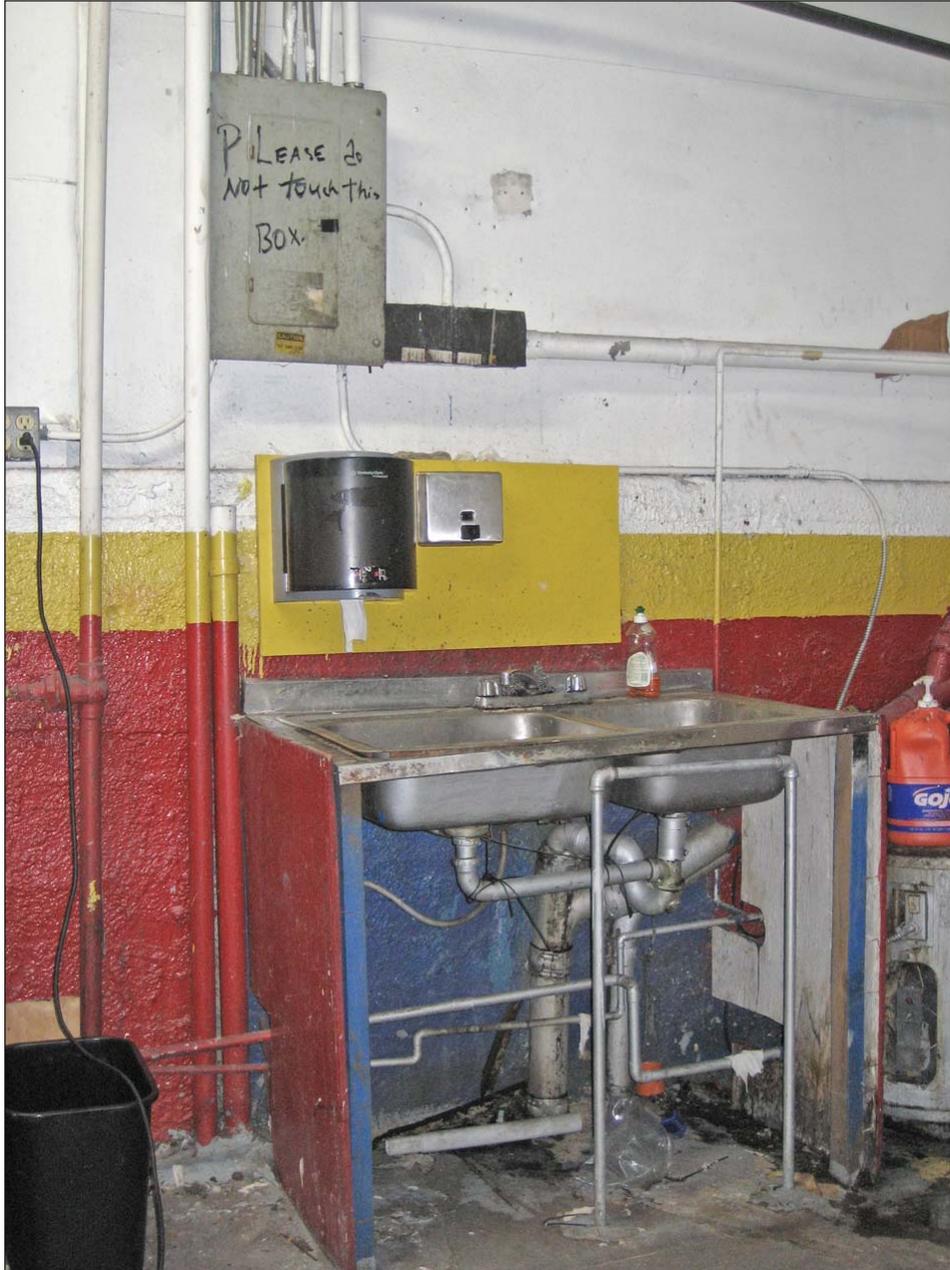
**Photograph 1998-61-M**

Unsafe conditions noted on the site include: a fuse box located directly above a sink (see Photograph M), auto-painting that appears to be performed without proper ventilation systems, and the parking of cars on the sidewalk, which is a hazard to pedestrians. Also, roof access is obstructed as the stair to the roof from the second-floor is boarded up with plywood.
