MANHATTANVILLE NEIGHBORHOOD CONDITIONS STUDY

May 2, 2008

Review of Manhattanville Neighborhood Conditions Study

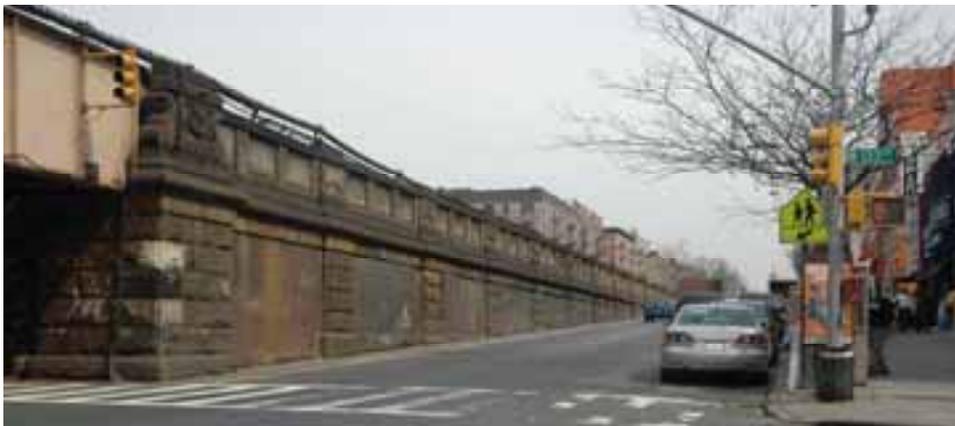
Photo 6: Abutment of IRT viaduct on Broadway between W. 133rd and W. 135th Sts.

The viaduct and abutment are in poor physical condition, with damaged stone and brick on the abutment and peeling paint and rust on the trussed steel arches, girders and columns, frequently accompanied by a surfeit of graffiti (photos 7-9).

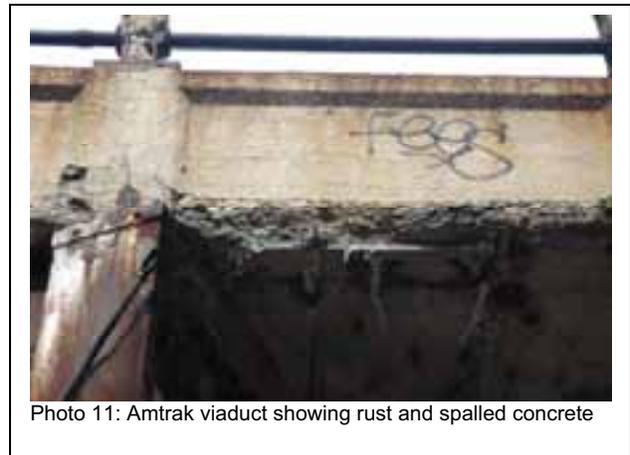
Farther west, the Amtrak Empire Corridor rail line runs on a plain girder and column viaduct only about 25 ft. above grade; this viaduct is in relatively poor condition with spalling concrete, rusting steel and graffiti (Photo 11).

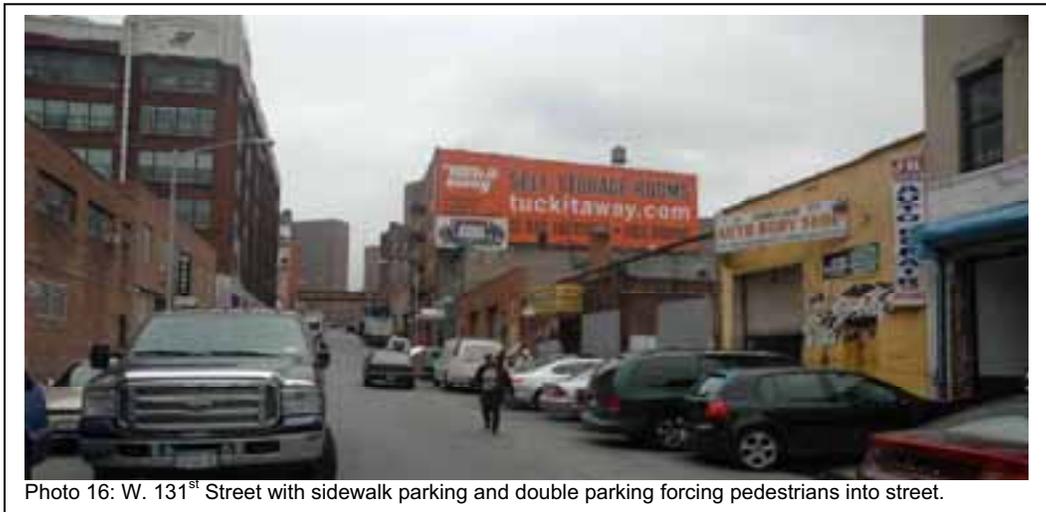
Photo 16: W. 131st Street with sidewalk parking and double parking forcing pedestrians into street.

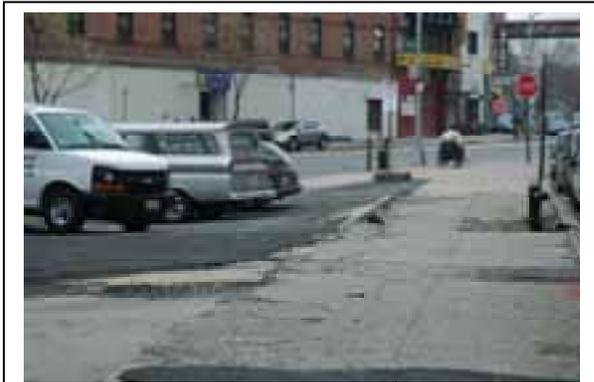
Particularly as a result of this practice of sidewalk parking, many sidewalks in the study area have suffered substantial deterioration, with extensive cracks and spalling of the concrete, and broken or absent curbs (Photos 23 & 24). In several cases, sidewalk vault covers have been damaged by vehicles. Not only are these sidewalk conditions safety hazards for pedestrians, they also create a visual impression of neighborhood neglect and unsightliness.

Photo 23: Damaged sidewalk at W.125th Street

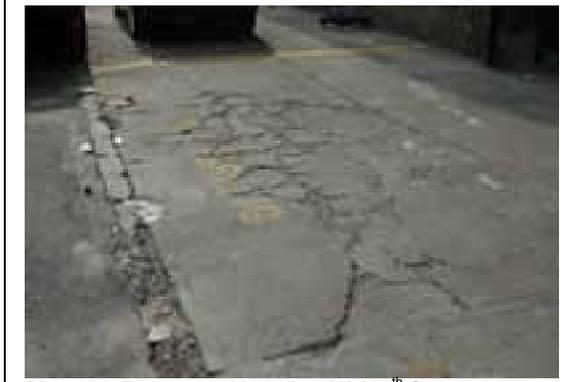
Photo 24: Damaged sidewalk at W.130th Street

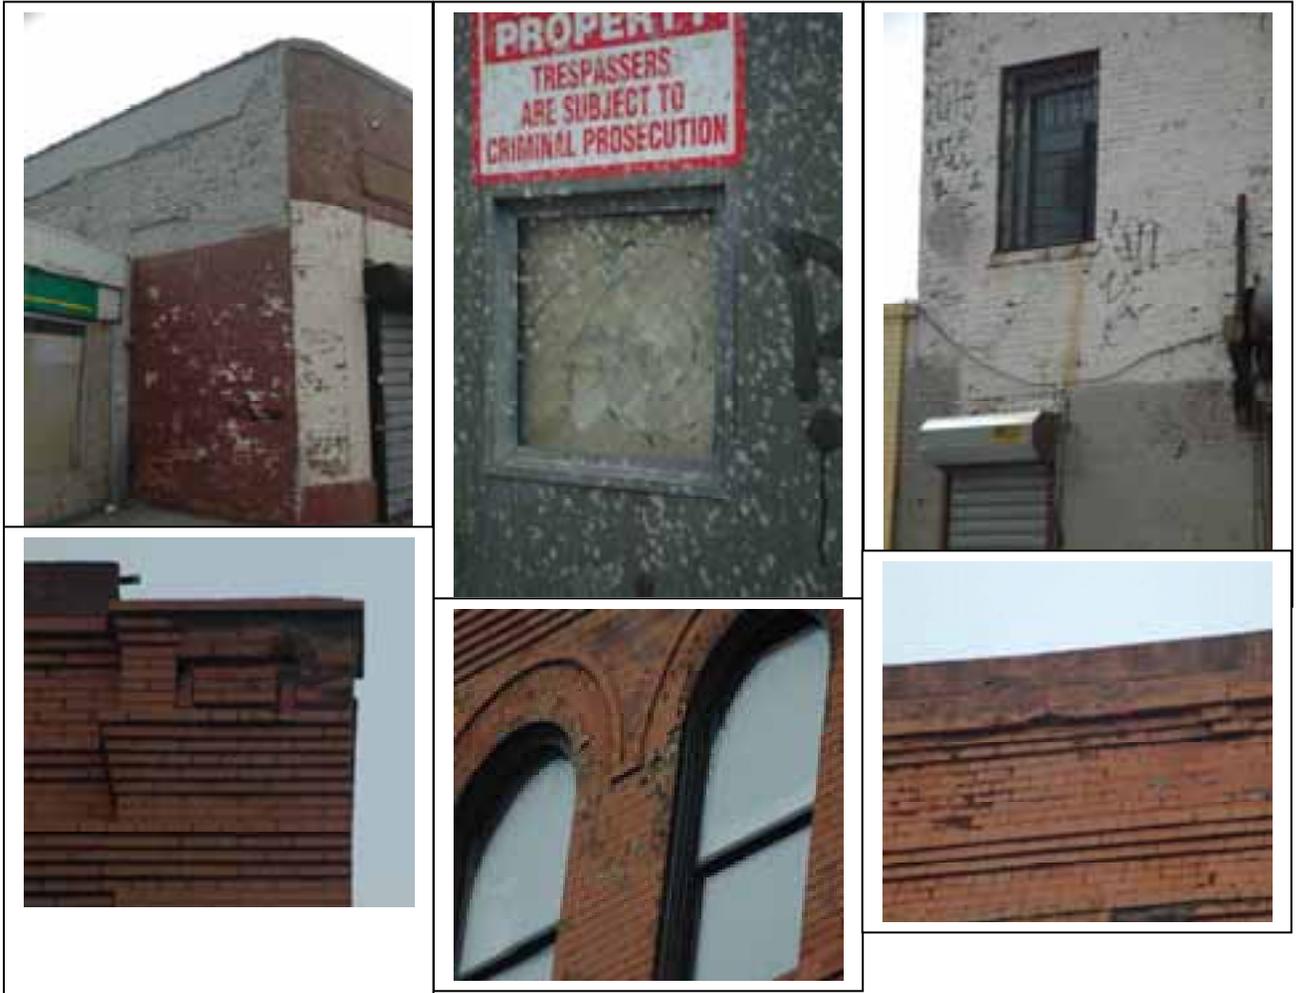
Building walls often display structural deterioration, with cracks in masonry and other deteriorated features, reflecting years of neglect. Several buildings have been “sealed” by the Fire Department because of their unsafe condition and numerous properties now have sidewalk sheds to protect pedestrians from falling masonry (Photos 28-37). These sheds inevitably add to the gloom and clutter along several streets.

Photos 31-37: Examples of deteriorated facades in the study area

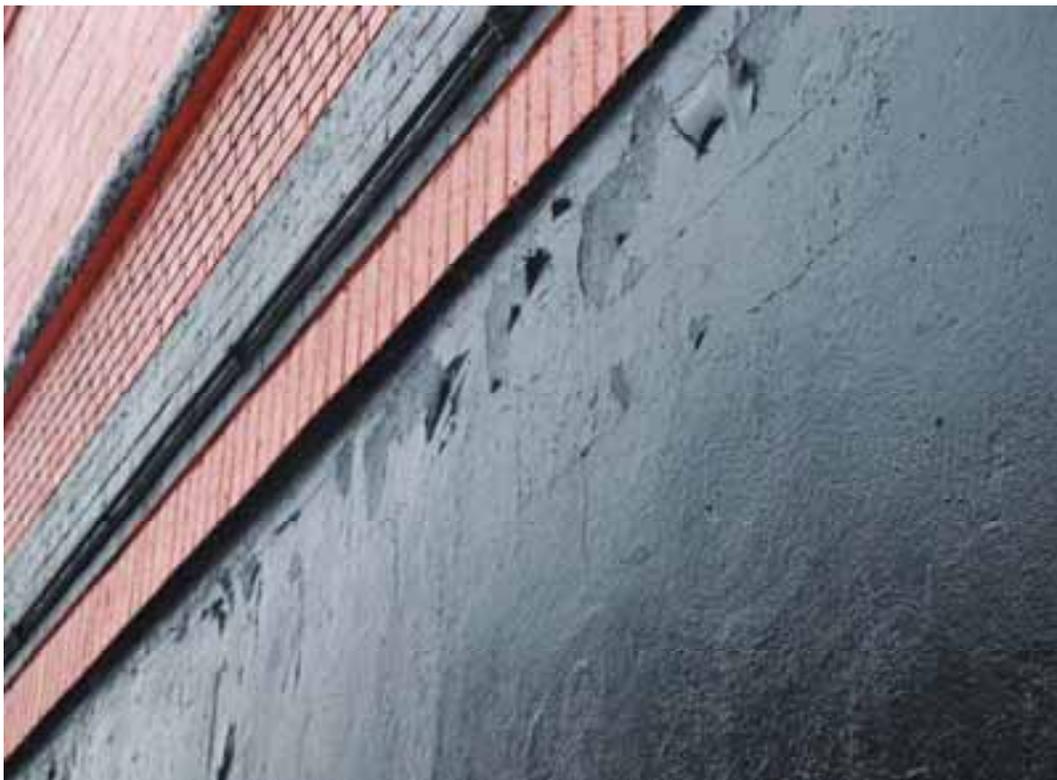
Painted walls are often chipped and peeling, presenting a careless and unsightly element to viewers. (Photos 38 & 39).

Photo 38: Recently painted masonry already peeling off at a self-storage warehouse

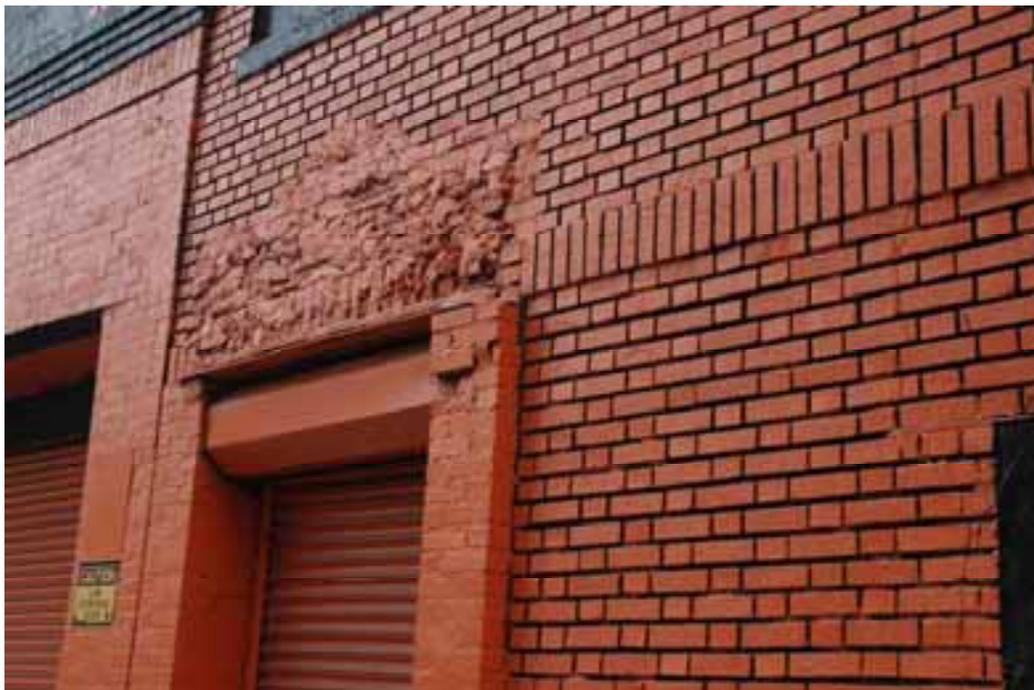
Photo 39: Paint covered deficiencies at a self-storage warehouse

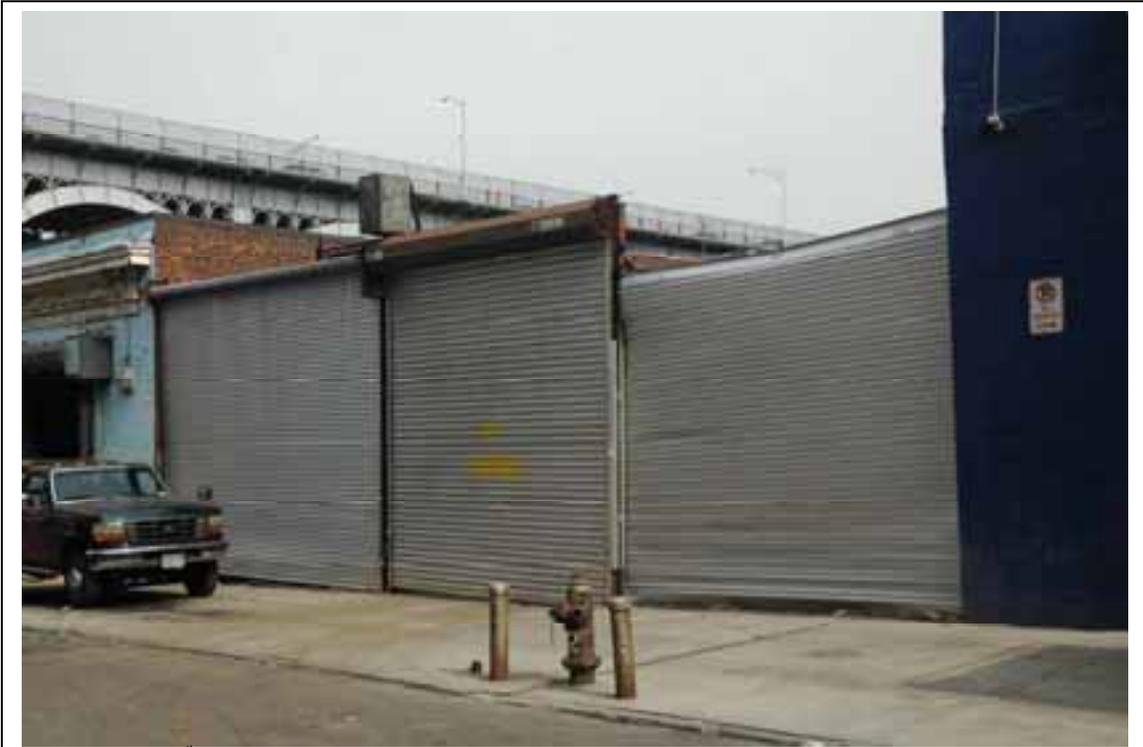
Photo 40: W. 130th Street

Roll up metal doors, common throughout the study area, are often in damaged and poor condition; again limiting transparency and contributing to the uninviting and unsafe perception of the area (Photos 40-42).

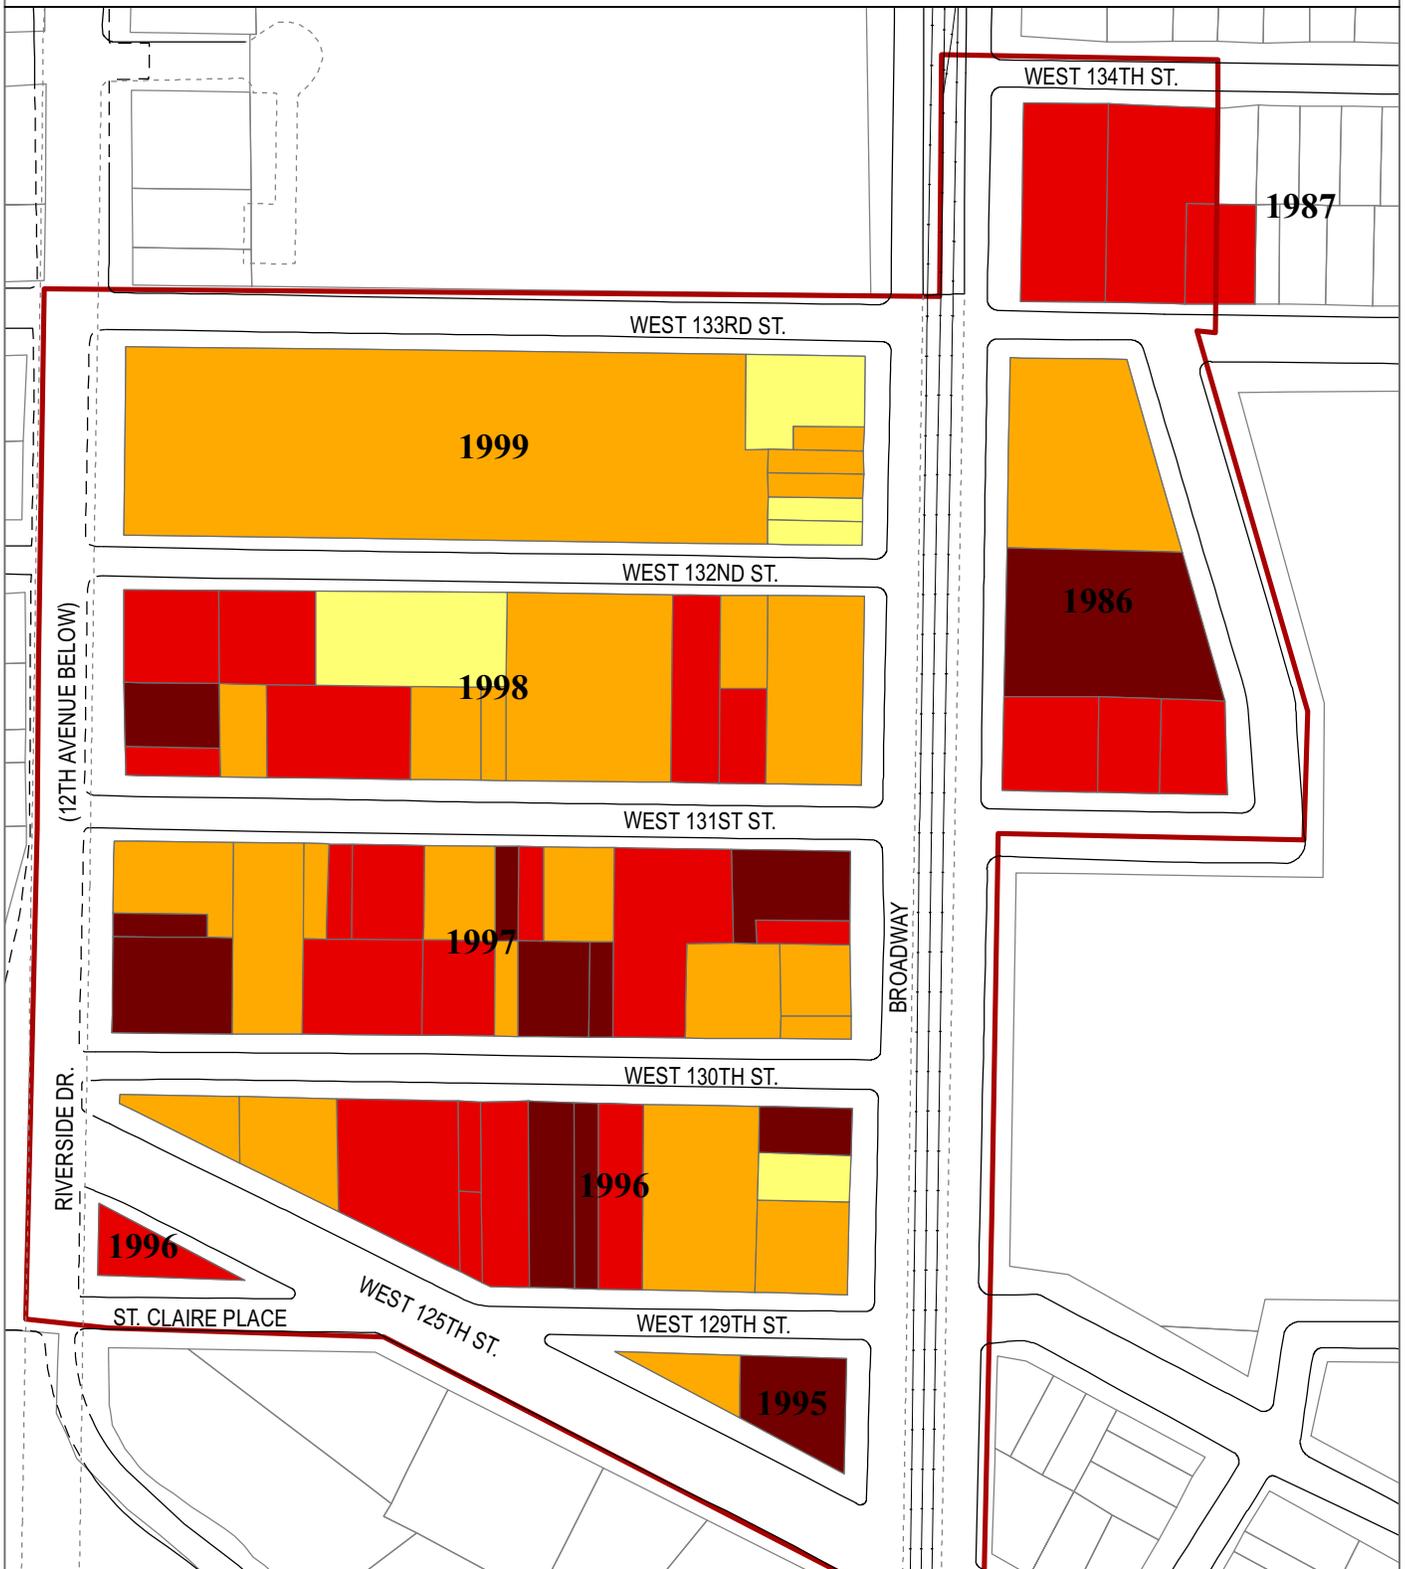
Lot Conditions

The consequence of these converging problems has been a significant deterioration in the conditions of buildings and their lots. The earlier inspections by Thornton Tomasetti and AKRF had rated 12 sites (18 percent) in critical condition, and a further 22 sites (33 percent) in poor condition. They rated only six sites (9 percent) as good; and the remaining 27 sites (40 percent) as fair. Earth Tech generally found the same conditions and rated them similarly to the AKRF report in the great majority of cases. However, Earth Tech downgraded four of the lots: one from good to fair, and three from fair to poor, reflecting deteriorating conditions since the prior inspections. Earth Tech rates 12 sites (18 percent) in critical condition, 25 (37 percent) in poor condition, 25 (37 percent) in fair condition, and 5 (7 percent) in good condition. Thus, Earth Tech rates 37 sites (55 percent) in critical or poor condition.

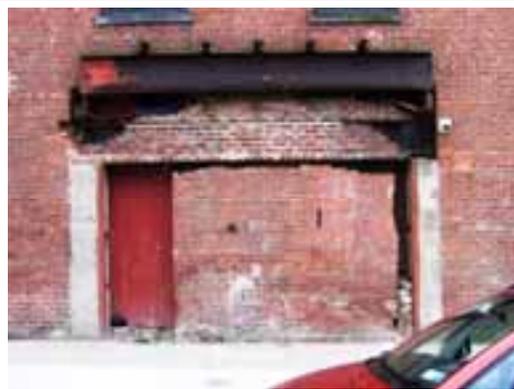
Photo 47: Block 1996 Lot 14

Damage to Building Exteriors – structural deficiencies were noted on buildings in many parts of the study area, including large cracks, missing or loose bricks, deteriorated lintels and window sills. Photos 47-50 show examples of these conditions.

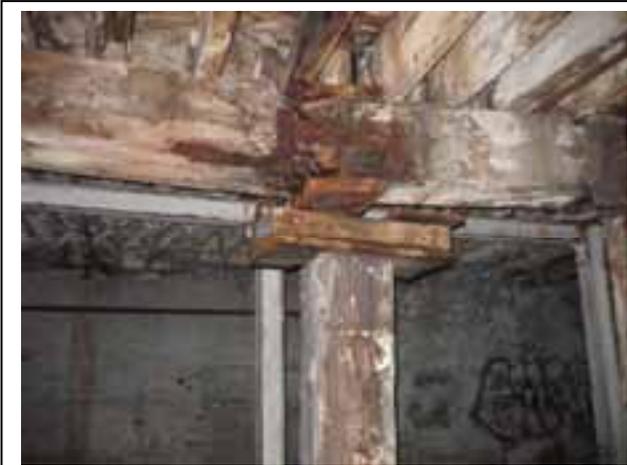
Photo 51: Block 1996 Lot 36

Deteriorated columns and beams – chronic water intrusion, ad hoc repairs and damage to encasements have affected beams and columns, leading to severe rusting, spalling and other structural problems (see photos 51-54).

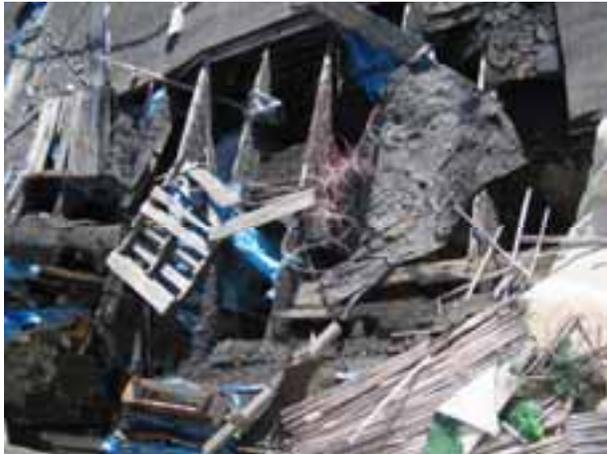
Photo 55: Block 1997 Lot 64

Chronic neglect of roof maintenance – Deteriorated roof membranes; damaged parapets, coping, flashing or waterproofing; blocked drains, and debris; and poorly sloped roofs, are typical causes of water infiltration to the interior of buildings and the source of much structural damage (see photos 55-58).

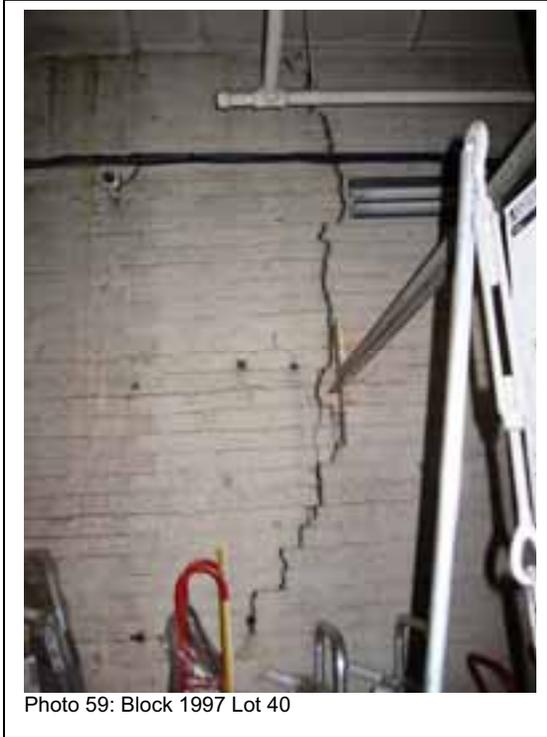
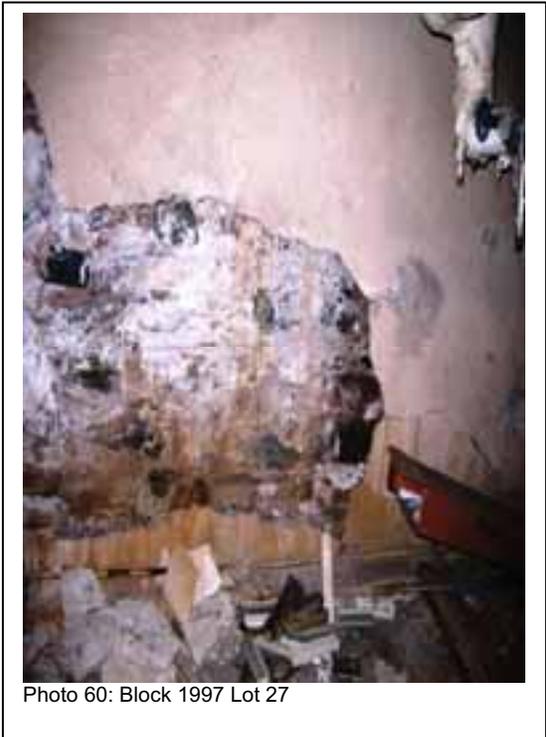
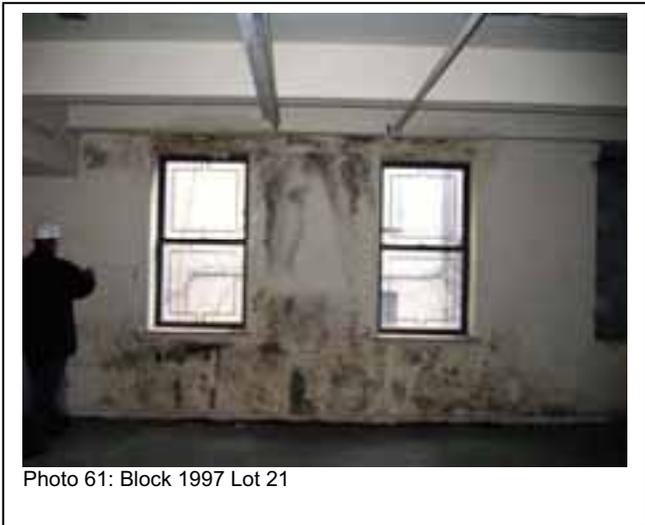
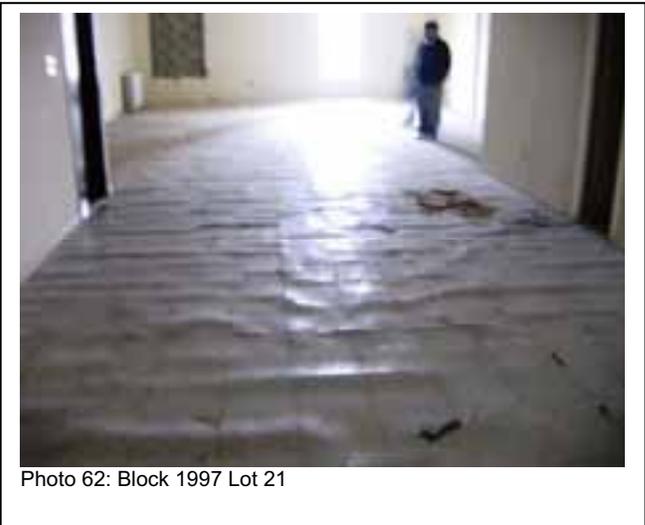
Deterioration of interior walls and floor slabs - Cracks, spalling, efflorescence and mold on interior walls and floor slabs are examples of deficiencies caused by chronic water infiltration, as well as wear and tear associated with the nature of occupants (e.g., auto parking) (see photos 59-62).

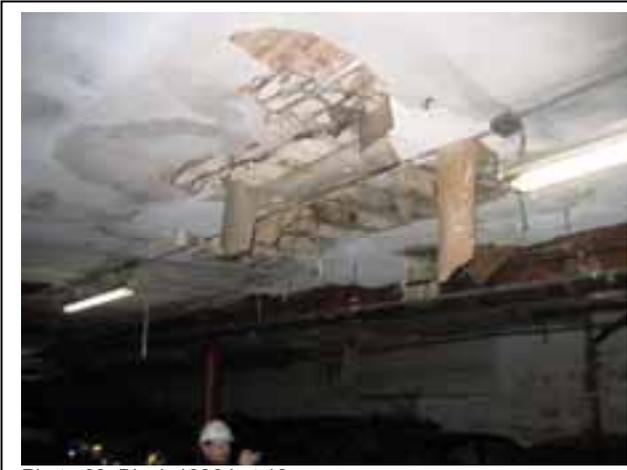
Photo 63: Block 1996 Lot 18

Large holes or missing ceiling - Numerous properties have problems of broken, damaged and deteriorated ceilings, mostly caused by chronic water infiltration (see photos 63-66).

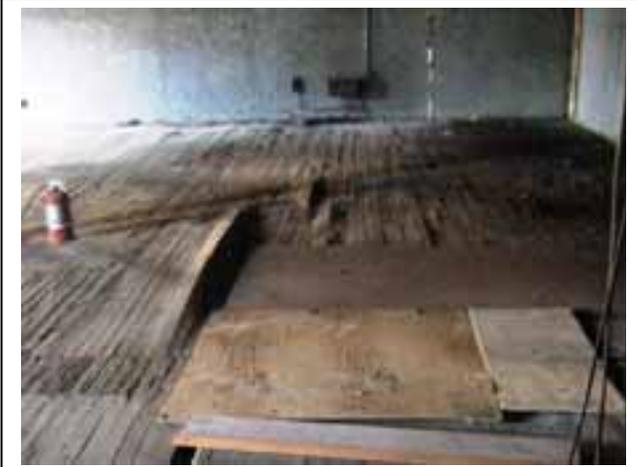
Photo 67: Block 1997 Lot 18

Damaged or cracked interior flooring – interior finishes are often damaged from water infiltration, causing buckling, delamination, other dangerous conditions for building occupants (see photos 67-69).

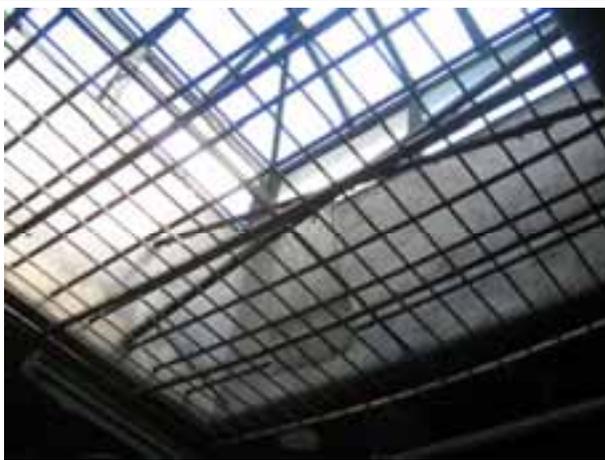
Photo 70: Block 1996 Lot 16

Broken or missing windows and skylights - Improperly sealed windows, broken or missing window panes or window frames are another common source of water infiltration that causes further structural damage (see photos 70 and 71).

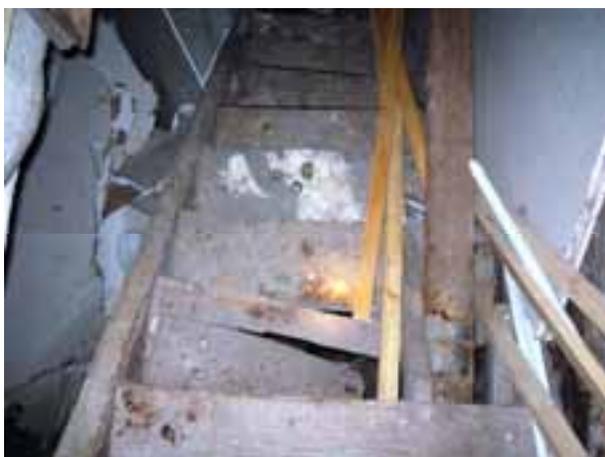
Photo 72: Block 1997 Lot 48

Structurally unsound stairs – Corrosion, spalling, of supports, landings, and stair treads, missing hand railings are examples of safety issues for building occupants (see photos 72 and 73).

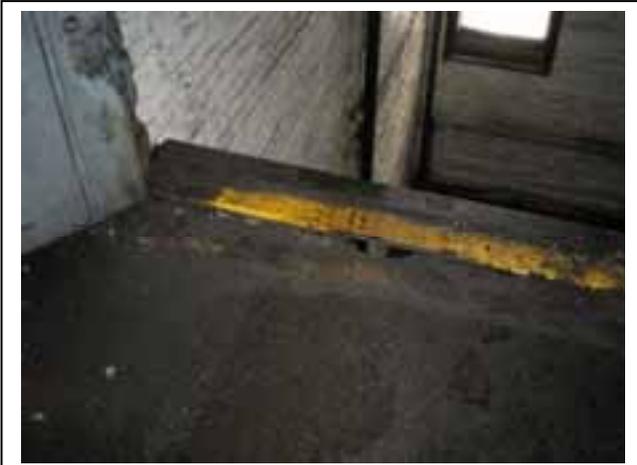
Photo 74: Block 1996 Lot 18

Elevators that are inoperable or with hazardous building code violations – Elevator shafts with damaged walls, floor plates, and other inadequate safety features present dangers to employees and others in the building (see photos 74 and 75).

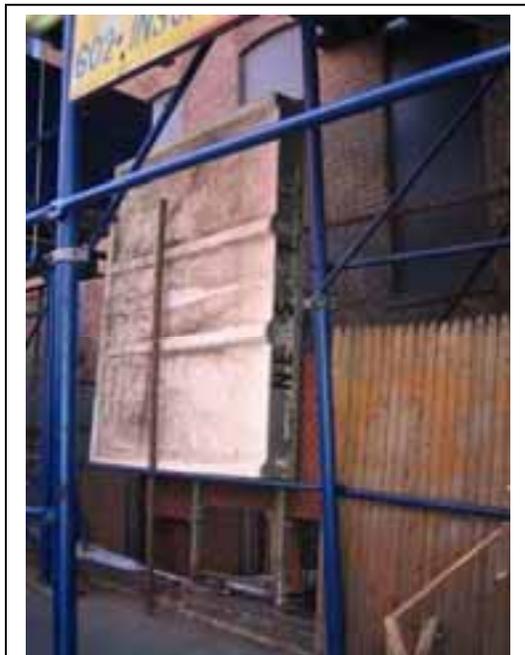
Photo 76: Block 1997 Lot 34

Inadequate or blocked emergency exits - Emergency exits with blocked or inoperable doors, or corroded metal or damaged wooden stairs, missing handrails or other deficient features are found in several buildings, posing safety hazards to building occupants (see photos 76 and 77)

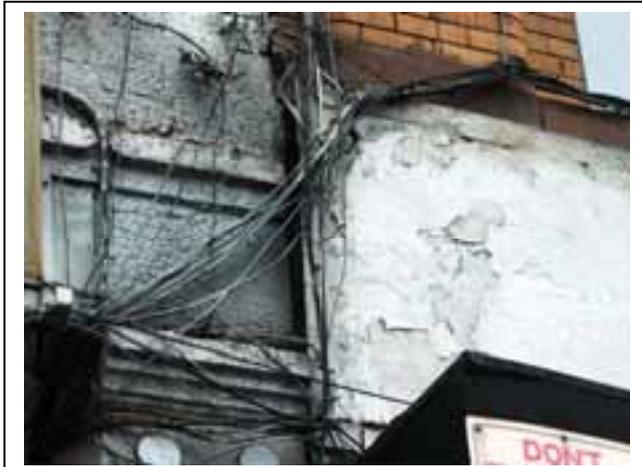
Photo 78: Block 1996 Lot 18

Exposed and haphazardly installed electrical wiring – Poorly installed and/or maintained wiring was identified in several buildings, sometimes near water leaks or areas prone to flooding, creating safety concerns (see photos 78 and 79)

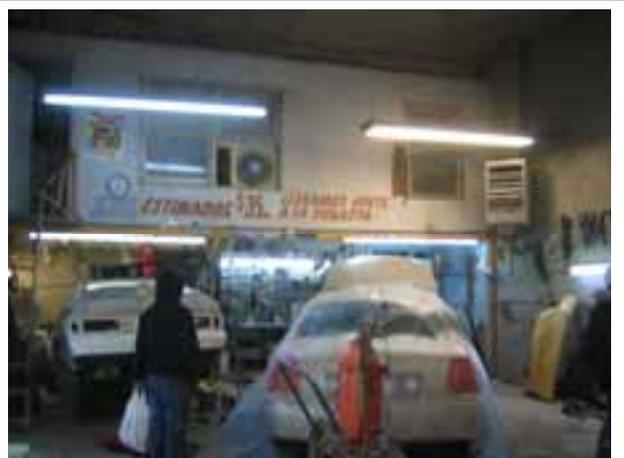
Photo 80: Block 1997 Lot 34

Open spray painting of automobiles – Several properties used for auto repairs operate paint spraying within their interior spaces without adequate ventilation systems, which is hazardous to employees and other building occupants. Auto repair shops also are noted with car washing activity without adequate drainage, thereby aggravating water infiltration problems (see photos 80 and 81).

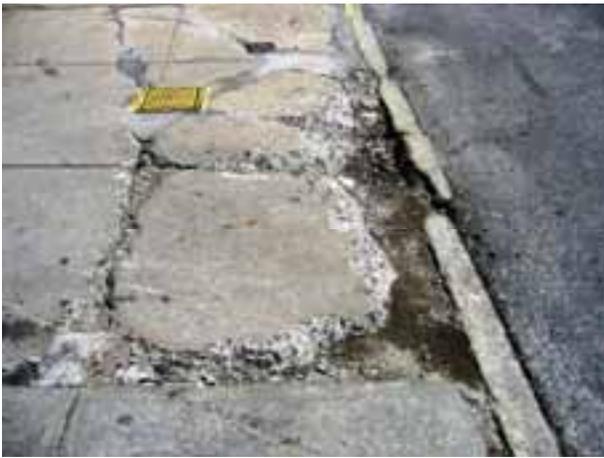
Photo 82: Block 1998 Lot 16

Broken and deteriorated sidewalks and curbs – Sidewalks with cracks, broken and spalled concrete slabs, and broken curbs are common in the study area and pose tripping hazards to pedestrians. Sidewalk parking and unloading by many businesses in the area contribute to these problems and create addition hazards to pedestrians (see photos 82 and 83).

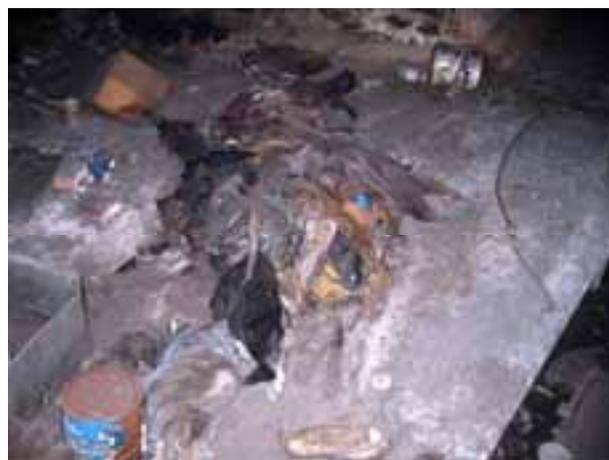
Photo 84: Block 1996 Lot 20

Unsanitary conditions – Conditions in several buildings present health hazards to occupants from severe mold, standing water, leaking chemicals, excessive garbage and debris and poor pest control (birds, rats, roaches, etc.) (see photos 84-87).

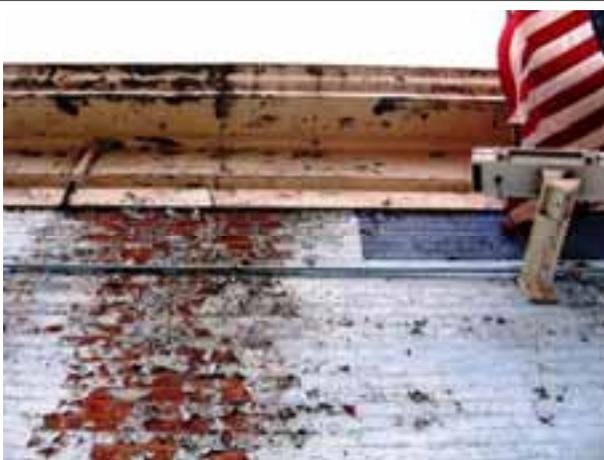
Photo 88: Block 1997 Lot 6

Other poor exterior conditions – Many buildings suffer from deficient finishes, peeling paint, rusted fences, gates and equipment. Graffiti and litter is also a common eyesore in the study area (see photos 88 and 89).
