SITE CONDITION: POOR

Block 1987 Lot 1

LOCATION, USE, ZONING, AND OWNERSHIP

PHYSICAL AND STRUCTURAL CONCERNS

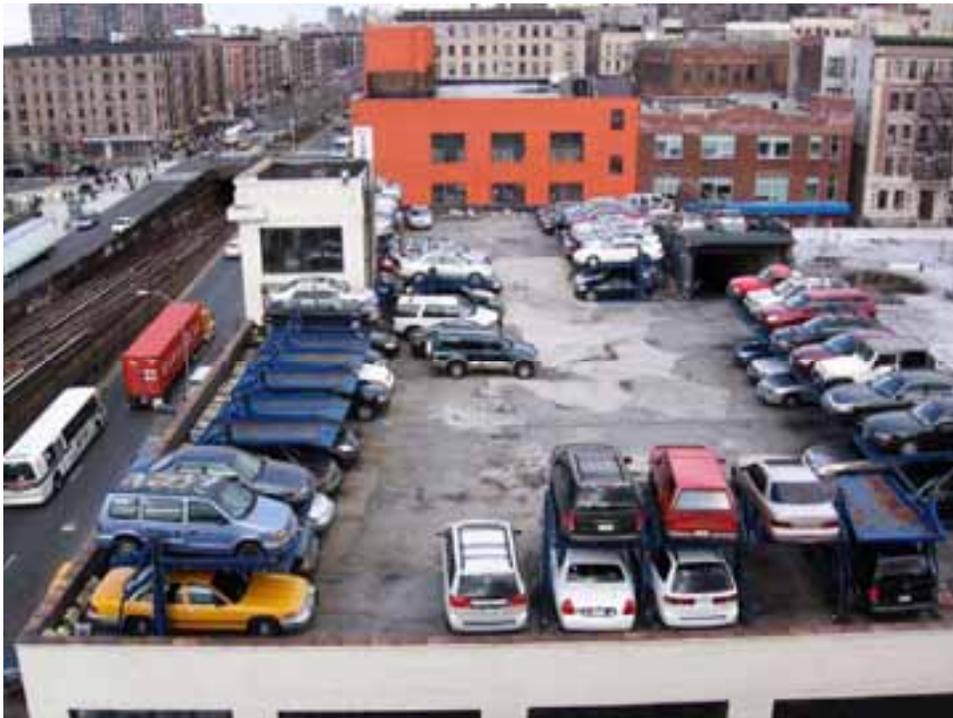
Photograph 1987-1-B

floor office space and a parking facility on the roof accessed from 134th Street (see photo B). Earth Tech reviewed the NYC Department of Finance Automated City Register Information System (ACRIS) and found that Lot 1 was acquired by Tuck-it-Away Associates in September 1983 (date of deed transfer). At the time of the AKRF report, Lot 1 was zoned M1-2; however, it has since been designated C6-2 as part of the Special Manhattanville Mixed Use District (MMU) rezoning (effective December 19, 2007).

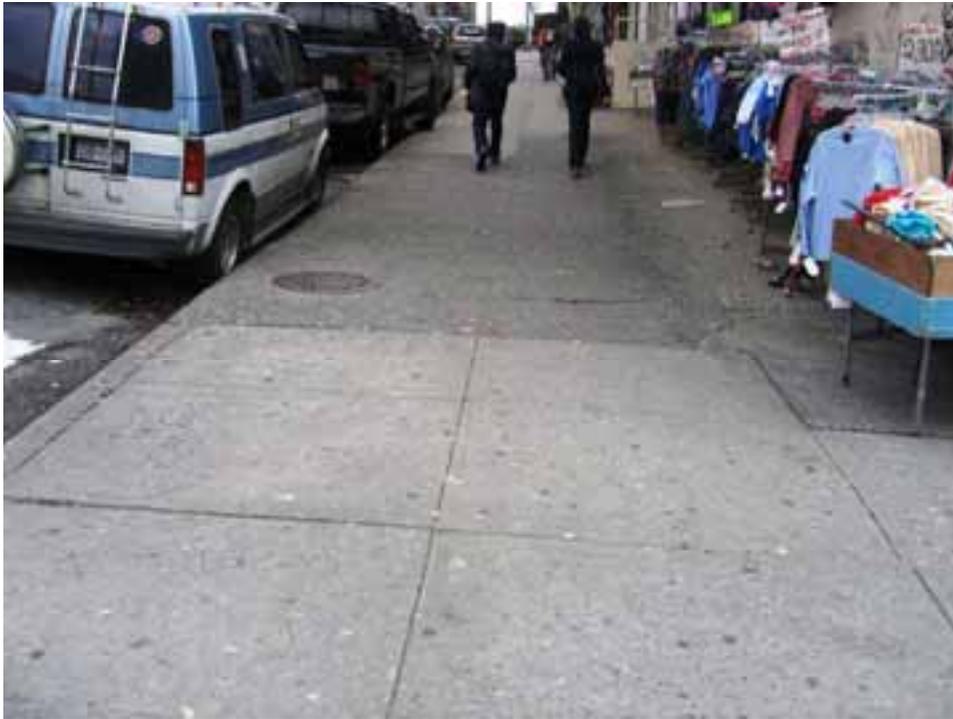
Photograph 1987-1-C

Based upon their visual, exterior inspection in Sept 2006 and April 2007 Thornton Tomasetti reported sidewalks in fair to poor (cracks and spalls, see photo C and D) condition, a poor (corroded, see photo E) sidewalk vault cover on W. 133rd Street, and poor window frames and glazing (corroded, broken). When inspected on March 12, 2008, Earth Tech's observations were generally consistent with the conditions reported by Thornton Tomasetti, except for subsequent upgrades to the building faces and some signs of advancing physical deterioration, either new, or not previously reported.

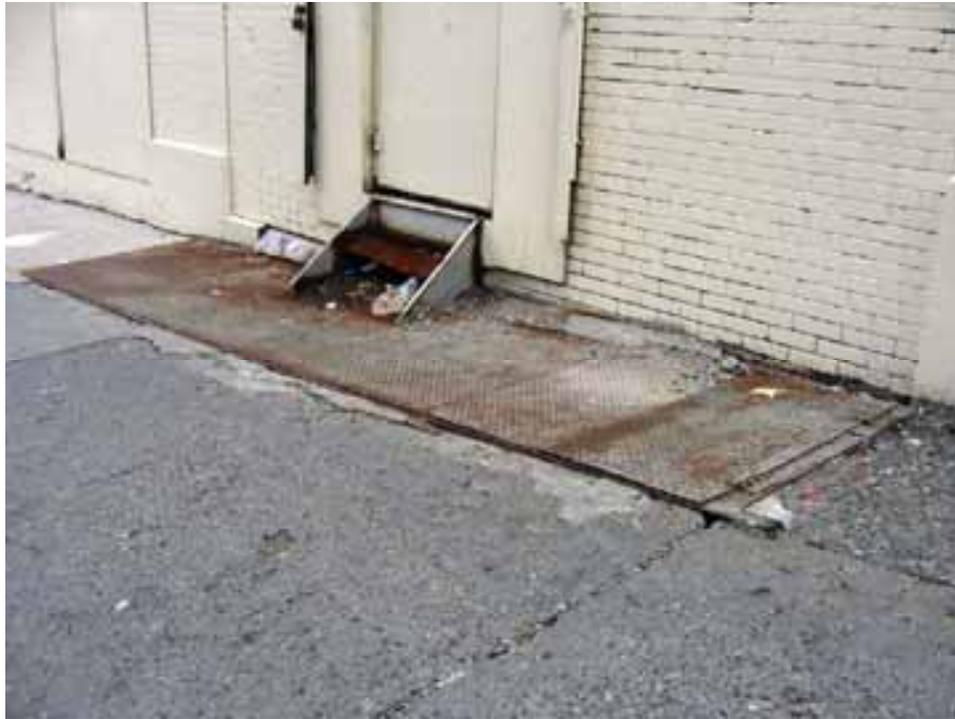
Photograph 1987-1-E

- Corrosion of the sidewalk vault cover and exterior steps along West 133rd Street (see photos E and M).
- Cracks and spalling of the concrete sidewalk slab, especially at the southwest corner of building (see photos N and O).

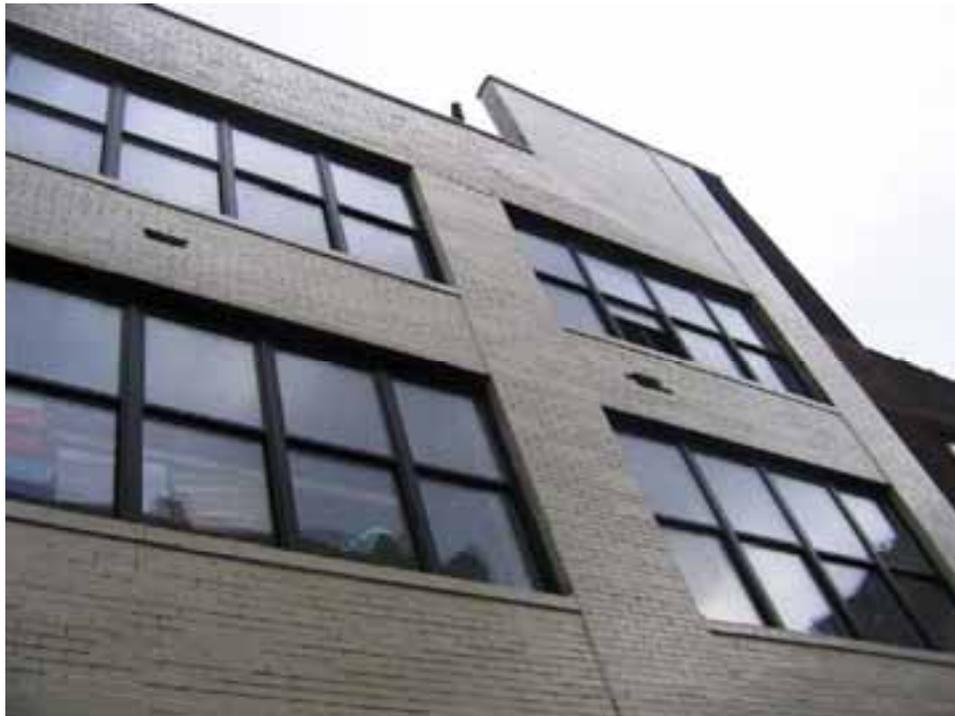
Photograph 1987-1-F

Following the 2006/2007 inspections, the window frames and glazing were replaced (see photo F) and the faces of the building painted white (see photo G). Repairs to the brickwork, if present, were not noticeable. There has been loss of mortar in most of the brickwork joints (see photo H) which should be repointed, rather than simply painted over. There appear to several new or unreported vertical cracks in the brick parapets (see photo I) and the brickwork below the third story window facing Broadway at the corner with W 133rd St. is bulging outward (see photo J), at the elevation where a lintel would be expected to be. The lintel (or its cover) above the entrance door to the rooftop garage is corroded and sagging (see photo K), and the surface of the rooftop parking area, as seen from a neighboring building, is severely abraded, revealing an underlying strata of the wearing surface (see photo L).

- The poor condition of the building's windows, which have, subsequent to AKRF report, have been replaced with the new ones (see photos P and F); and
- A safety concern for pedestrians due to the potential for falling bricks – the basis for this statement is unclear. There are several “probing” holes in the exterior brick veneer under the second floor windows on all three facades of the building (see photos Q and R), but the nature of these openings is unknown to Earth Tech and Earth Tech can not speculate on their safety implications.

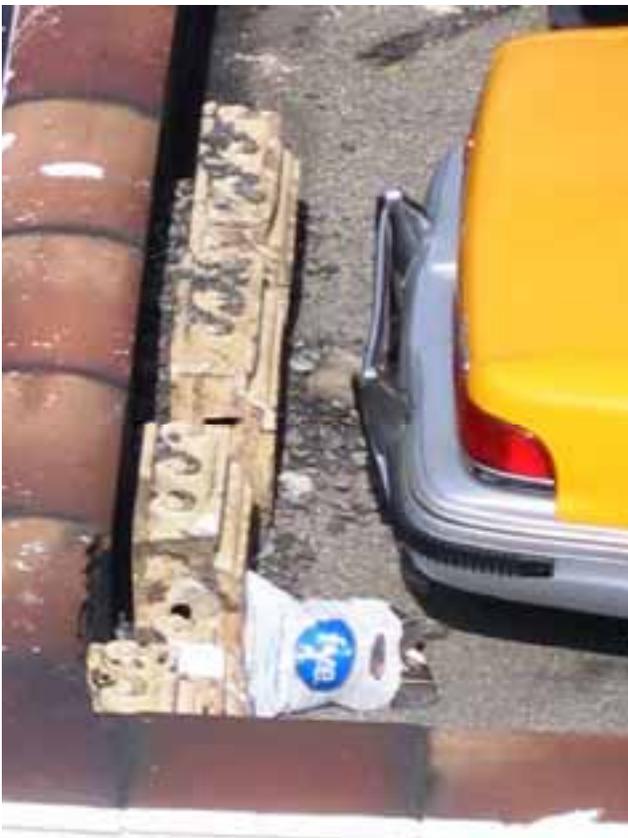
Photograph 1987-1-T

An additional concern Earth Tech noted from its visual survey of the roof of the building from a higher roof across West 133rd Street. The roof is currently used for parking vehicles. Earth Tech observed a multitude of what appeared to be terra cotta blocks lying along the parapets, probably the remains of the former cornice. Given that the roof is actively used and accessible, this debris is a potential safety hazard for pedestrians below (see photos S and T).

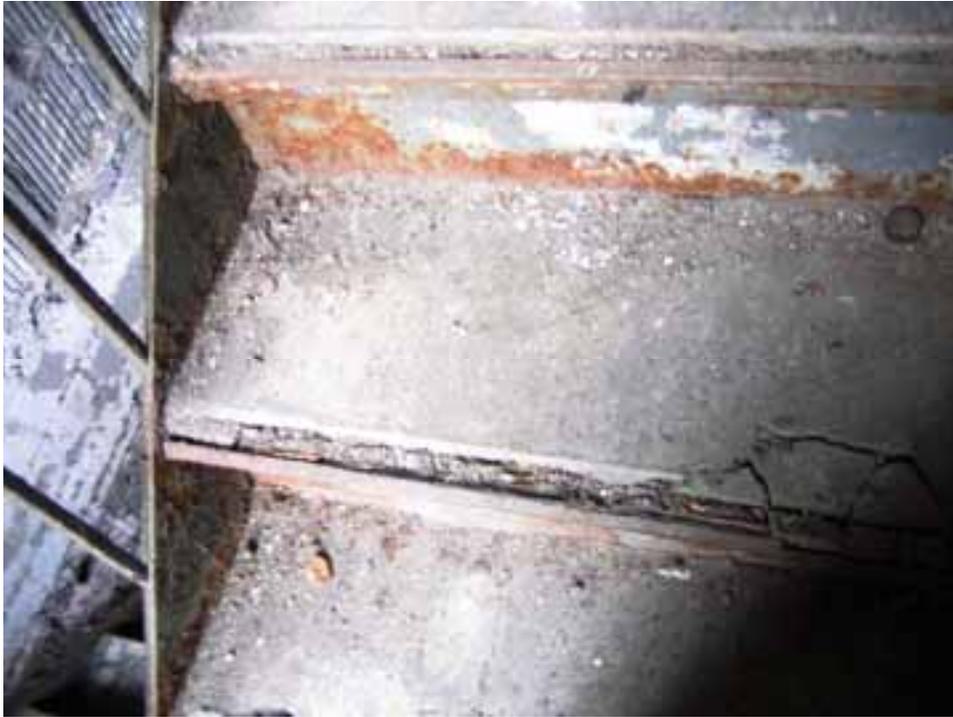
Photograph 1987-7-K

(see photos K and L); large pool of water in roof bays with broken, buckled or missing cross bracings (see photos M, N and O).

- The stair from the second floor to the roof has corroded steel members (see photos T and K) and cracked and spalling treads (see photo U).
- The second floor has a fire separation wall with a self-closing door between two building portions; the door is inoperable and remains open all the time, thus rendering it ineffective for containing a fire; this is a fire hazard (see photos V and W).

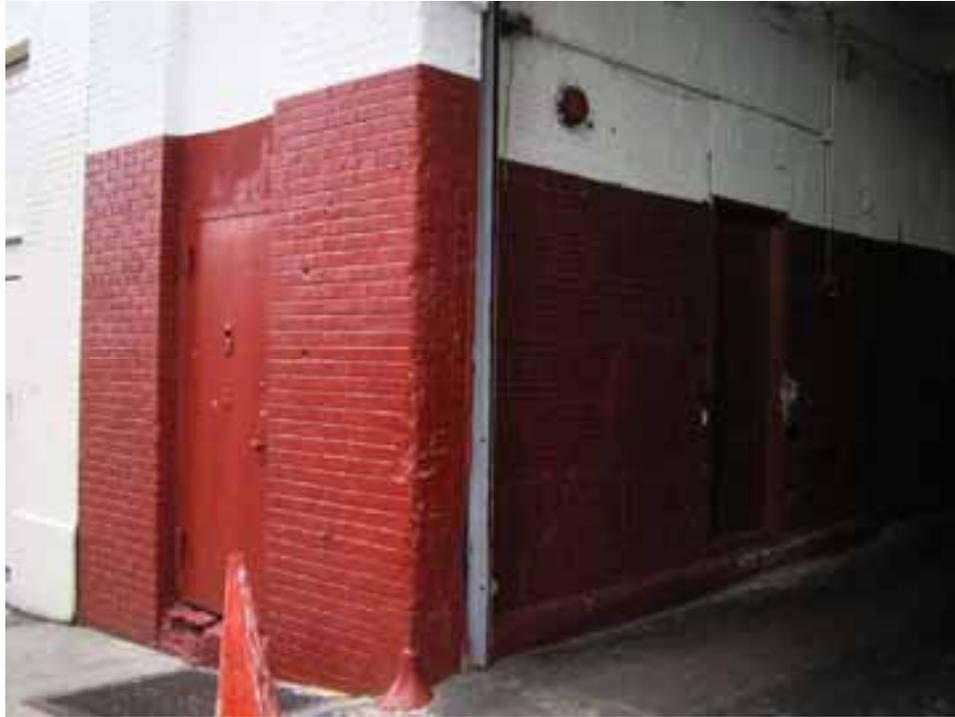
Photograph 1987-7-S

- Both fire exits from second floor leading to West 133rd Street are not usable. The stairwell to the southwest is used as storage (see photo Q); its exit door does not have an exit sign, the required hardware, and was locked at the day of survey (see photo R). The stairwell at the southeast corner was blocked by parked cars and inaccessible; at street level, the threshold step at exit door is damaged and does not meet code (see photo S).

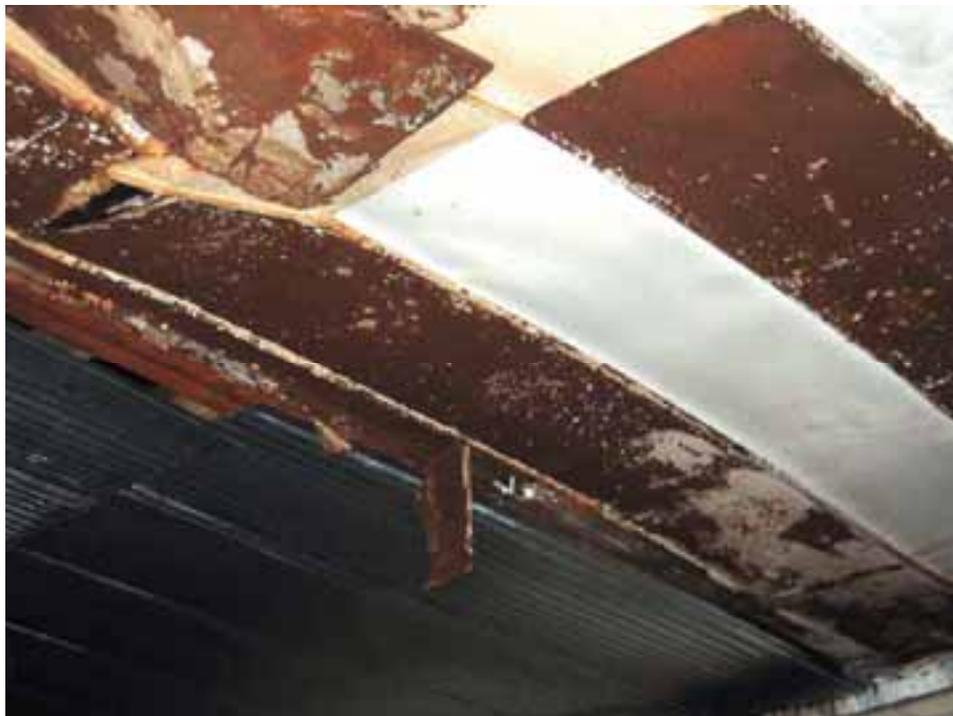
Photograph 1987-7-Y

- There are areas of local ceiling collapse on the second floor with broken/missing sections of tin panels; evidence of severe water damage throughout (see photos I and Y).

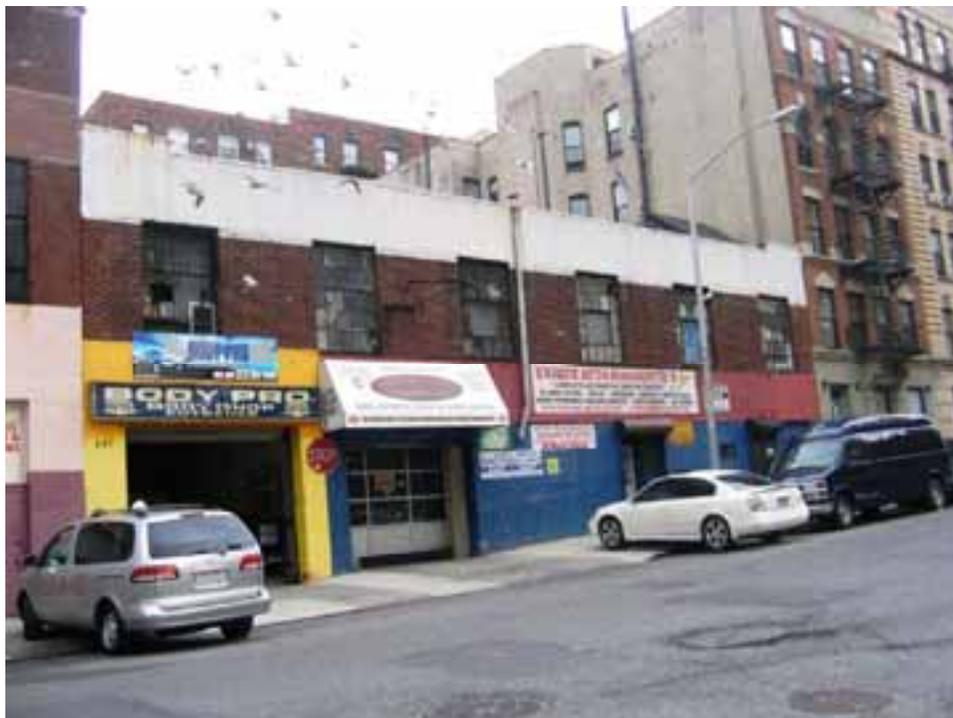
Photograph 1987-9-A

- The fire exit from the second floor through the stairwell leading to West 133rd Street is not code compliant. All exit doors are missing the required exit hardware (see photos J and K), and the first floor exit door was blocked by the closed and locked overhead shutter door from outside on the day of the survey (see photo A). This is a safety hazard for employees and customers

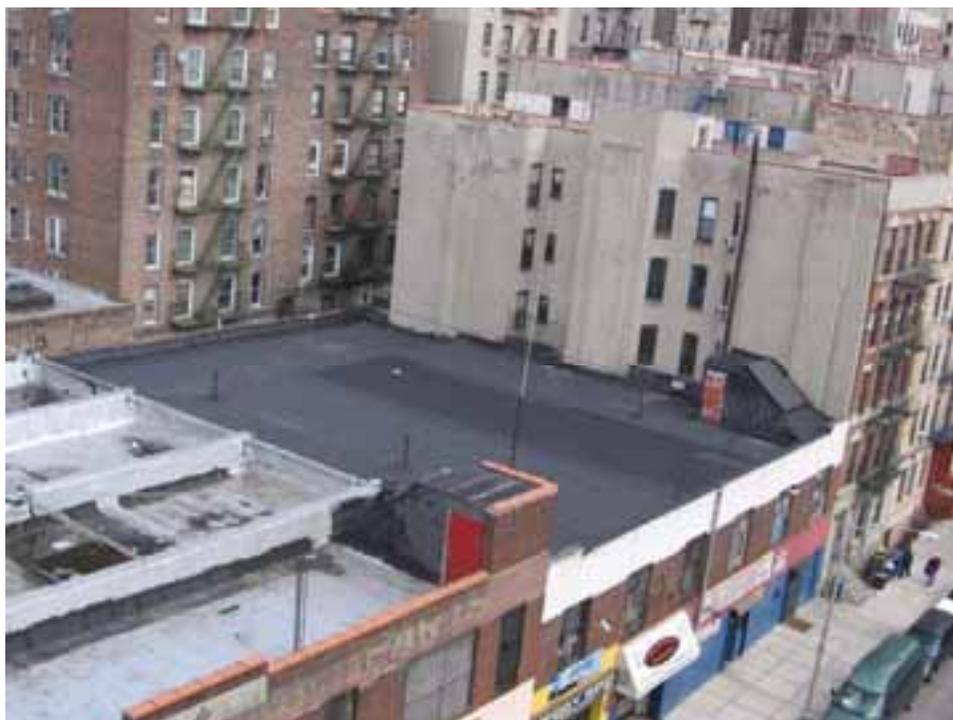
Photograph 1987-9-B

At the time this building was inspected by Earth Tech on February 27, 2008, it was observed that a new roof had been installed in order to prevent water infiltration and mitigate any further damage and distress to various structural and architectural elements (see photos B and C). A sheet rock ceiling was installed, consequently, the actual

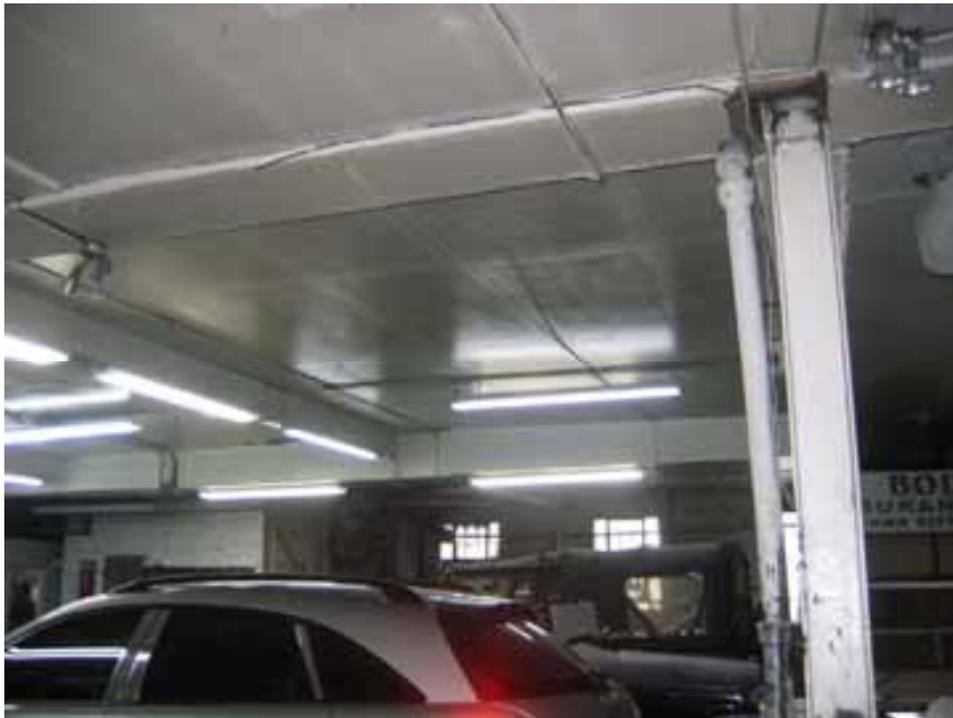
Photograph 1987-9-D

condition of the previously rotted timber joists could not be inspected (see photo D). The Thornton Tomasetti observed deficiencies, including: cracked concrete encasements (see photos E and F); water stains and stepped cracks in the foundation walls; microbial growth on the north first floor walls (see photos G and H) and soffit; minor sagging of ramp slab; and structurally inadequate and deflected mezzanine floor (see photo I), remained evident.

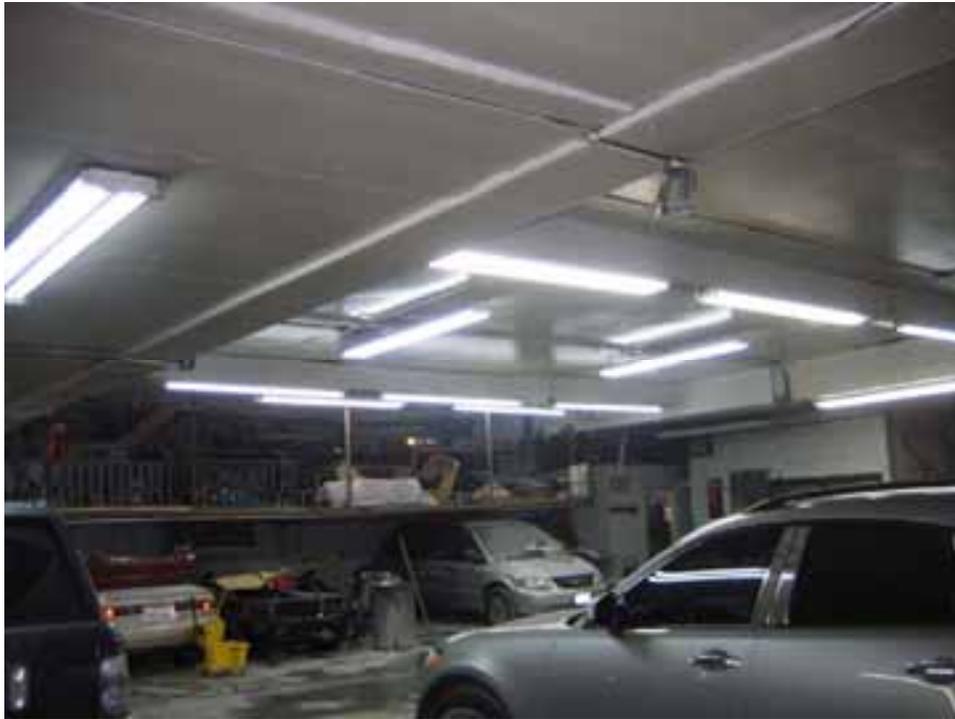
Photograph 1987-9-I

- There are structural concerns for the 2nd floor "mezzanine level", which is used as a storage rack. The "mezzanine level" is suspended from roof framing that might have been rotted and deteriorated due to water infiltration; this condition can result into a local failure (see photo I). The storage appears haphazard and is a safety concern.

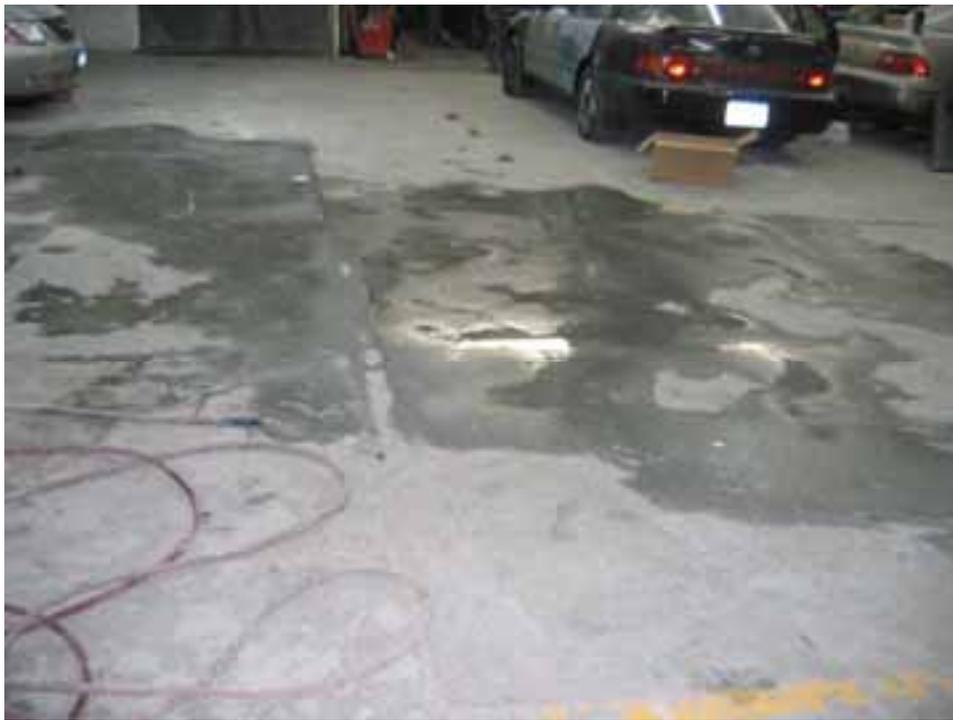
Photograph 1987-9-N

- On the day of the survey Earth Tech observed standing water on the 2nd floor, probably from washing cars; a sign that the floor is not properly sloped to floor drains. This is a safety and health concern (see photo N).

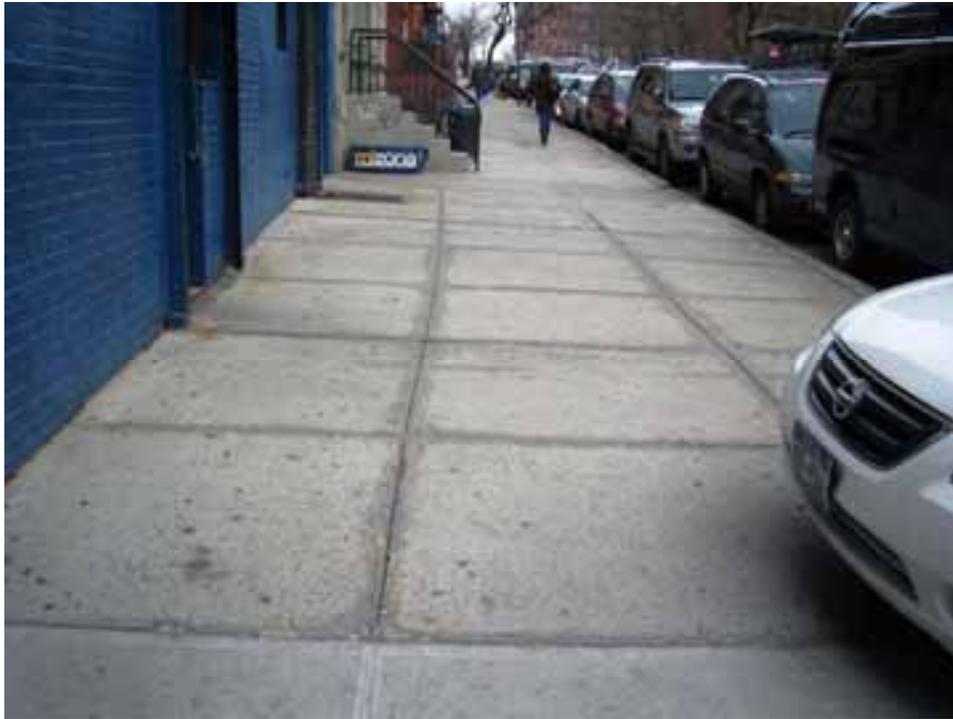
Photograph 1987-9-O

- Earth Tech observed cars, parked on the sidewalk, as previously reported by AKRF, which is a safety concern for pedestrians. However, the sidewalk appears to be in fair condition (see photo O).

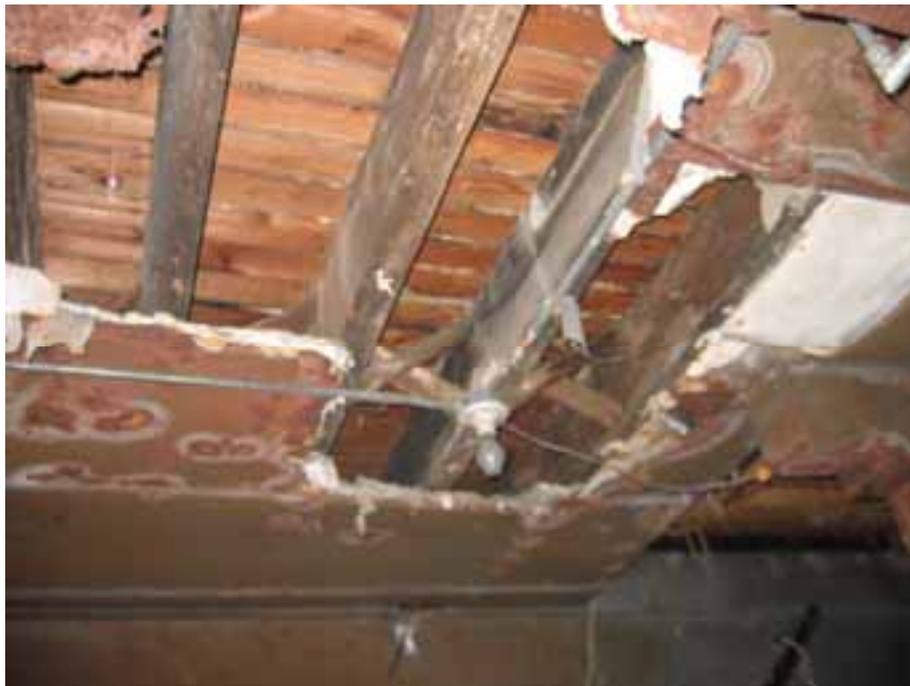
Photograph 1995-31-D

At the time this site was inspected by Earth Tech, on February 21, 2008, the observed instances of structural damage and distress, which could be directly observed or indirectly deduced (e.g. structural elements covered with damaged finishes), appeared generally consistent with the findings reported by AKRF and Thornton Tomasetti. Following the inspections by Thornton Tomasetti, superficial, cosmetic repairs (see photo C) had been performed upon the underside of the first floor deck and its supporting structure, but not substantial repairs or reconstruction of primary structural elements. The reported deficiencies, including widespread water damage (Photos D and E), makeshift
