SITE CONDITION: POOR

Block 1996 Lot 14

PHYSICAL AND STRUCTURAL CONCERNS

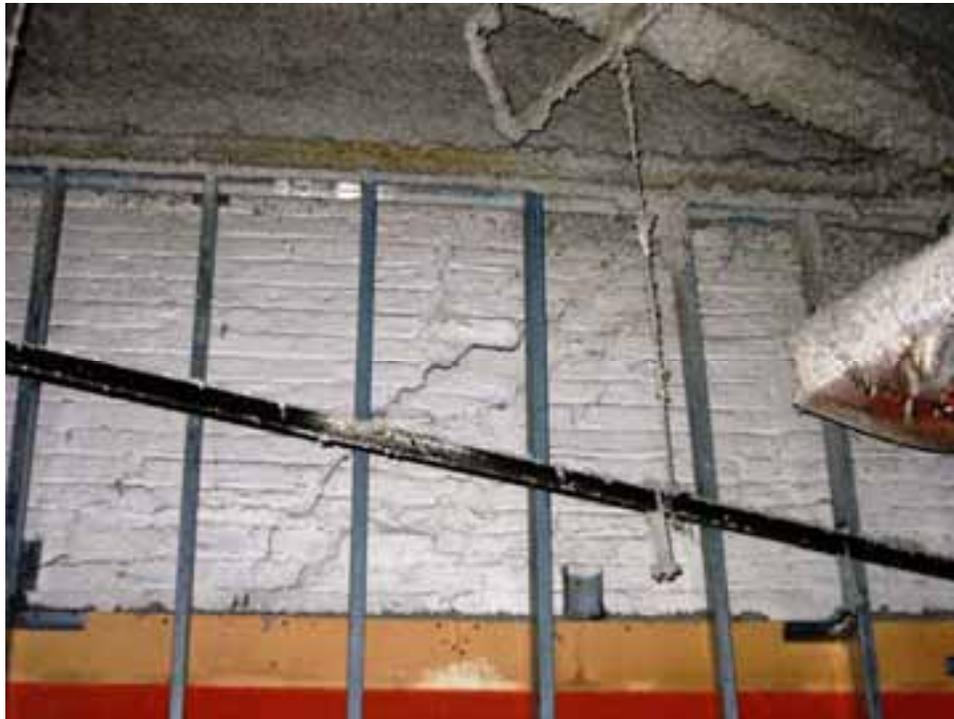
Photograph 1996-14-C

1. Cracks in the masonry walls along the interior and water infiltration on various floors (see photos C, D, E and F).
2. Cracks in the masonry walls along the exterior of the building (see photos G, H and I).

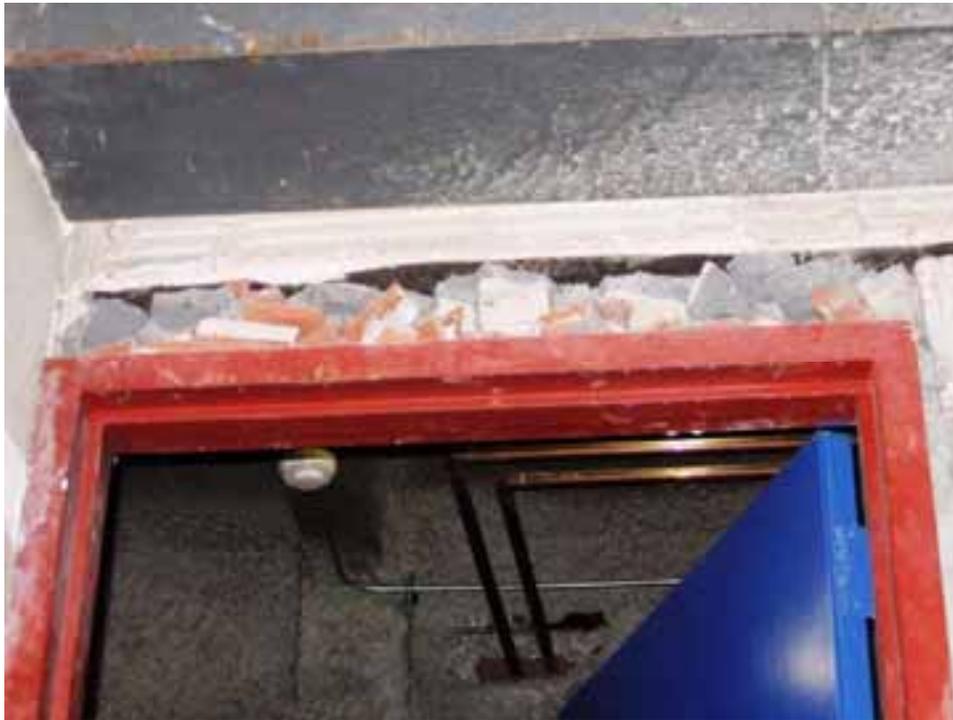
Photograph 1996-14-Y

1. The top of door frame is filled in with broken-up masonry outside of the electrical room on the first floor (see photo Y).
2. Cracks in stairwell walls (see photos Z, AA and AB).
3. Missing fireproofing on beams in first floor room (see photos AC and AD).
4. Temporary repairs to ceiling slab (see photos AE and AF).
5. On the 4th floor, an opening has been cut out in the masonry wall without providing a lintel or other means of masonry support above opening (see photo AG).
6. Exterior anchors to brick facade are no longer bearing against exterior wall (see photos AH, AI and AJ).
7. Chimney requires repointing (see photo AK).
8. North east parapet needs repointing (see photo AL).

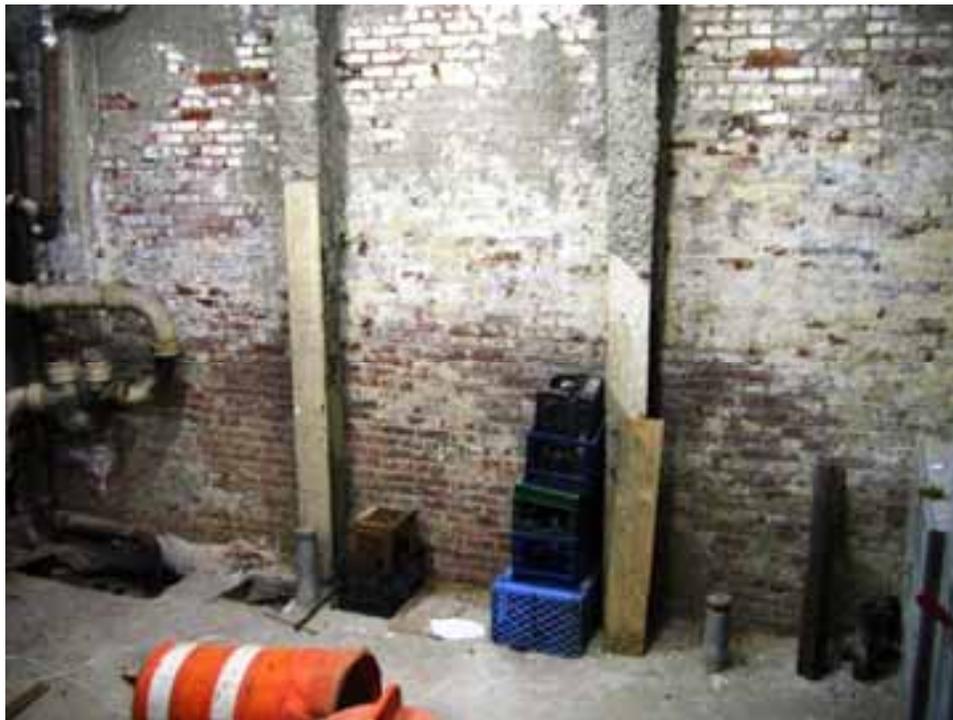
Photograph 1996-14-AN

- Spray-on fireproofing was only applied to partial height of several columns (see photo AM).
- Steel columns and beams in the electrical room are not fireproofed (see photo AN).
- A drain pipe outlet located above the electrical switch board is a safety hazard (see photo AO).
- Mold on the ceiling and masonry walls, peeling paint, cracks at various locations on the walls, signs of vermin, and excessive debris throughout the unoccupied space (see photos AP, AQ, AR AS, AT, AU AV and AW) - these are all confirmed safety concerns.

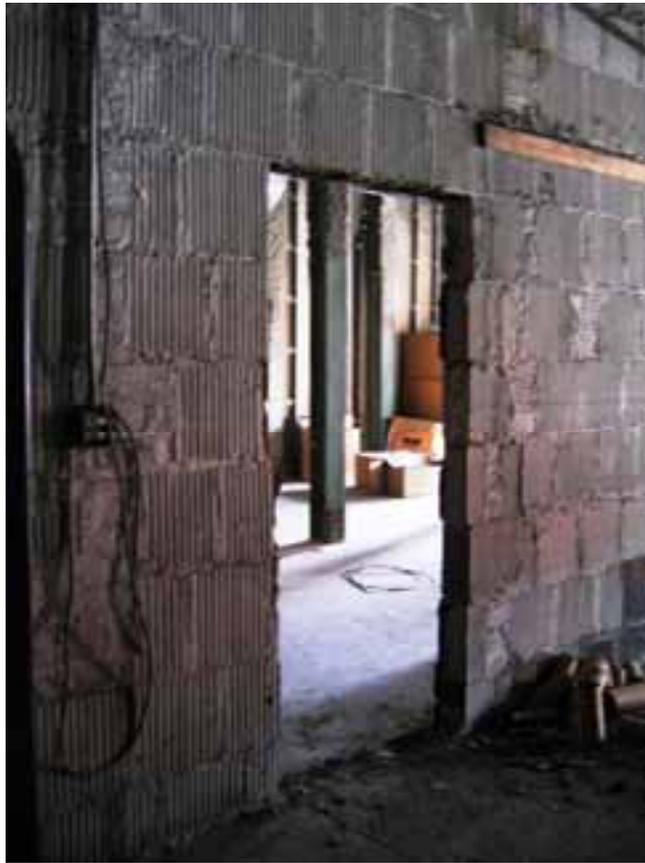
Photograph 1996-14-AY

- The 3rd and the 4th floors of the building are vacant with unfinished construction materials, haphazard storage, and lots of debris. There are similar areas on 1st floor as well. The access to these floors and areas is unrestricted for people employed in the building; this is a major health and safety concern.
- In the electrical room, a gap above the door frame has been filled haphazardly with loose masonry pieces, which appears unsafe (see photo AX).
- On the 4th floor, an opening has been cut out in the masonry wall without providing a lintel or other means of masonry support above opening. This is a safety hazard (see photo AY).

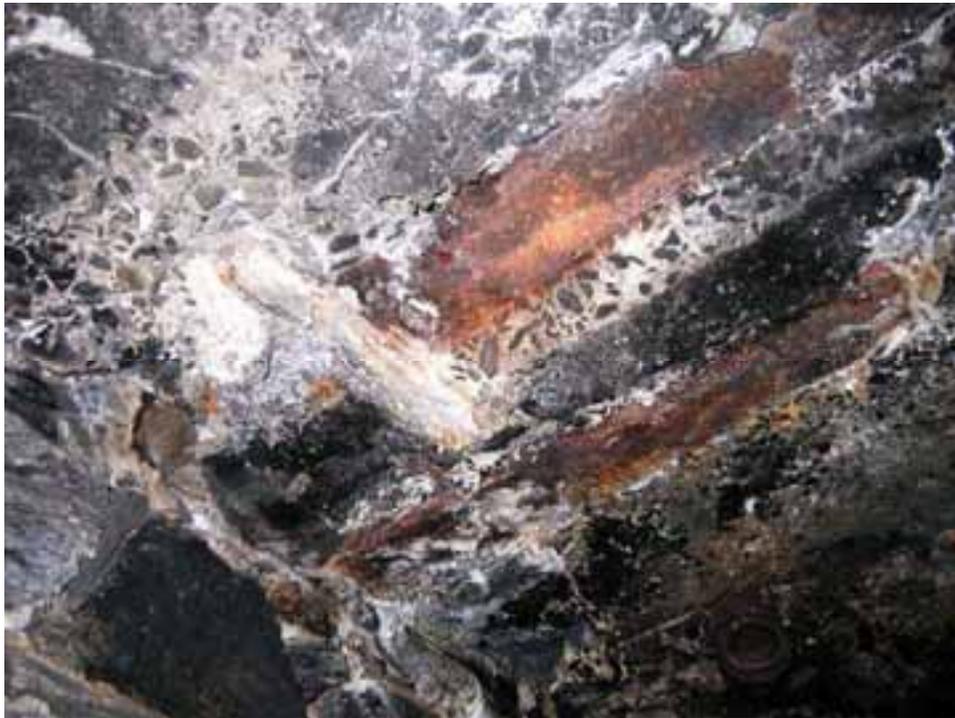
Photograph 1996-15-C

The basement and boiler room steel members show heavily rusted bottom flanges of the steel beams (see photos C and D), timber joists are deteriorated and wet patches are visible (see photos E and F). The first floor portion of sheet rock ceiling has collapsed

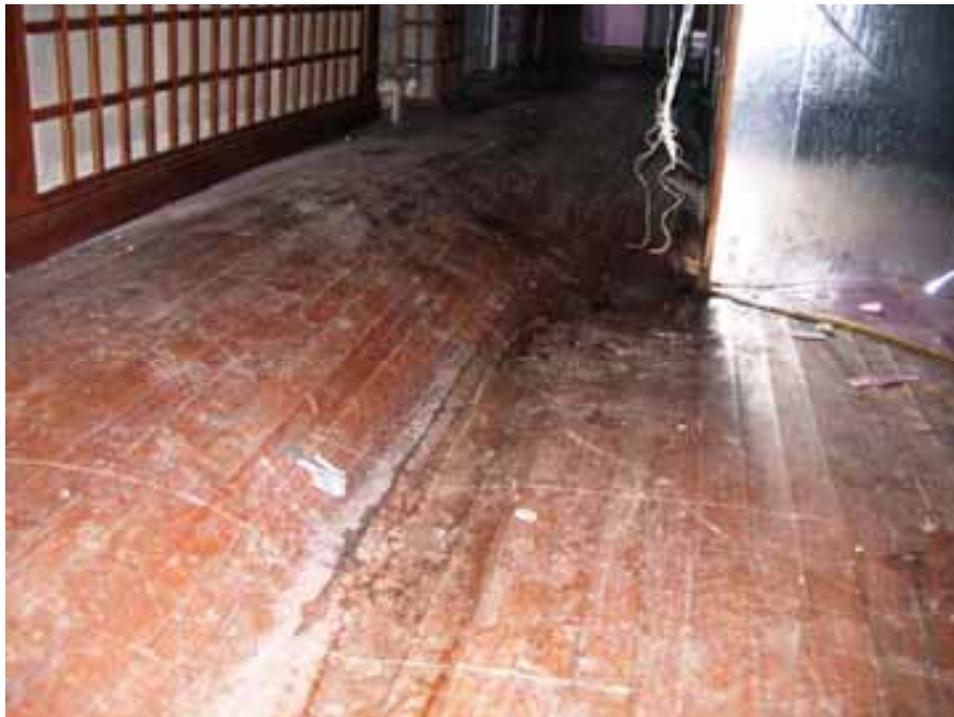
Photograph 1996-15-N

- Water infiltration has caused severe buckling in the parquet floor on the 2nd floor, making it unsafe to walk on (see photos N and AG).
- There are several holes in the 2nd floor of the structure (probably a result of attempts to salvage stone floor tiles) and debris; these are safety hazards (see photo J).
- Earth Tech observed haphazard wiring, corroded electrical conduits and boxes throughout the building (see photos AH, Q and AI).

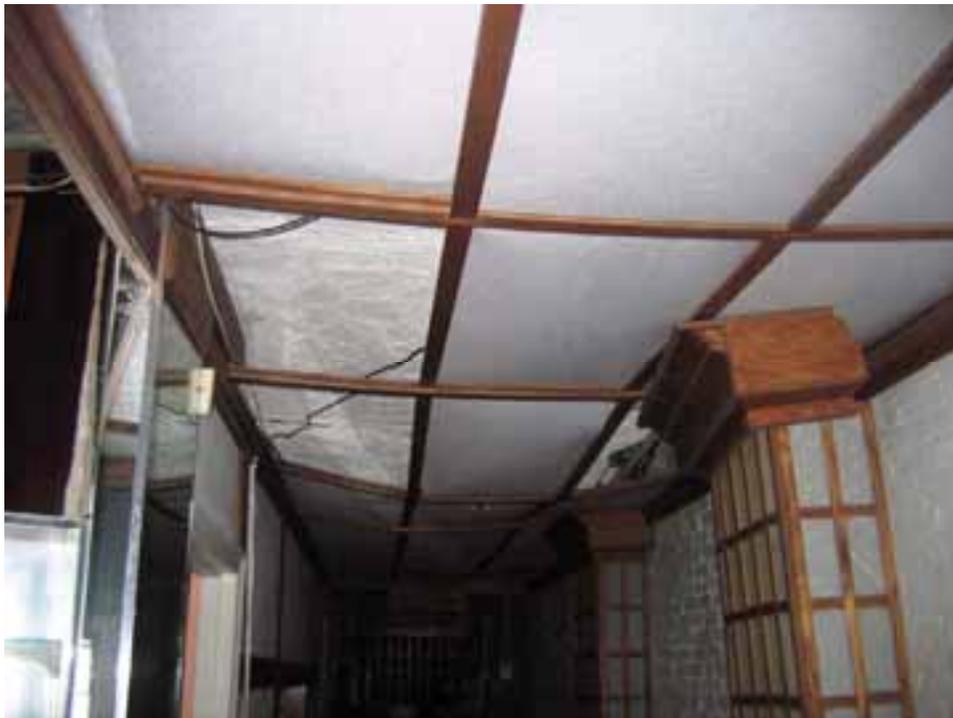
Photograph 1996-15-R

- The existing fire escape at the northern wall, shared with the building on Lot 50 and leading to the roof of the building on Lot 15, is obstructed by a plant at the intermediate landing and blocked with the air conditioner unit on second floor. This renders the fire escape virtually useless and is a major safety concern for both properties (see photos Y, Z and AA).
- Stairs leading to the basement have uneven, broken steps, and no handrail, - a safety concern (see photos AB and AC).
- Earth Tech observed active water leaks throughout the building, causing saturation of sheetrock ceiling panels and their subsequent local collapse in the basement (see photos AD and V), on the 1st floor (see photos G and AF), and local collapse of hang ceiling panels on the 2nd floor (See photos R and AE).

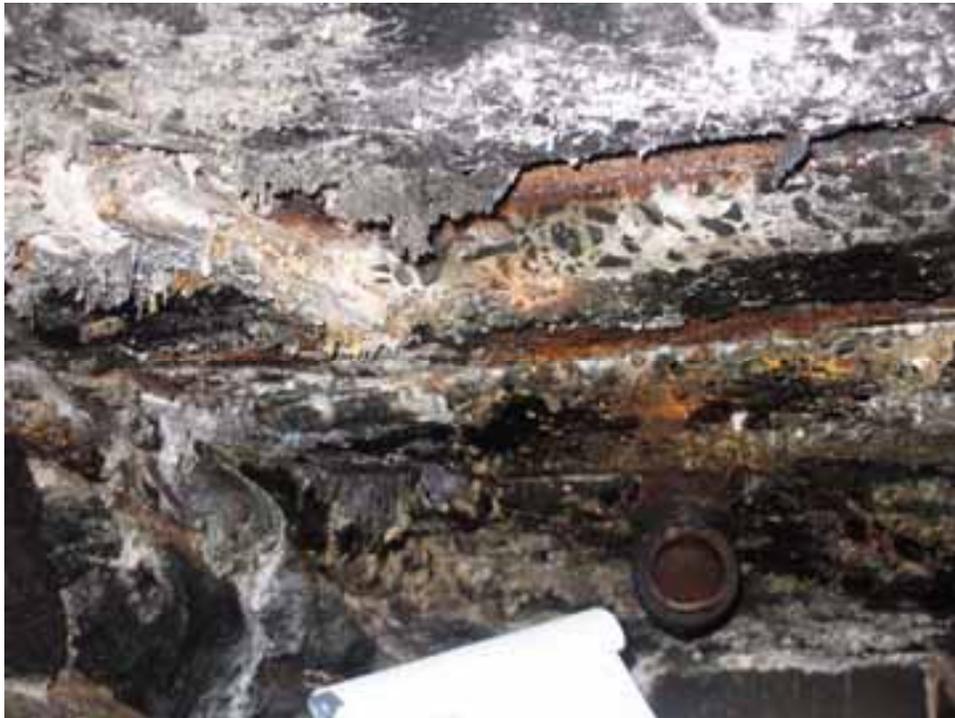
Photograph 1996-15-W

- Egress doors at the northern wall leading to the fire escape were locked and/or inoperative on all floors and basement (see photo V)
- Mold growth, peeling paint and evidence of vermin infestation were observed throughout the building (see photos W, A, and X).

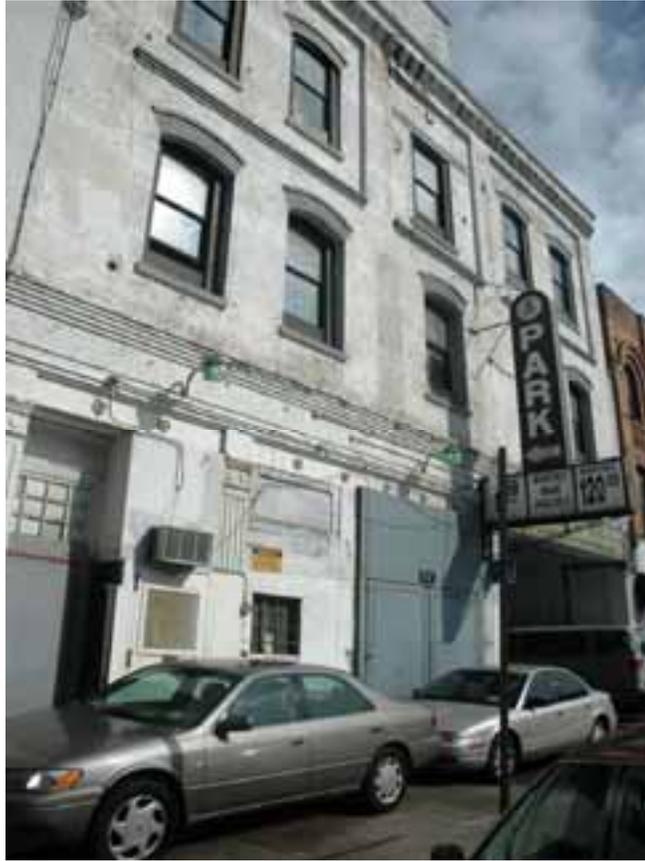
Photograph 1996-18-A

- Exit stair leading from basement to 1st floor has broken and loose treads (see photo Y).
- Vehicles are routinely parked on the sidewalk of West 129th Street, creating a safety hazard for pedestrians (see photos A and X). Sidewalks exhibit extensive cracking and spalling.
