SITE CONDITION: CRITICAL

Block 1996 Lot 20

SITE CONDITION: POOR

Block 1996 Lot 21

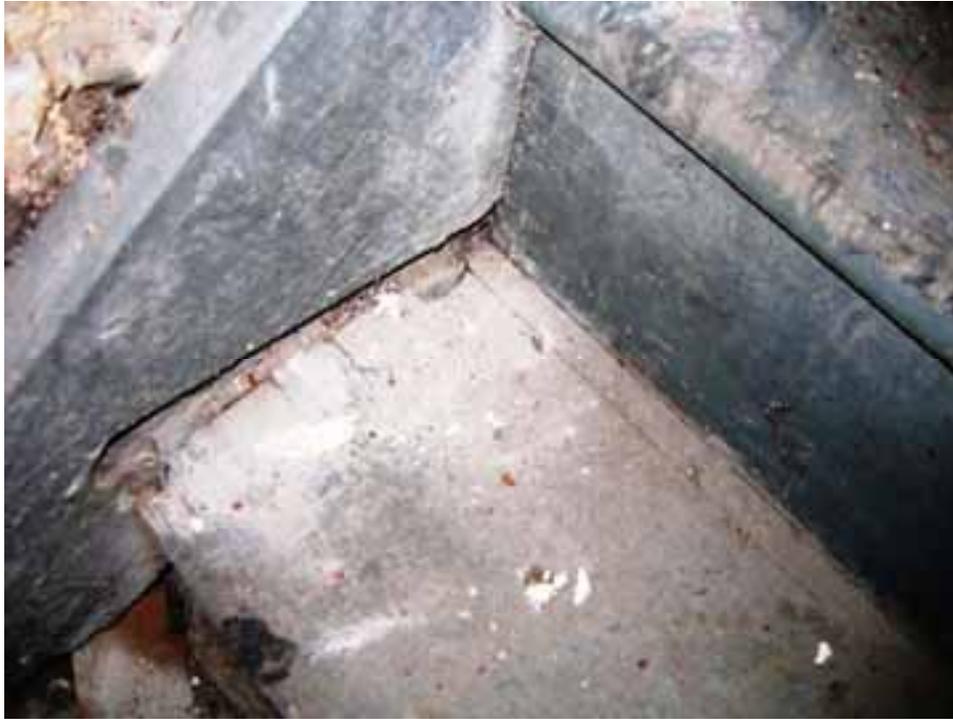
Photograph 1996-18-Y

- In the two-story building: the stair leading to basement has broken and loose treads and is unsafe (see photo Y).
- In the two-story building: the stair leading to the second floor has uneven steps and is unsafe (see photo Z).

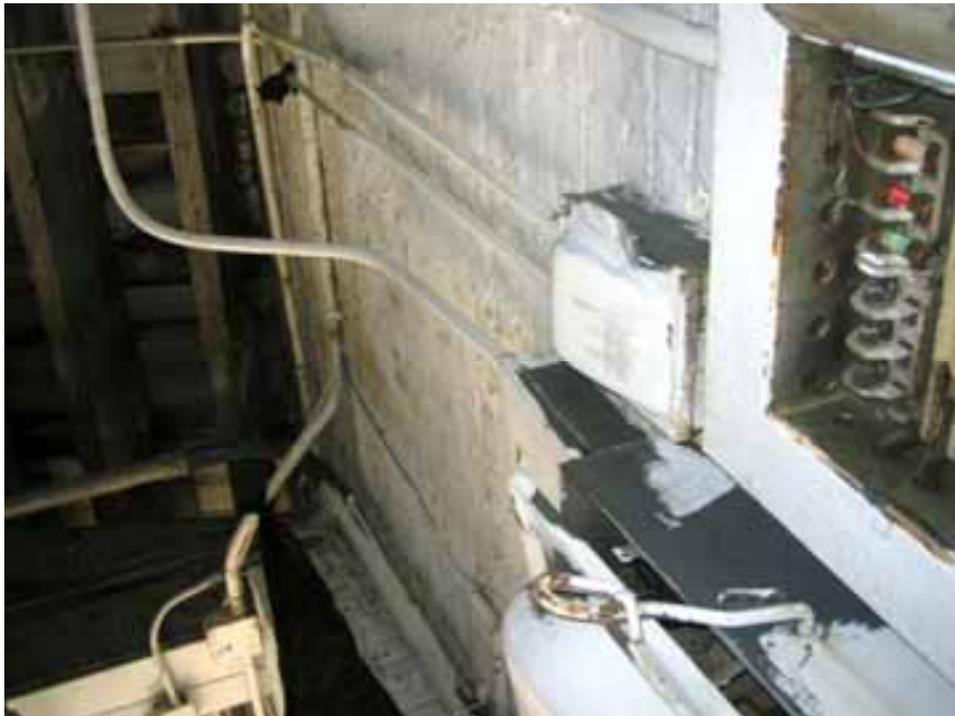
Photograph 1996-21-N

- Water infiltration directly above electrical panel is a safety hazard (see photo N)
- Mold on masonry walls (see photo O)
- Litter and debris with evidence of vermin infestation (see photo P).

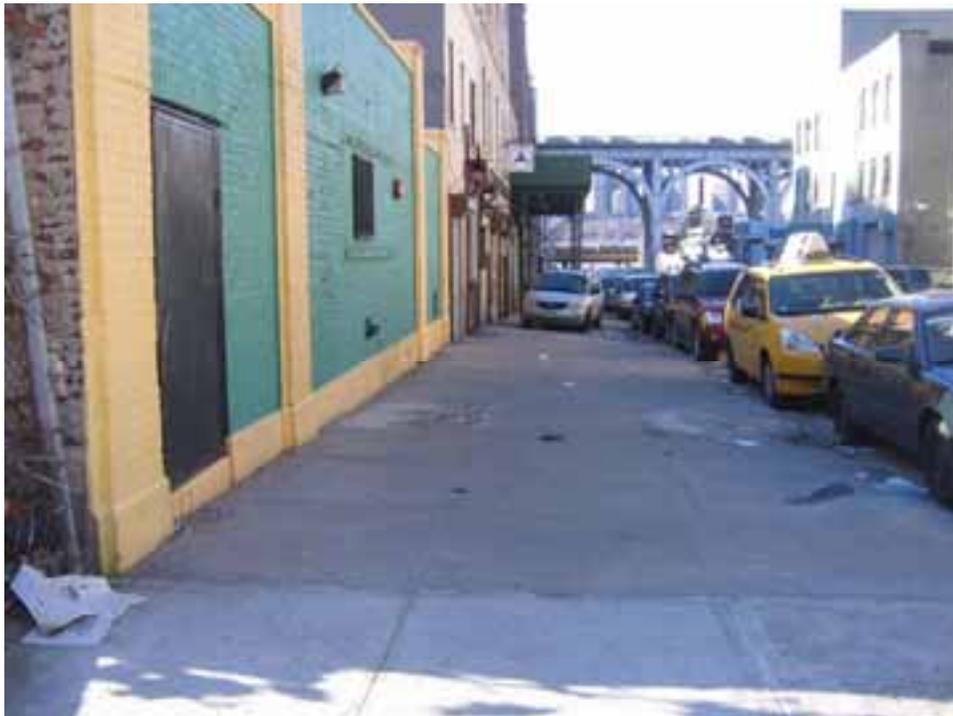
Photograph 1996-21-T

- Metal drums with unidentified content were stored at the northern part of the building, possibly presenting a safety/ health hazard (see photo S).
- Although portions of sidewalk at 129th Street appear to have been repaired and are in fair condition now, the 130th Street sidewalk now has two areas of poor spalled concrete that present a hazard to pedestrians (see photo T).

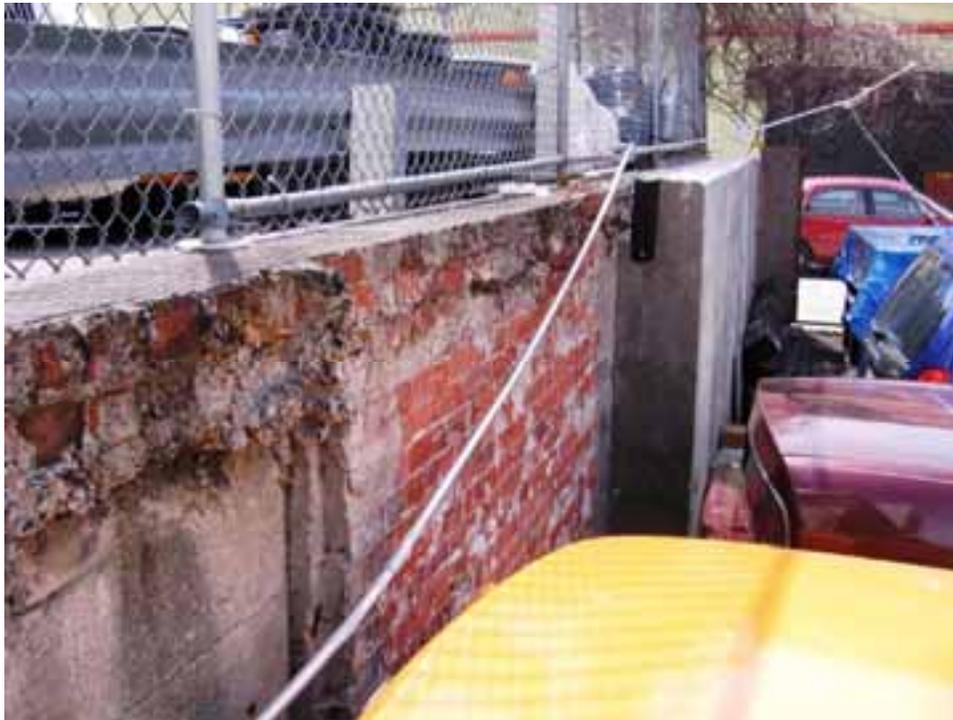
Photograph 1996-23-G

Earth Tech noted the pavement surface of the open parking lot is a slab-on-grade concrete with asphalt topping. The entire surface is uneven with large pot holes, wide random cracks and settlement. More damage is visible near the north entrance area causing the bottom of the vehicles to rub against pavement (see photos D). The chain link fence on the north side is in poor condition with loose fabric and all posts, top and bottom rails being corroded (see photo E). One post at the north exit has bent due to collision (see photo F). The chain link fence on the south side shows light rust. A portion of the brick retaining wall (approximately 25 ft) is rebuilt (see photo G).

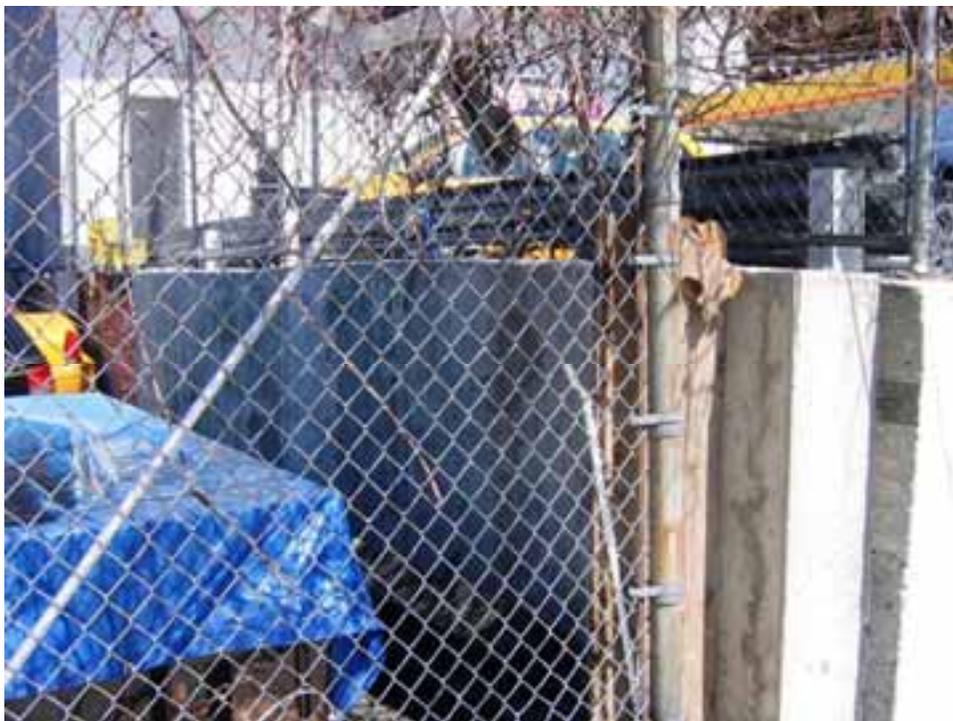
Photograph 1996-29-B

The portion of brick retaining wall at the south west corner end that was in collapsed condition has been replaced with a new concrete wall (see photo B). The concrete retaining wall at the south end exhibits one wide diagonal crack at the west end area, and two medium vertical cracks in the mid area (see photos C and D). The chain link fence mounted on top of the south retaining wall is leaning over and corroded (see photo E). A stepped medium crack is present in the west wall of the service garage (see photo F). The spall in concrete or gap is visible all along the west wall between floor and foundation wall causing potential water intrusion (see photo G). The major portion of the building was covered with the suspended ceiling and primary structural members could not be inspected.

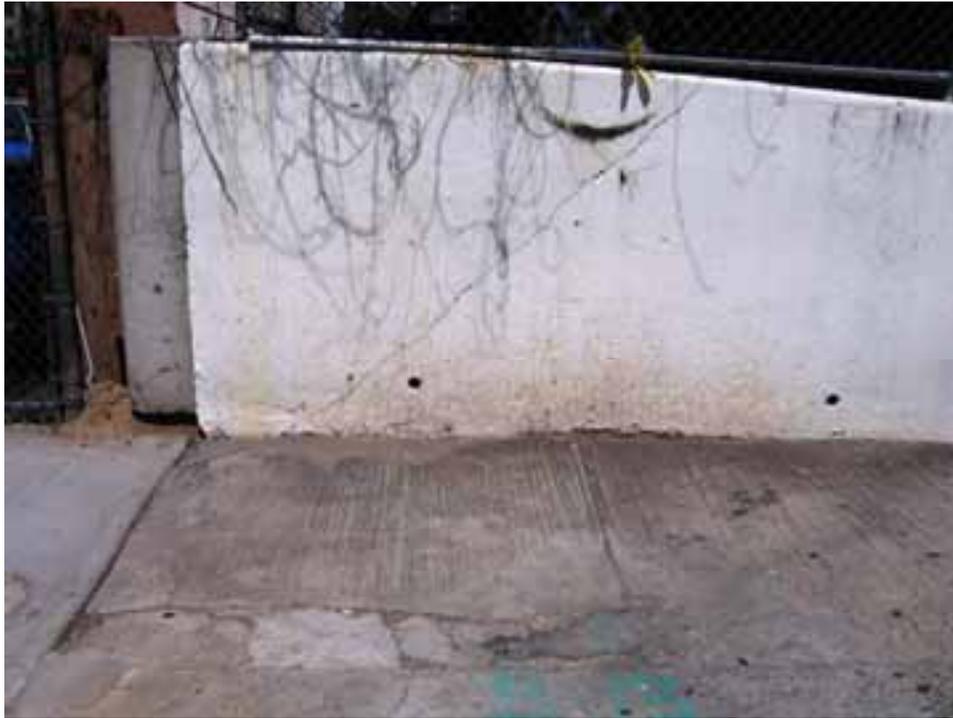
Photograph 1996-29-I

- The sidewalk is generally in fair condition except for some local cracking and spalling (see photos I, J and K).
- The retaining wall separating the sidewalk and elevated parking area at the southwest corner of the site has a chain link fence on top of it. The fence appears to have been impacted by parked cars (see photo F). Earth Tech notes that the lack of a guard rail along this retaining wall is a potential safety concern for pedestrians on the sidewalk along West 129th Street.

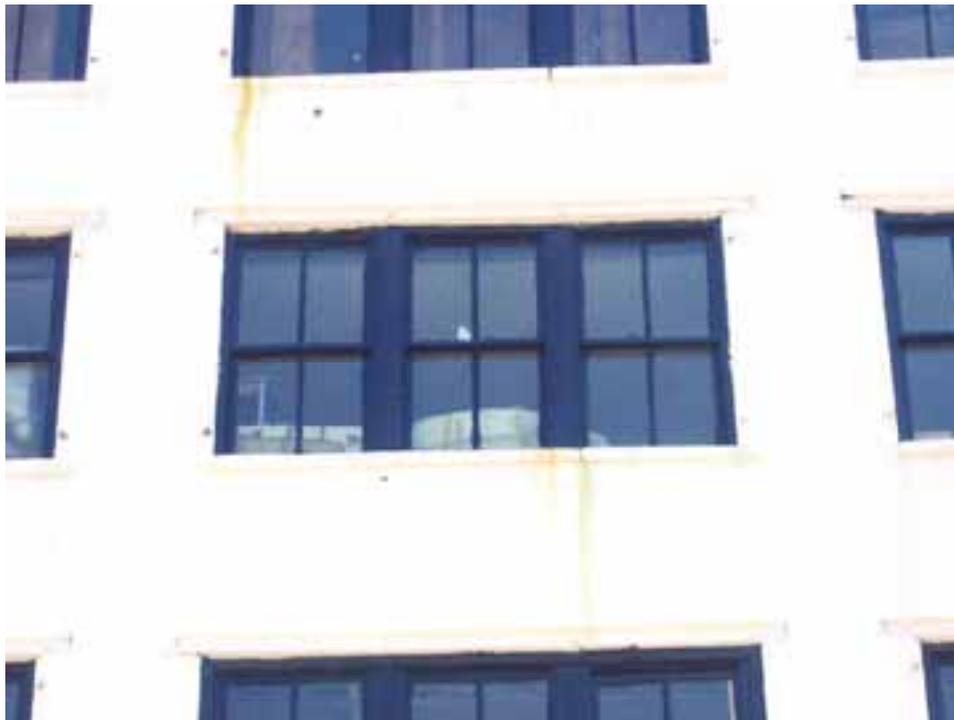
Photograph 1996-34-D

1. There is water and rust stains at the east exterior wall (see photos A and B).
2. The north exterior wall exhibits minor paint deterioration (see photo C).
3. The west exterior wall shows minor paint deterioration and rust at various spots (see photos D and E).
4. The sidewalks are generally in good condition, despite a few cracks at random locations (see photo F).
