SITE CONDITION: POOR

Block 1996 Lot 50

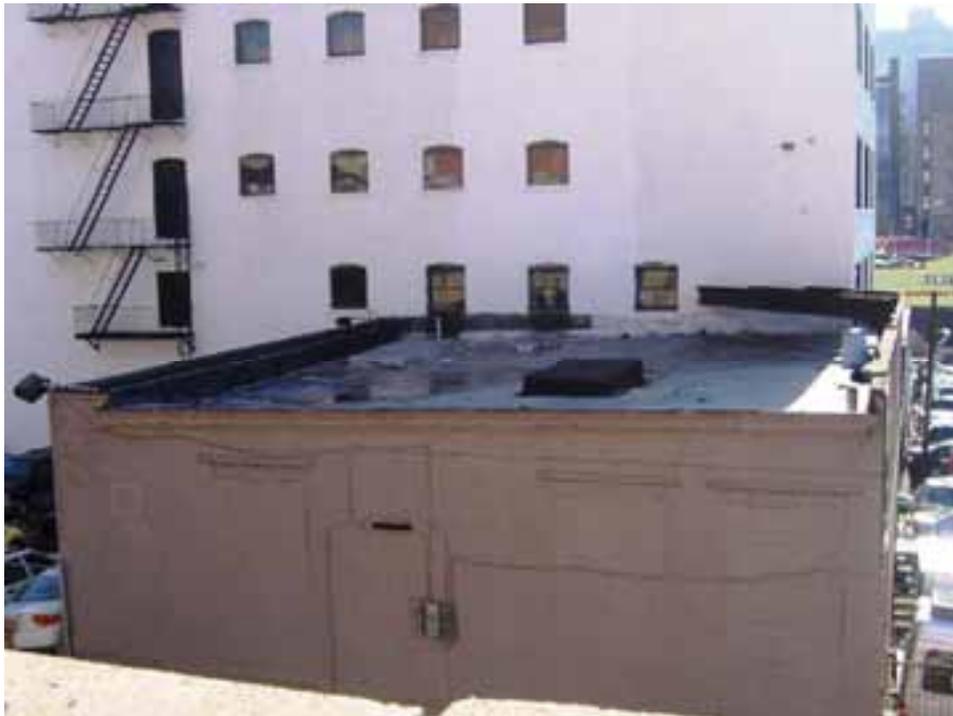
Photograph 1996-36-N

The AKRF report stated that *“overall health and safety concerns associated with this property make it essentially unusable in its current conditions”*. The building is currently vacant; but the parking lot is used by a local automotive repair shop (see photo M). The building was marked in November of 2007, on its West 130th Street façade, by the Fire Department of the City of New York as “shut down” (see photos N and O).

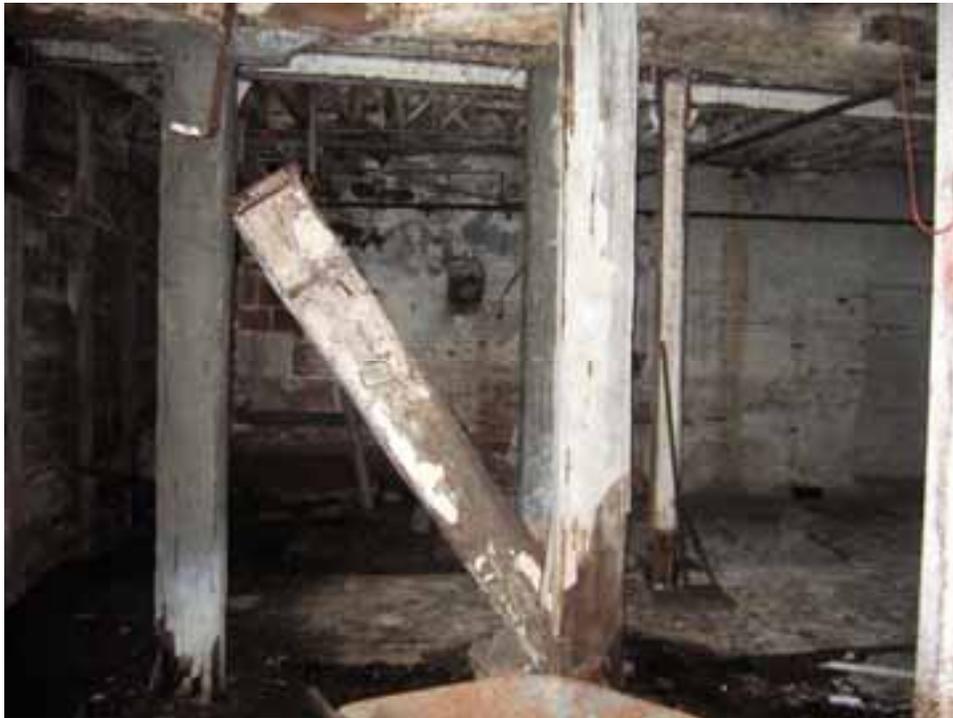
Photograph 1996-36-S

Earth Tech concurs with all the health and safety concerns listed in the AKRF report (see photos R, F, B, S and T), including:

- Deteriorated condition of first floor framing due to rot as unsafe for occupancy without extraordinary renovations;
- Displaced plaster ceilings, and finishes on columns and girders creating a fire hazard;
- Haphazard electrical wiring; and
- Overall filthy conditions in the building, making it essentially unuseable in its present condition.

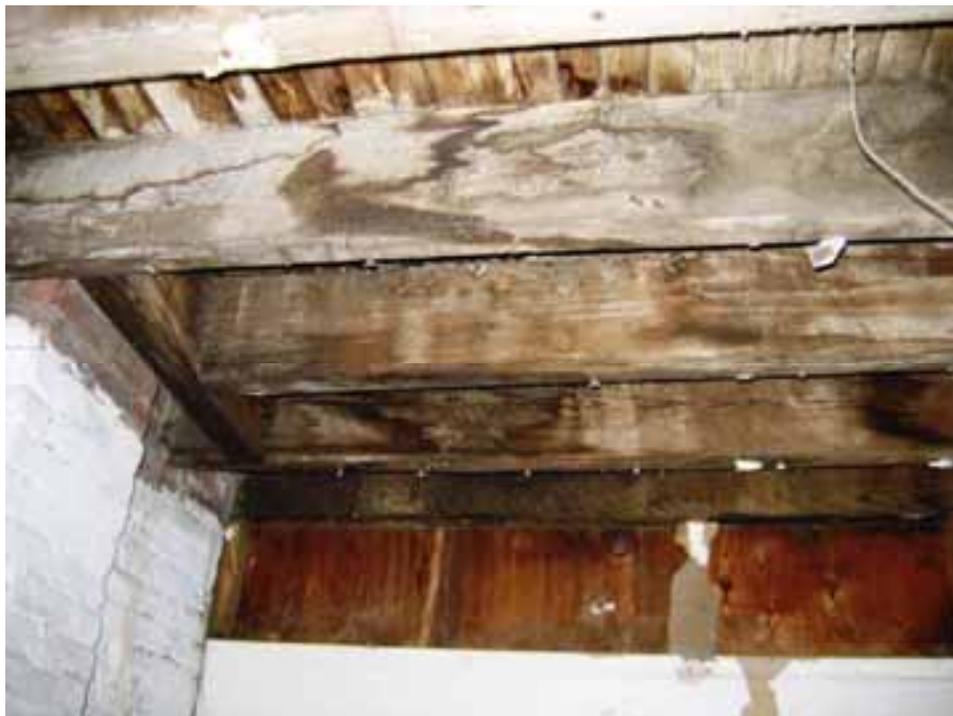
Photograph 1996-50-D

1. The basement entrance area shows minor water damage with wet patches on the ceiling and mold on the timber joists (see photo D).

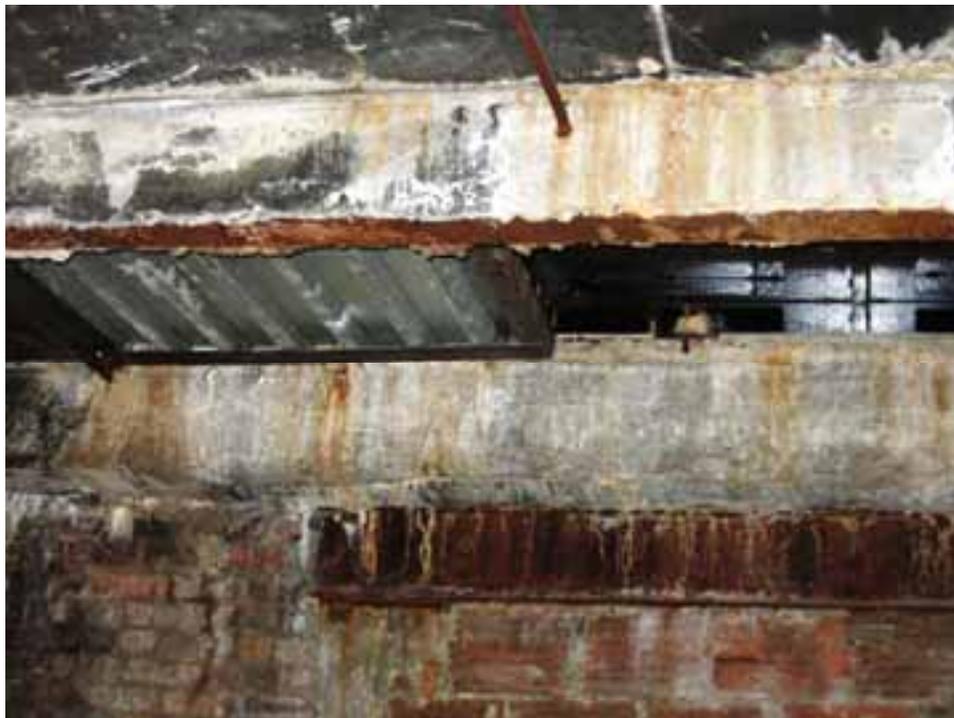
Photograph 1996-50-E

2. The water damage is evident by heavily corroded steel beams on the south side of the building (see photos E and F), cracks in the exterior and interior walls with mold, wet patches (see photos G, H and I), mold and wet patches on the roof timber beams with deflection (see photos J and K).

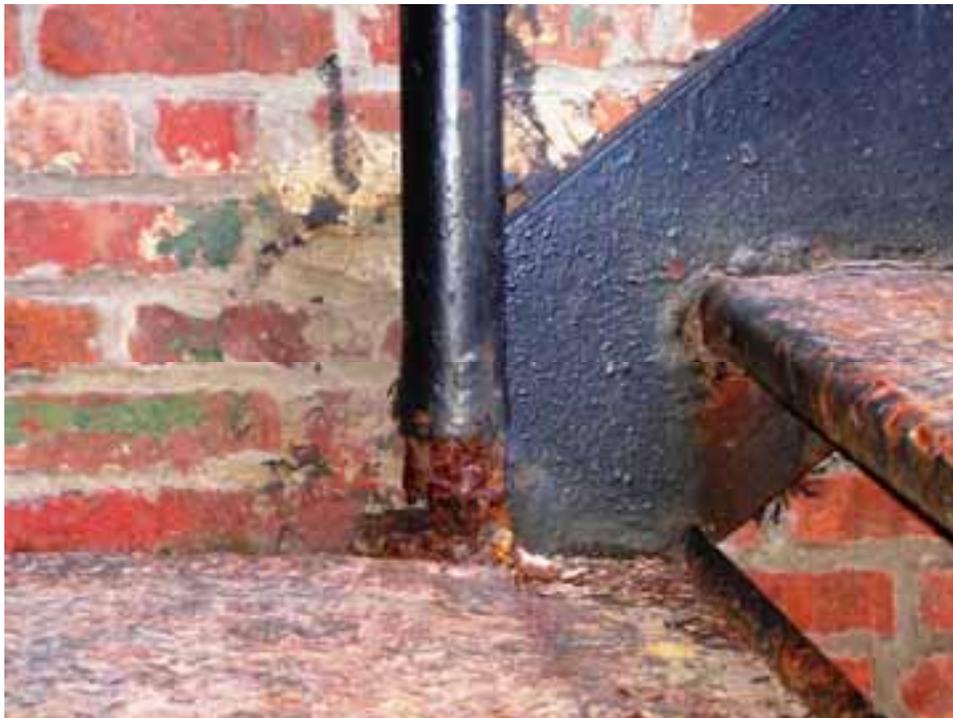
Photograph 1996-50-N

5. The exterior steel stair is in poor condition with heavy corrosion on all members, a hole in the pipe column due to severe deterioration (See photos N, O and P), bent and buckled steel angle column in the entrance area, probably due to collision damage (see photo Q).

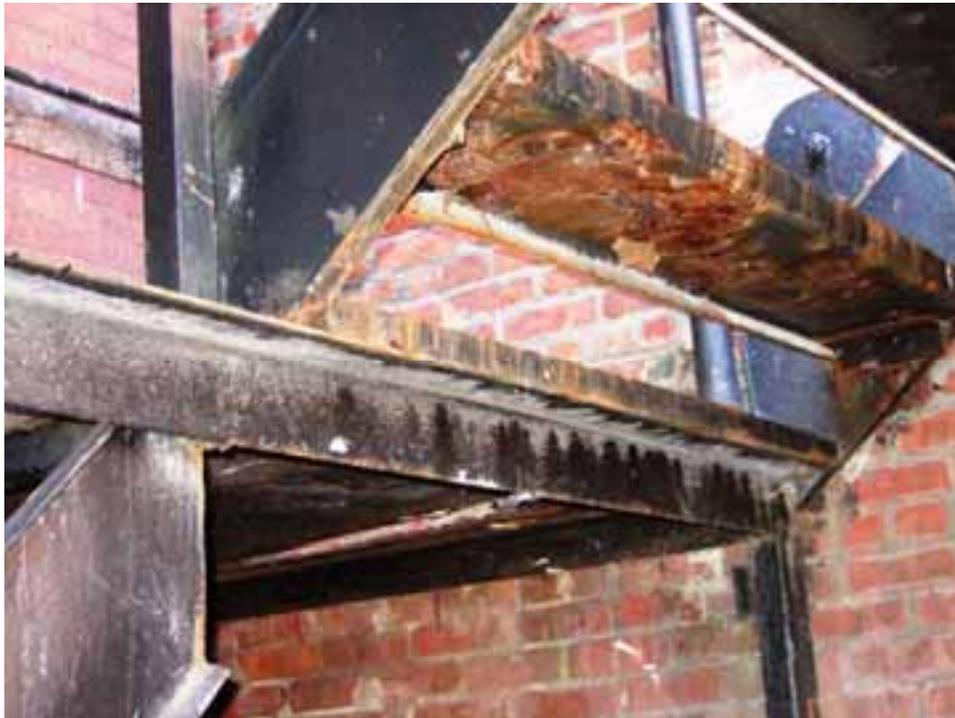
Photograph 1996-50-S

6. One steel column supporting the stair has no anchor bolts (See photo R) and, at the first landing, the steel plate is lifted up and detached from its support due to severe deterioration (see photo S).

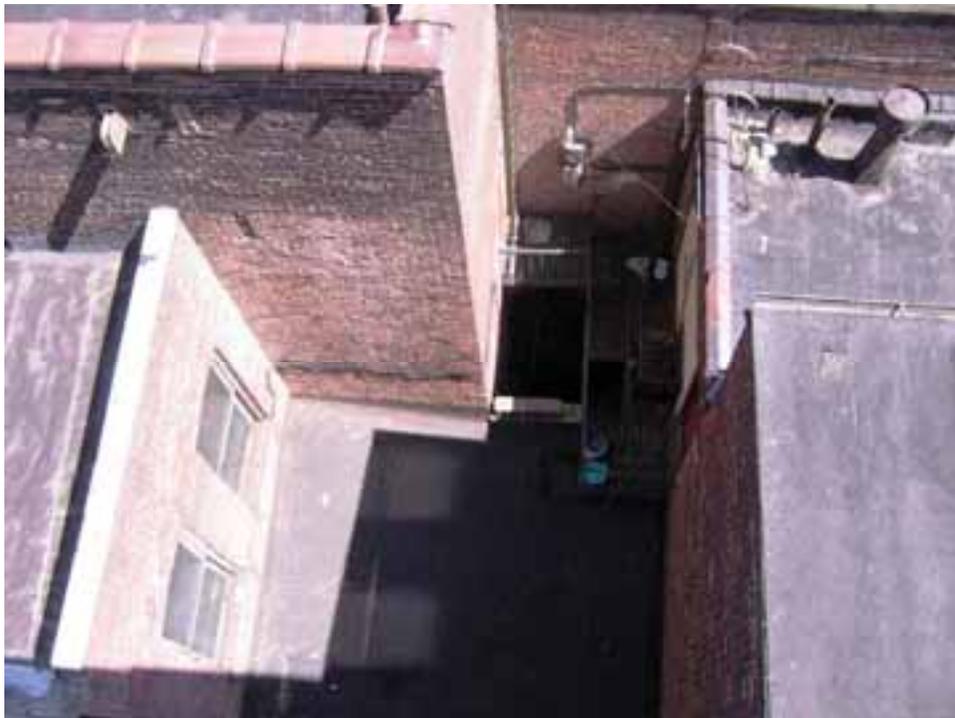
Photograph 1996-50-T

- *“the fire escape and ladder in the courtyard on the building's south side does not provide easy egress from the building”*. Earth Tech concurs with this statement (See photo T).
- *“The masonry on the north parapet appeared to be leaning towards the front loading area and showed signs of movement”*. Earth Tech did not observe this condition (see photos U and V).

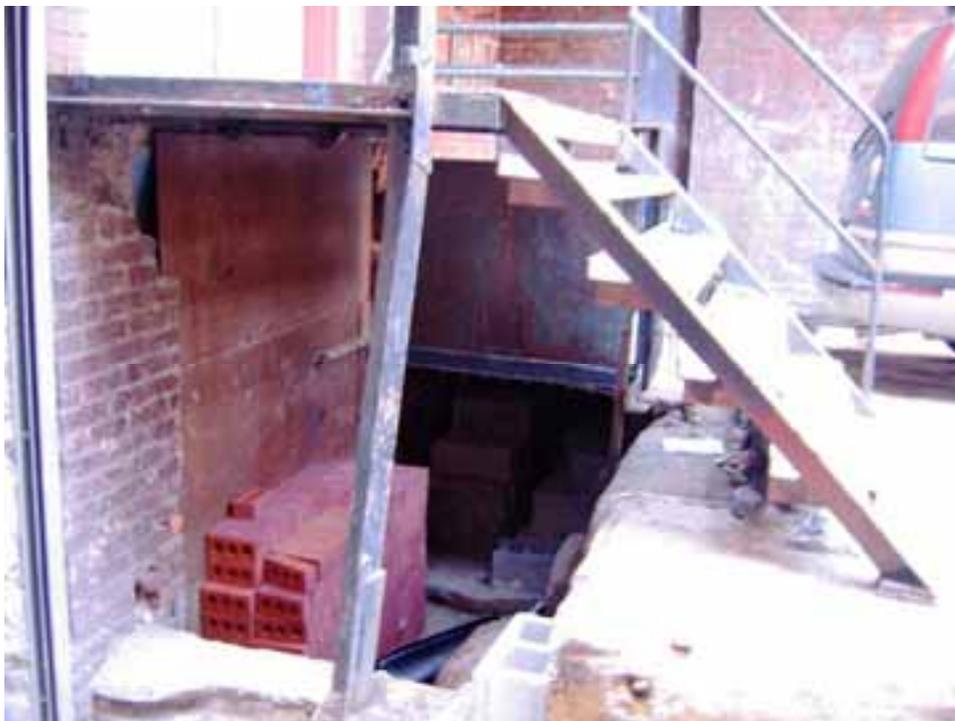
Photograph 1996-50-Z

- The flight of exterior stairs (at north façade) leading from grade to the first floor is missing a handrail on one side (See photos Z and AA). The first floor stair landing doesn't match the first floor slab elevation, and there is a gap between the two (see photo AB). These are safety hazards.
- On the day of the survey, Earth Tech observed water ponding in the basement above the floor drain. According to the occupant, this happens “*every time after it rains*” (see photos AC and AD).
- The sidewalk in front of the building on West 130th Street is in poor condition with cracks and spalling, presenting a safety hazard to pedestrians (see photo AE).

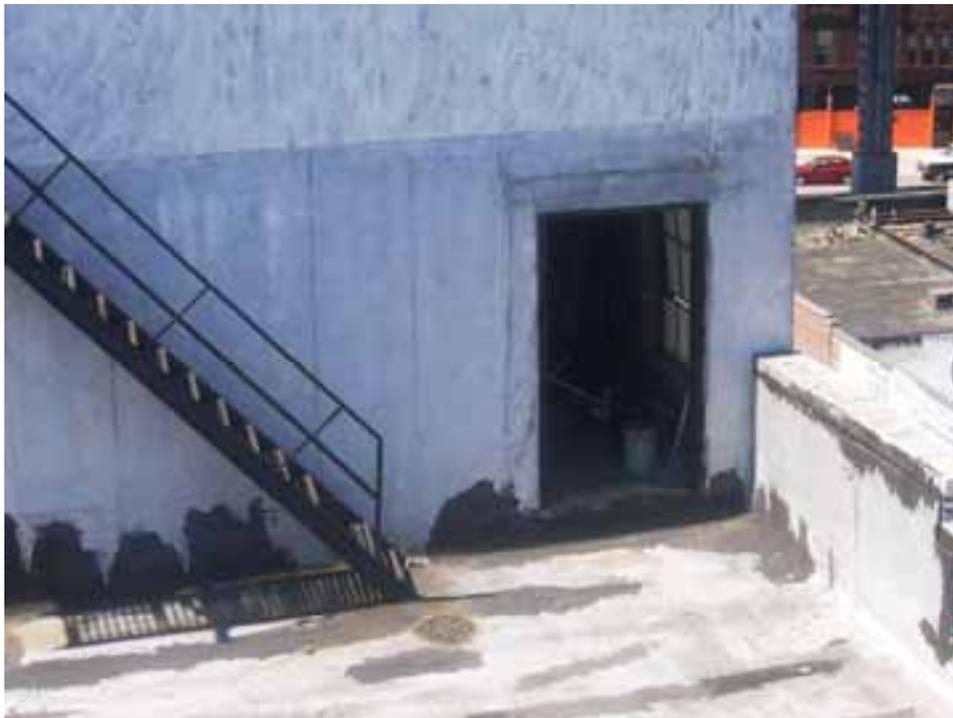
Photograph 1996-56-D

Earth Tech could not verify any signs of ponding water as previously observed by AKRF. The building's exterior has minor cracks including the roof top structures (see photos C and D). Various locations show lintels with deflection (see photo E). The sidewalk is in fair condition (see photos F and G).

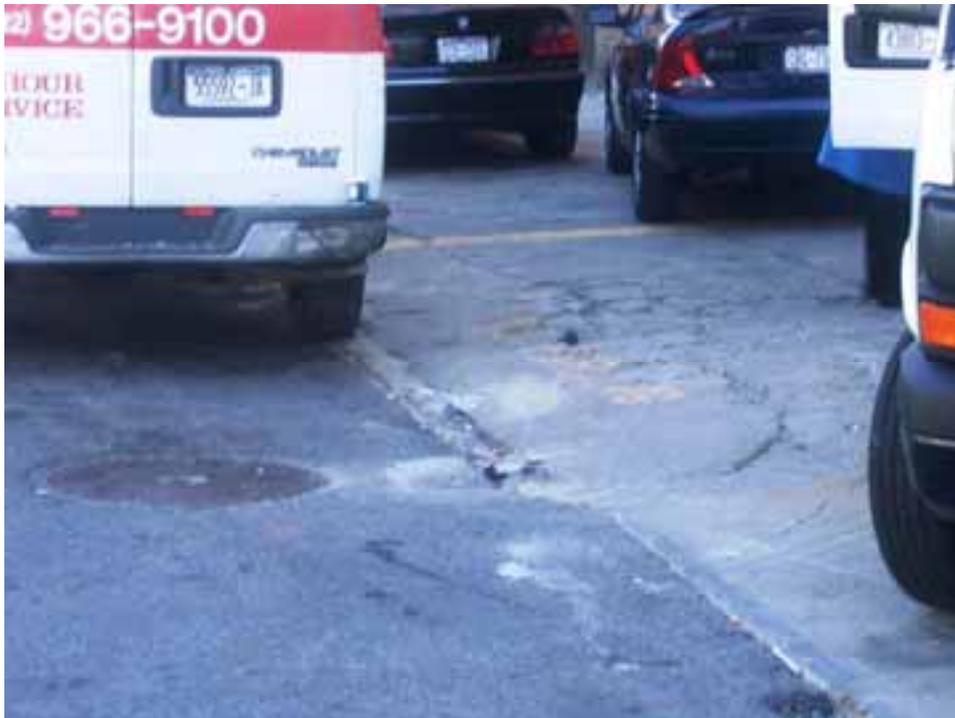
Photograph 1996-56-F

Earth Tech concurs with the AKRF evaluation of the sidewalks, which were listed as "*in fair condition, with some cracking on West 125th Street and spalling in one panel on West 130th Street*" (see photos H and F). At West 130th Street, cars are routinely parked on the sidewalk, - a safety hazard for pedestrians (see photo F and G). On the day of survey, Earth Tech observed an excessive amount of litter on the sidewalk at West 130th Street (see photo G).

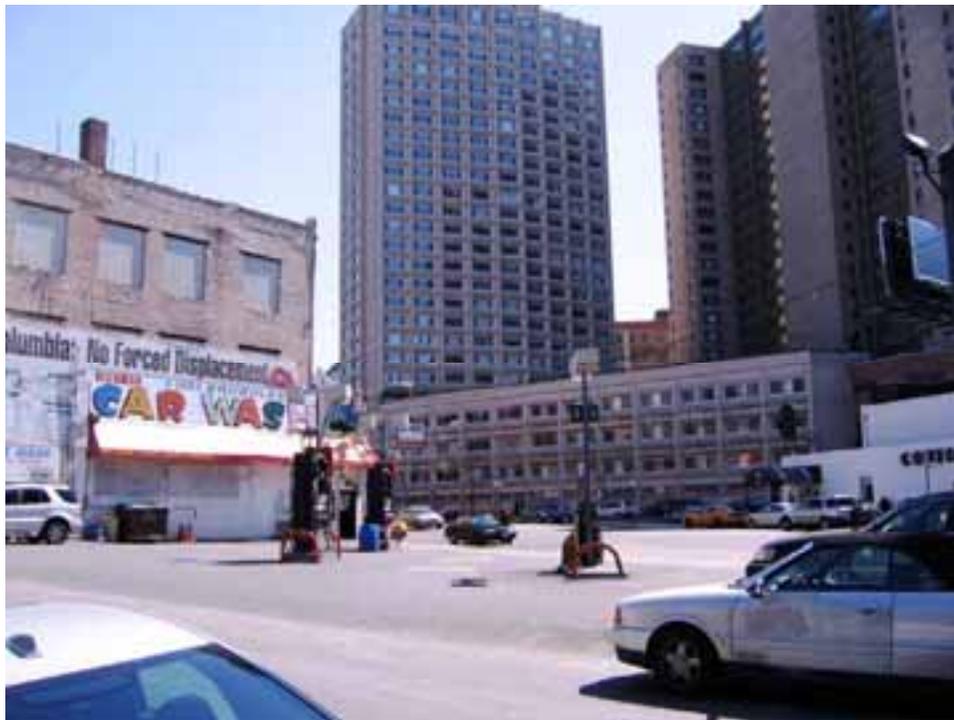
Photograph 1996-61-A

Earth Tech concurs with the AKRF/Thornton Tomasetti's evaluation of the asphalt-paved sidewalk (see photo A). In addition, Earth Tech noted the following safety concerns:

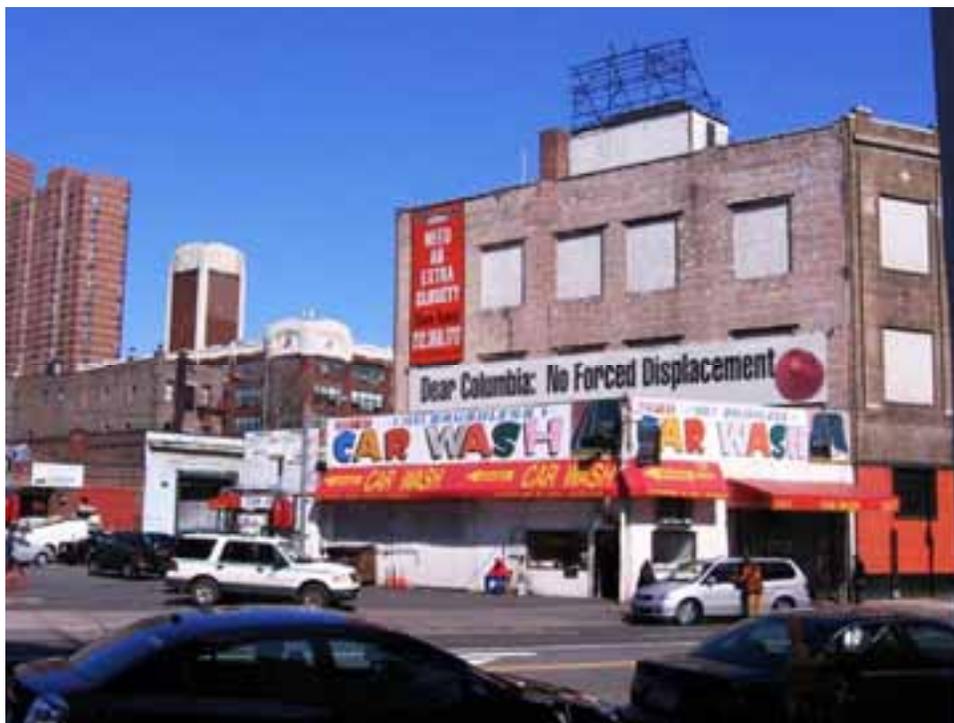
Photograph 1996-61-B

The west and south walls have minor cracks, with the window on the south wall having minor cracks and spalls (see photos B and C). AKRF reported exposed timber roof joists at the north façade; Earth Tech was not able to verify that. The roof membrane was not available for inspection. The sidewalks and curb cuts appear to be in fair condition with minor cracks, spalls and a displaced catch basin cover (see photos B, D and E)

- At the West 130th Street sidewalk, a steel curb at the street storm drain has been shifted from its location and turned on its side creating a potential tripping and safety hazard for pedestrians (see photos S and E).
- Cars routinely parked on sidewalks, which is a safety concerns for pedestrians (see photo B).

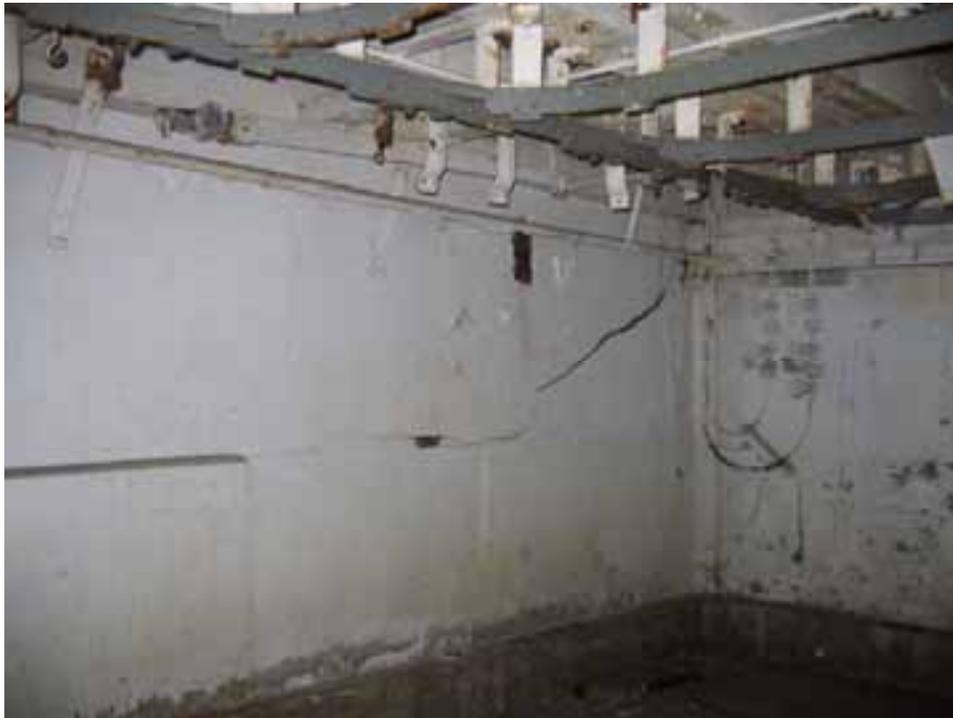
Photograph 1997-1-C

At the time this site was inspected by Earth Tech, on February 20, 2008, no interim or permanent repairs to correct or mitigate the reported instances of structural damage, distress or instability were found where inspection was possible. The deficiencies in the former meat wholesale area remained evident, including: a wide full height vertical crack and a wide separation in the exterior wall along Twelfth Avenue due to unequal settlement of the buildings (see photos A and B); settlement and medium random cracking of the floor slab; a wide diagonal and horizontal crack in east and west basement walls of the meat shop indicating imminent settlement of the building (see photos C and D).

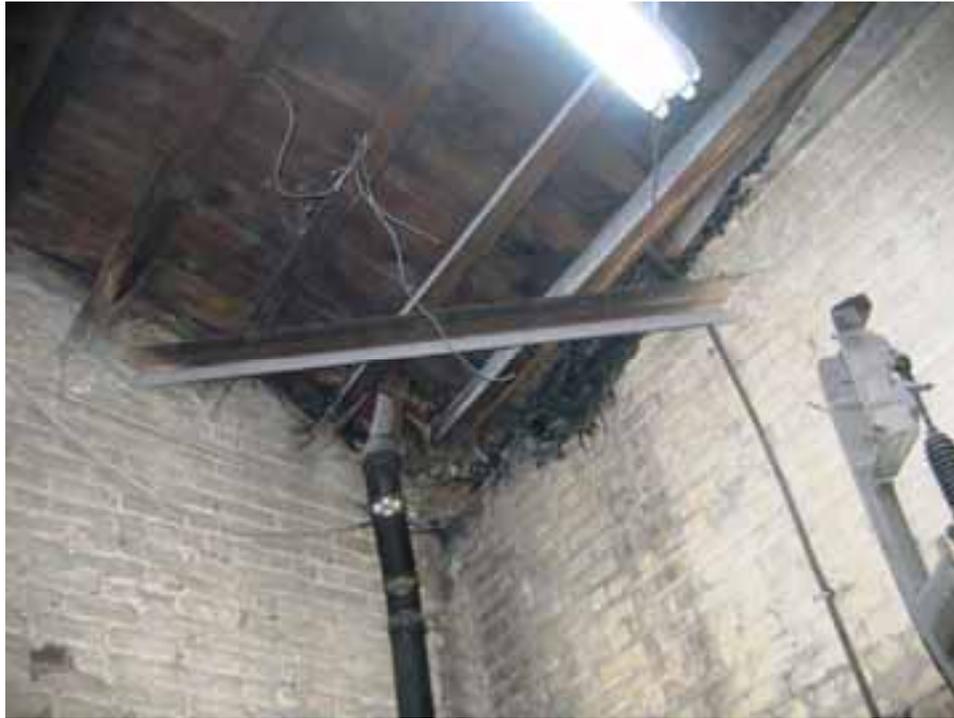
Photograph 1997-1-G

The deficiencies in the auto repair shop also remained evident, including: wide vertical cracks in walls (see photos E and F); water stains and severely water damaged and deteriorated timber roof joists at north east corner of the building, provided with a diagonal support (see photos G, H and I); significantly rotated timber roof joists (see photos J and F).

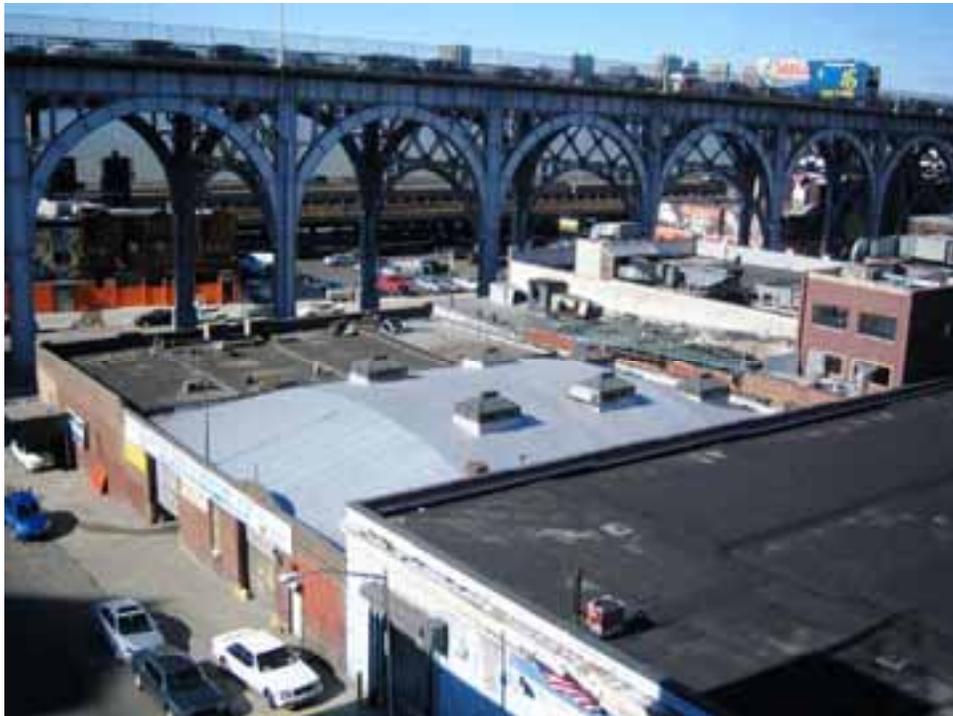
Photograph 1997-1-M

- The sidewalk at West 130th Street is routinely used for parking cars, which have contributed to the overall poor condition of both sidewalk and curbs and is hazardous to pedestrians (see photos M and N).
- An advertising panel on the West 130th Street façade is attached haphazardly and is a safety concern to pedestrians (see photo O).
- On the day of the Earth Tech survey, the spray painting inside the automotive repair shop was observed without proper ventilation – a health hazard for employees (see photo P).
