SITE CONDITION: POOR

Block 1997 Lot 14

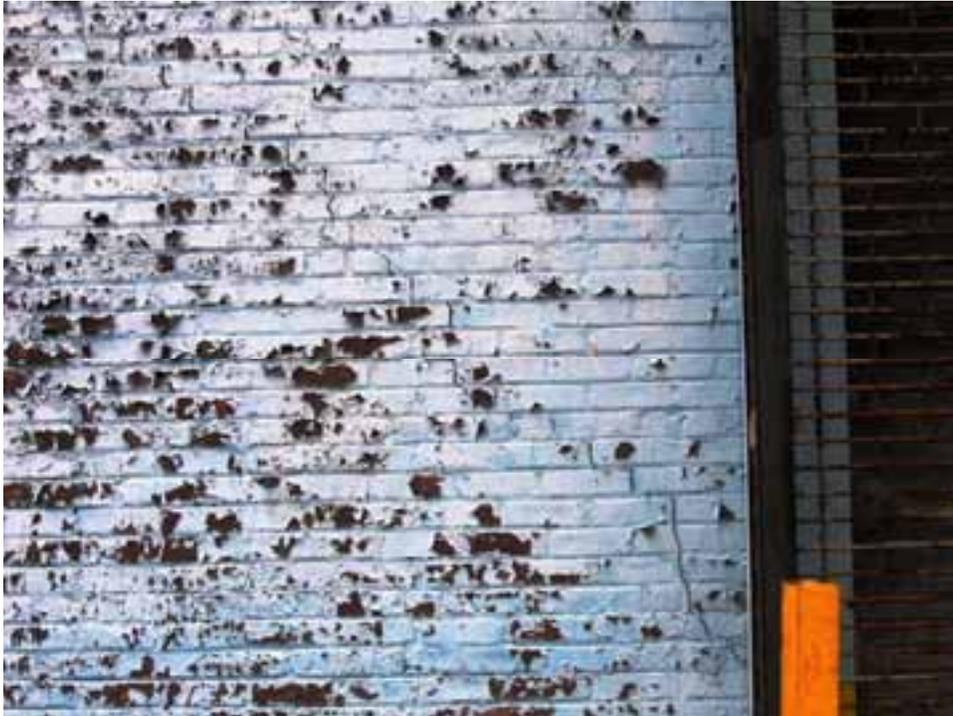
Photograph 1997-6-K

4. Extensive water infiltration is evident and has caused timber joists, steel framing and masonry wall to deteriorate (see photos I, J and K).
5. The timber joists throughout the building exhibit discoloration, severe splitting and cracking, mold and wet patches and show significant rotation (approximately 10 to 15 degrees) at first floor (see photos L and M).

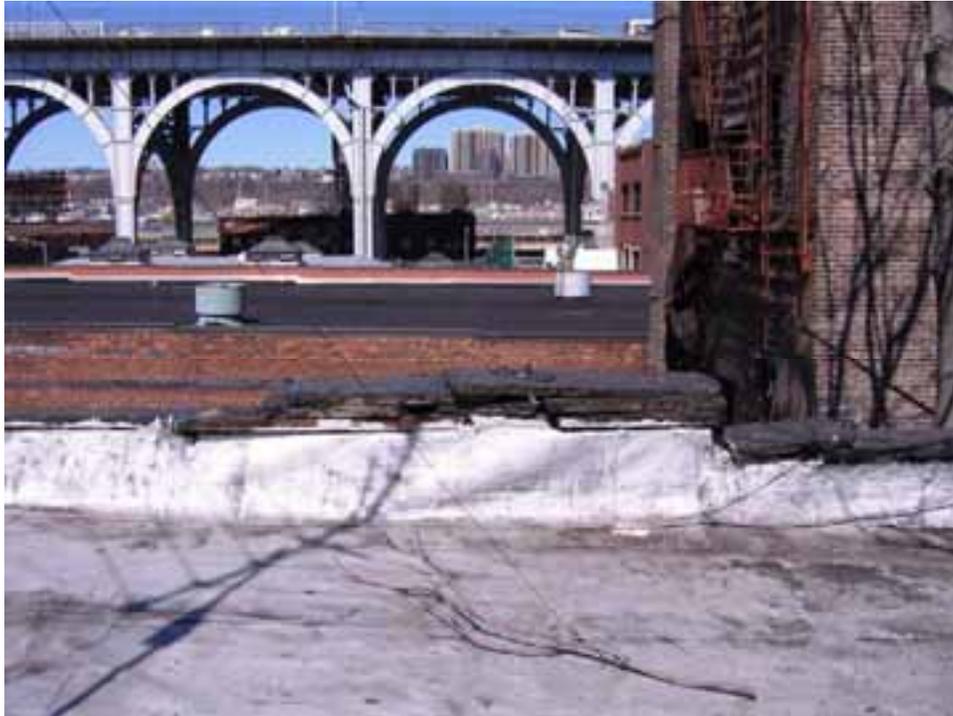
Photograph 1997-9-AC

- On the roof, which could be accessed only with removable ladders, Earth Tech noticed several parapet coping stones (north and east building) that appear to be stacked and not properly secured (see photo AC); this might present a safety hazard for people working in the yard to the west of the building.

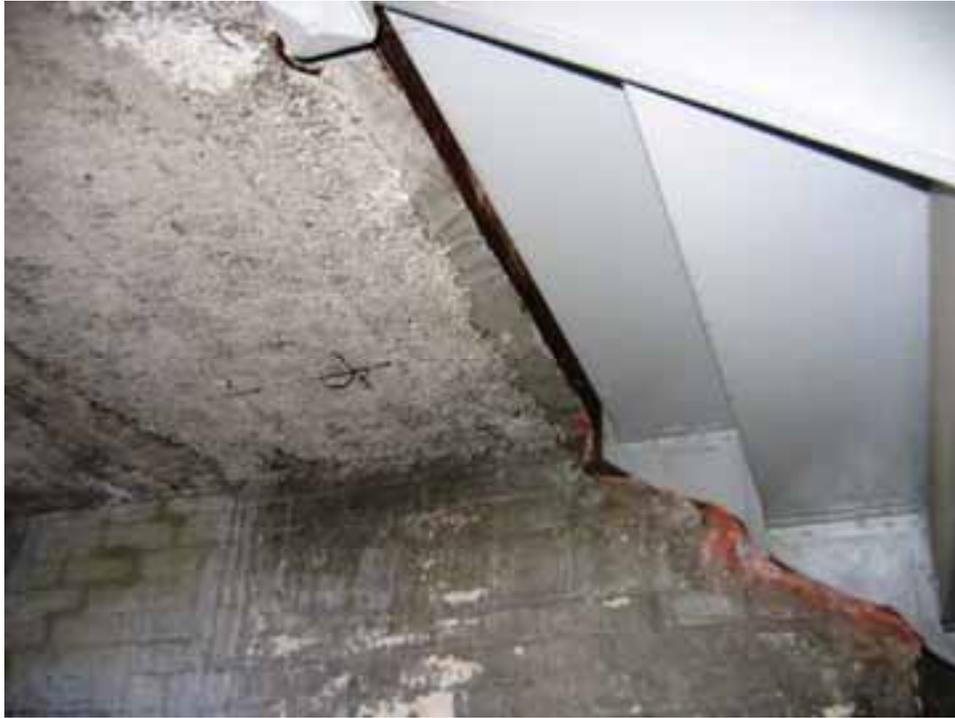
Photograph 1997-14-I

1. Signs of efflorescence and wide crack on masonry walls (see photos B, C, D, E, F, G and H).
2. Cracks and spalling on the underside of the concrete slab. (see photos I and J)
3. Corroding exposed reinforcement bars (see photos K and L).
4. Corroding sheet metal ceiling (see photo M).

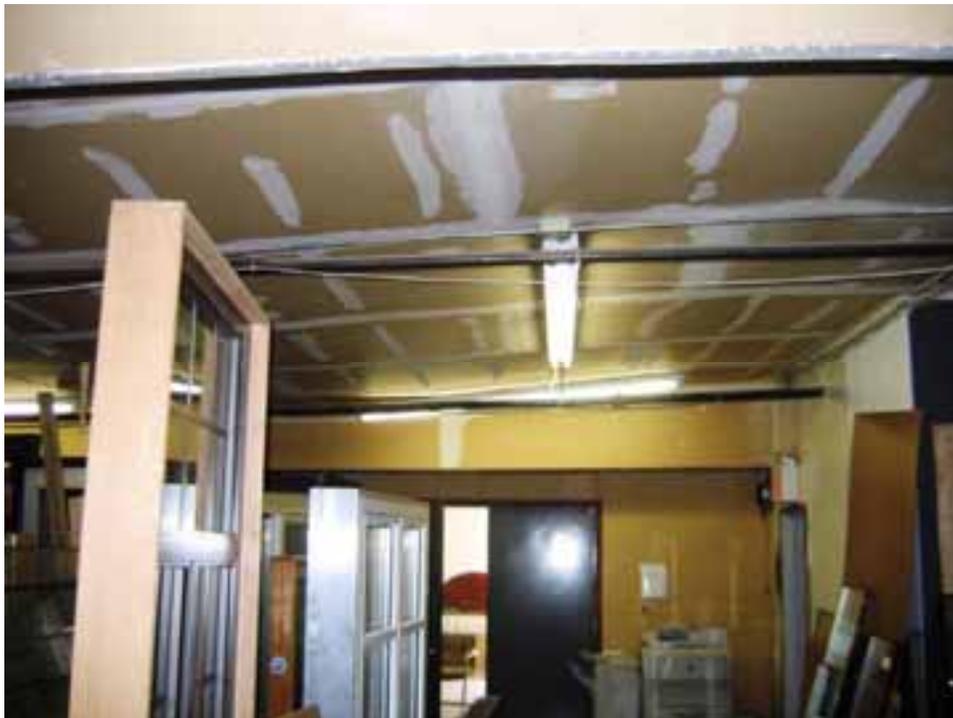
Photograph 1997-14-N

5. Water stains on ceiling (see photo N)
6. Spalling and cracking of west stair's concrete treads (see photo R)
7. Cracked and spalled stucco on chimney (see photo O)
8. Basement floor has numerous cracks. (see photos P and Q)
9. Ponding continues to occur on roof. (see photo S and T)
10. Lower roof is completely covered with moss (see photo U)
11. Sidewalks along West 130th street are in fair condition. Trucks continue to use the sidewalk as a parking area. (see photo V)
12. Staining on first floor ceiling by garage entrance. Possibly from fire damage. (see photo W)

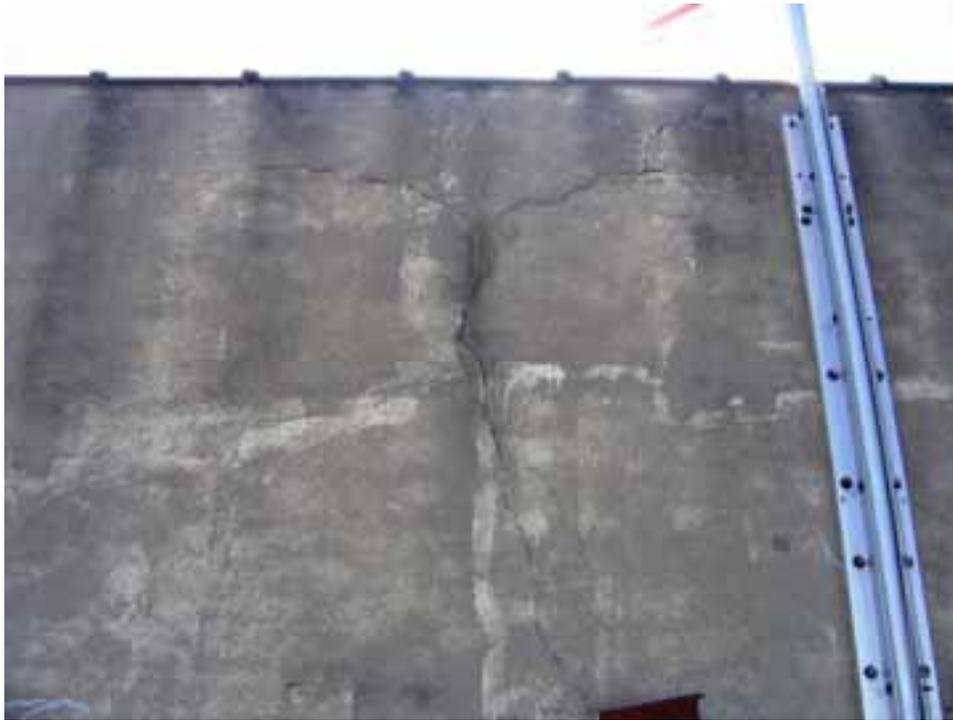
Photograph 1997-14-Y

1. Cracked wall above door lintel to roof top staircase (see photo X).
2. Exterior concrete walls around elevator motor room on roof have cracking (see photos Y, Z, AA and AB).
3. Lintel above elevator motor room entrance is sagging (see photo AC).
4. Ceiling in elevator motor room is in poor condition and reinforcement is exposed with signs of corrosion (see photo AD and AE).
5. Second floor ceilings are not level and show water damage (see photos N and AF).
6. Cracks above window lintel on second floor (see photo AG).
7. Stairwell concrete ceilings are in poor condition (see photos AH and I).
8. Vehicle Impact damage to first floor ceiling (see photo AI).
9. Ceiling of back room at the north side of the building has temporary repairs. It was noted previously that the roof is covered with moss (see photo E).

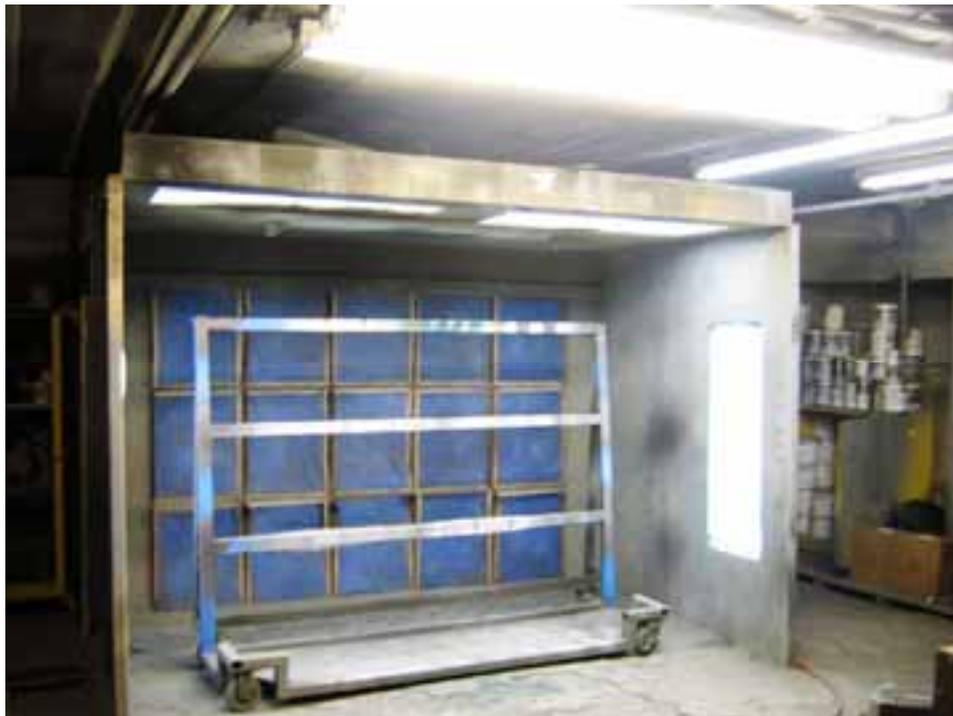
Photograph 1997-14-AJ

- *“There is a spray-painting booth with improper ventilation in the basement”*. Earth Tech concurs with this statement (see photo AJ).
- *“During several site visits, the roll-up door in front of the emergency exit door in the west stair was closed, blocking egress through this door”*. Earth Tech concurs with this statement; the shutter door was closed and padlocked on the day of Earth Tech’s survey (see photos A, AJ and AK). This is a safety hazard.
- *“Egress to the roof on the east side of the building is also blocked by a padlocked access hatch”*. Earth Tech concurs. Also, the roof access from the stairwell was bolt latched at top and bottom (see photos AL and AM).
- AKRF reported severely damaged portion of the sidewalk and sidewalk parking as safety concerns. Earth Tech concurs with this statement (see photos A and AN).

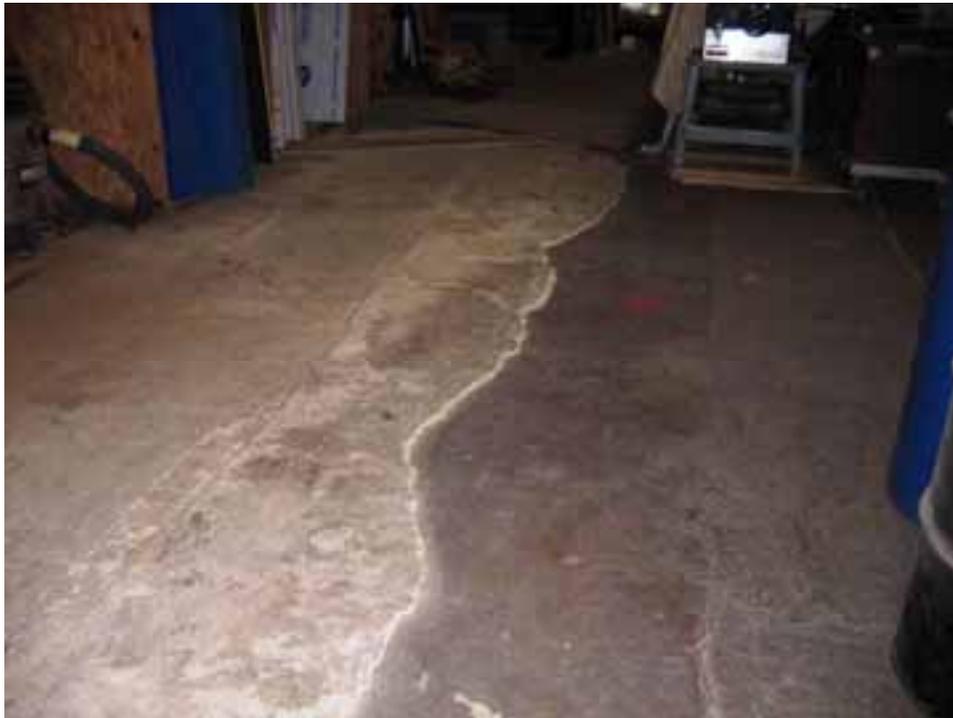
Photograph 1997-14-AO

- Concrete floor slab at basement has cracks, spalls, patches, and holes, covered with plywood (which could be easily moved from its location), - all presenting tripping hazards (see photos AO, AP and AQ).
- The plywood floor in the elevator cabin is damaged and presents a safety concern (see photo AR).
- The concrete surface of treads in both stairwells is spalled and chipped off in several locations (see photos AS and AT).
- There are signs of efflorescence on the brick walls and water damaged GB ceiling in several locations throughout the building (see photos AU, AV and AW).
- Most of the roof parapet is lower than 42 inches required by code (see photo T); this is a safety concern.
- Earth Tech noted haphazardly mounted electrical wiring in the office (see photo AX).

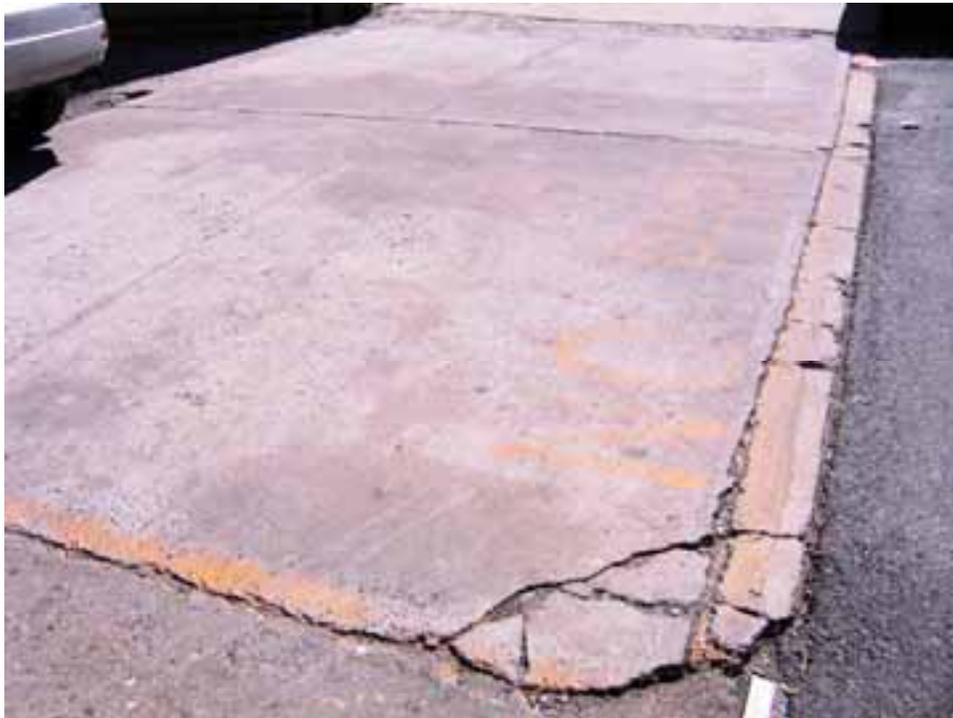
Photograph 1997-17-E

1. The site consists of a gravel surface parking lot, with some weeds growing the east and west sides (see photo B).
2. The security fence topped with barbed wire at the entry way appears to be in good condition, although minor corrosion has begun on the barbed wire fence (see photo C).
3. The sidewalk and curb cut on West 130th Street are in fair condition, although there still remains some wide cracks (see photos D and E)

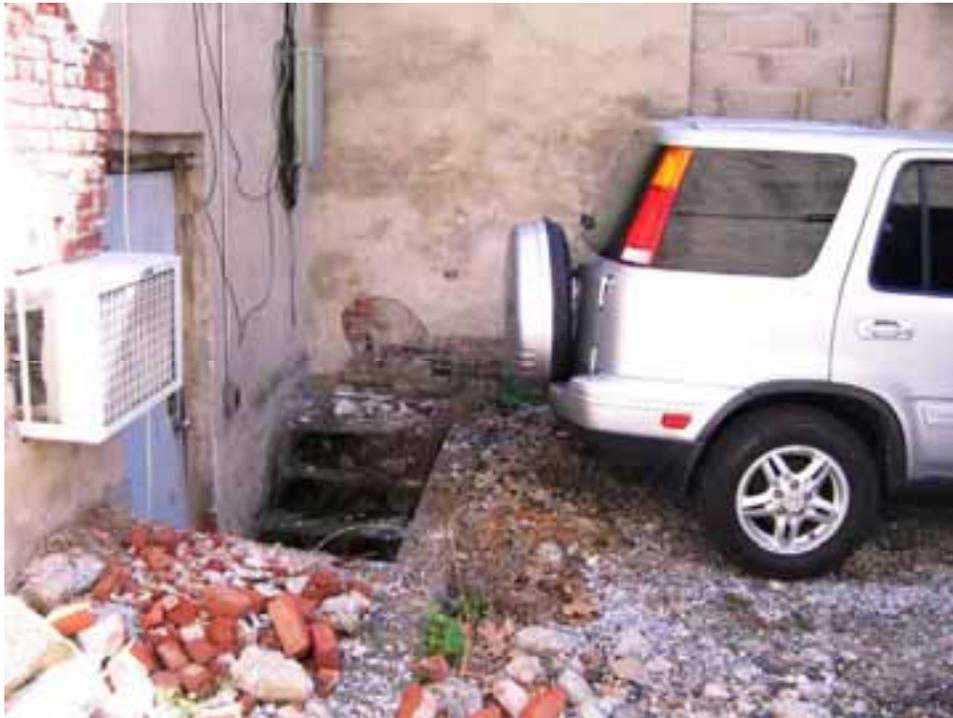
Photograph 1997-17-I

- The above mentioned egress door opens into an exterior stair landing, which is approximately 30 inches below the grade level of Lot 17. Neither parapet nor railing is provided at the stair, making this condition a safety hazard (see photos H, I and J).
- Construction debris at the north portion of the lot (see photo K), and spalled concrete at the south side (see photo L), present a safety concern.
