SITE CONDITION: CRITICAL

Block 1997 Lot 21

LOCATION, USE, ZONING, AND OWNERSHIP

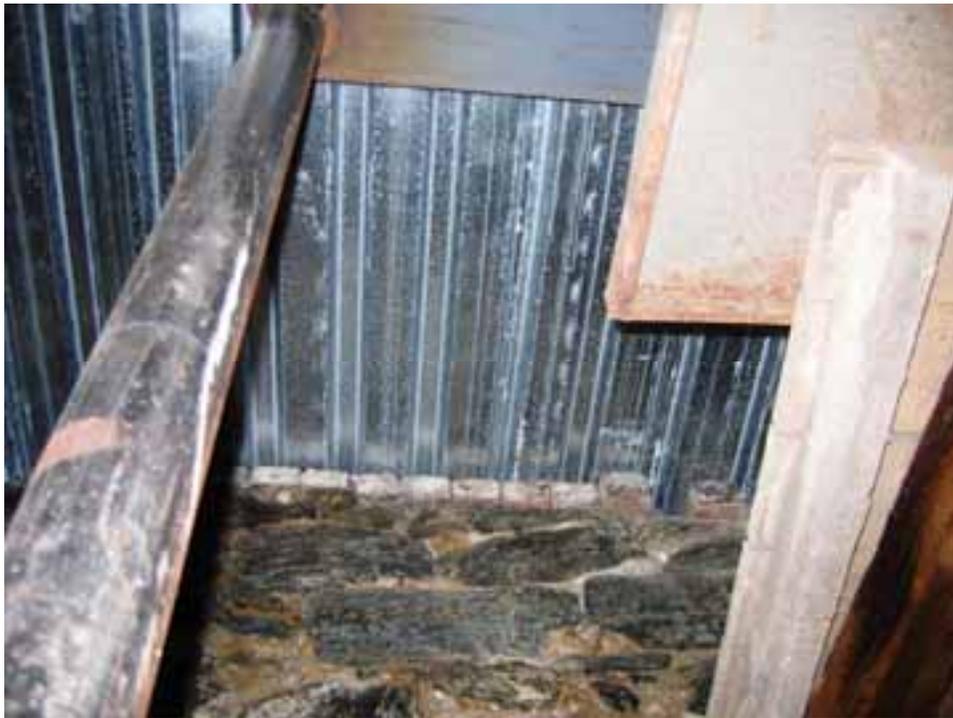
Photograph 1997-18-T

A sign on the West 130th Street façade, indicates that the building was declared unsafe by the Fire Department of the City of New York in March of 2007 and locked (see photo R). Columbia University has performed some minor upgrades to the West 130th Street building façade, including: blocking with CMU several openings on the first floor; boarded missing windows with PCB plastic sheets; and painted the first floor of the façade (see photo S). Also, emergency repairs were conducted at the sidewalk vault on the southwest corner; a new sidewalk slab (concrete slab on corrugated metal deck) was installed by Columbia University (see photo T).

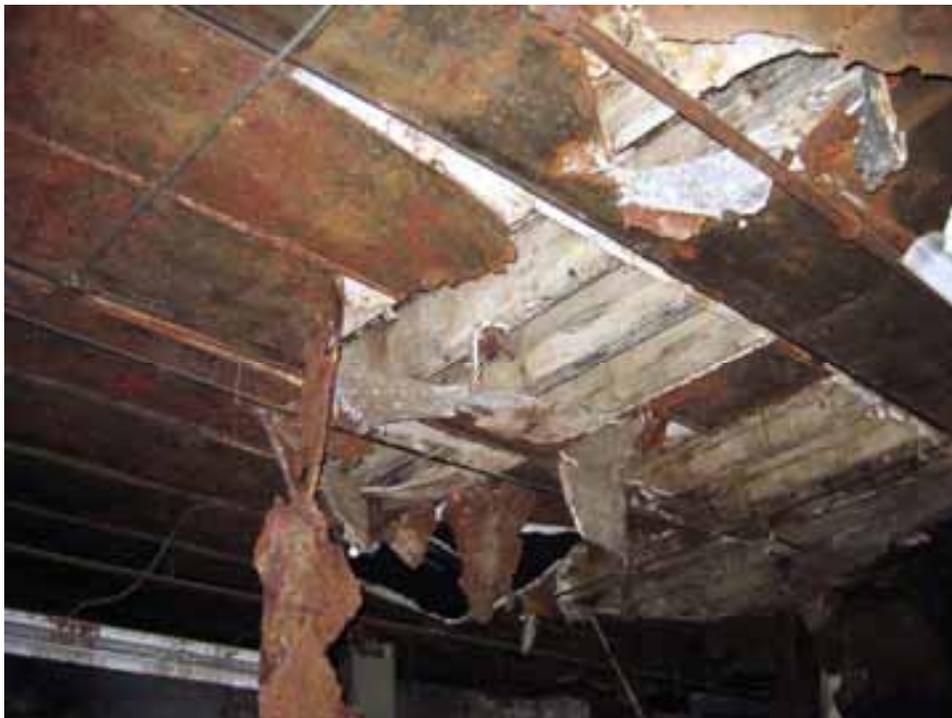
Photograph 1997-18-U

Earth Tech concurs with all the health and safety concerns listed in the AKRF report (see photos U, V, W, X, Y, Z, AA, AB and AC). The building is unsafe and essentially unusable in its current condition.

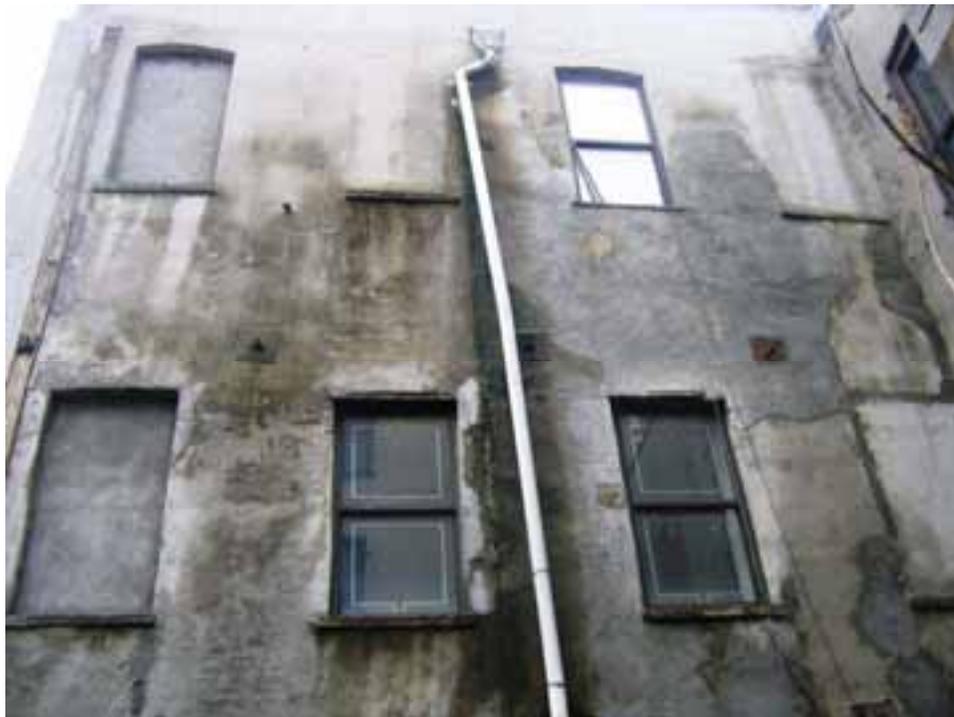
Photograph 1997-21-D

including: efflorescences, mold, and water stains; and collapsed ceilings at all floors (see photos F, G, H and I). The steel lintels in the north wall are severely deteriorated, and extensive mold and efflorescences are present around windows, all due to water infiltration (see photo J). The south roof parapet shows a wide stepped crack, and plaster is hollow with random cracking (see photos K and L). A medium crack in the north wall above the first floor is visible, permitting leaks into the building. The crack and damaged stucco is patched but water continues to infiltrate the building, causing extensive water damage (see photos C and D).

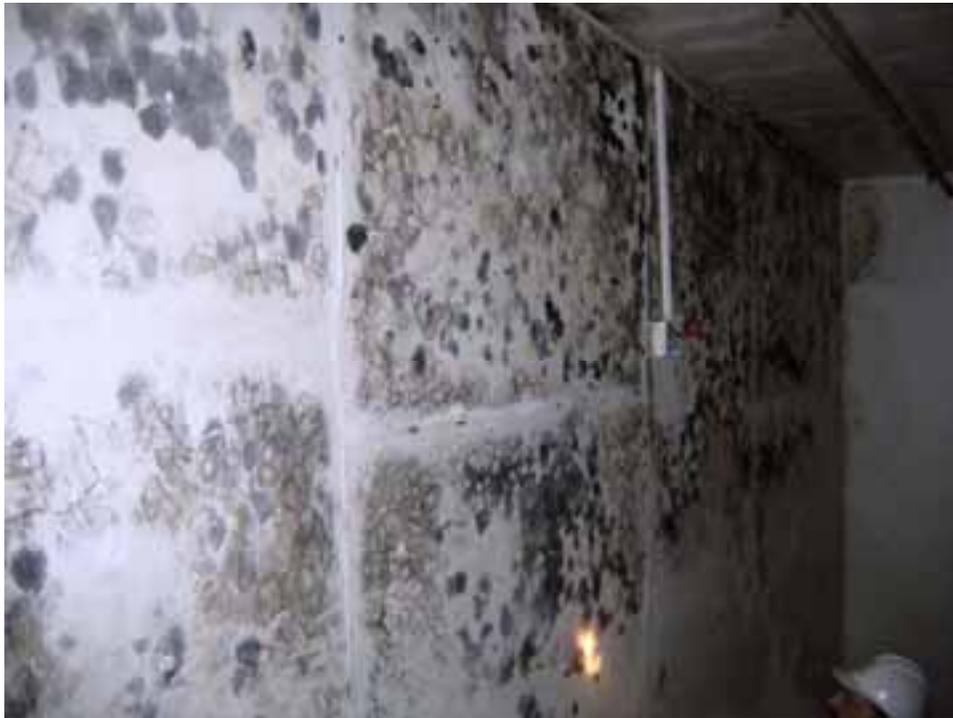
Photograph 1997-21-M

- *“A significant amount of mold was observed throughout the building... which is a health concern“.* The extensive mold was observed throughout the building's north side and along the stair walls (see photos M, N, O and P).
- A 4' wide gap between the north edge of the yard and a building wall on Lot 44 *“presents an unsafe condition for those in the yard as there is no barrier between the yard and the gap”* (see photos Q and R).

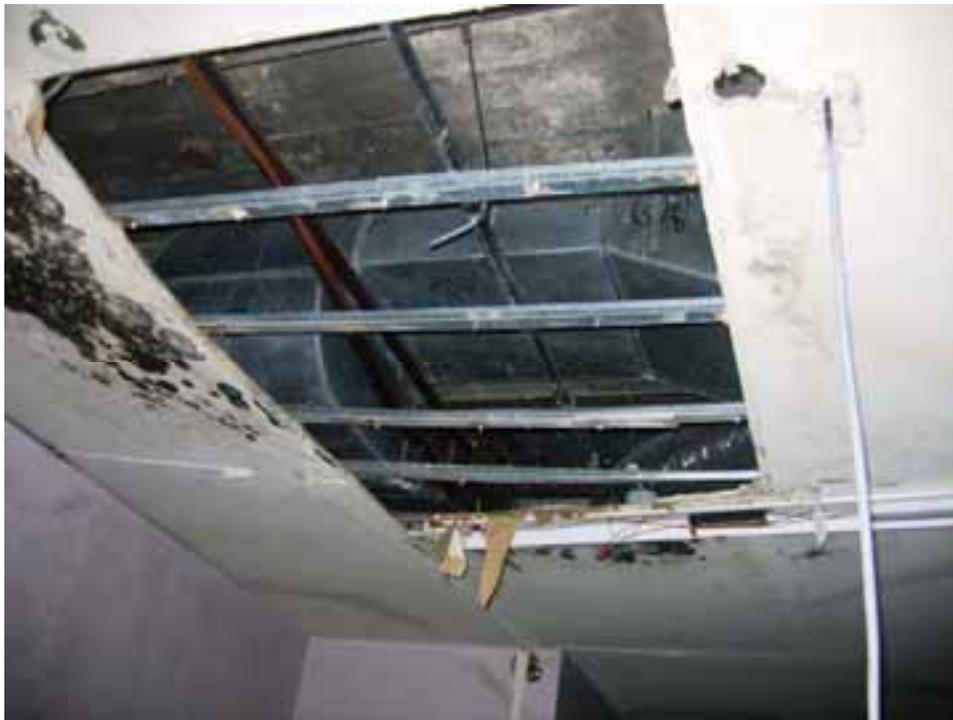
Photograph 1997-21-T

- Areas of local collapse of the gypsum board ceiling and debris on the floor (see photos S and T);
- Insulation haphazardly hanging from ceilings (see photo U); and
- The Fire Department has shut down the building.

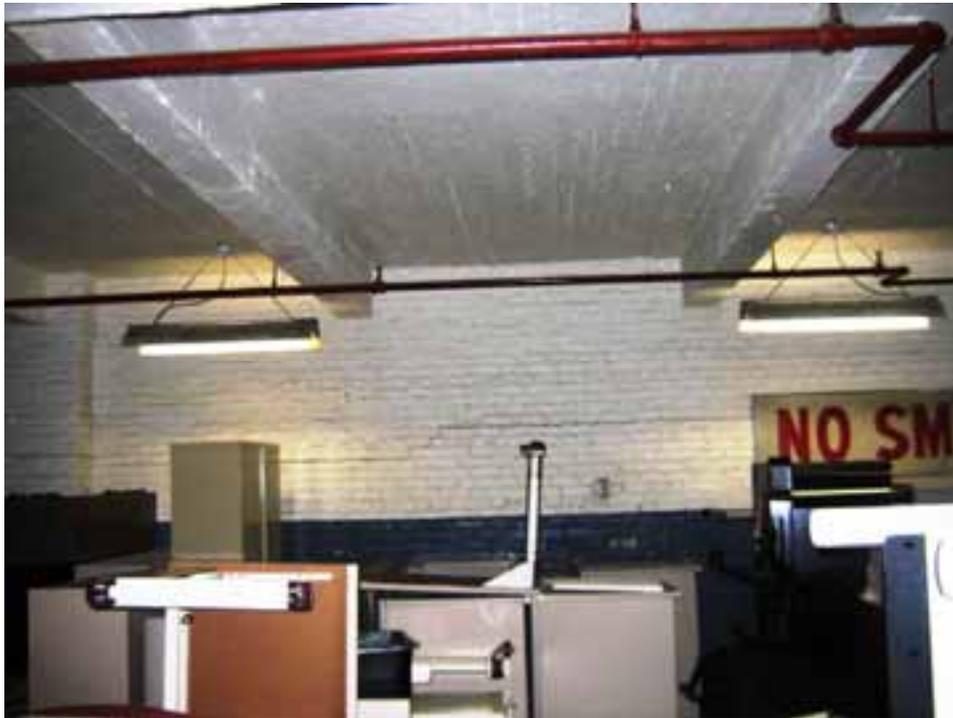
Photograph 1997-27-E

3. Horizontal crack along the first floor masonry wall has not been repaired (see photos E and F).
4. Water infiltration on the east masonry wall has caused the need to remove a portion of the drywall and ceiling damage (see photos G, H and I).

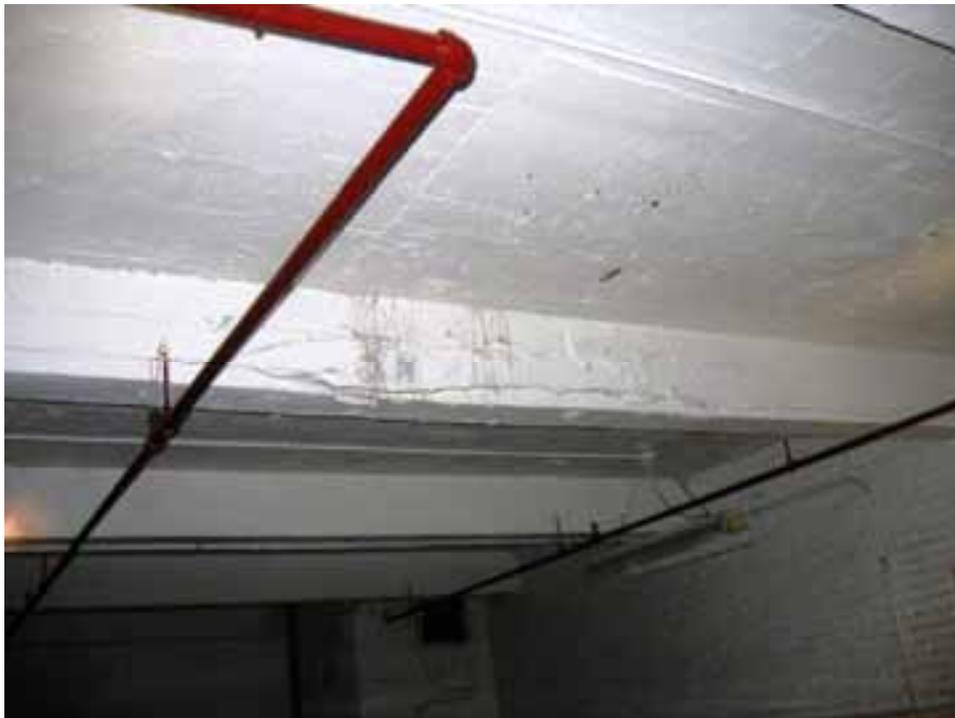
Photograph 1997-27-J

5. Cracking and spalling in a few locations along the roof framing and first and second floor slabs (see photo J, K, L, M, N and O).
6. Water ponding on the roof continues to occur (see photo P).

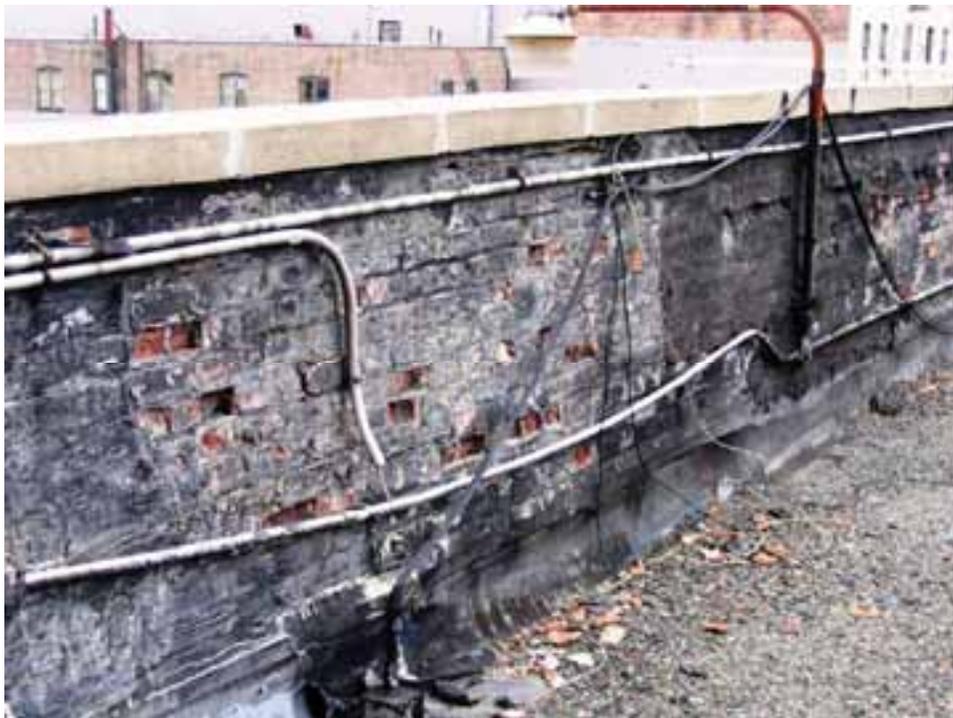
Photograph 1997-27-Q

7. Waterproof coating on the inside face of the south parapet continues to be in poor condition and allowing water infiltration through the roof (see photo Q).

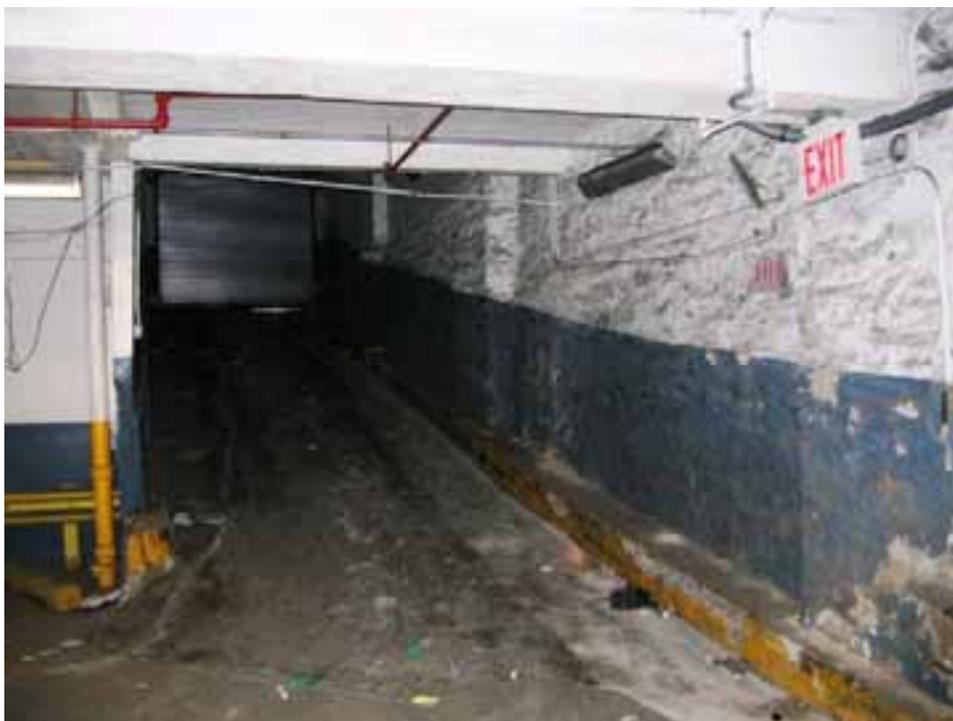
Photograph 1997-27-R

8. Water intrusion along the top of the south basement wall continues to cause deterioration to steel lintels above the openings to sidewalk vaults.
9. Spalling surface and curb along the vehicular ramp from the basement to the sidewalk (see photo R).

- At the basement level, an exit sign points up the ramp where there is no exit door, but an overhead roll-up door only. This is misleading and dangerous, and is a safety concern (see photo R).
- In the basement, a large area of cementitious wall plaster has collapsed; this is a potential health and safety concern (see photo AI).
- On the second floor, paint is peeling off the ceiling - a potential health hazard (see photo AJ and AK).

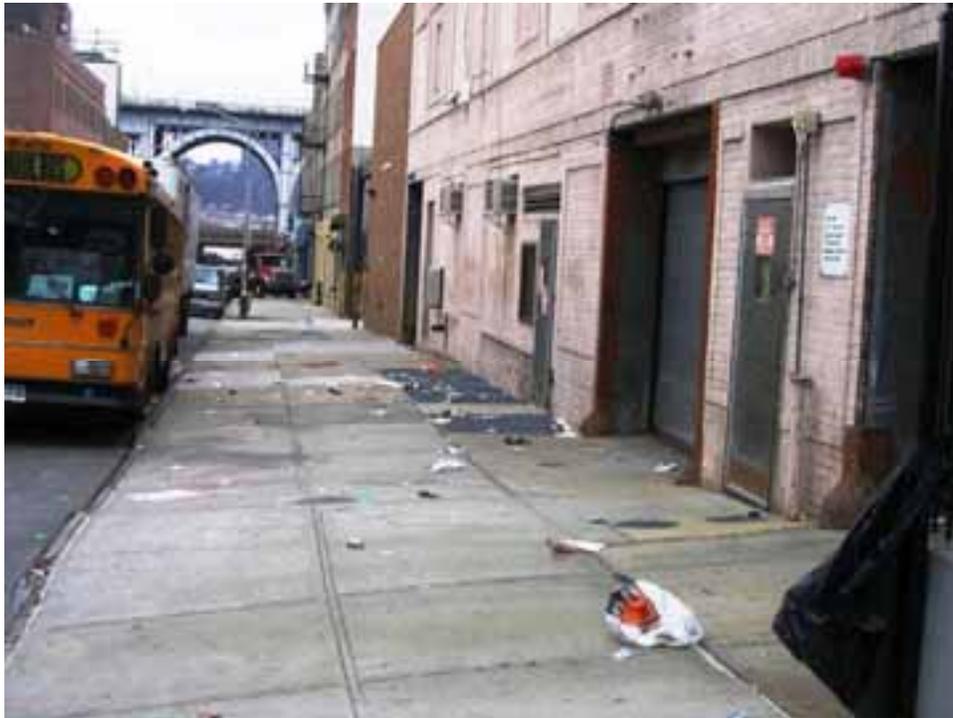
Photograph 1997-27-S

10. The sidewalk and curb along West 130th street are in fair condition (see photos S and T).

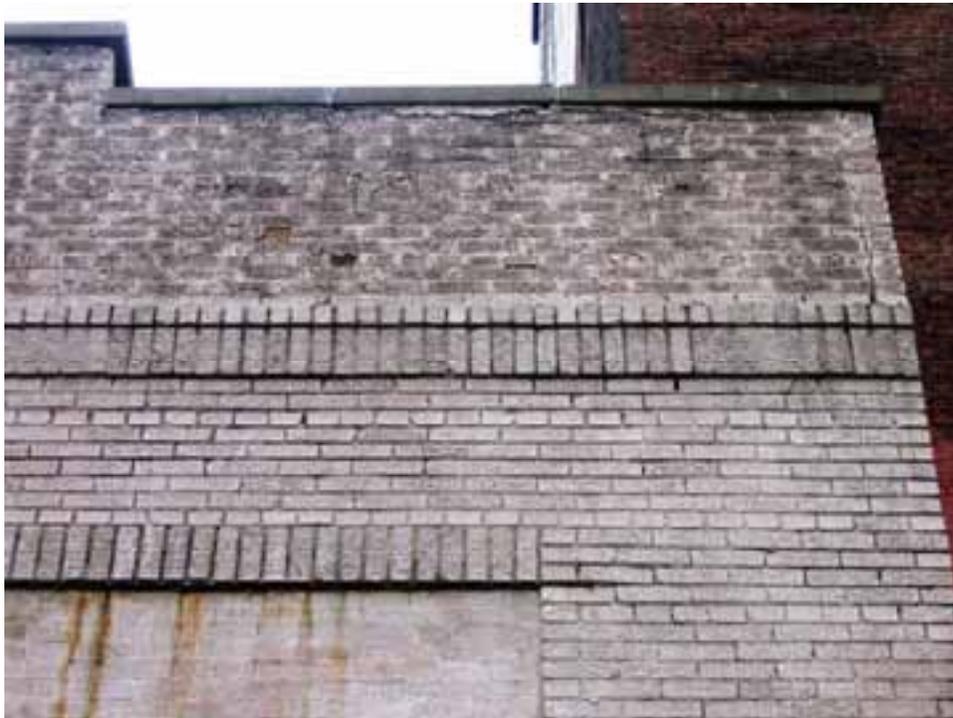
Photograph 1997-27-U

1. The east corner of the south fascia of the building has a vertical crack at the parapet (see photos U and V).
2. The lintel above the garage entrance on the south fascia of the building seems to be sagging as evident by the gap formed with the brick facing (see photos W and X)
3. Crack in masonry wall at south west corner of building along the south elevation. (see photo Y)
4. Concrete facing on masonry wall in boiler room failed (see photos Z and AA).
5. Crack in masonry wall above door lintel (see photo AB).
6. Second floor concrete wall has a vertical crack the height from floor to ceiling (see photo AC).
7. Stay-in-place forms show signs of corrosion causing paint to chip (see photo AD and AE).
8. Chimney along east side of building has separated from the exterior wall of the adjacent building (see photo AF).
9. Beam supporting stair landing is sagging (see photo AG).

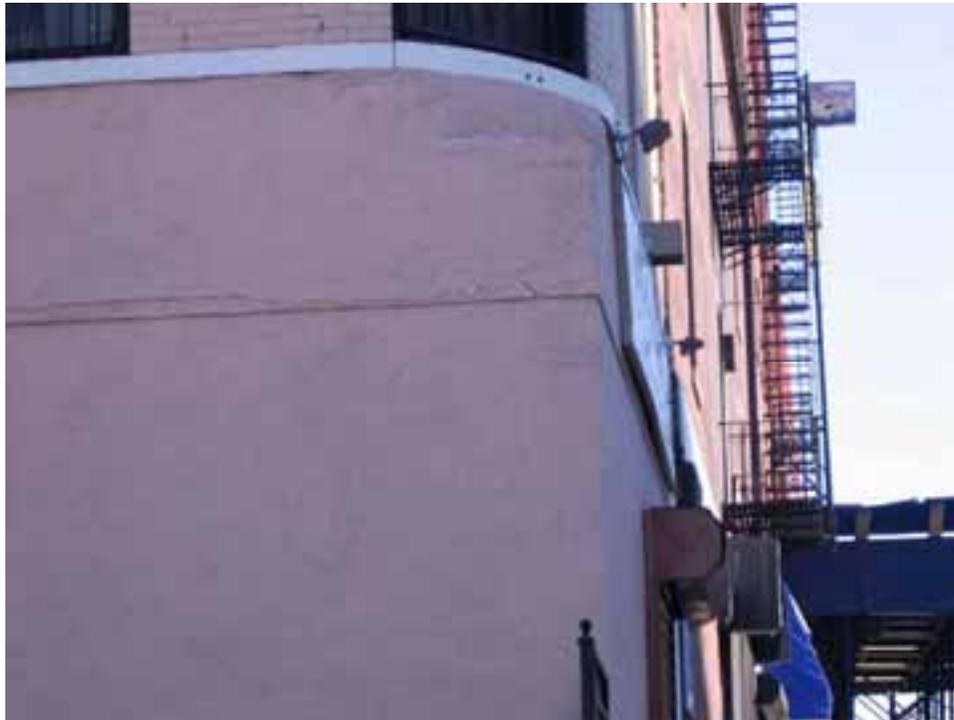
Photograph 1997-29-E

The east exterior wall has a wide step crack with the bricks in need of repointing (see photo B), and the rollup door has step cracks on both sides of its lintel (see photo C). The south east corner of the building has vertical and horizontal cracks, and signs of paint deterioration (see photos A, D and E). The south exterior wall is in need of brick repointing (see photo F). The west exterior wall has wide random cracking typically around the windows (see photo G). The cornice at the south west corner appears to be

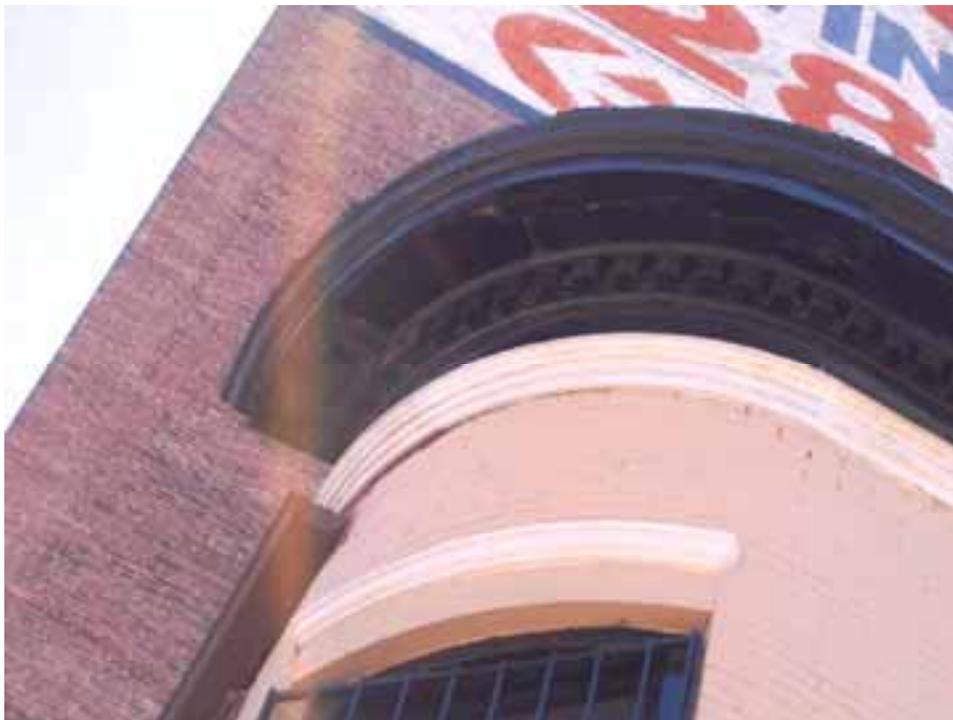
Photograph 1997-29-H

damaged (see photos H and I). The sidewalks are in fair to poor condition as a result of random cracks and a severe spall at one location (see photos J and K).

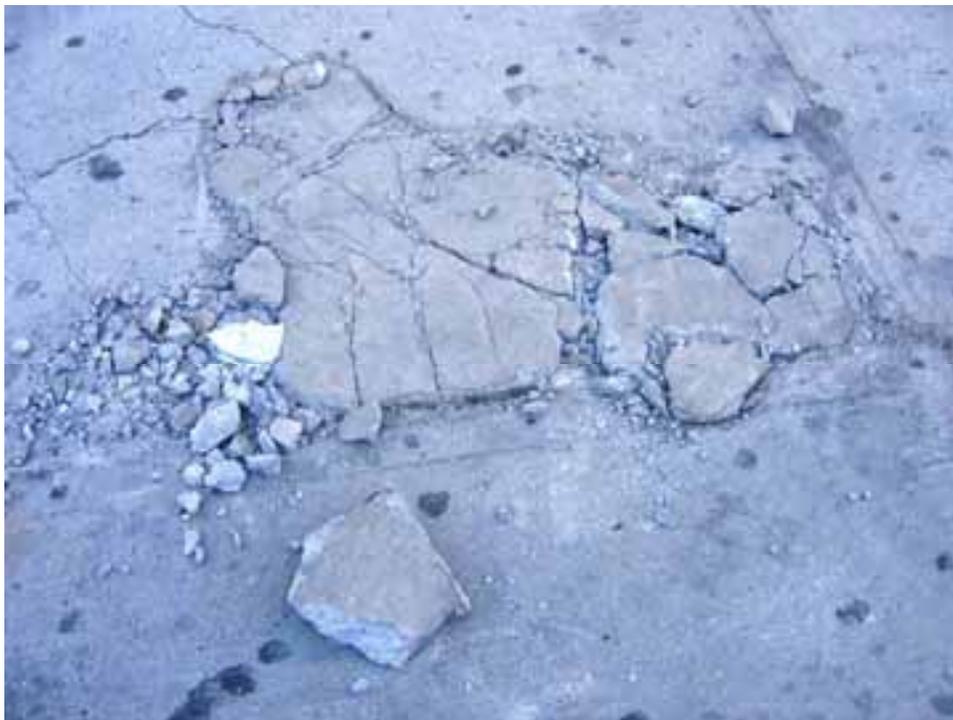
Photograph 1997-29-J

The AKRF report did not list any health and safety concerns for this building, except for the poor condition of the sidewalk on Broadway. Earth Tech's observations confirmed the condition of the sidewalks and curbs (see photos A, L and M). However, Earth Tech notes that, at one location on Broadway, the sidewalk is in critical condition with excessive spalling concrete, which is a safety concern for pedestrians (see photos N and J).

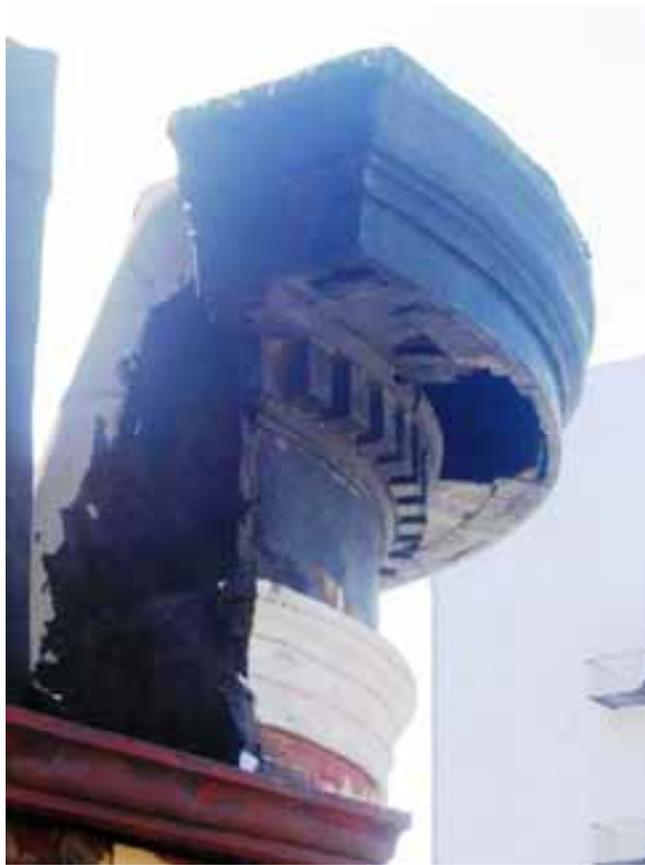
Photograph 1997-29-O

In addition, Earth Tech notes that the cornice at the building's southwest corner exhibits the signs of severe corrosion and deterioration; further deterioration may lead to a structural collapse, which is a safety concern for pedestrians (see photo O).

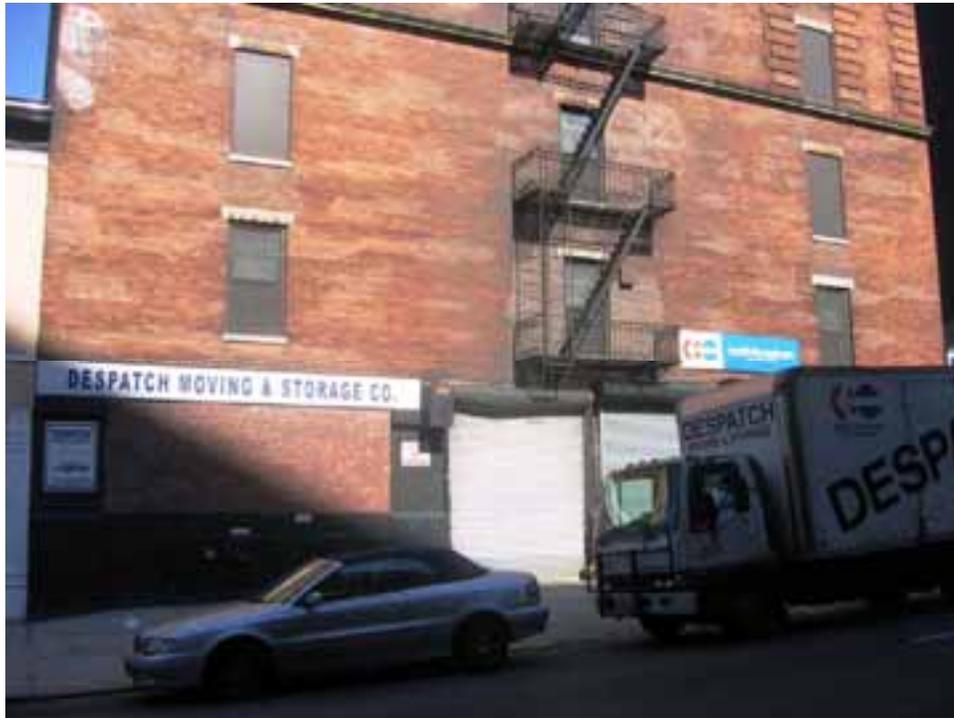
Photograph 1997-30-C

The rollup doors, windows and the wall at the east exterior appear to be in good condition (see photos B and C). The west exterior wall is generally weathered (see photo D), and has a wide vertical crack at the south corner (see Photo E). The fire escape on the building's east façade is in fair condition with minor rusting (see photo F). The sidewalk is in poor condition (see photos F and G).

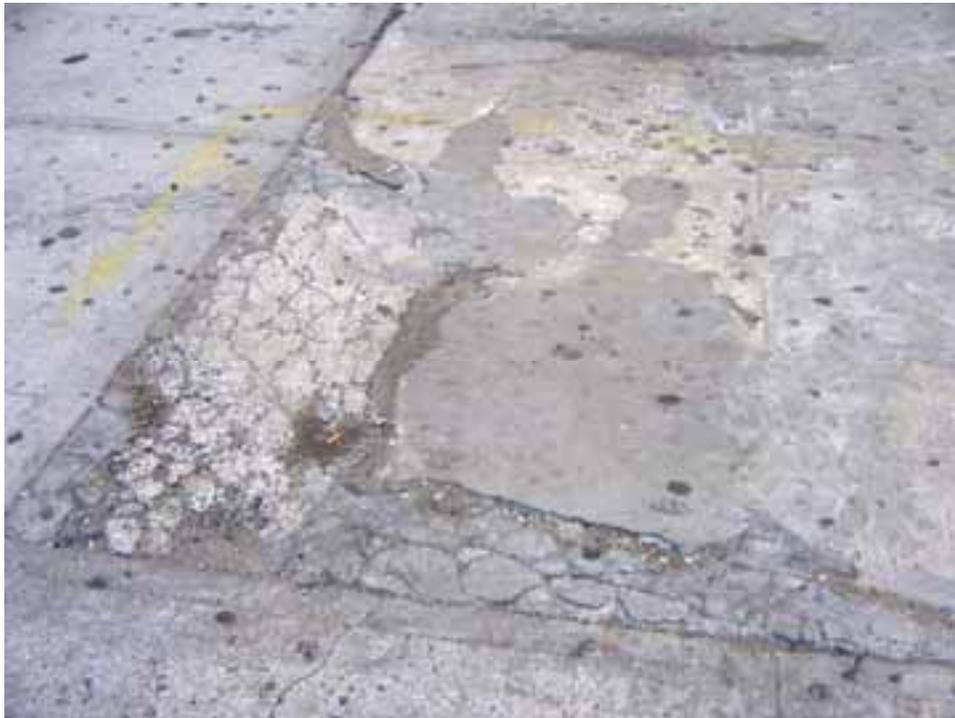
Photograph 1997-30-G

The AKRF report did not list any health and safety concerns for this building, except for the poor condition of the sidewalk on Broadway. Earth Tech concurs with the AKRF evaluation of sidewalks and curbs (see photos G and H).
