<b>SITE CONDITION: POOR</b>
-----------------------------

## Block 1997 Lot 33

### LOCATION, USE, ZONING, AND OWNERSHIP

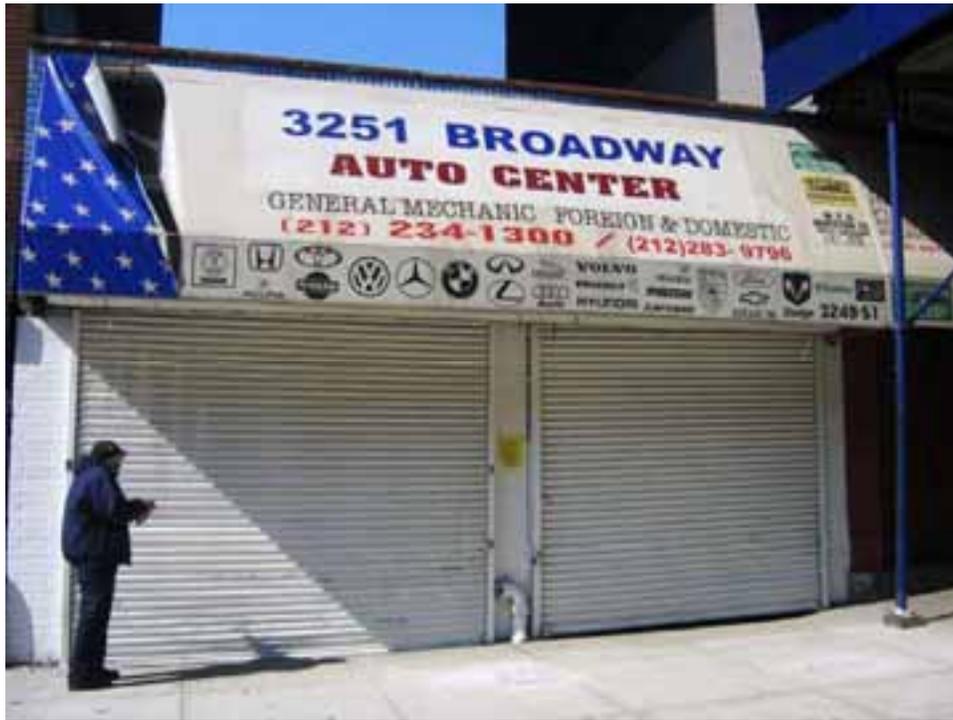
Photograph 1997-33-A

- The building has two overhead roll-up doors on the Broadway façade and no man door/ fire exits whatsoever (see photo A).
- The timber stair from mezzanine is not code compliant with a handrail on one side and a splice at a stringer that is potentially unsafe (see photos N and O).

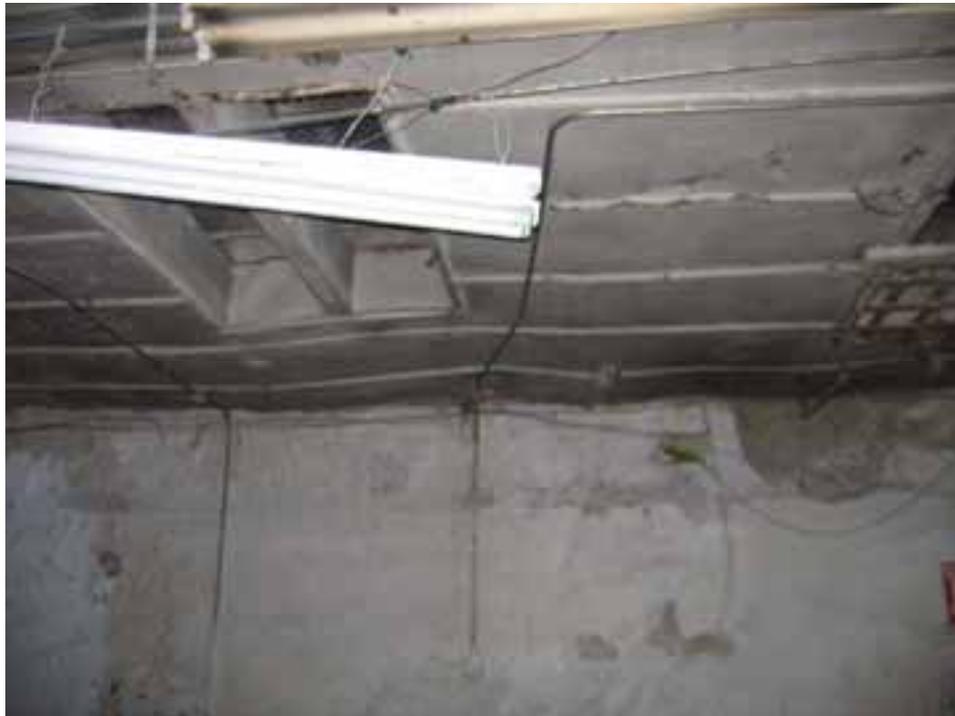
**Photograph 1997-33-C**

The building interior is open and continuous, about 25 feet by 100 feet in plan with a concrete slab-on-grade floor. The building consists of two distinct structural units: to the east, a timber joist roof (“low roof”) spans north-south between concrete bearing walls; and to the west, the roof is approximately 4 feet higher (“high roof”), spans north-south between brick bearing walls, and is made up of metal deck on steel channels (see photo B). The underside of the high roof is exposed, whereas the low roof is covered with a sheet metal ceiling, with timber joists and sheathing visible only through a few small openings in the metal ceiling channels (see photos C and D).

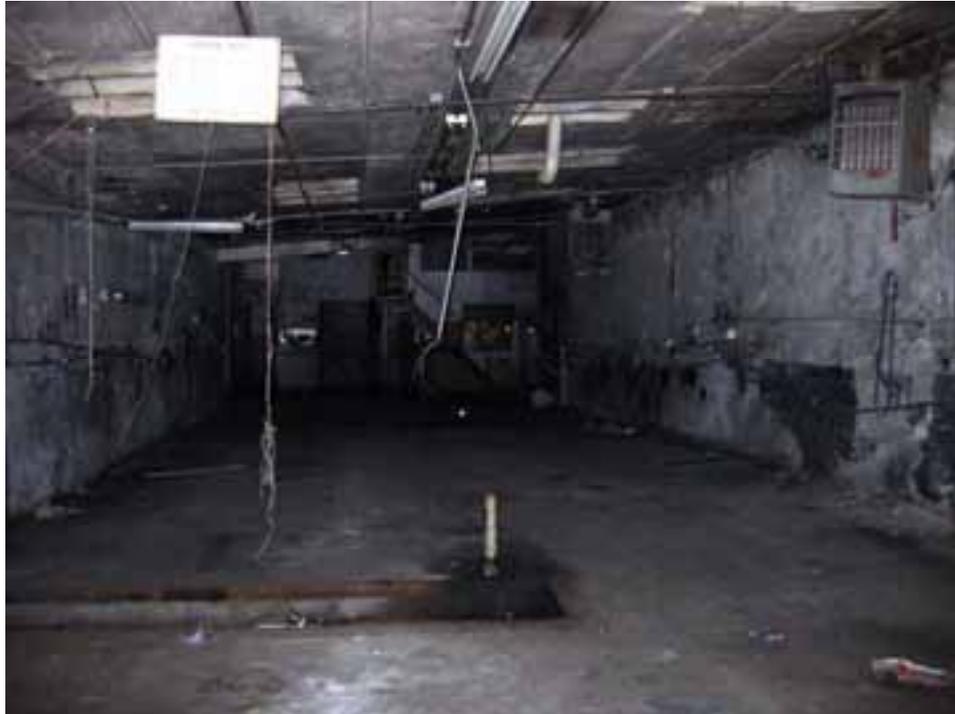
Photograph 1997-33-E

Most surfaces of the interior structural elements and finishes are deteriorated, soiled and in a poor state of repair (see photos E and F). The slab-on-grade exhibits surface deterioration, e.g., cracks, spalls and non-level areas, and the brick and concrete bearing walls also have cracks and a few spalls (see photos G, H, I and J). The sidewalks along Broadway appear to be relatively new (see photo K).

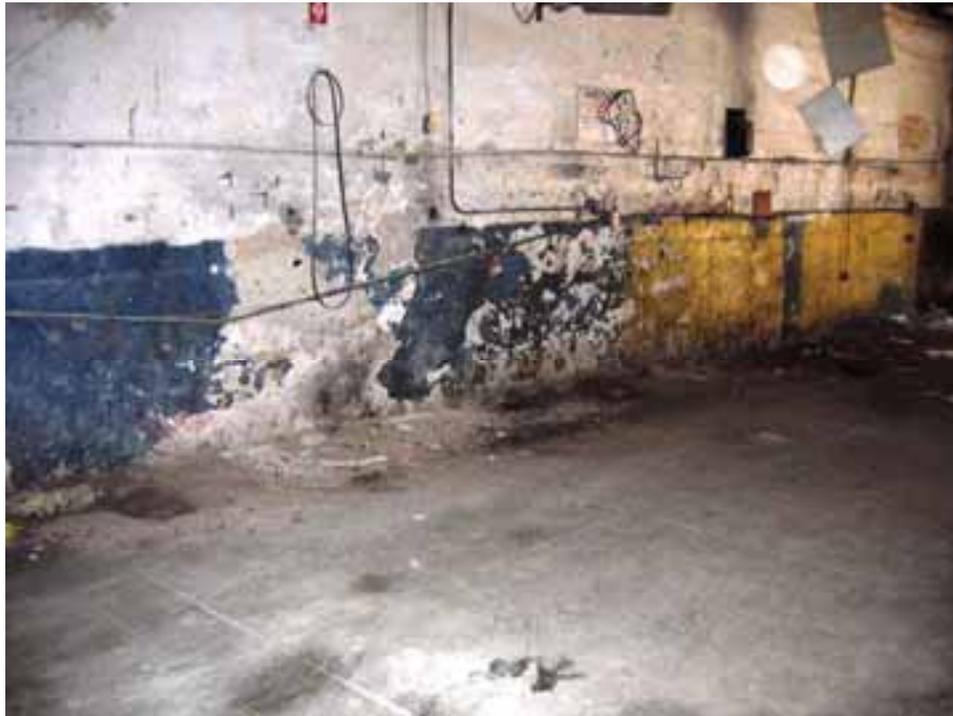
Photograph 1997-33-J

- Interior wall surfaces exhibit miscellaneous examples of water damage with paint spalling and peeling off throughout the building (photo P); (see photo J).

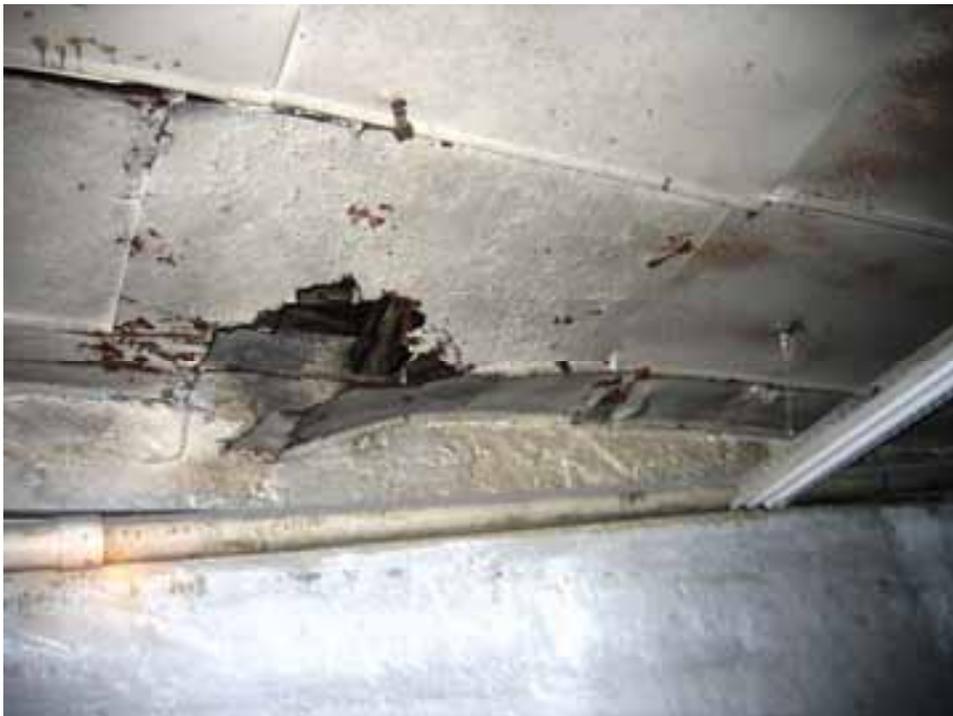
Photograph 1997-33-L

The conditions that deserve immediate attention are the state of the low timber roof, and the steel high roof. Where exposed, the timber roof structure exhibits severe water damage (see photo L), and received an appropriate condition rating of poor by Thornton Tomasetti. Little of the building's timber roof is exposed, but the water stains, corrosion and sagging panels on the sheet metal ceiling suggest that the observed timber damage is prevalent (see photo C). Unless the remainder of the roof is exposed and found to be structurally sound, casual access upon the low roof should be prohibited until the roof's ability to sustain pedestrian loads or the design roof live load is confirmed. The high steel roof, as observed from grade, also exhibited widespread evidence of water infiltration such as stains and corrosion on the metal deck soffits and supporting framing (see photo D). Much of the metal deck sags between supporting beams, and the entire roof deck seemed excessively flexible in response to pedestrian loading (see photo M). If this building is to remain in service, a thorough, hands-on inspection of the roof members is warranted to measure the extent of corrosion damage, followed by stress analyses to confirm the roof's load capacity.

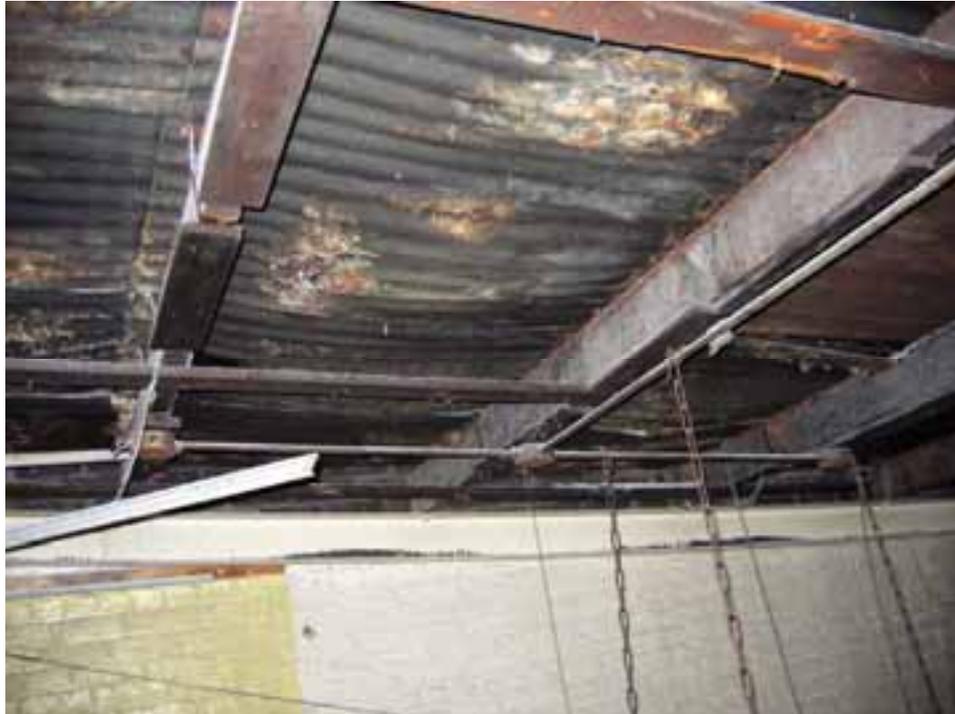
Photograph 1997-33-M

- The electrical wiring is haphazard, with open panels and exposed wires (see photo R).
- The mezzanine at the western portion of the building exhibits signs of corrosion (see photo M); the metal deck is sagging several inches at every span, and noticeably bounces when walking on the roof (see photo S). The eastern portion of the roof is

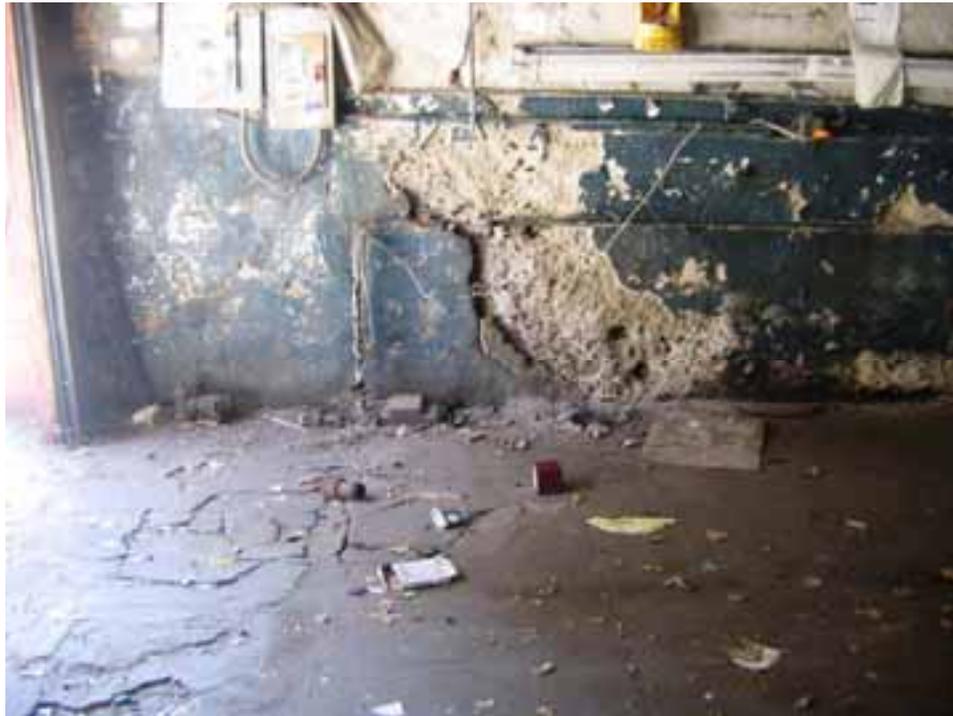
Photograph 1997-33-P

- The floor slab is in poor condition, uneven (in one location, the difference is about 3 inches) and has miscellaneous cracks and spalls; this presents a safety (tripping) hazard (see photos Q and P).

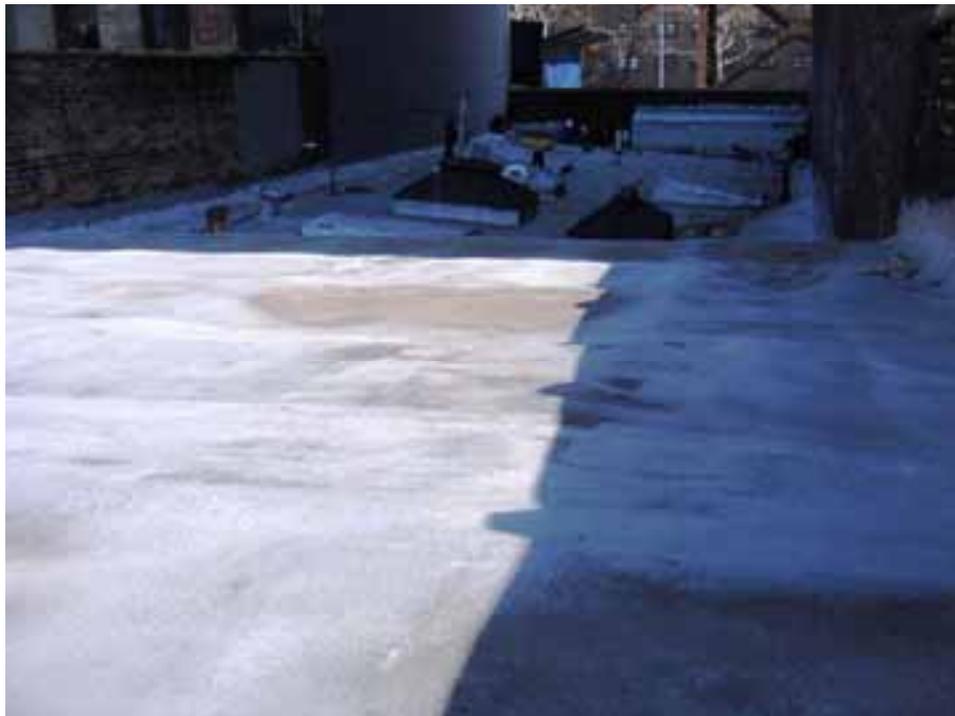
**Photograph 1997-33-T**

about 4 feet lower, creating a roof pocket without any access ladder, and has only one drain for the whole roof area (see photo T). The parapet masonry wall at the eastern side (facing Broadway) has a wide crack and is potentially unsafe for pedestrians below.

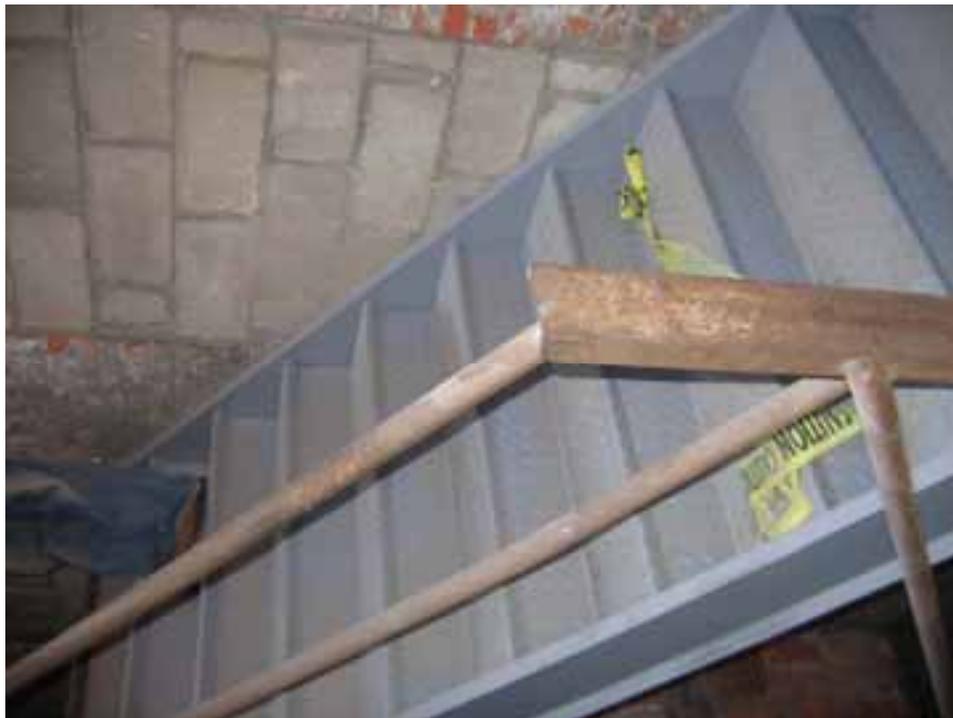
Photograph 1997-34-F

Following the inspections by Thornton Tomasetti, local repairs (see Photo F) had been performed in both fire exit stairs (replaced skylight glass at the SE stair and a replaced flight of steel steps at the NW stair, fifth floor) of the five story building, but no substantial repairs or reconstruction of primary or secondary structural elements. Significant reported deficiencies, including widespread water damage (see Photo G), racked and spalled concrete wearing courses on timber floor decks (see Photo H), cracked masonry bearing walls (see Photo I) and deteriorated roofing, remained evident.

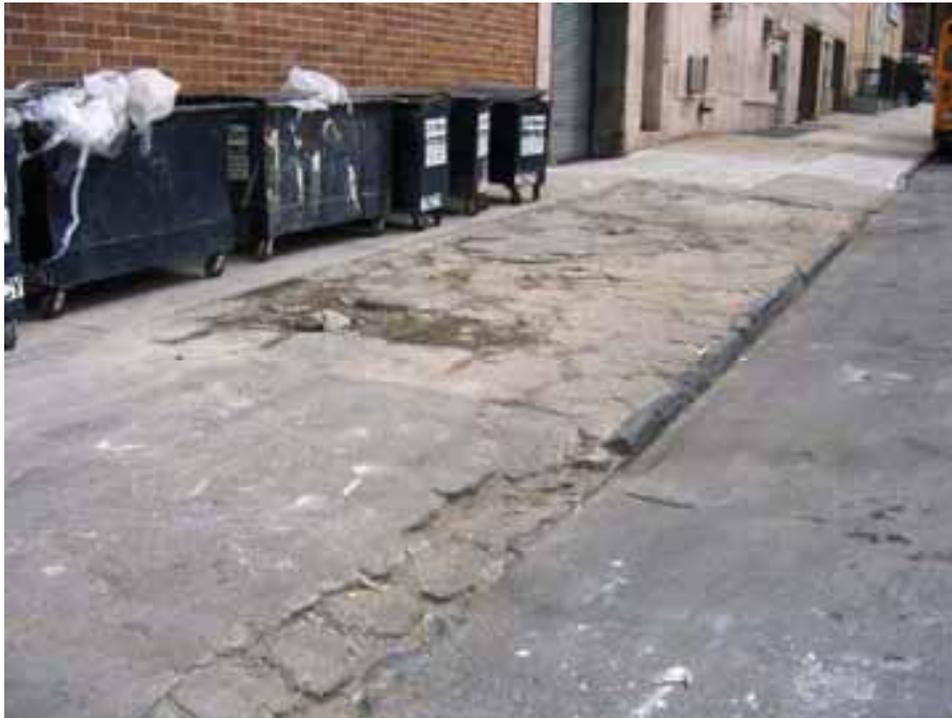
**Photograph 1997-40-L**

- The sidewalk at West 131<sup>st</sup> Street is in fair to poor condition (see photos Y and Z). However, the sidewalk at West 130<sup>th</sup> Street is in poor to critical condition with wide open cracks and spalling concrete; this is a hazard for pedestrians (see photos AA, AB and L).

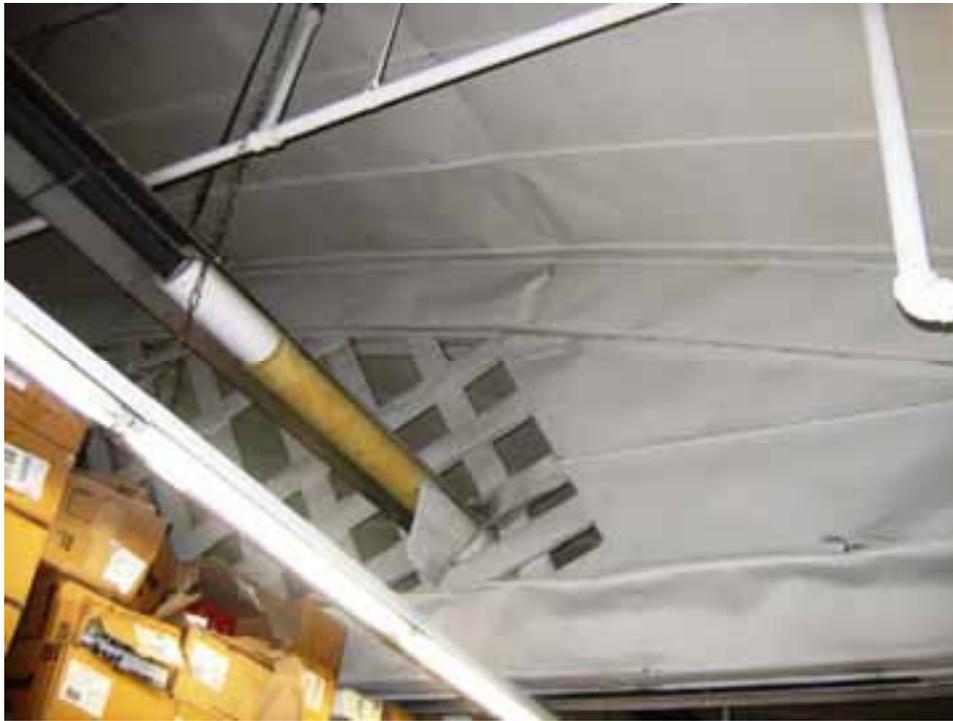
Photograph 1997-40-O

The unknown condition and construction of the timber roof trusses and the roof deck carried by the trusses is a similar concern. The deck and each timber truss member is covered with sheet metal (see photo O), which at several locations is stained with corrosion (see photo P), indicating possible, hidden water damage.

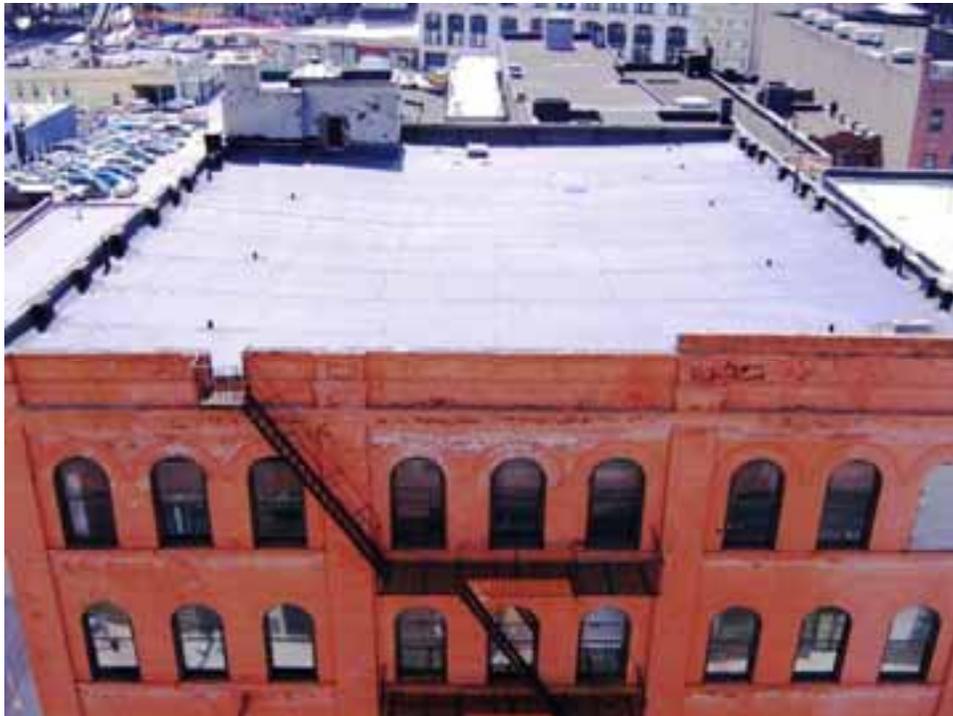
**Photograph 1997-44-E**

roof membrane was observed from the roof of the adjacent building, it appears to be in good condition (see photo E). The sidewalks are in fair condition (see photo K and L).

- Earth Tech observed from the roof across the street that the height of the roof parapet is much lower than 3 ft-6 in required by the building code of the City of New York. It appears that the corrective work on raising parapet height started at some point, but has never been finished (see photos E and J).

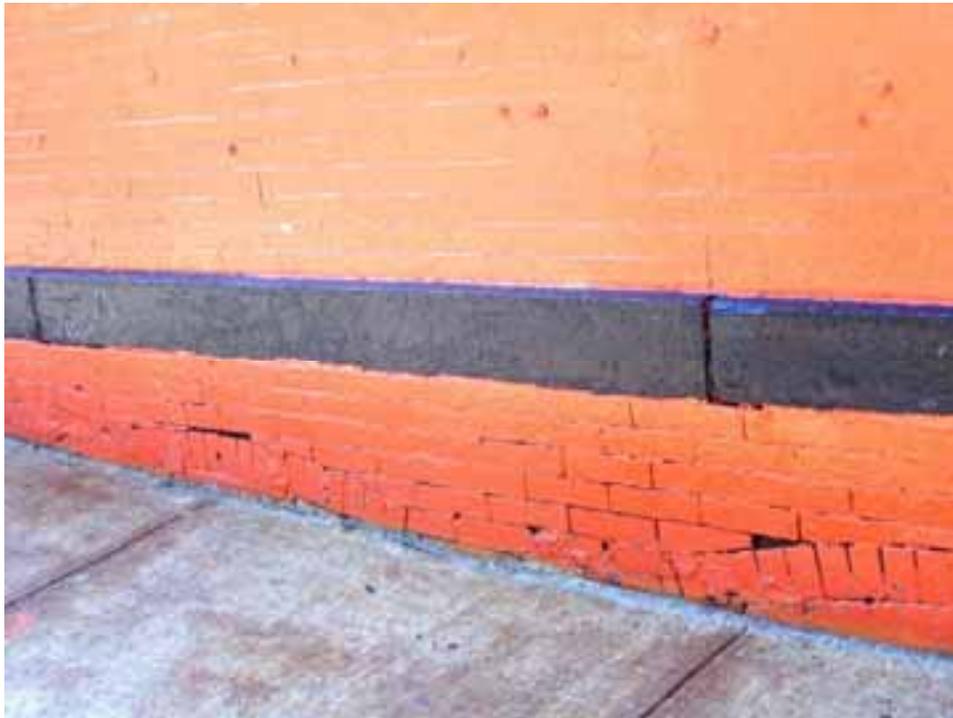
**Photograph 1997-44-I**

The east exterior wall has a wide vertical crack that extends from the roof to the second floor and rust marks between windows at all floors (see photos B and C). The south exterior wall shows signs of rust and spalling towards the top of the wall (see photos D and C). The west exterior wall has minor paint deterioration towards the roof area. The north exterior wall has severe paint deterioration typically around the windows, and possible water damage at those locations (see photos E and F). It also has stepped cracks (see photos F and G), a vertical crack at the rollup personnel door (see photo H), displaced bricks (see photo I), and a damaged possible parapet coping (see photo J). The

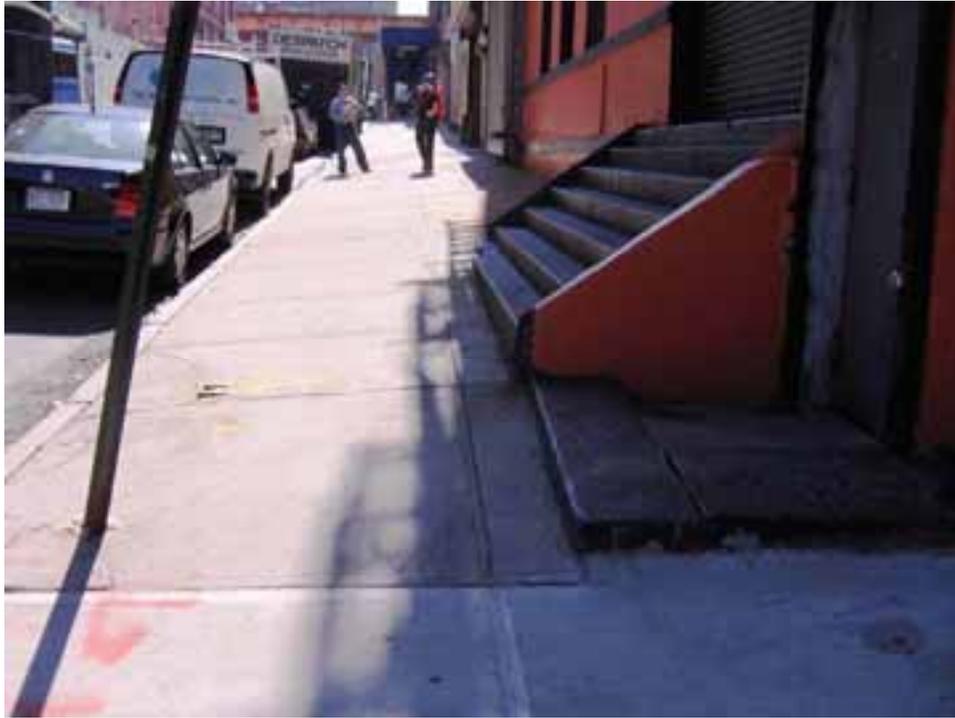
**Photograph 1997-44-K**

- Earth Tech concurs with the AKRF evaluation of sidewalks and curbs as fair and good, respectively (see photos K and L).
- Earth Tech did not observe hazardous *“spalling stucco on the south exterior wall”* as reported by AKRF (see photos M and N).
