<b>SITE CONDITION: CRITICAL</b>
---------------------------------

## Block 1997 Lot 48

As evaluated by Thornton Tomasetti, and later reported by AKRF, the building is in critical condition due to a combination of structural damage, deficient interior and exterior building conditions, other health and safety concerns and hazardous site conditions.

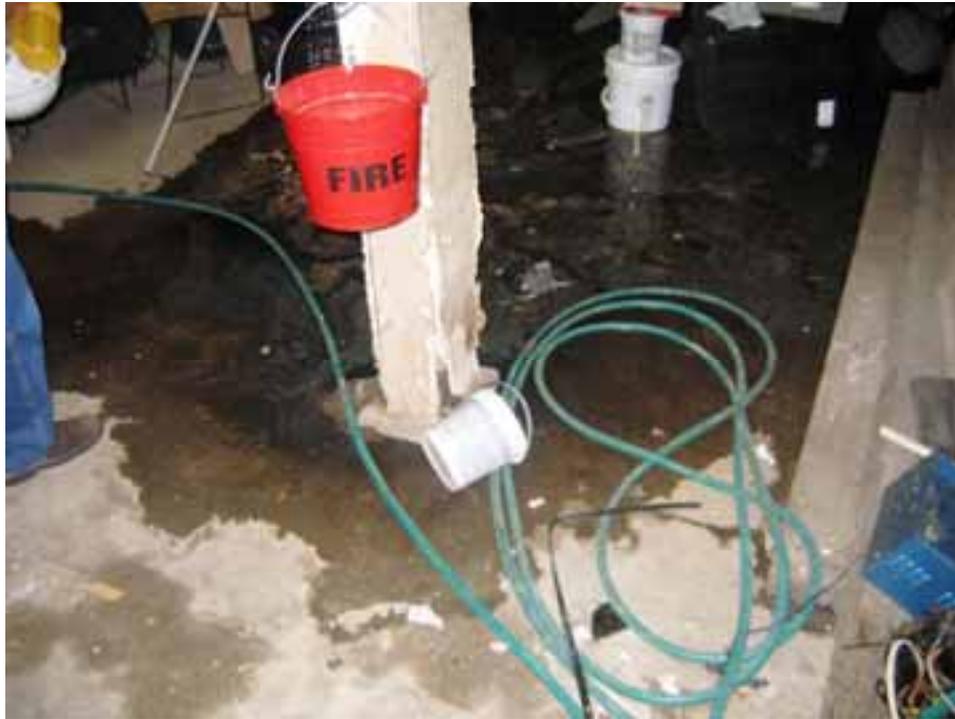
Photograph 1997-48-C

in the north building, including: water leakage from a broken sewer pipe in the basement (see photo C and photo D); microbial growth and mold on the basement walls (see photo E); the timber entrance stairs leading to the second floor are tilted significantly (see photo F); wide cracks and separation in the north wall of the north building near the downspout pipe (see photo G), remained evident. The reported deficiencies in the south building also remained evident, including: a collapsed ceiling and hanging insulation in the basement (see photo H); a timber joist is cut and has lost its support (see photo I); several timber joists in the south building basements have rotated (see photo J); one of the columns is enclosed by a CMU wall, probably to provide an additional support to the timber beam (see photo K); extensive water damage and water stains in the entrance stair well leading to the second floor (see photo L); the walkway from north building to south building is sloped causing water to flow into the buildings from sidewalk (see photo M),.

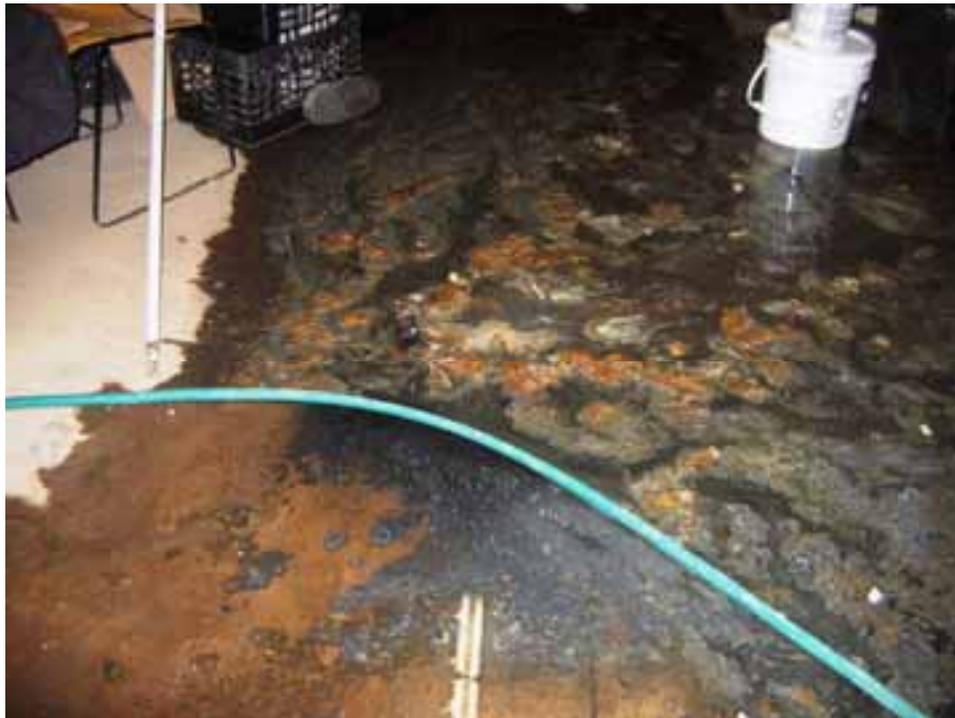
Photograph 1997-48-D

- Stairs going to basements in both buildings do not meet code and are both damaged, a safety hazard (see photo R).
- The basement in the North building (boiler room) was flooded with what appeared to be sewer waste coming up from the floor drain; an active health hazard that needs to be corrected (see photos S and D).

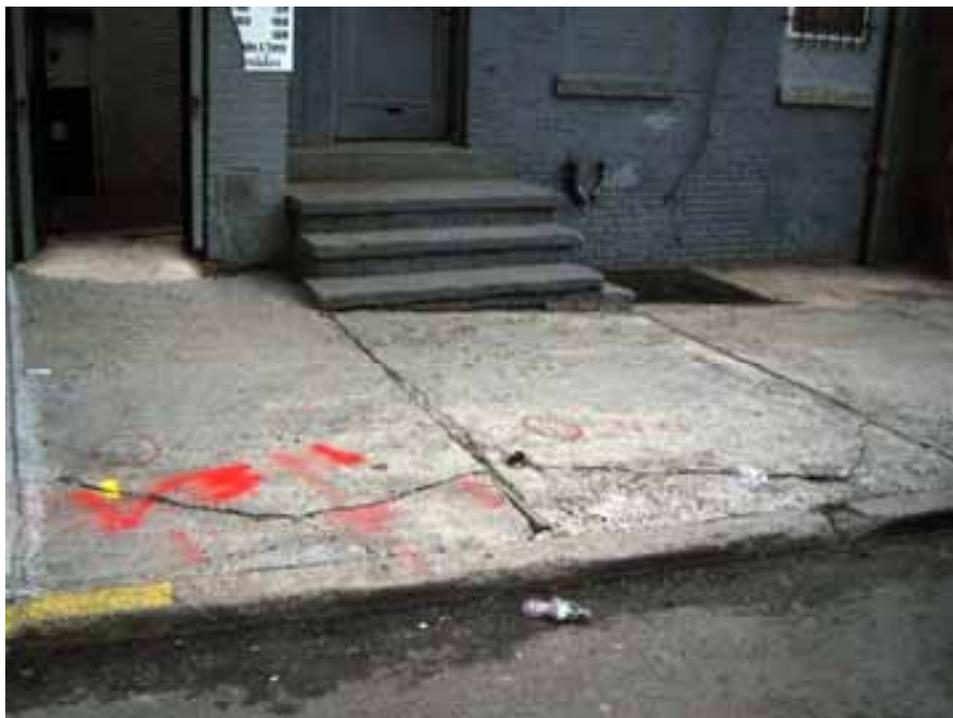
Photograph 1997-48-P

- The sidewalk and curb on West 131<sup>st</sup> Street in front of the building is in poor condition and a hazard to pedestrians (photo P).
- The awning above the entrance is hanging in a tilted position and might be hazardous to pedestrians (see photo Q).

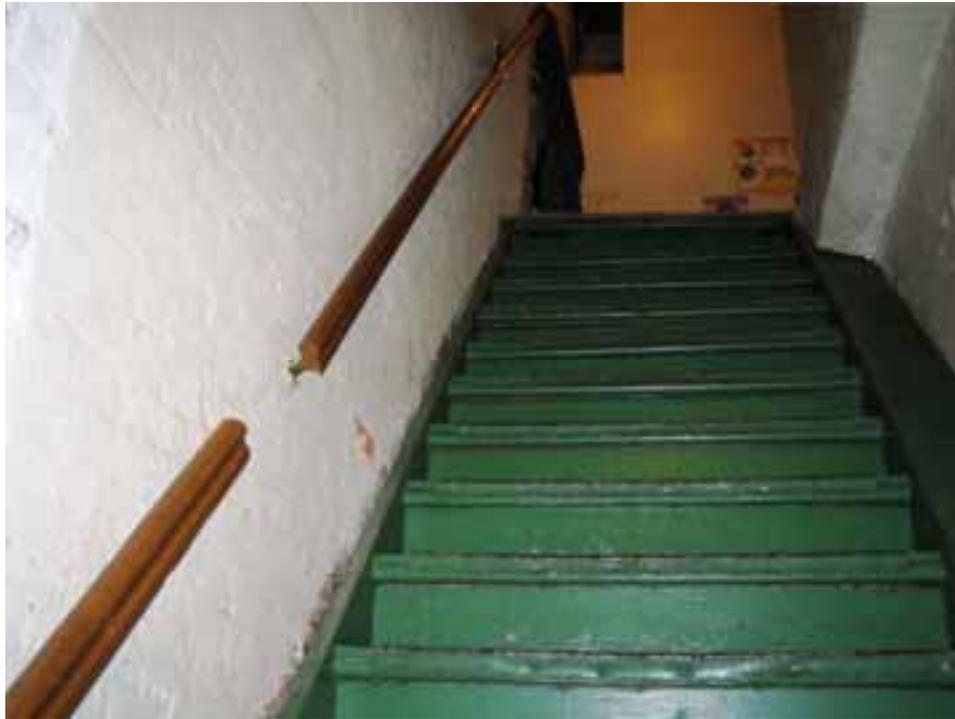
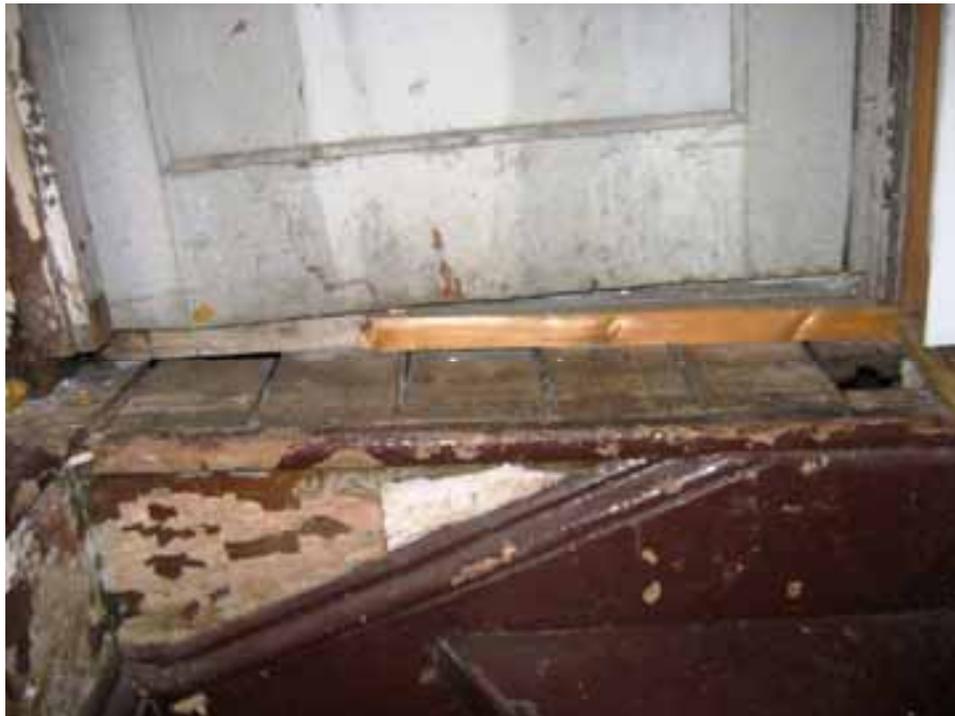
- Stairs to upper floors in both North and South buildings do not meet code requirements, with miscellaneous violations (see photos T, U, V, and W).
- Second exit door from the main prayer hall is obstructed with band equipment and flower arrangement; no panic exit hardware is provided; - a safety hazard (see photo X).

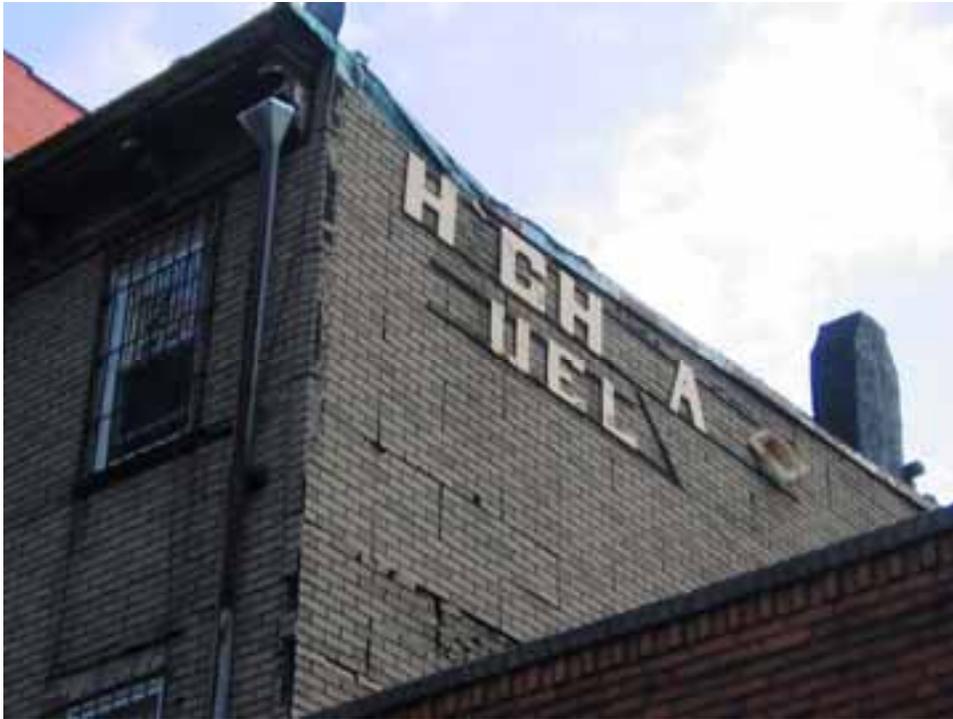
Photograph 1997-48-Y

- Brick imitation shingles on western façade of the North building, along with remaining sign letters, are severely damaged, peel off in many locations, and might be hazardous to pedestrians if they collapse (see photo Y).

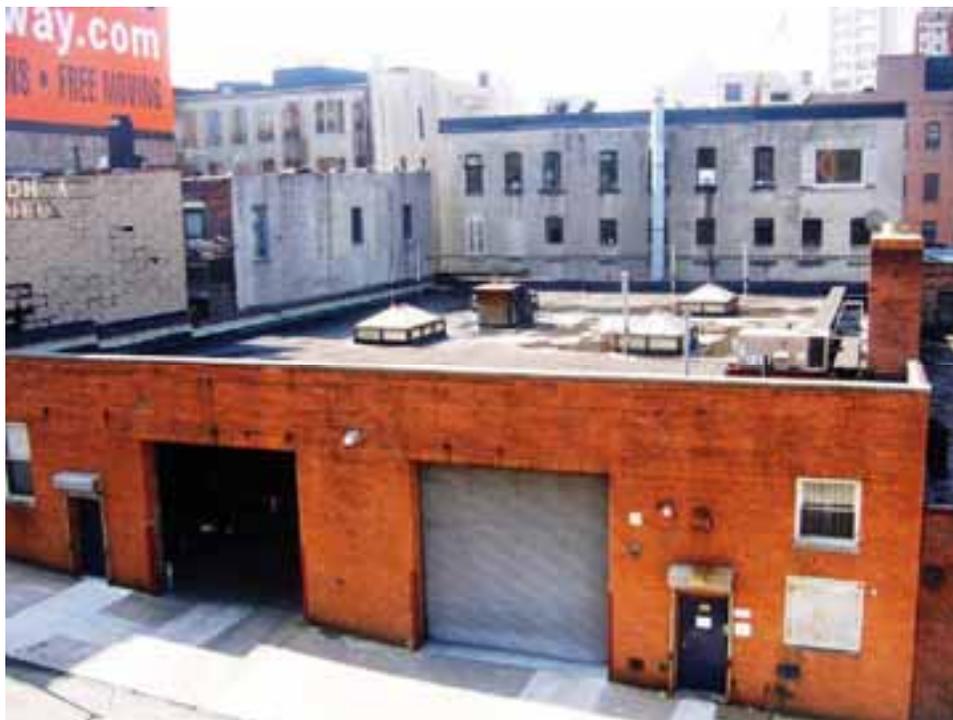
Photograph 1997-49-A

The exterior brick wall on the north side shows a wide stepped crack at both ends (see photos A and B). The stepped crack at the west end above the window extends to the top of the parapet and bricks are significantly displaced along the crack (see photo C). The concrete floor shows wide random cracks and several small spalls (see photo D). There is water infiltration and damage with paint peel off and water stains on the interior of the north wall (See photo E). The water appears to be infiltrating through the stepped crack at the east end (See photo F). The concrete roof planks and steel beams are in good condition but appear to be carrying excessive load (see photos G and H).

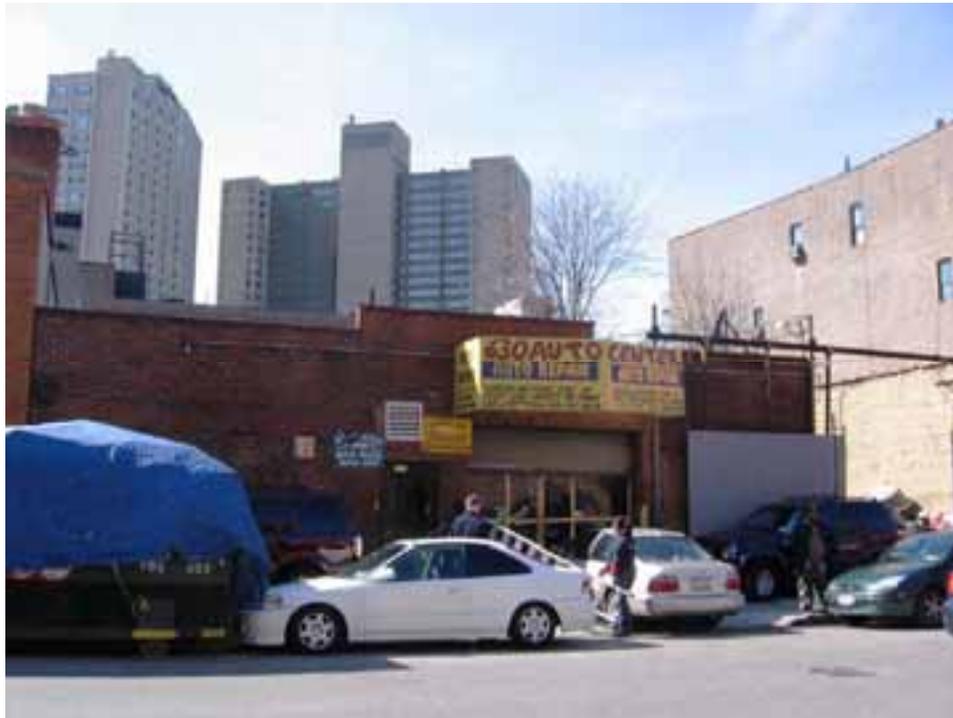
**Photograph 1977-52-A**

- The fire exit door is missing the appropriate push bar hardware (see photo N).
- The tenant washes cars inside; on the day of the survey, Earth Tech observed stalled water on the floor in several locations, a sign of improper slab slope/drainage - a health and safety concern (see photos O and P).
- The tenant routinely parks cars on the sidewalk, which is a safety hazard to pedestrians (see photos A and B).

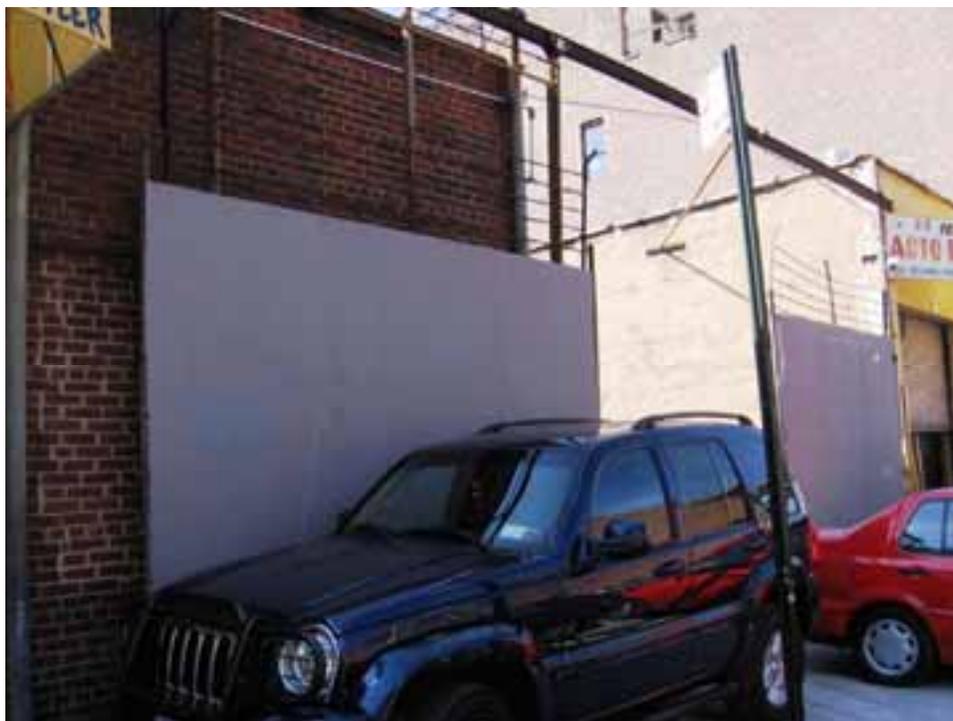
**Photograph 1977-52-B**

Lot 52 is located at 630-634 West 131<sup>st</sup> Street between Broadway and Twelfth Avenue. The 7,494-sf site contains a one-story 5,196-gsf building that, according to the Department of Finance RPAD Master File, was constructed in 1948 with no subsequent recorded alterations (see photo A). Earth Tech surveyed (February 2008) the property and found that eastern portion of the lot contains an auto repair shop; and the western portion of the lot contains a gated parking area (see photo B). AKRF noted that the building was

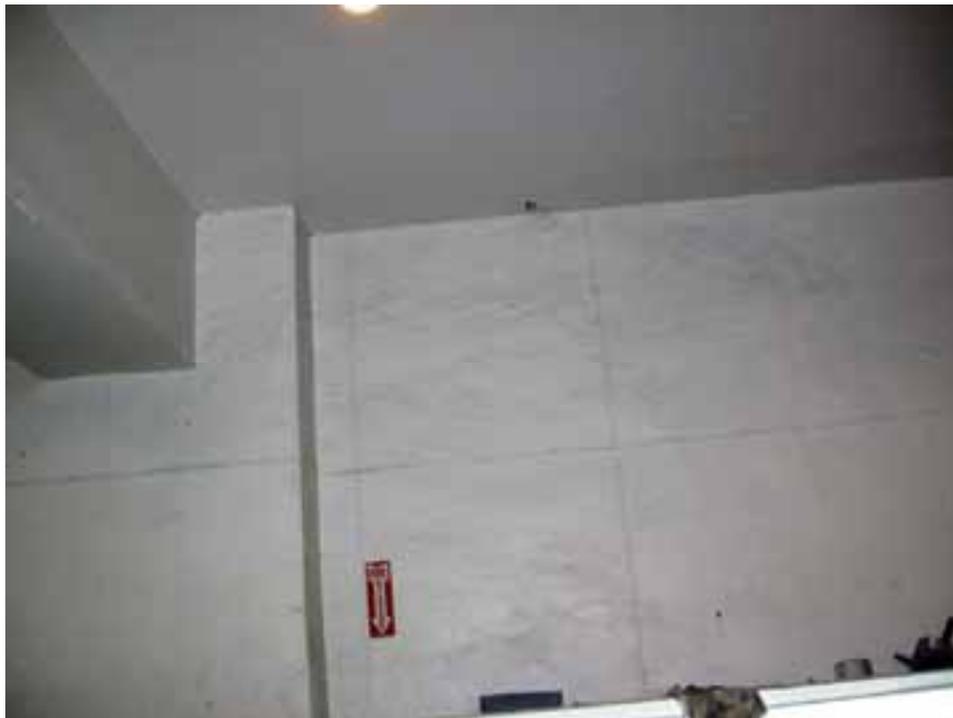
**Photograph 1977-52-F**

repainting (see photo F), a new sidewalk, and roof membrane and coping repairs (see photo G).

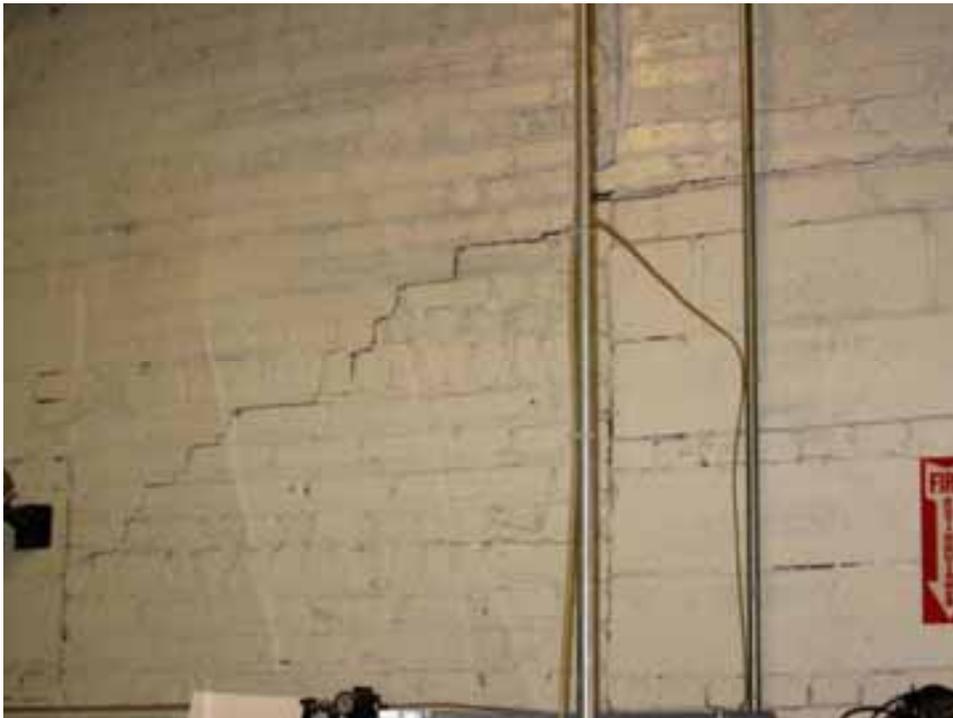
**Photograph 1977-52-H**

- 1) Widespread, wide, restraint cracks (vertical and stepped) in the exterior brick walls (see photo H, I); and
- 2) Severe water damage to the timber roof.

Earth Tech concurs with the evaluation by Thornton Tomasetti for this building as in structurally poor condition. If extended service for this property is desired, positive measures should be taken to evaluate and correct its standing structural concerns.

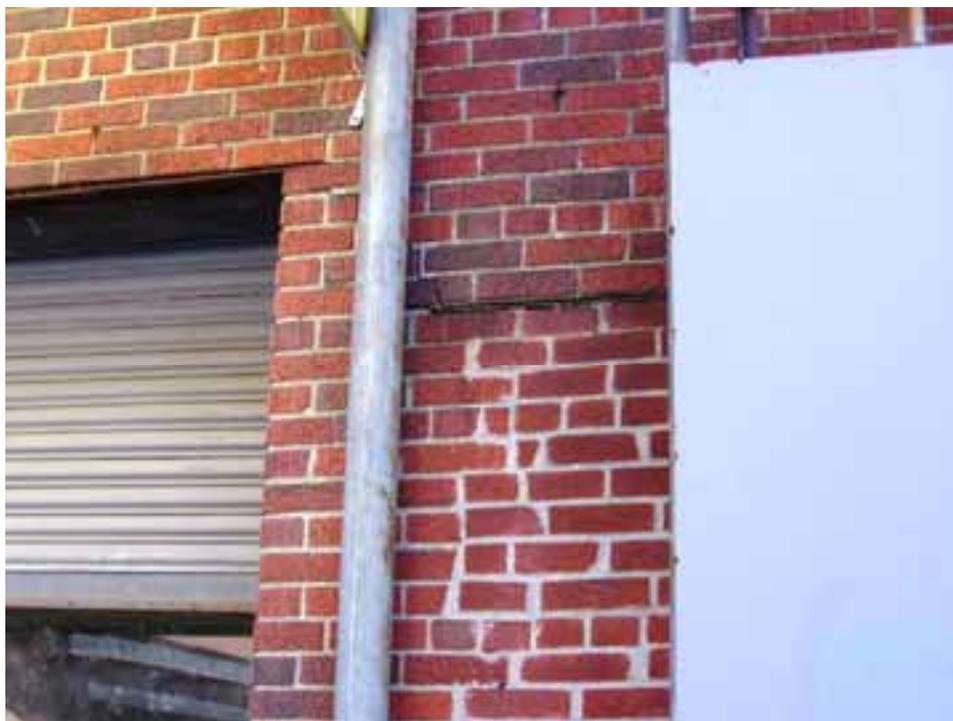
Photograph 1977-52-L

AKRF report did not list any health and safety concerns for this building other than citing it as having "some substandard exterior and interior building conditions, and hazardous site conditions". The new tenant is an automotive repair shop (previously a restaurant supply warehouse). According to Columbia University personnel, repairs have recently been done by Columbia University to the building's structure and/or finishes, namely: roof membrane repairs (see photos G and J); ceiling and interior walls painted (see photo K); the overhead shutter door appears to be recently installed (see photo L). Portions of sidewalk appear to be recently replaced (see photo M).

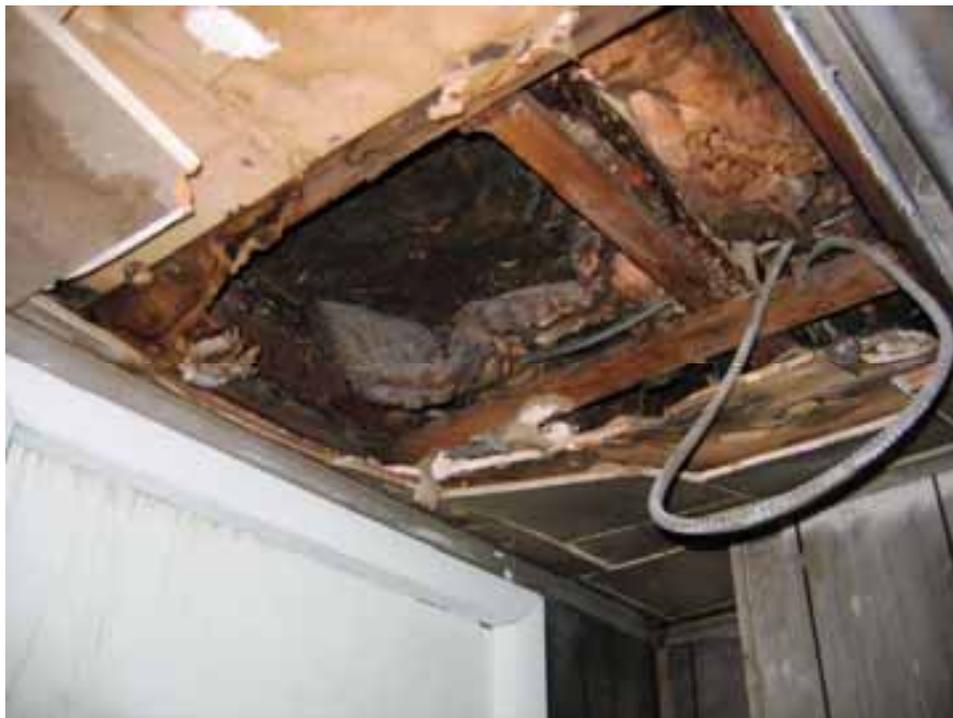
Photograph 1997-55-B

- There are numerous signs of water damage, peeling paint and bacterial growth on walls and ceilings throughout the building (see photos P, Q, and R), a health concern. In two locations, yellow tarps are hung under the ceiling, apparently to mitigate active water leaks (see photos S and T). On the mezzanine level, one area of ceiling is severely damaged with exposed insulation, a potential health hazard (see photo B).

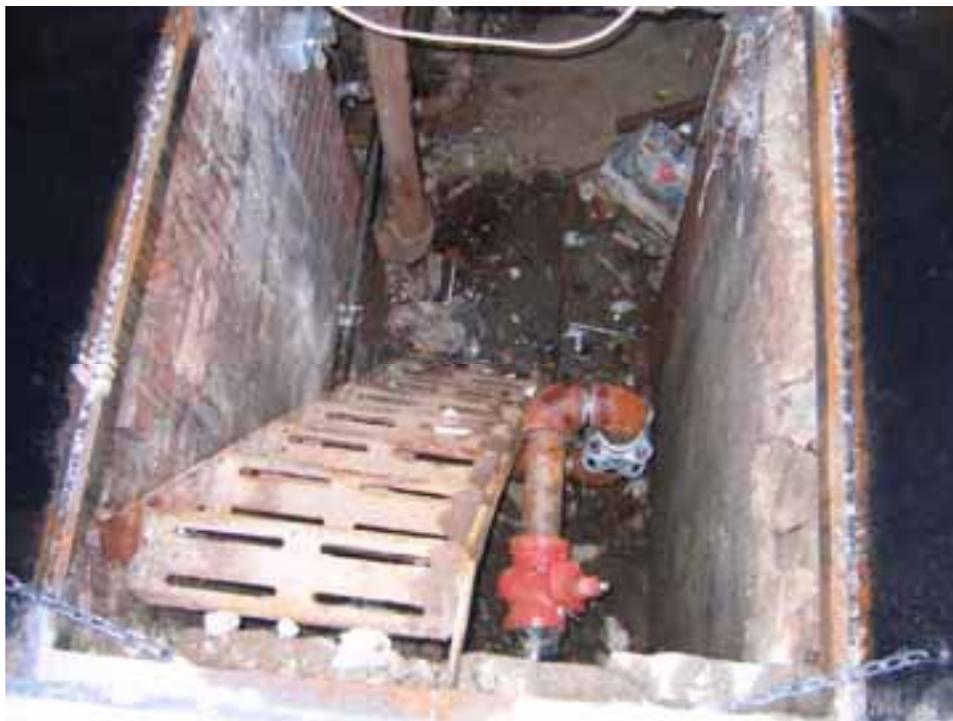
Photograph 1997-55-M

- The exit door on the south side of the building opens into a fenced area haphazardly filled with discarded auto parts and debris (see photos J and K) obstructing egress through this door. It appears that a lintel, supporting the exterior plastered veneer above door, has collapsed at some unknown time and the façade veneer is currently supported (possibly, inadequately) by a metal angle (see photo L), this is a safety hazard.
- The stair leading to the sidewalk vault and basement does not have handrails see (photo M), a safety concern.

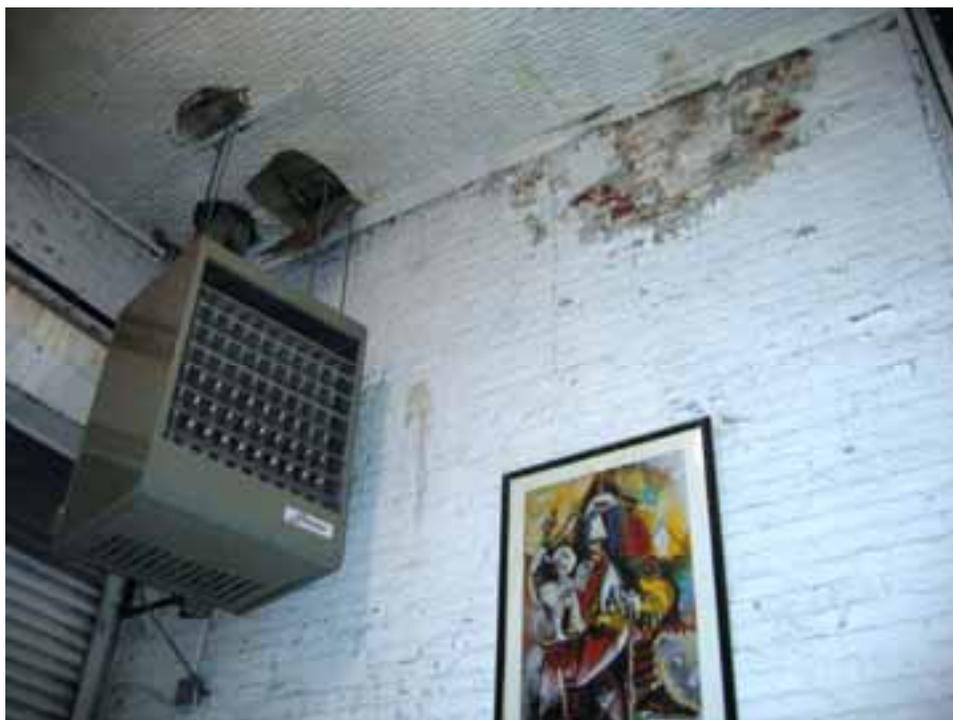
Photograph 1997-55-N

- In several locations, holes were cut out in original tin ceiling panels (possibly, a part of fireproofing assembly), reducing the protective quality of the ceiling (see photo N). Similar holes were observed in the cementitious plaster ceilings in the basement vault (see photo O).

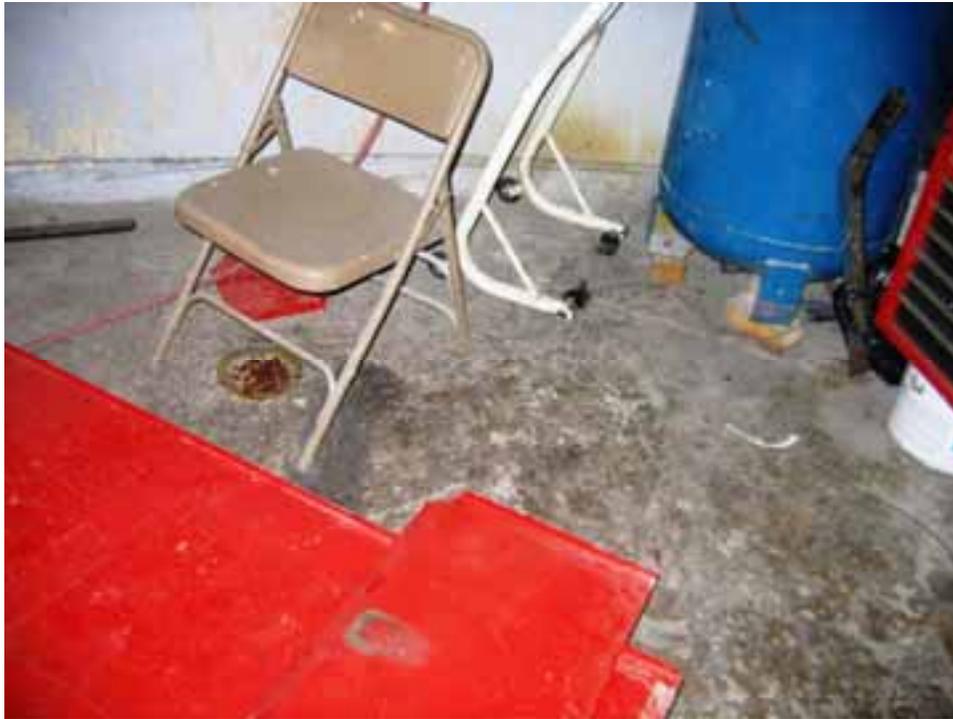
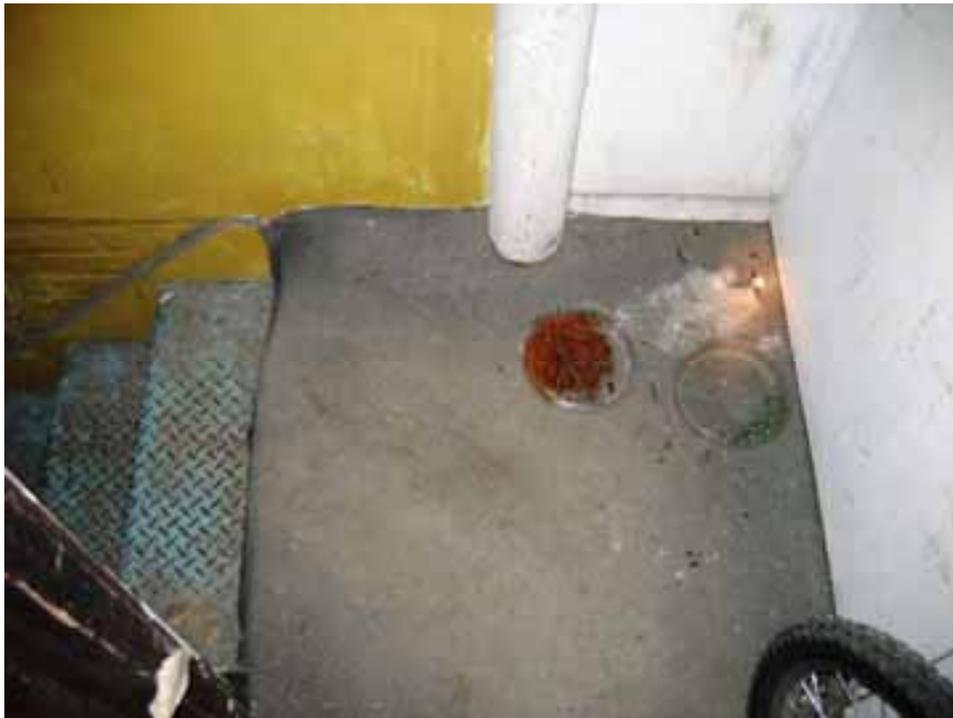
- On the day of the survey, Earth Tech observed what appeared to be food offerings on the floor at several location, and rice scattered throughout the building (see photos U and V), a sanitary hazard and health concern.
