Block 1997 Lot 61

SITE CONDITION: FAIR

PHYSICAL AND STRUCTURAL CONCERNS

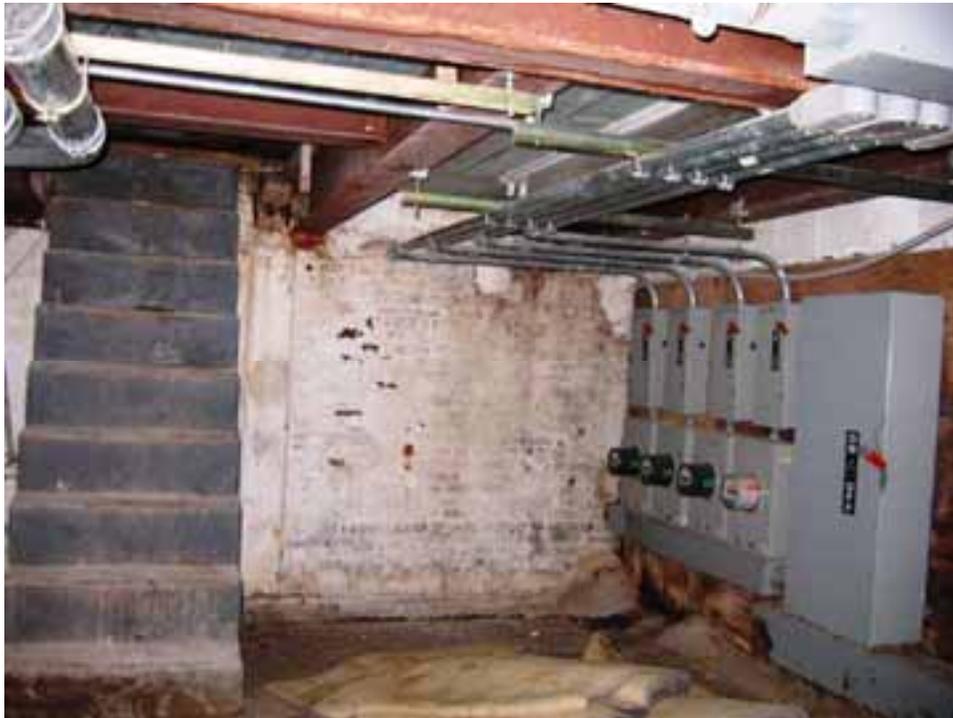
Photograph 1997-61-I

Most of the structural damage is localized to the basement of the building, as a result of prolonged water infiltration, and is evident by severe spalling of the bottom of concrete beams and significantly corroded and exposed reinforcing bars with section loss and a wide longitudinal crack in the bottom of concrete beams (see photos C, D, E and F). This structural damage is visible at many locations in the basement (see photos G and H). The electric room in the basement, on the north side wall, shows extensive water infiltration,

mold, efflorescences, and wet stains (see photo I). A large spall 4 ft by 1 ft is present in the second floor soffit in the entrance area (see photo J). The basement area of the restaurant area on west side also shows signs of water intrusion as evident by the presence of mold, water stains and a few wet patches (see photos K and L). The floor shows wide extensive cracking over large areas (see photos M and N). An opening in a brick wall; is provided without a door frame or lintel (see photo O).

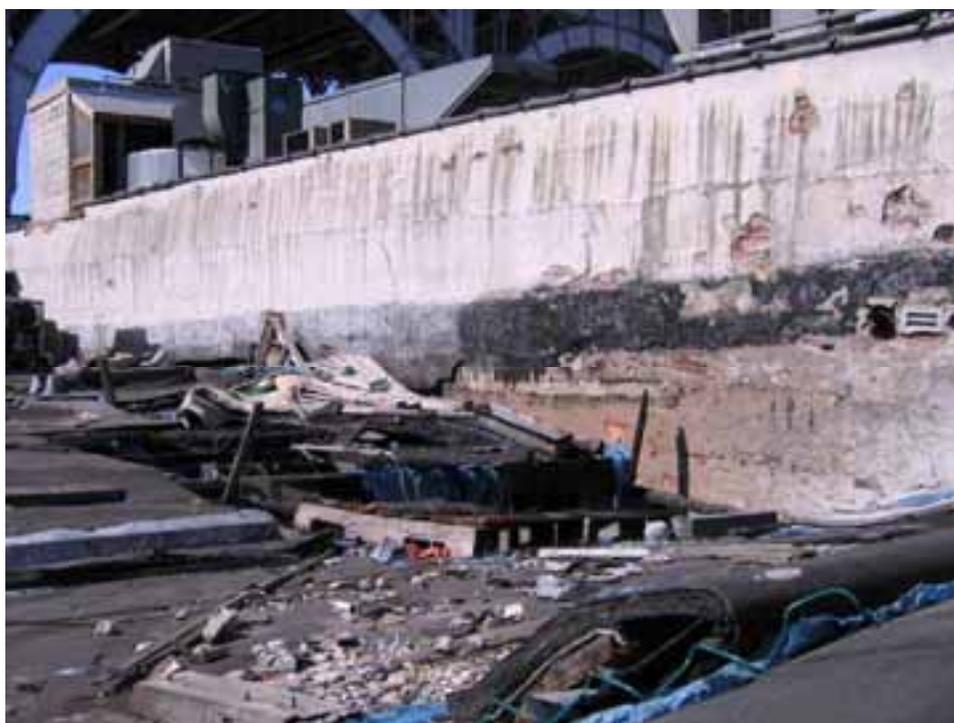
Photograph 1997-61-T

The portion of the roof of the adjacent building on south side of the building is in a collapsed condition (see photo T), a result of which is water intrusion in the south wall due to the absence of flashing.

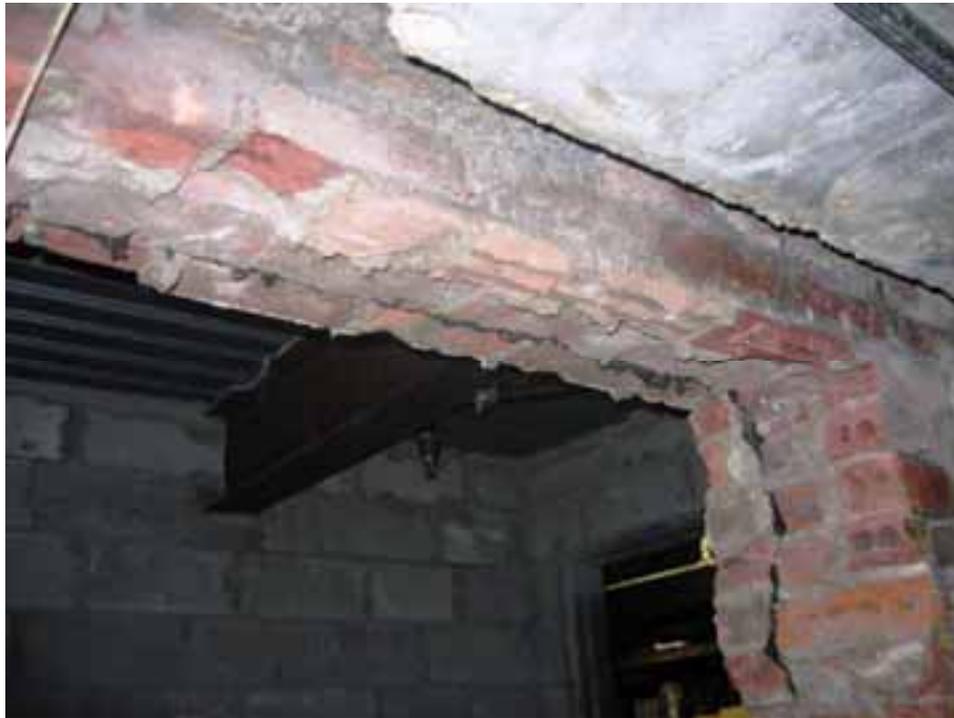
Photograph 1997-61-U

- *“The absence of a lintel above the opening in the demising wall... is a safety concern”* – Earth Tech concurs with this statement (see photos U and V).
- *“water accumulation on the floor of the basement... create an unsanitary condition”* – Earth Tech did not observe water accumulation in the basement on the day of survey, however, a small active water leak was noticed in the area below the restaurant kitchen area (see photo W).
- *“problems with vermin in the building are likely as several rat traps were noted”*- on the day of Earth Tech's survey, no rat traps were visible.

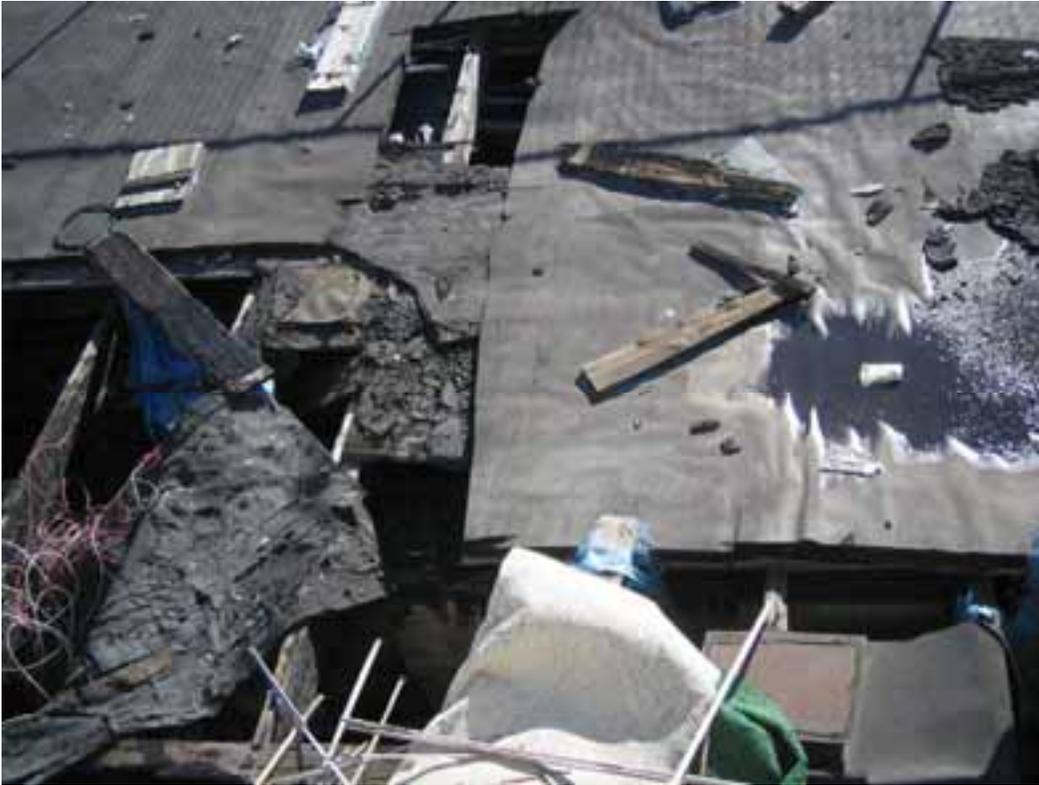
Photograph 1997-64-E

At the time this site was inspected by Earth Tech, on February 21, 2008, no significant interim or permanent repairs to correct or mitigate the reported instances of structural damage, distress or instability were found where inspection was possible. The reported deficiencies, including widespread water damage (see photo B), partial sagging and partially collapsed ceilings (see photo C), warped flooring (see photo D), deteriorated roofing and the partially collapsed roof (photo E), remained evident

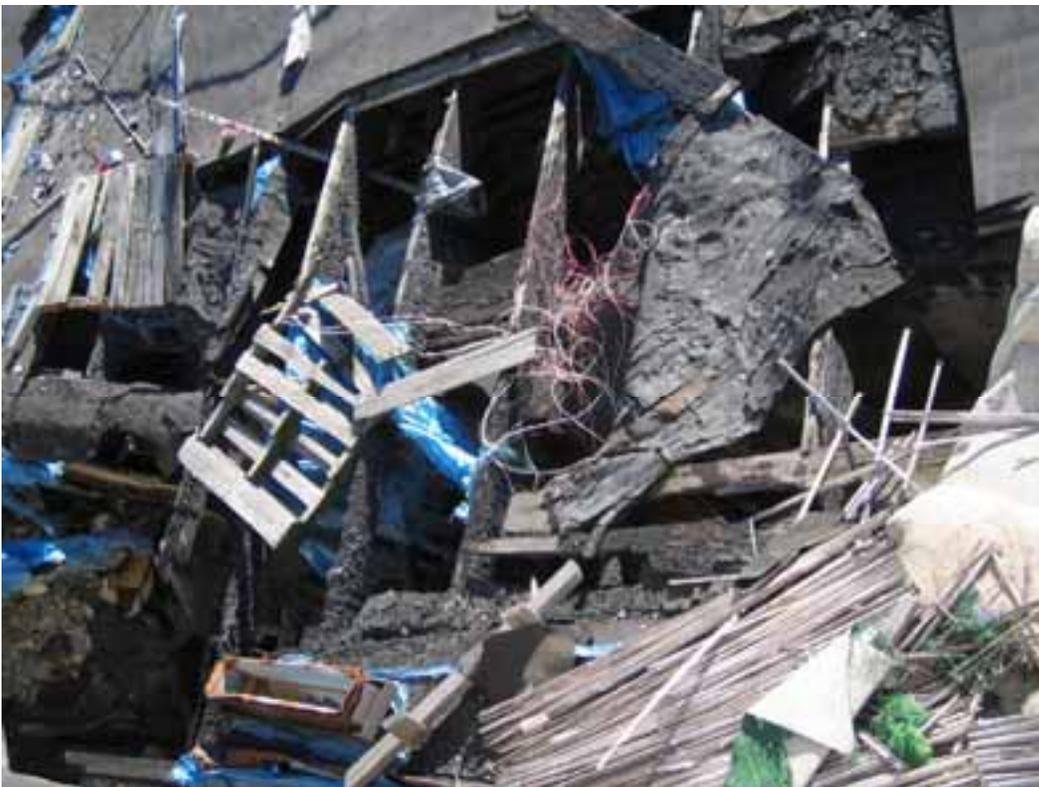
Photograph 1997-64-F

Most of the damage to the buildings interior and to the timber roof and floor structures, appears attributable to water infiltration and the fire on August 15, 2000, which has left a large area of the east side of the timber roof deck open to the elements. The roof was observed from the roofs of adjacent buildings to the north and south, but for safety reasons, the interior spaces directly below the damaged roof were not entered. Within the fire-damaged section of the roof, the wooden sheathing is absent, the wooden rafters

charred (see photo F), and a section of siding along the south exterior wall just below the roof deck, are missing along the damaged area. The report by Thornton Tomasetti describes the building system as masonry bearing walls carrying timber 2nd floor and roof decks, and notes that the interior walls are everywhere covered with finishes and not visible to inspections. At the second story, the south “masonry bearing wall” appears to be a wood-framed bearing wall with studs and top plate carrying rafters and a simulated brick veneer siding (see photo G). This south wall does not appear in immediate risk of collapse, and the more present danger is failure of the fire-damaged rafters of the roof deck itself. The roof opening currently contributes to the existing water damage, which appeared widespread and is probably long standing. Surface damage to the finish materials covering the second floor deck suggest that its integrity may also be compromised. If this building is indeed entirely timber framed, the walls may also be at risk.

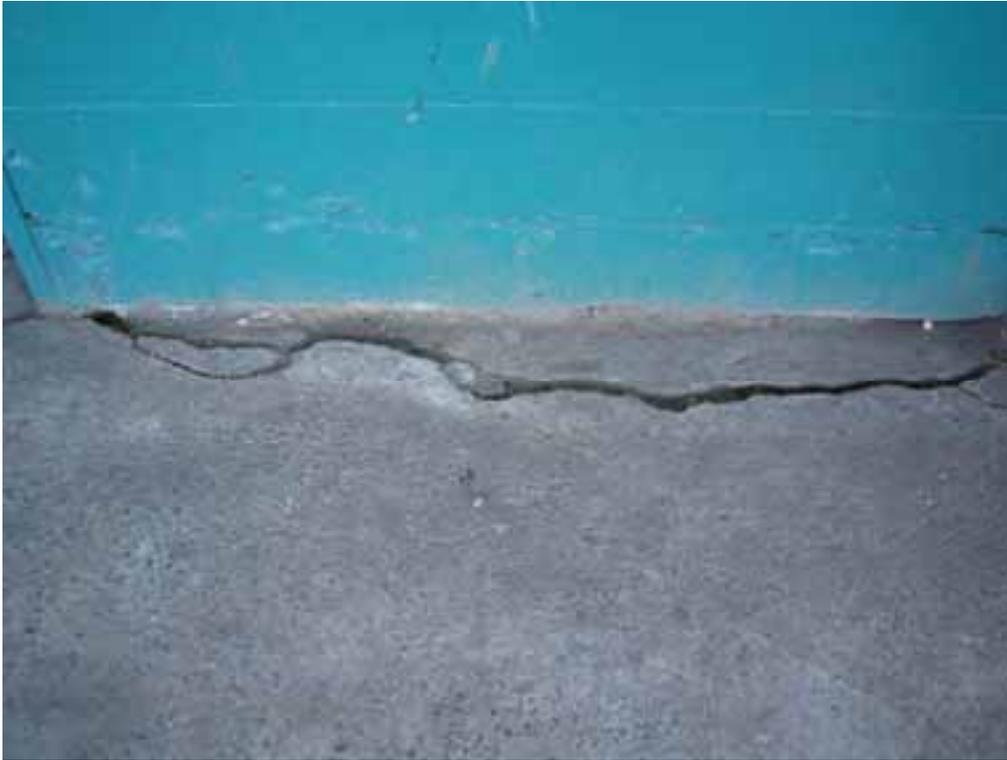
Photograph 1997-64-I

Earth Tech found that since the AKRF report, the West façade of the building was painted; attachments (sign, meat conveyor belt) and A/C units removed; broken glass removed; windows blocked with concrete masonry units or boarded with plywood; holes in exterior cladding boarded with plywood (photo A). Additionally, the sidewalk in front of the West façade was cleared from palettes/ debris, and the large area of spalled concrete, reported by AKRF, has been recently patched. The large (more than half an inch wide) crack at the sidewalk next to building wall is still present (see photo I).

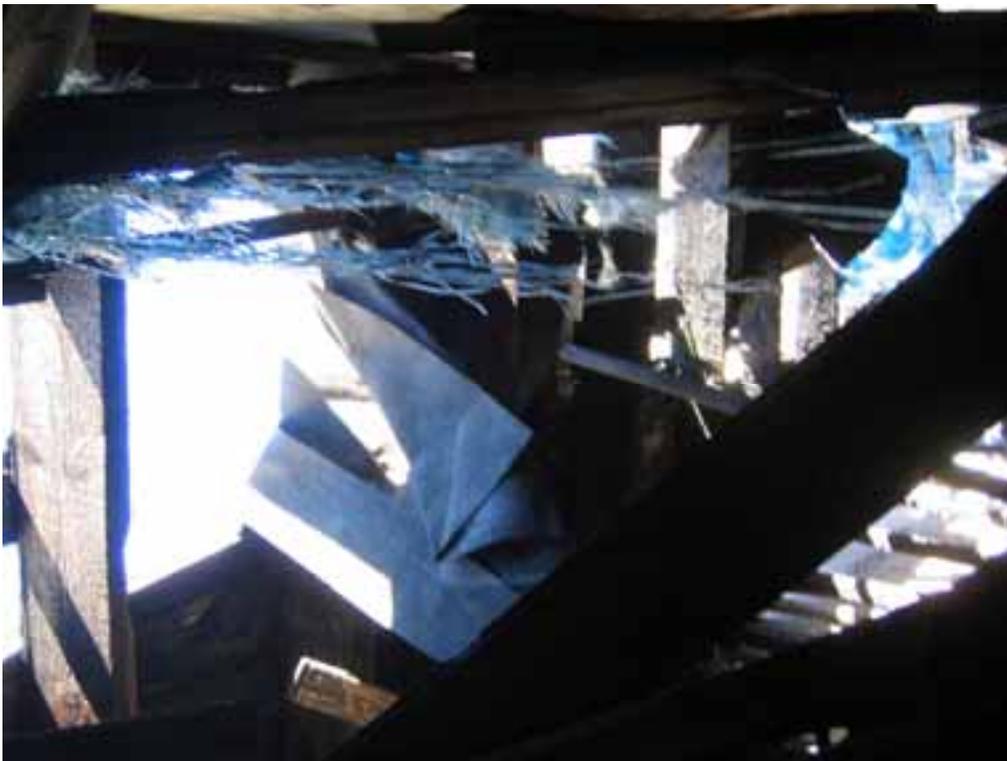
Photograph 1997-64-J

Despite these stabilization efforts, the continuous water infiltration through the collapsed portion of the roof contributes to further deterioration of the building structure and may lead to subsequent additional collapses (see photo J). The exit stair from the second floor is not enclosed, does not have guardrails/handrails, and has severely deteriorated and loose treads (see photo K).

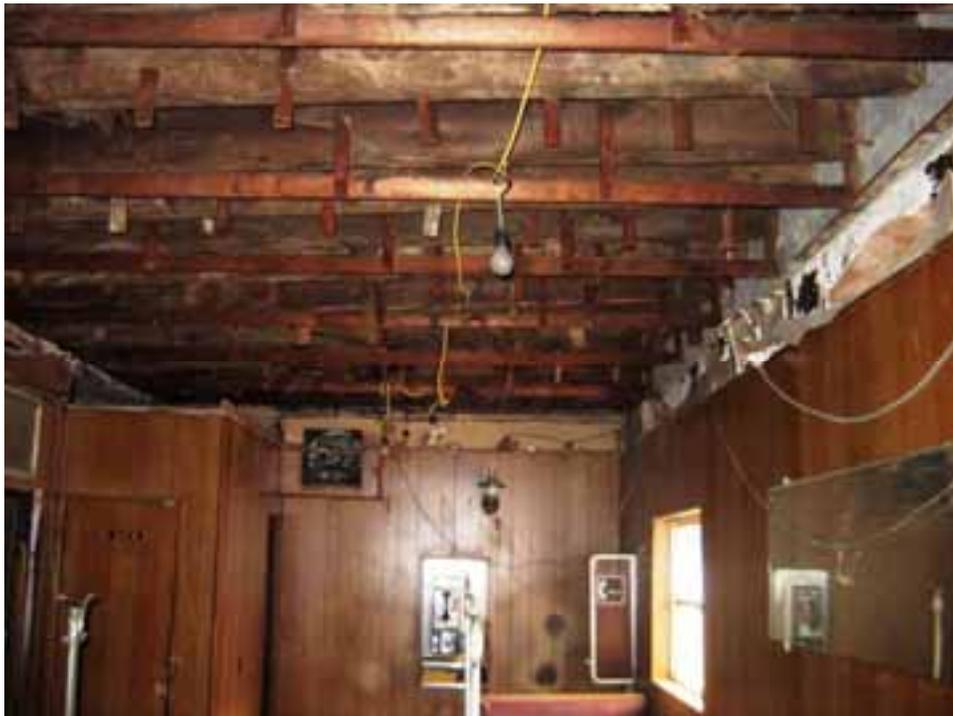
Photograph 1998-1-F

The exposed interior area of the roof structure of the masonry building exhibits severe water damage (see photos F and G), and received an appropriate condition rating of poor by Thornton Tomasetti. Less than half of the masonry building's roof is exposed, but unless the remainder of the roof is exposed and found to be structurally sound, casual access upon the roof should be prohibited since the roof's ability to sustain pedestrian loads or the design roof live load is questionable. The exposed east exterior CMU wall exhibits several wide vertical cracks, and would also be rated poor according to the condition rating system established by Thornton Tomasetti, but remains serviceable and probably could be repaired (see photos H and I).

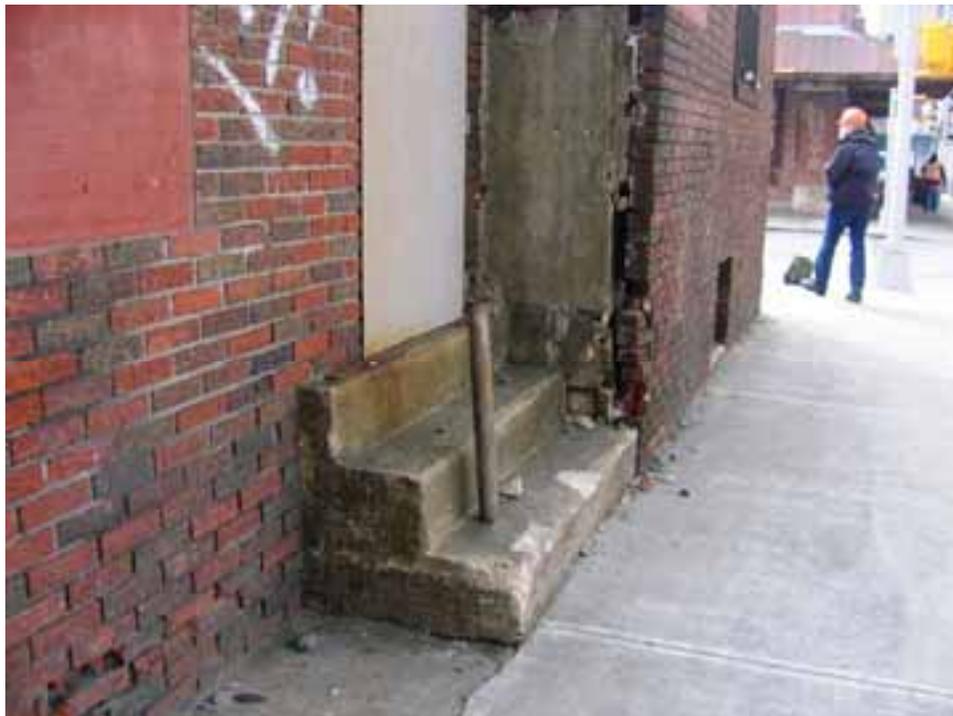
Photograph 1998-1-J

The interior and exterior finish materials (brick veneer, paneling, plaster, ceramic or vinyl flooring etc.) are deteriorated, soiled and generally in a poor state of repair (see photos J, K and L). There are scattered instances of minor water damage, which does suggest that the underlying structure may also be compromised. If continued service is contemplated for any of these three units, further investigation would be necessary to confirm structural integrity, esp. the roof structures.

Subsequent to the AKRF report, the broken lower tread of the exterior stair at the West 131st Street entrance was repaired (or, rather, eliminated with the adjacent repaired sidewalk elevated to cover this step). This was the only repair noticed by Earth Tech (see photo N). Both exterior stairs of this building are not code-compliant and are not safe (see photo J).

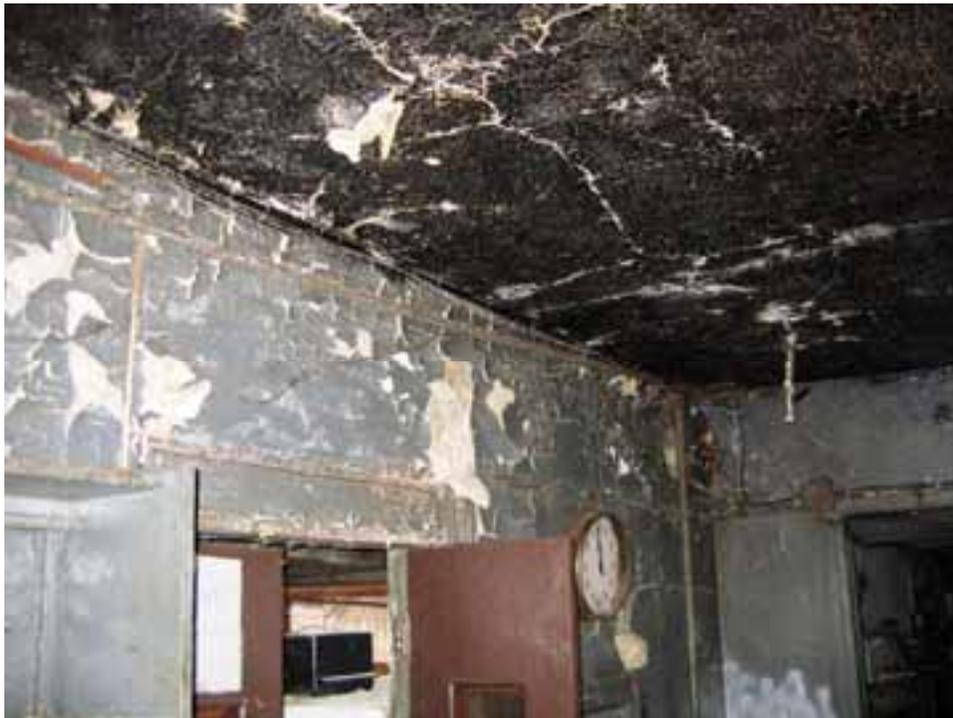
Photograph 1998-1-L

Earth Tech concurs with the health and safety concerns noted in the AKRF report. At the time of the Earth Tech survey, several health and safety hazards were noted, including: mold on the walls and ceiling of bathroom in the masonry portion of the building (photo M) and peeling paint on walls/ ceiling in the kitchen (see photo L) – these are health hazards.

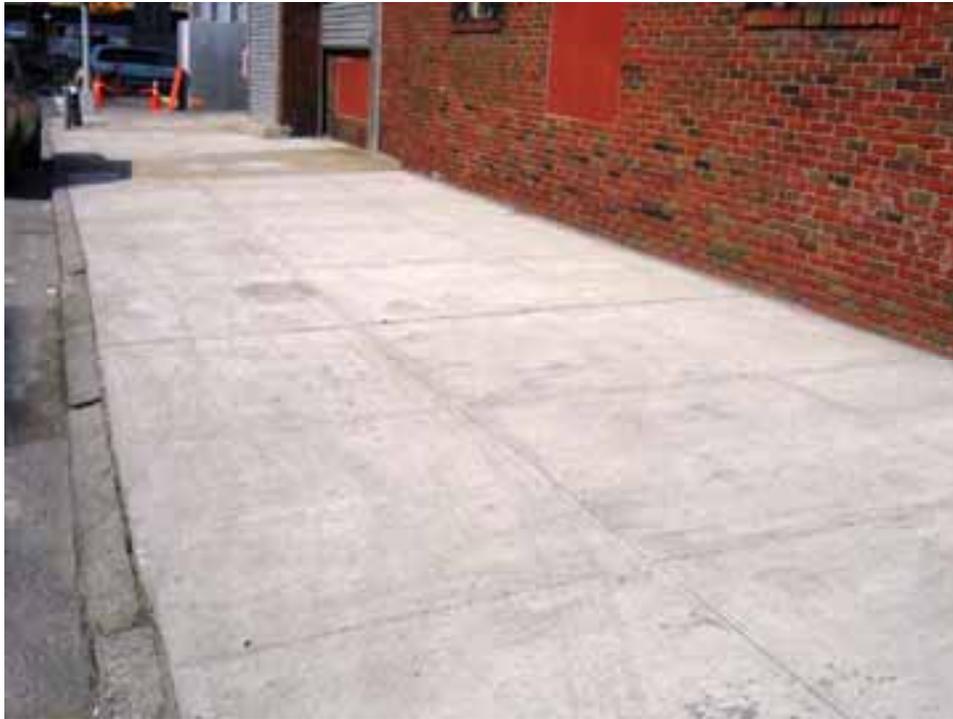
Photograph 1998-1-O

The dumpster cited in the AKRF report as a “potential breeding spot for vermin”, was not present at the time of the Earth Tech survey. Also, about 50 percent of the adjacent sidewalks along 12th Ave and 131st Street have been replaced, apparently over the last few years, and are in generally fair to good condition (photo O).

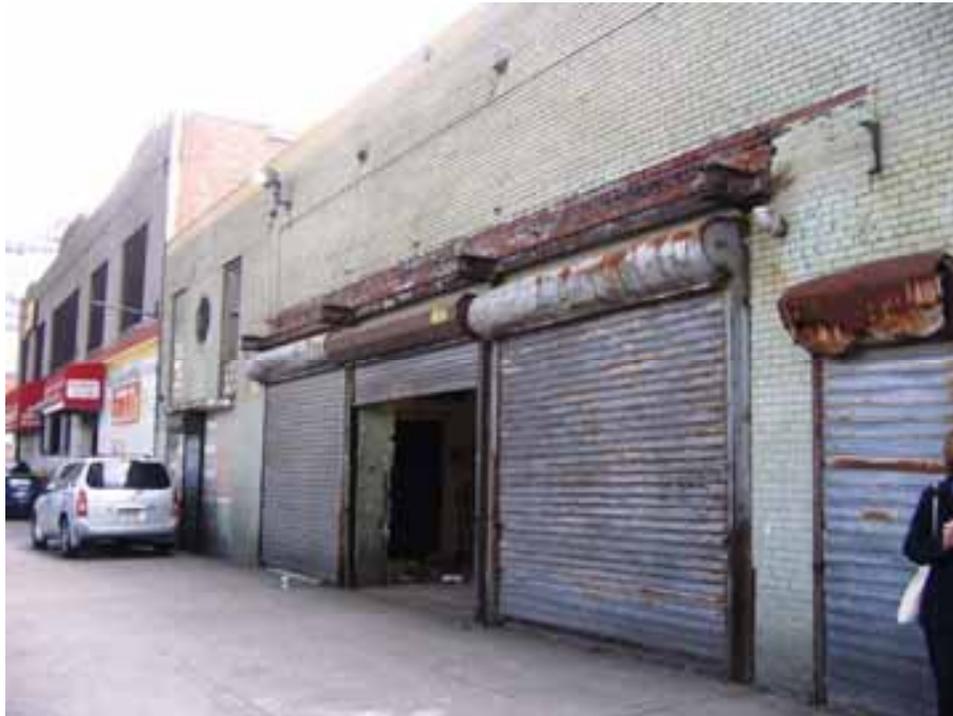
Photograph 1998-3-N

Thornton Tomasetti also reported two critical falling debris hazards: loose brick above the three west façade roll-up doors, and impact-damaged bricks at the corner of the center roll-up door at this location. However, at the time of Earth Tech's inspection, the brick did not appear in any immediate danger of dislodging and falling. (see photo N)

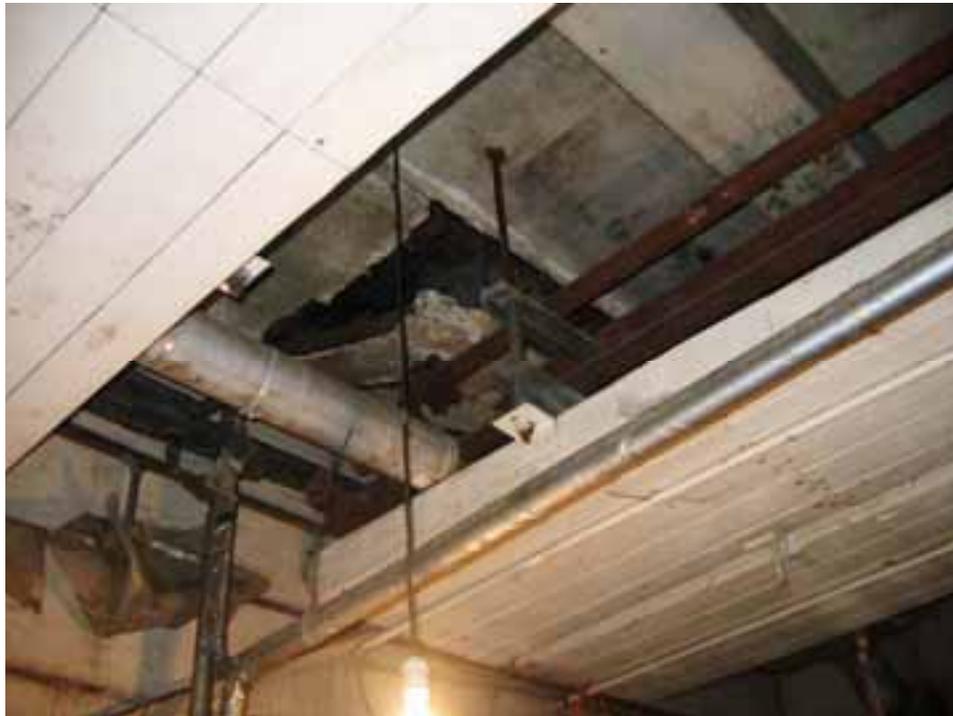
Photograph 1998-3-S

- Earth Tech observed ceramic tiles, plaster and what appeared to be cork insulation panels that are falling off the walls and ceiling in numerous locations throughout the building (east wall in northern refrigerator room; column pilasters and ceiling in southern refrigerator room) (see photo K); (see photo R); (see photo S), (see photo G), which presents a falling debris hazard.

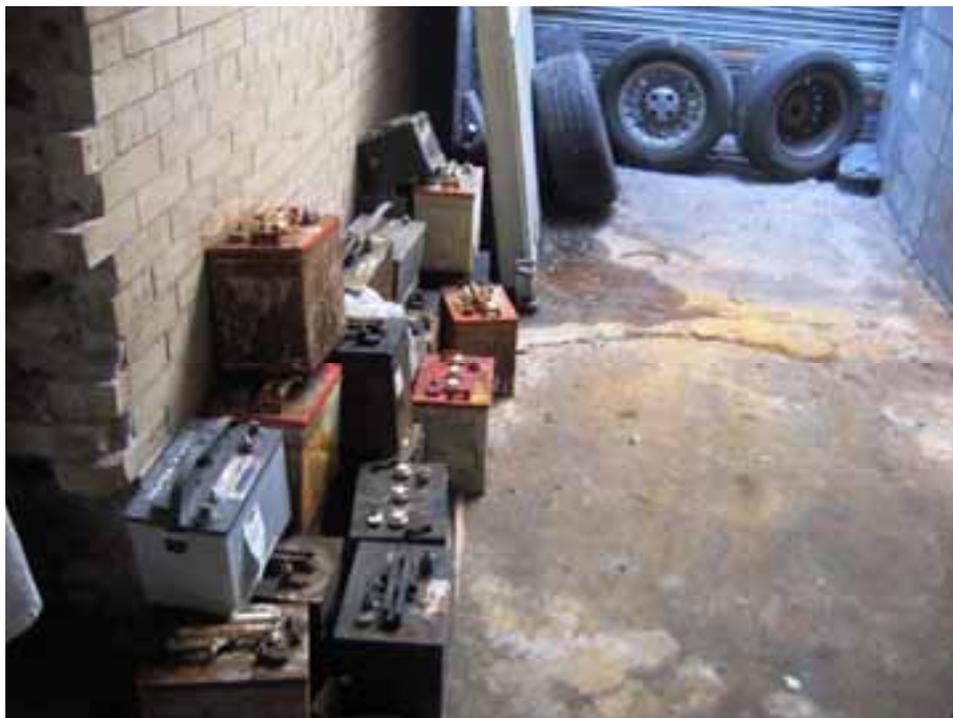
Photograph 1998-3-T

- Automotive-type batteries were haphazardly stored next to the utility/electrical room, leaking battery fluid onto the floor (see photo T). The skylight above this room had an opening (one of the glass panels slid back) allowing the elements into the building (see photo U); (see photo V).

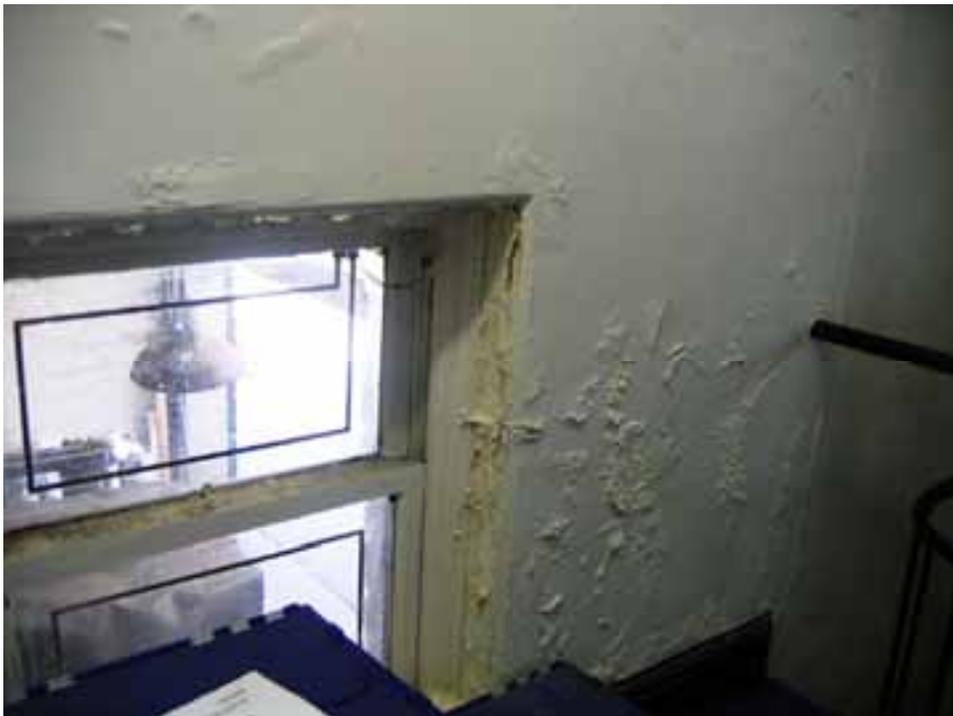
Photograph 1998-3-Z

- In the second floor office area, the walls, although appeared as recently painted, presented numerous areas of spalling paint, probably a result of the previous water damage (see photo Z).

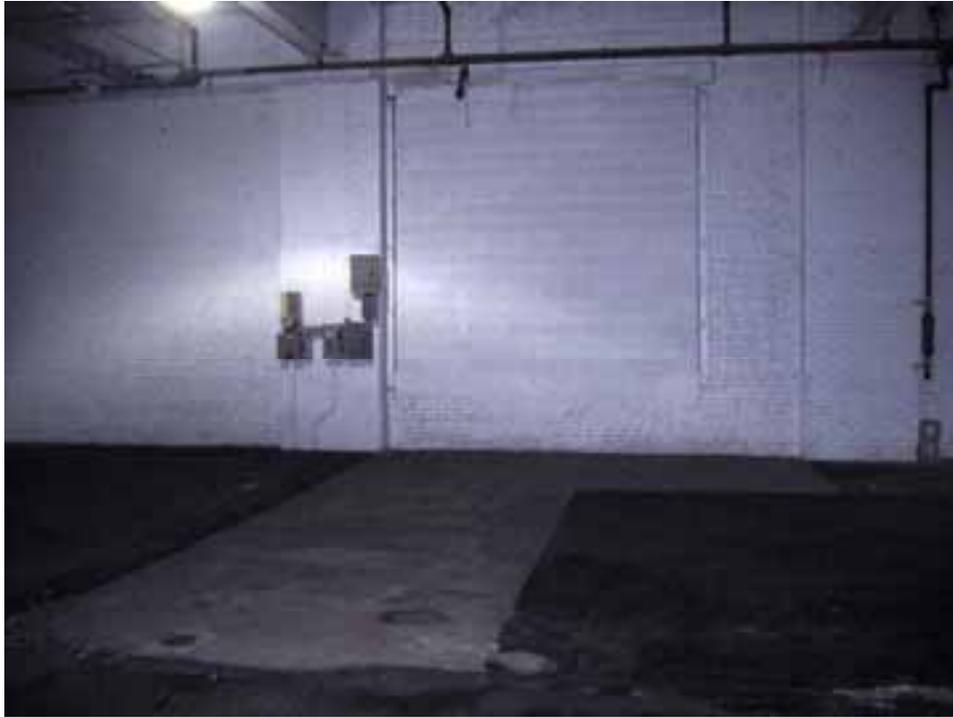
Photograph 1998-6-C

At the time this site was inspected by Earth Tech on March 5, 2008, no major interim or permanent repairs to correct or mitigate the reported instances of structural damage, distress or instability were found where inspection was possible, except that all walls are cleaned of the water stains and painted (see photo B); also a portion of the brick wall in the east wall is removed and replaced with concrete masonry unit wall (see photo C), and the previously water damaged ceiling is replaced.
