Block 1986 Lot 6

Block 1986 Lot 10

Block 1986 Lot 30

Block 1986 Lot 65

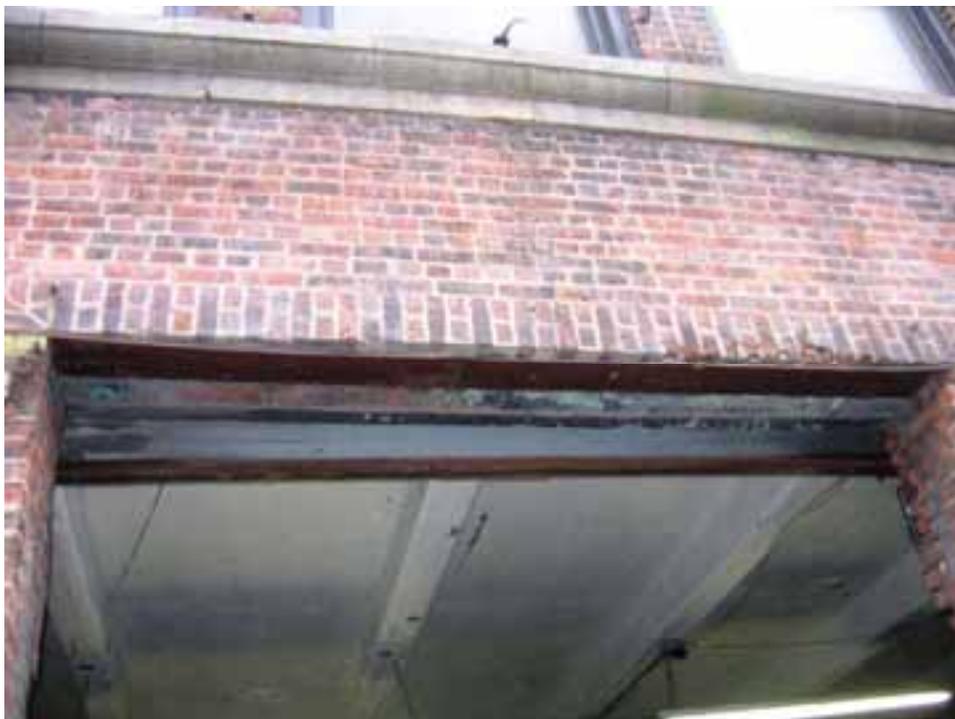
Photograph 1986-6-B

The rolling doors on the south side of the building shows heavy corrosion on lintels with significant deflection and 1 in. to 2 in. separation between brickwork and lintel is present (see photos B and C). Several wide and stepped cracks are visible in the north and west walls (see photos D, E and F). Water stains and microbial growth are present on the east wall (see photos G and H). A large 1ft 6 in by 1 ft 6 in hole is visible in the second floor

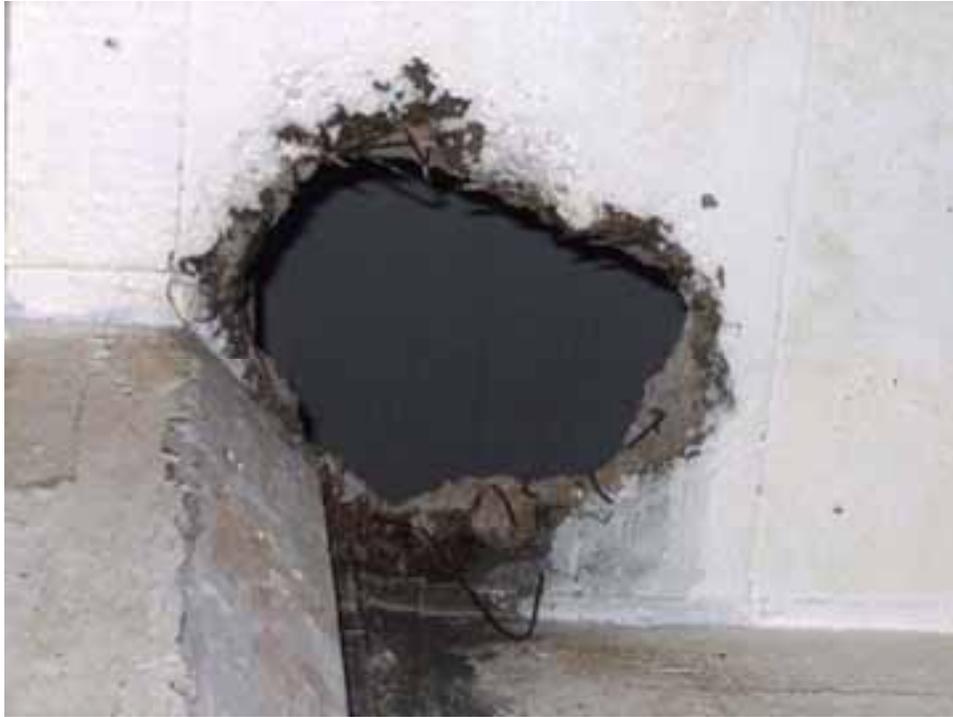
Photograph 1986-6-I

slab on north side (see photos I and J). The basement walls are wet and extensive mold is present (see photos K and L). The exterior steel stair from first floor to fourth floor shows severe deterioration with heavy laminar rust and section loss on a steel angle column. The pedestal supporting this angle is cracked and other supporting steel members also exhibit heavy corrosion (see photos M and N). Several medium to wide cracks are visible in the floor slabs at the second and third floors, with some through cracks apparent in the soffit of the slab also (see photos O and P). Extensive paint peel off is visible on the beams and soffits of slabs (see photos Q, R and S). The soffit of the roof slab shows a wide transverse crack near the northwest corner of the building, with dripping water and rust stains through the cracks (see photos T and U). Despite efforts to seal cracks, new cracks have formed and water is now leaking through these cracks. The soffit of roof slab and south wall in stair area shows wide cracks and displaced brick work (see photo V).

- There are holes in the concrete floor slab (2nd floor; up to 12" in diameter) in several locations; these are safety hazards (see photos AA, I and J).
- Active water leaks on the 4th floor (at roof slab) and peeling paint throughout the building; a health and safety concern (see photos AB, AC, AD and AE).
- There is excessive litter on the 3rd floor (See photos AF) and litter and dog feces (?) in northeast corner on 4th floor (see photos AG).

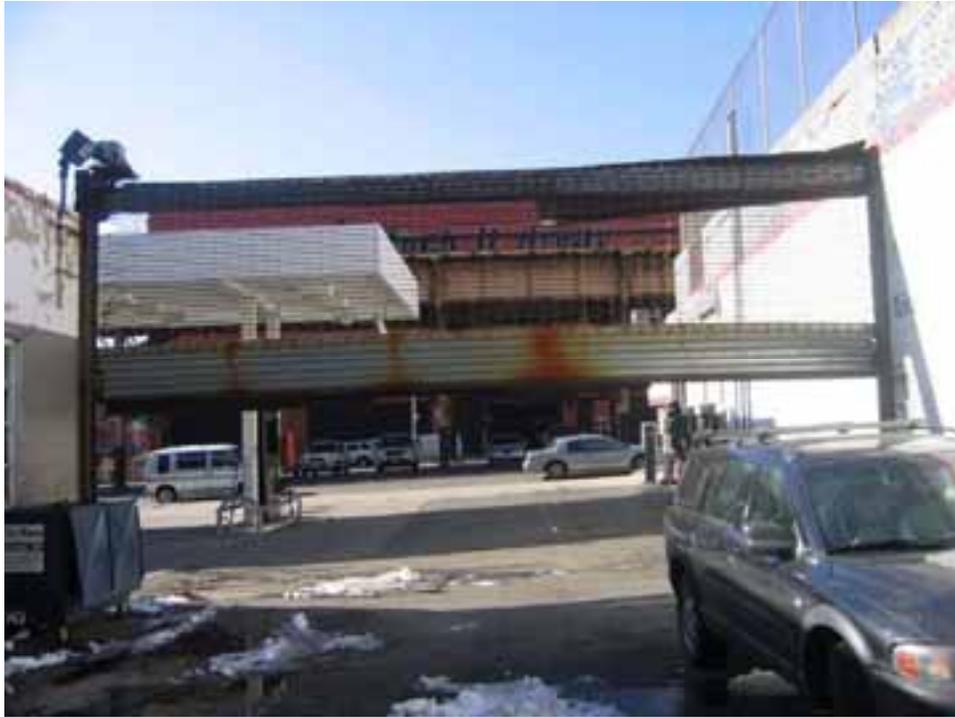
Photograph 1986-6-Y

- The stair from the 4th floor to the roof has non-uniform tread/riser dimensions, which is a safety hazard (see photo W).
- The emergency exit from this building leads to the adjacent property of Block 1986 Lot 1, which is locked with roll-up door at night; this is an unsafe condition (see photos X and Y).
- However, the exit corridor, which was reported blocked in the AKRF report (photo 1986-6-M), was clear of obstructions on the day of Earth Tech's survey (see photo Z).

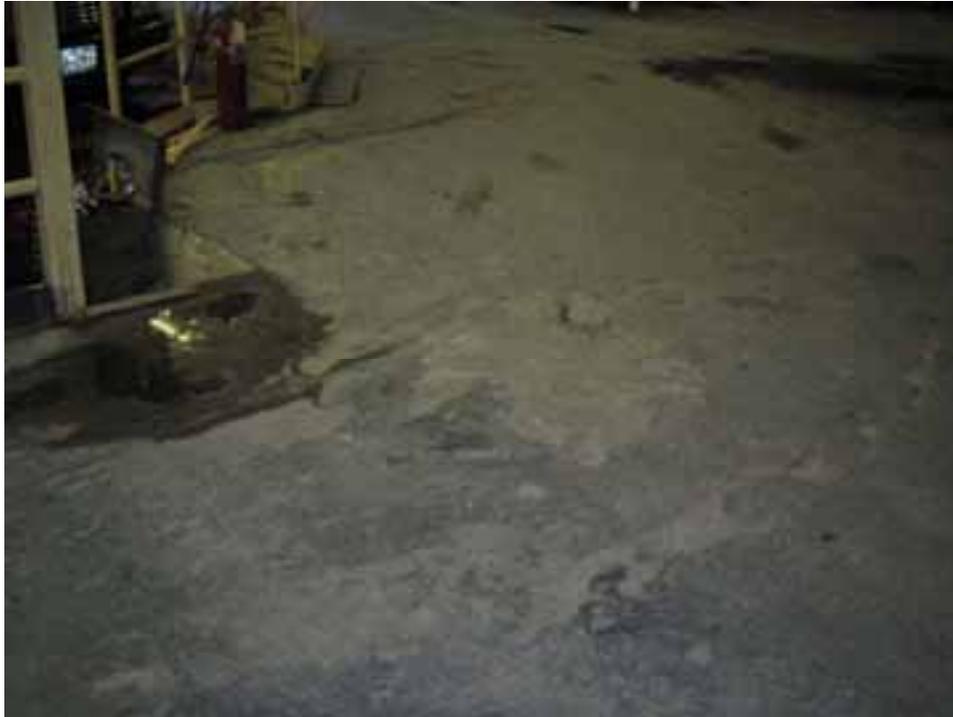
Photograph 1986-10-C

At the time this site was inspected by Earth Tech, on February 25, 2008, the observable instances of deteriorated or damaged physical features appeared generally consistent with the findings reported by AKRF and Thornton Tomasetti. According to the condition rating system established by Thornton Tomasetti, the AKRF and Thornton Tomasetti reports describe the condition of most of the building elements (e.g. steel columns and girders, brick masonry bearing walls, timber roof rafters and membrane roofing) as fair to good. Such elements remain in an acceptable state of preservation or could be rehabilitated to extend the facility's service life or for cosmetic improvements. The interior concrete slab on grade (see photo C) and sidewalks, however, were described as poor, and the lintel above a rollup garage door through the south exterior wall as "locally distressed" (sagging and carrying cracked brick).

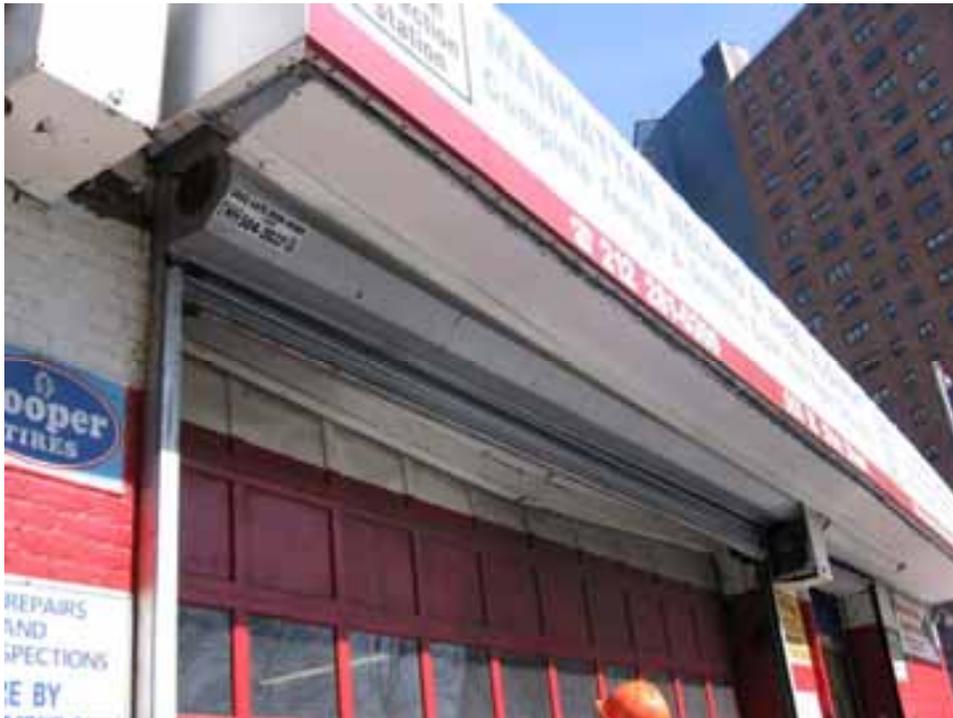
Photograph 1986-10-F

ET concurs with AKRF report that the sagged lintel beam as discussed above, could present an unsafe condition because of the cracked brickwork and the questionable structural condition (see photo F).

Subsequent to the inspections by Thornton Tomasetti, sections of the sidewalk (see photo D) were replaced. As to the “distressed” doorway lintel in the south exterior wall, Earth Tech could not determine by visual inspection alone whether it is the structural element (the lintel beam) itself or merely the finish materials (wooden soffit) covering the lintel that are sagging. In either case, the lintel clearly carries little more than the brick wall masonry directly above, and does not carry the roof deck or roof beams (the timber roof rafters run parallel to the south exterior wall). The cracked brick masonry should, however, be removed as soon as possible, along with finish materials so that the condition of the lintel beam can be confirmed.

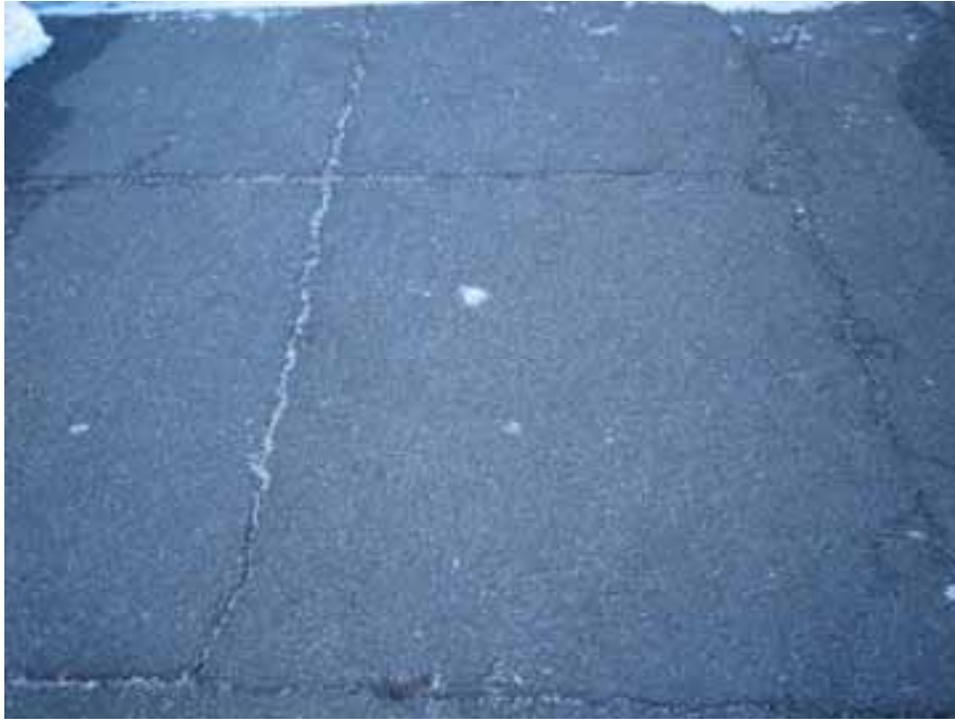
Photograph 1986-10-G

The curb and sidewalk ramp along the overhead doors at the south building face is in fair condition, while the sidewalk at corner of West 131 Street and Old Broadway appears to have been recently replaced. The asphalt paved sidewalk on Old Broadway exhibits numerous wide cracks and is in fair to poor condition (see photo G).

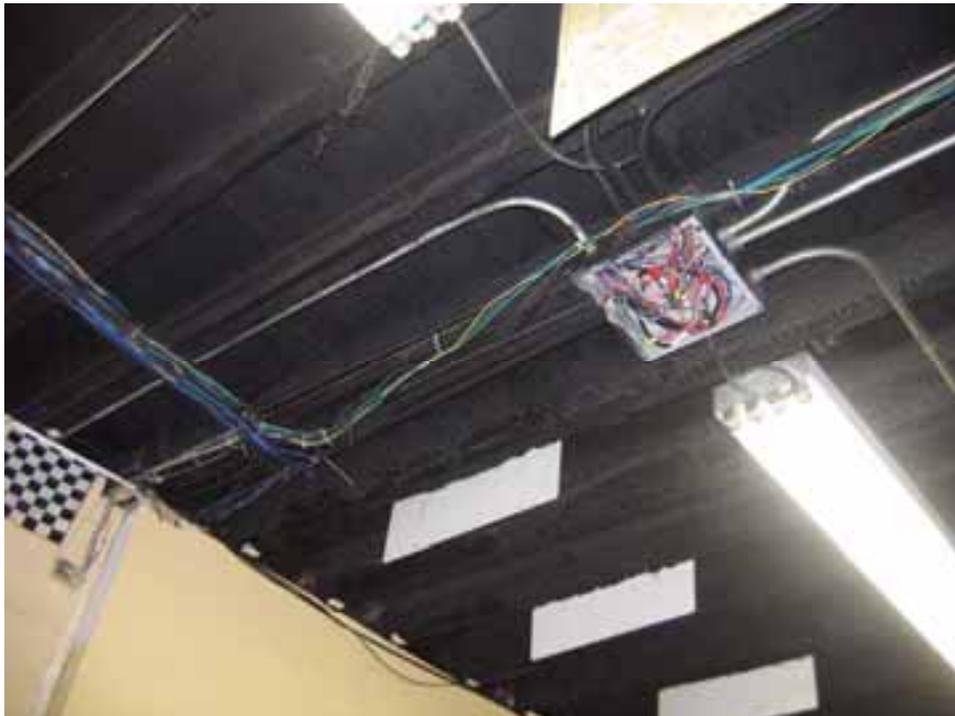
Photograph 1986-10-H

At the time of the visit, ET observed miscellaneous wires and open junction boxes in several locations, which is an electrical safety hazard (see photo H).

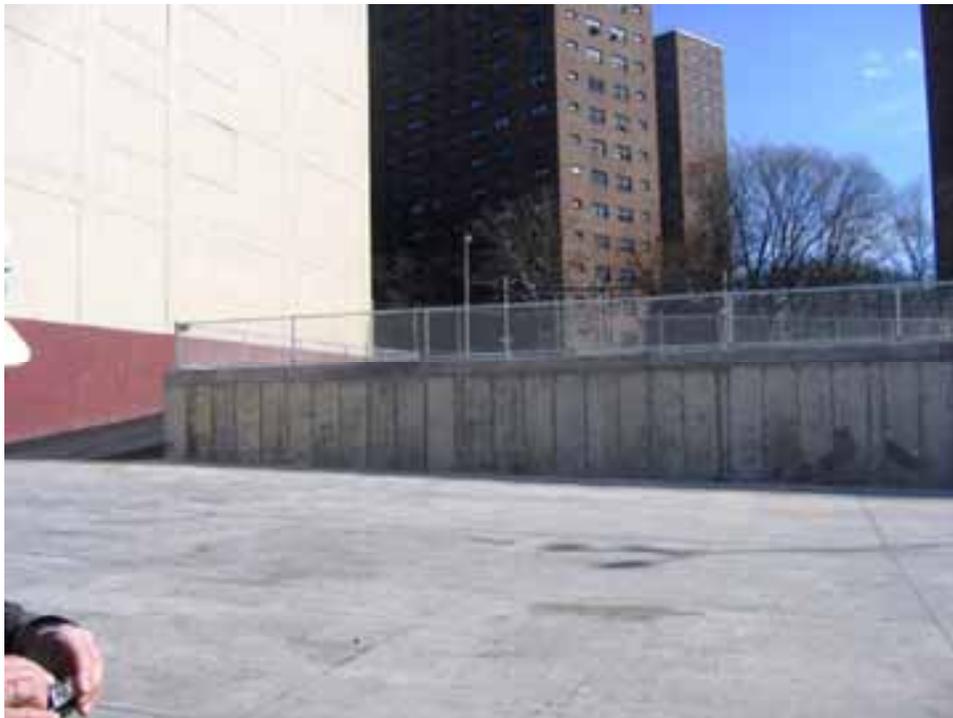
Photograph 1986-30-B

- The exterior retaining wall separating upper and lower open parking areas, which was in a critical and a partial failure condition, has been replaced with a new concrete wall (see photos B and C).

1. *"the condition surrounding the exterior retaining wall are unsafe...the wall could collapse in the near future"* – the retaining wall has been rebuilt (see photos B and N)
2. *"a chain link fence installed on the roof of the main building is missing, creating a safety hazard for employees who park vehicles on the roof"* – there is a chain link fence presently on the roof of main building (see photos O and P).

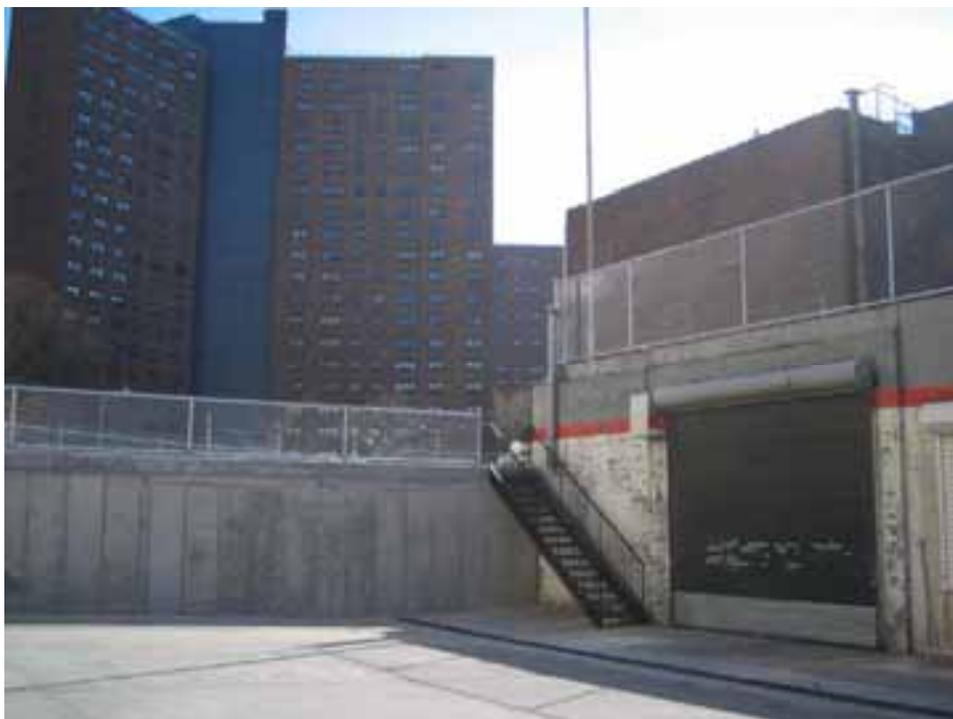
Photograph 1986-30-D

- The building roof with chain link fence along its perimeter has been replaced to enhance the safety conditions (see photo D).
- The eastern portion of the open parking area, which was unpaved and uneven, has been provided with new concrete paving (see photo E).
- Construction is in progress to remove and replace the clogged drain on the roof of the building (see photo F).

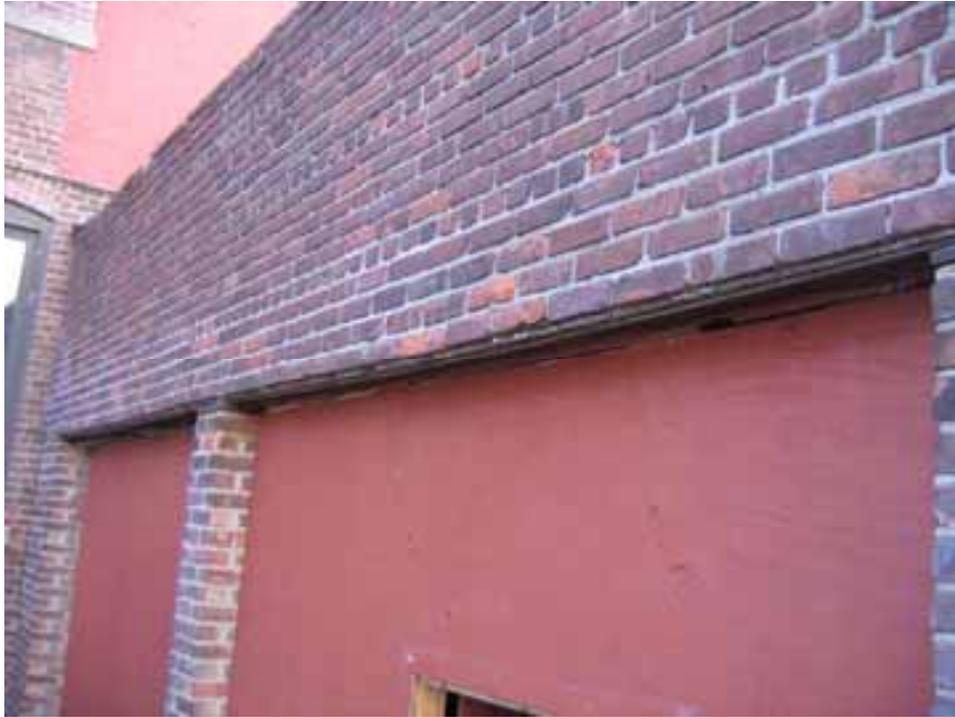
Photograph 1986-30-M

The remaining building deficiencies on the main commercial building include: medium vertical and horizontal cracks in the masonry walls (see photo G); medium corrosion on steel columns; water stain marks on the walls indicating water damage. The building to the rear and east of the commercial building has continuing evident deterioration with: large collapsed holes in the roof (see photo H); hanging steel ceiling (see photo I); wide stepped crack and separation and displaced brick wall (see photos J and K); missing or collapsed roof parapet, including missing coping stones (see photo L); severely corroded and deflected lintels of entrance doors (see photo M).

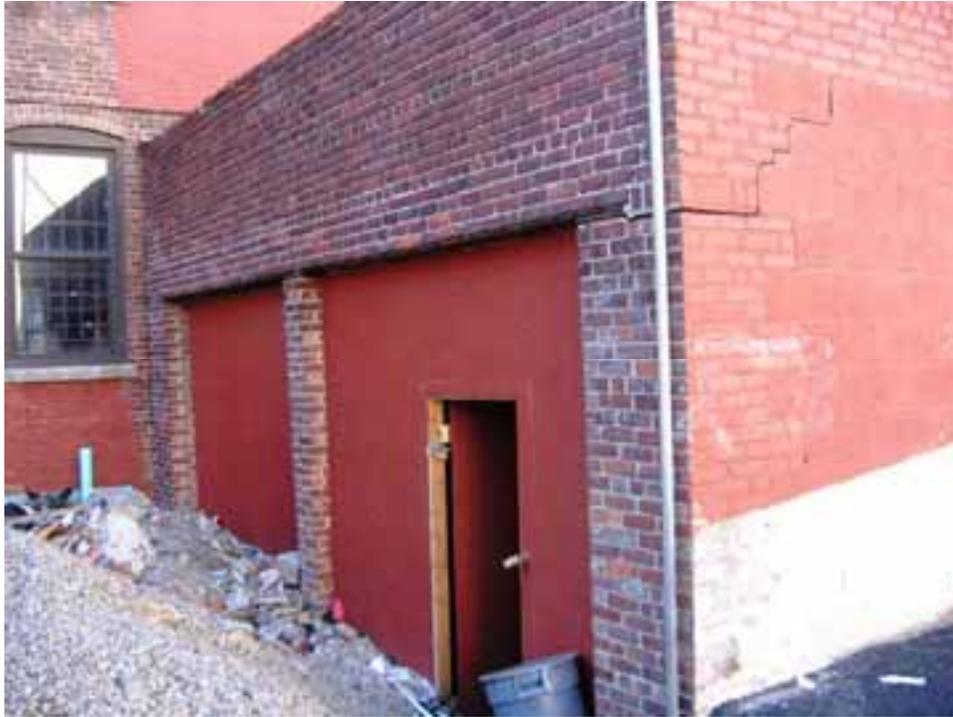
Photograph 1986-30-Q

Earth Tech believes that the statement in the AKRF report: *"the existing owner is allowing the vacant building to deteriorate without properly securing the structure, creating a hazardous condition for anyone who can enter the building."* refers to the small garage building to the south of the site. It is indeed in a state of serious disrepair (see section above). However, at the time of Earth Tech's survey, the building was securely locked, as was the site. Also, according to Columbia University personnel, this garage building is scheduled for demolition pending the DOB demolition permit (see photos Q, R and H).

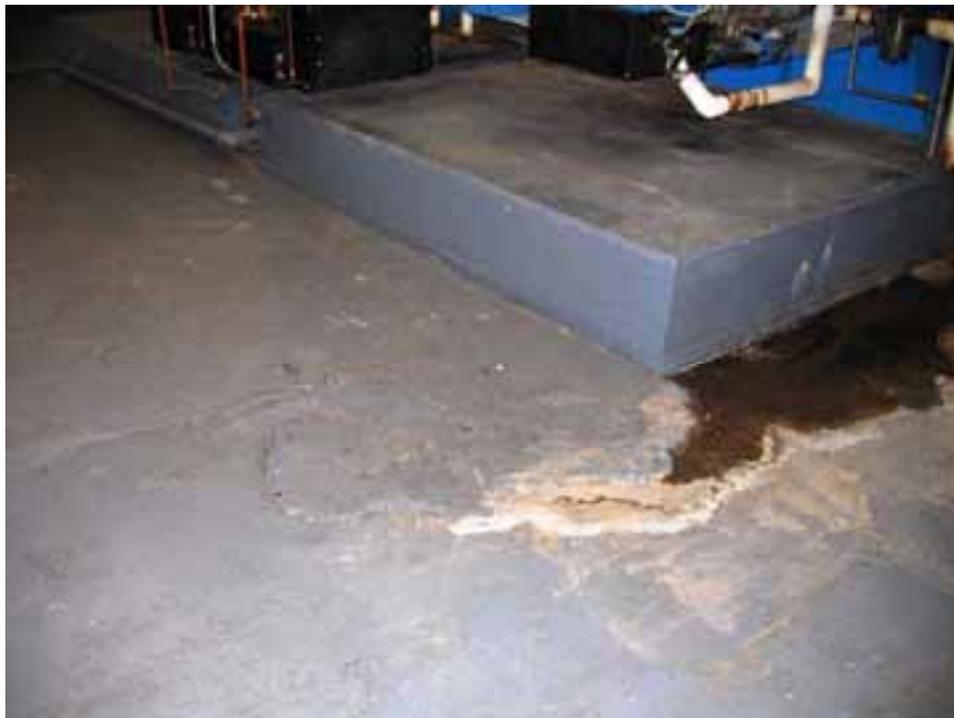
Photograph 1986-65-E

The localized deterioration of primary and secondary structural members is caused due to water infiltration, as is evident in the northeast basement area, boiler room and stairs leading to the basement from first floor. The metal deck in the passage area is severely deteriorated (see photos C and D). Water stains and wet patches, paint peel off are visible in the boiler room and mechanical room, including on the soffit of the slab (see photos E and F). Water

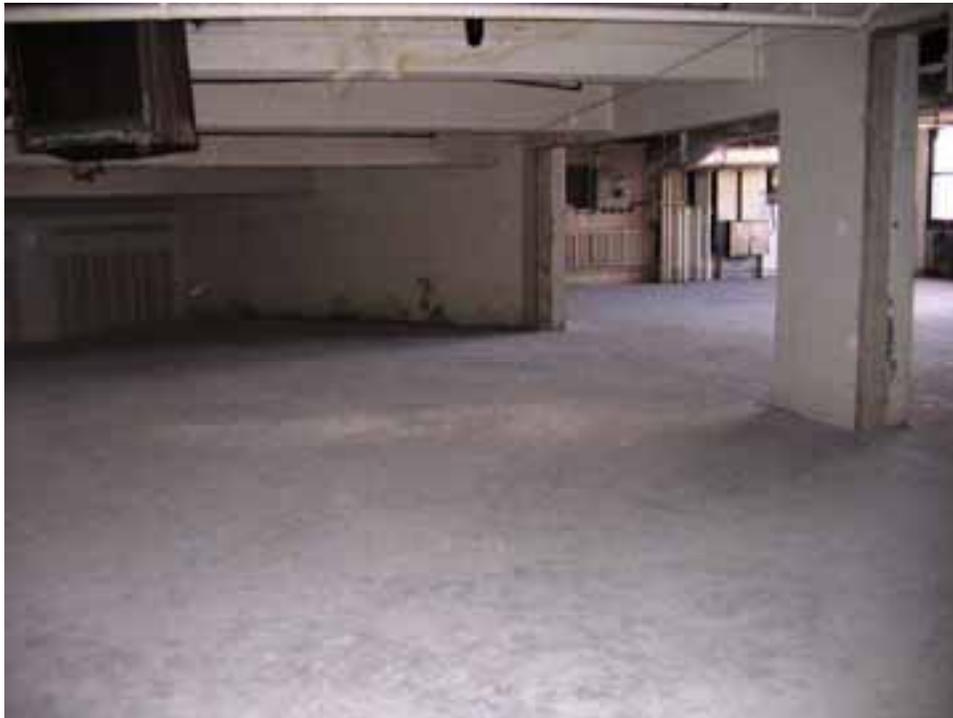
Photograph 1986-65-W

- *“Unsafe conditions appear to exist in several units within the former circular parking ramp”*
- Additional concrete added to the ramp by a former owner or tenant to make the floor even with the 5th floor slab remains a safety concern (see photos V and W).

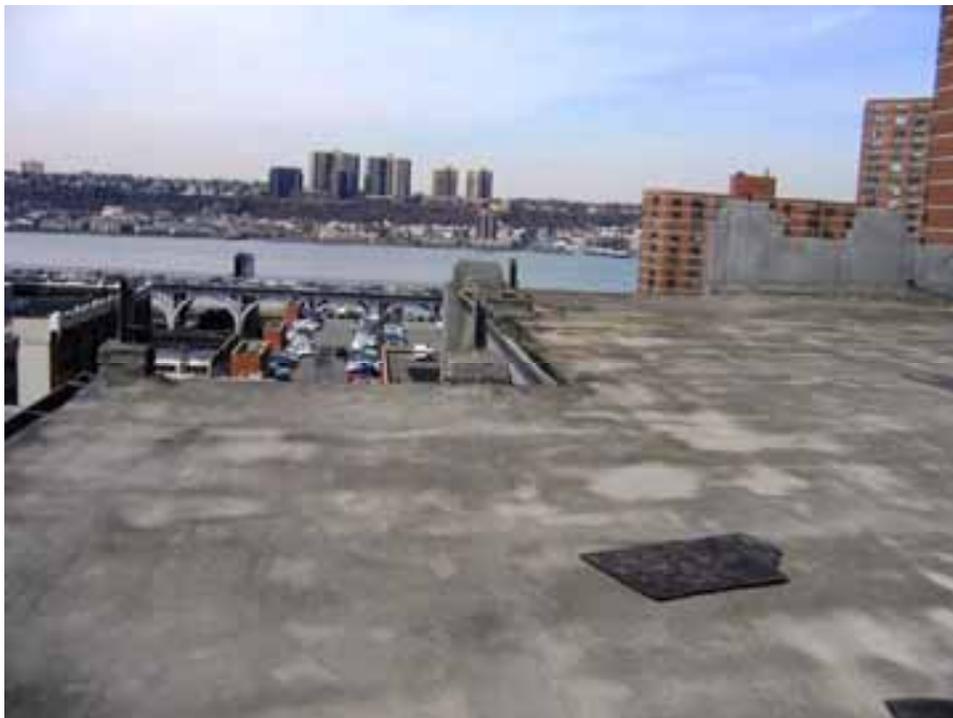
Photograph 1986-65-X

- On the roof of this 7 to 8-story building, portions of the parapet are completely absent at several locations; this is a code violation and a safety hazard (see photos X and Y).
- The flagpole on the roof near the west parapet has lost one out of three structural bracings; this creates an unsafe condition because of the instability and possible collapse of the flagpole (see photo Z).
- Earth Tech observed haphazardly installed electrical wiring at several locations throughout the building (see photos AA and AB).
- The ceiling paint in the parking garage (ground level) is peeling off throughout the level (see photo AC, AD, AE and N); this is a possible health concern for employees.
- The paint is peeling off in several other locations throughout the building (see photos AF, AG and AH).
