SITE CONDITION: FAIR

Block 1998 Lot 13

LOCATION, USE, ZONING, AND OWNERSHIP

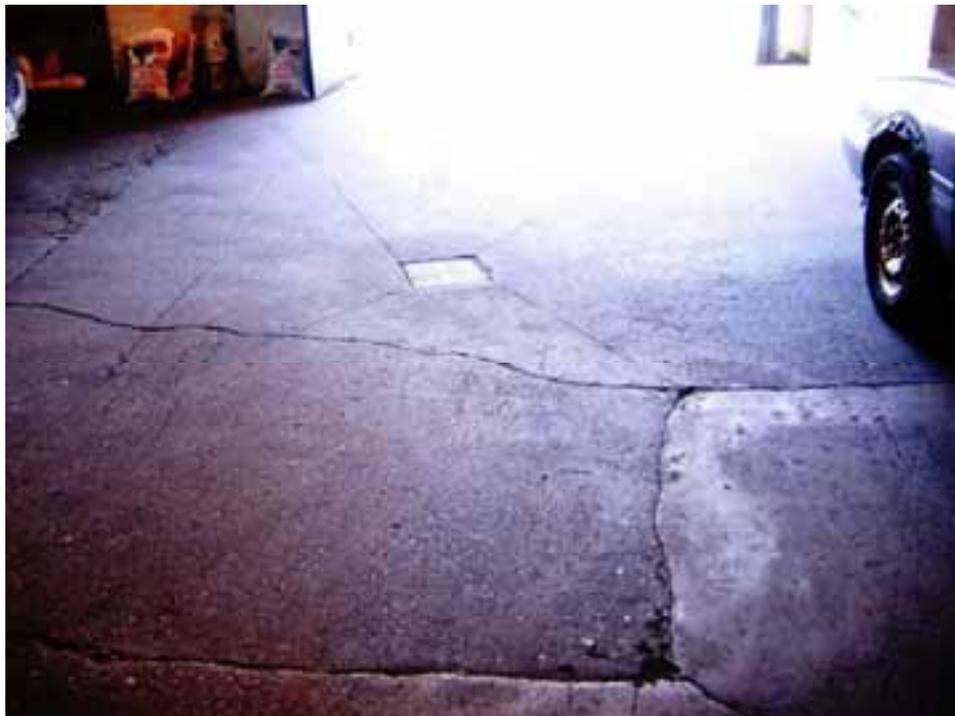
Photograph 1998-13-B

The entrance area in the parking area on first floor shows wide random cracking with settlement (see photos B and C). The metal deck and concrete encased beams are in fair condition with moderate amount of honeycombing (see photos D and E). The east wall has stepped cracks and a large spall at the bottom (see photos F and G). The underside of the ramp shows extensive paint peel off and several beams at the south end show heavy efflorescences and a wide crack at the bottom (see photos H, I and J). The second floor west wall shows water infiltration all along in the top area (see photos K, L and M). The aluminum channel framing for support of the roof shows significant rotation of a few channels and several cross bracing bars have bent (see photos N and O). The roof

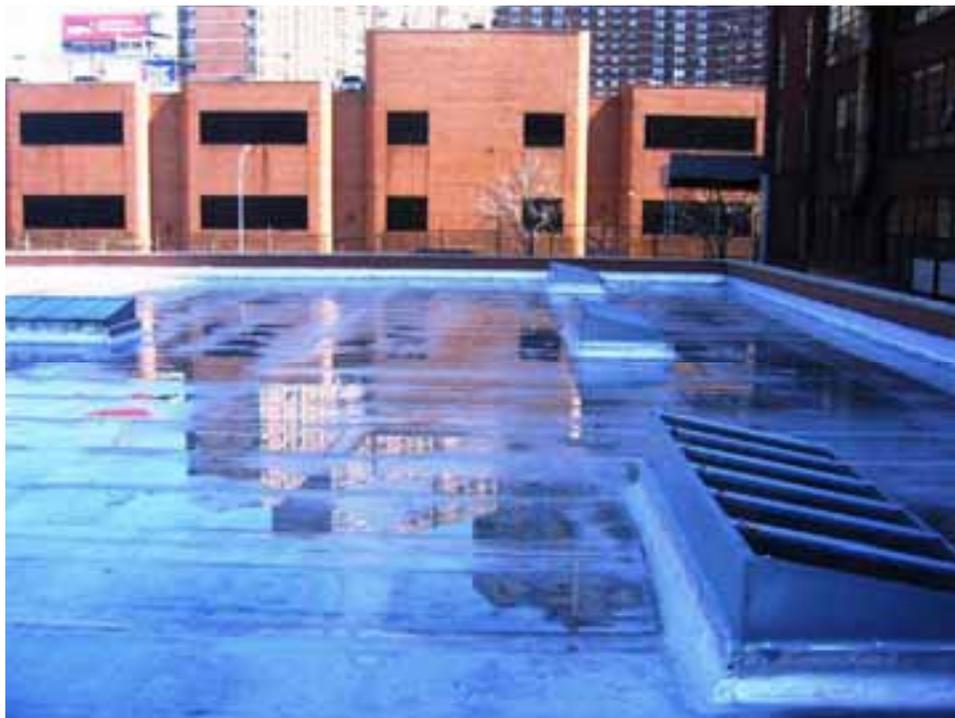
Photograph 1998-13-P

membrane is in fair condition but large pools of water are visible (see photos P and Q). Since the previous inspection there are no significant changes in the physical conditions of the building and Earth Tech concurs with the assessment by Thonton Tomasetti and AKRF as to the fair condition of the building's physical and structural systems.

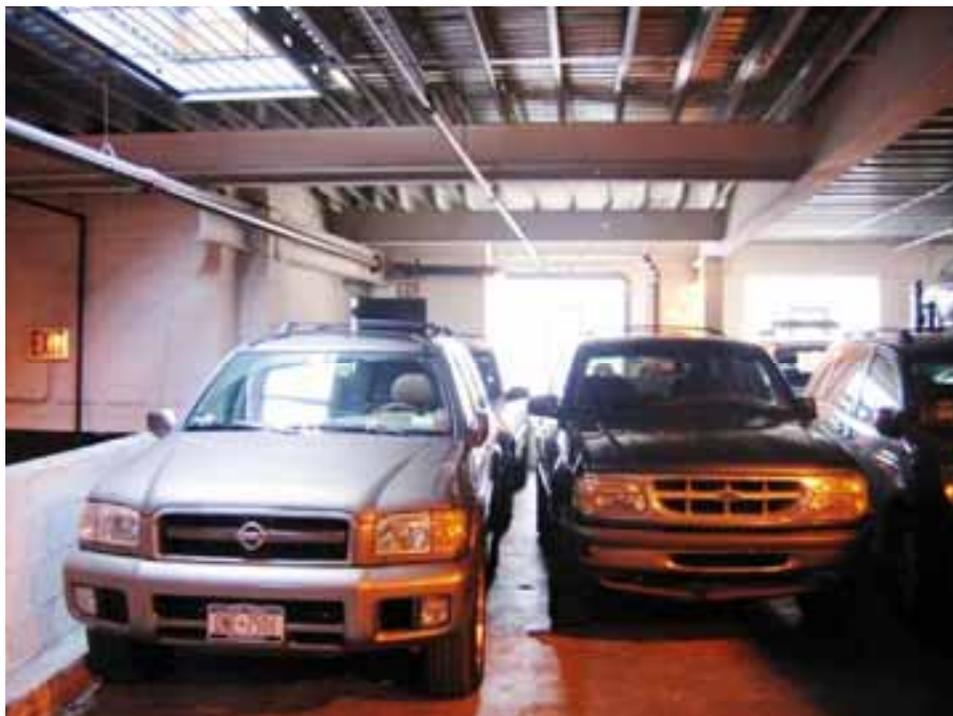
Photograph 1998-13-S

- *“Items stored between a flight of stairs and the door to West 131st Street, are obstructing a means of egress, and pose a tripping hazard”*. Earth Tech concurs with this statement (see photo R).
- *“On the second floor, tightly parked vehicles directly adjacent to the fire exit door would interfere with proper egress from the building”*. Earth Tech concurs with this statement (see photos S and T)

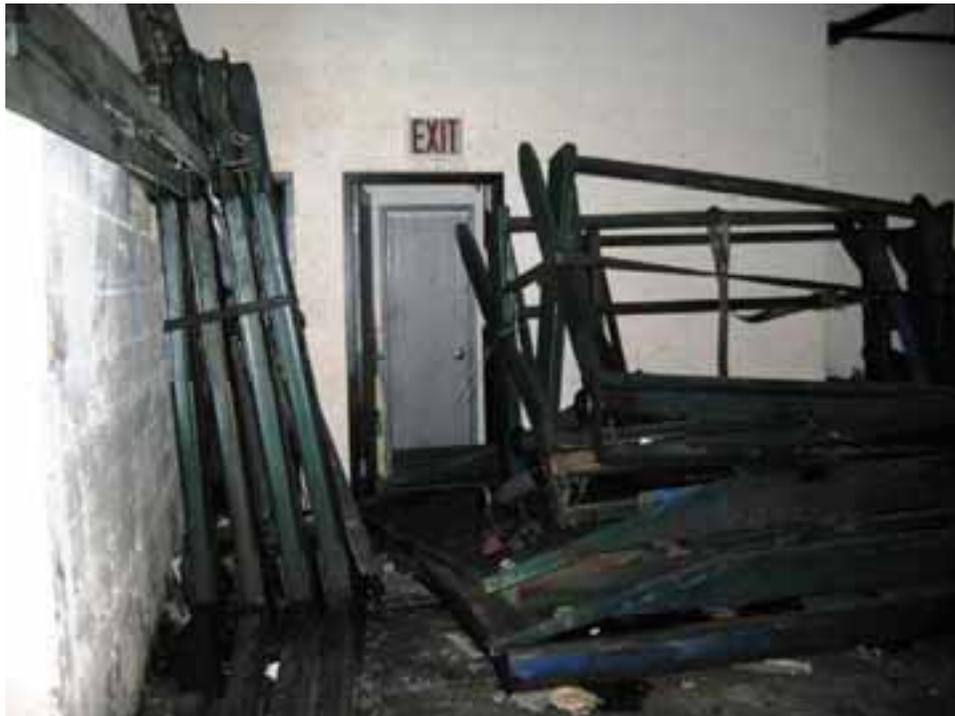
Photograph 1998-13-U

- On the day of the survey, direct access to exit door on the 1st floor was obstructed by stored equipment parts (see photo U). Also, some parts were protruding into the passageway at the height below the clearance required to safely pass under; this is a safety hazard (see photo V).
- The surface of the intermediate landing in the stairwell is not uniform; the elevations of concrete slabs differ by 1.5 in to 3 in; this is a tripping hazard (see photo W). Also, in the flight of the same stair leading to the roof, the last riser is at least 2 in higher than the rest of steps; this is another tripping hazard (see photo X).
- There are signs of water intrusion and efflorescence along the south and east interior masonry walls, as well as peeling paint - a potential health hazard (see photos Y, K, Z and AA).
- There are signs of local vermin infestation (see photos AB and AC).

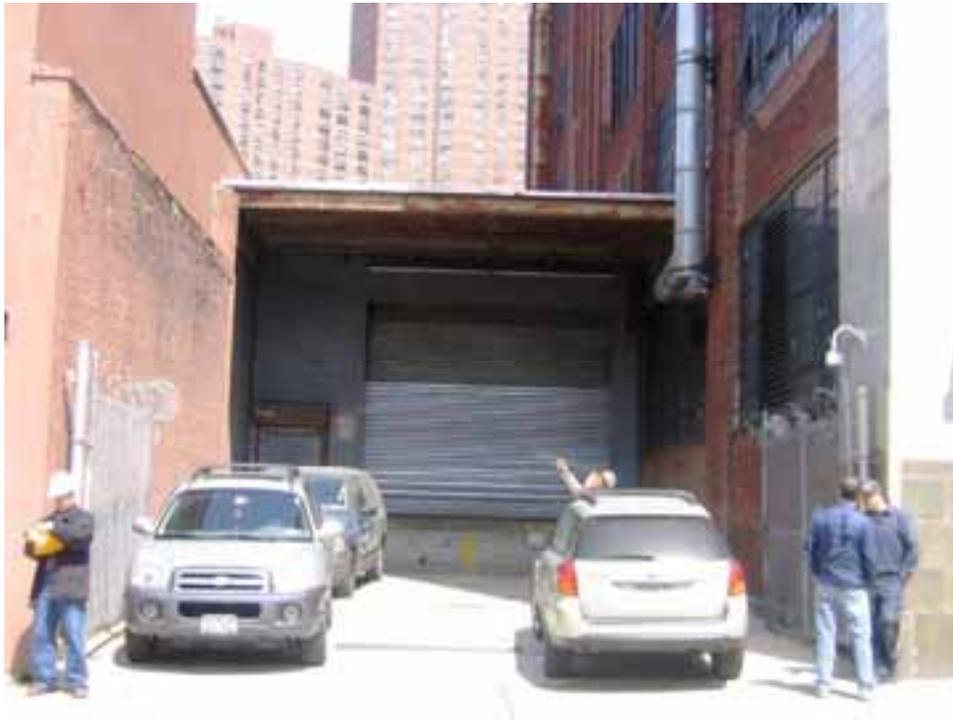
Photograph 1998-16-A

There are minor signs of light rust on the roof beams in the entrance area (see photo B). The slab on grade in the open entrance area shows wide cracks and minor settlement (See photo A and C). The CMU wall with a rolling door and the main door exhibits medium to wide cracks and stepped cracks (see photo D and E). Day light is visible through cracks in the wall above the lintel over the entrance door (see photo F). A brick column in the west wall has collision damage with loose bricks at the bottom area (see photo G). The spray-on fireproofing is missing on the roof beams at a few locations (see photo H).

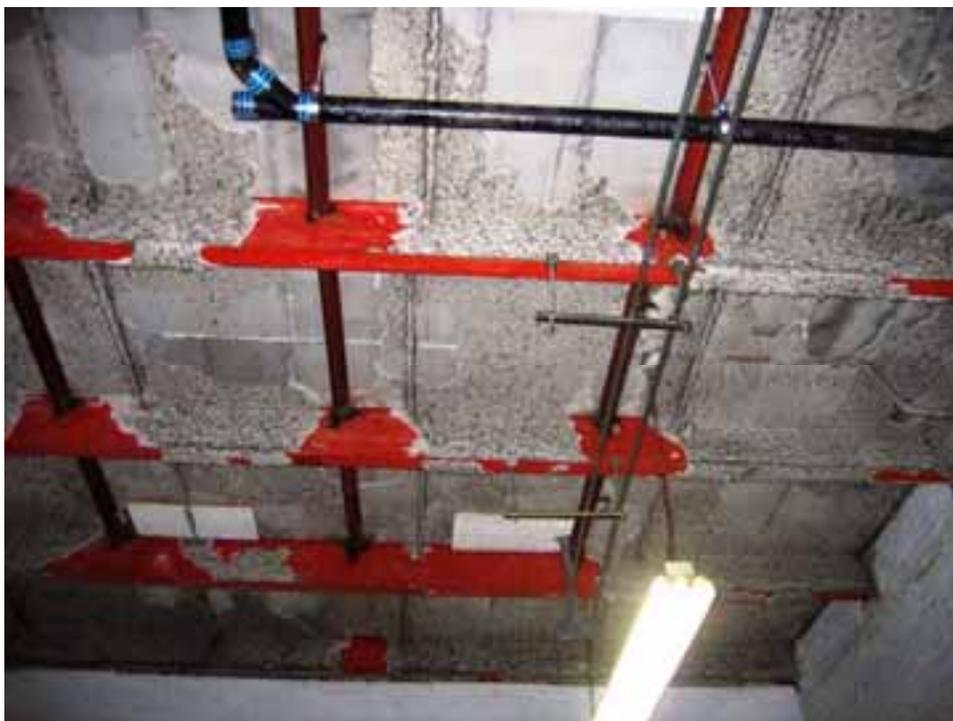
Photograph 1998-16-H

- *“Areas of missing fireproofing”* on the steel beams of the roof framing. Earth Tech concurs with this statement (see photo H).
- *“Severely cracked and spalling concrete on the sidewalk, which is a tripping hazard”*. Earth Tech concurs with this statement (see photo I).
- *“An unanchored vertical post of a handrail on the east side of the ramp”*. Earth Tech observed that this deficiency has been corrected (see photo J).

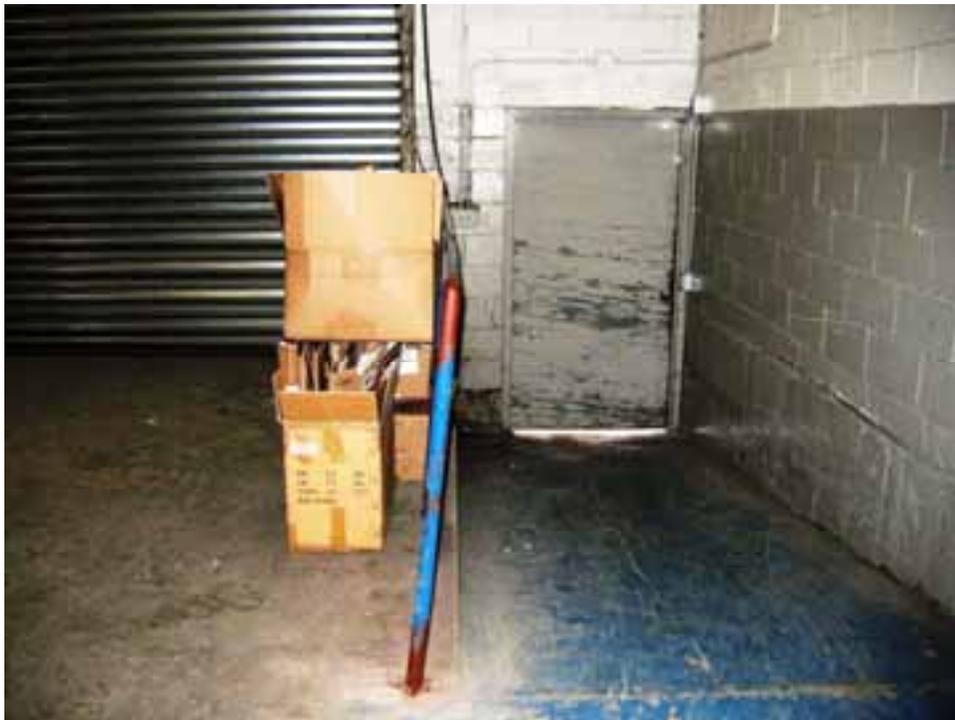
Photograph 1998-16-J

- Earth Tech noted that a new overhead roll-up door, connecting the loading dock on Lot 16 with the building on Lot 17 has been recently installed by the new owner (Columbia University). There is also a new exit door adjacent to it (see photo K). Neither this new door nor the existing man door (fire exit door) in the building on Lot 16 have any exit signs directing egress in case of a fire emergency (see photos L and J). They also lack appropriate panic hardware. This is a fire safety hazard.

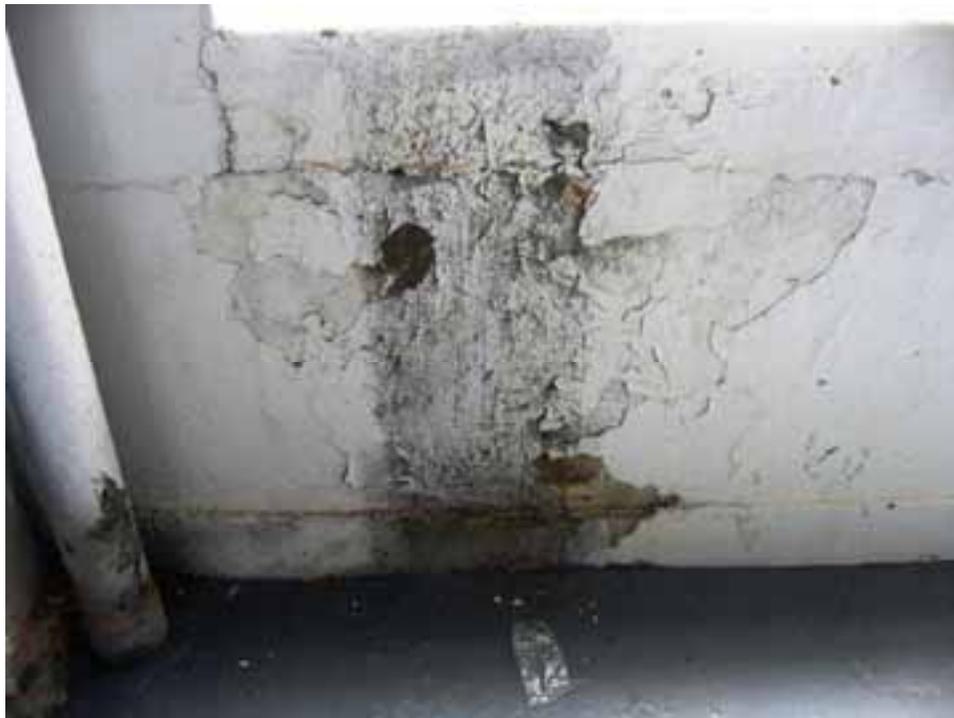
Photograph 1998-17-J

1. The lintels over the rolling doors on the north side are severely corroded and significantly deflected (see photos C, D and E).
2. A large stone is cracked and displaced over a boarded opening on the south side of the building (See photo F). The freight elevator block and stair walls exhibit some water damage, medium cracks, paint peel off and water stains (see photos G, H, I and J).

1. Efflorescence, peeling paint and similar deficiencies, typically associated with water damage, were observed in several locations throughout the (not-yet-renovated) portions of the building (see photos J, R, S and T). These are possible health concerns for employees.
2. An unused portion of steel flue was left on the north façade (facing West 132nd Street) of the building after a recent renovation. Earth Tech noted that the bottom portion of this flue appears to be inadequately supported, may become loose and present a safety hazard to pedestrians (see photo U).

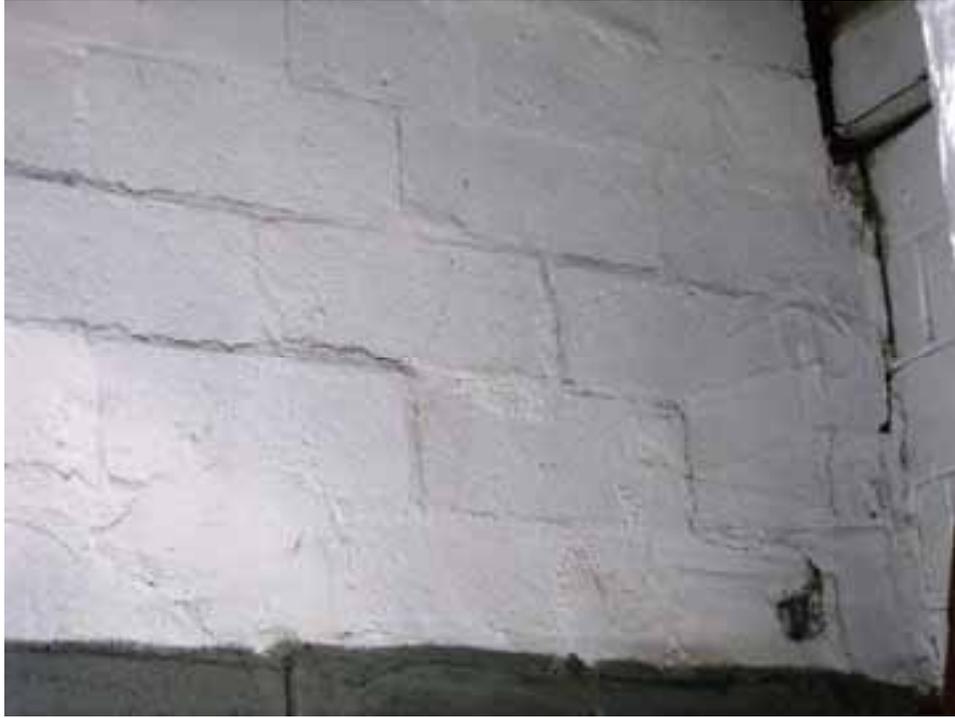
Photograph 1998-17-K

3. The deck area near the first floor shows a stepped crack and a vertical crack in the north wall (see photo K).
4. There is a buckled or damaged bracing member in the storage room at the first floor.
5. Bracing is provided between the second floor slab and walls all around the storage room (see photos L and M).
6. A 3 ft. by 2 ft. delaminated area on the soffit of the second floor slab of future office space area is evident (see photo N).

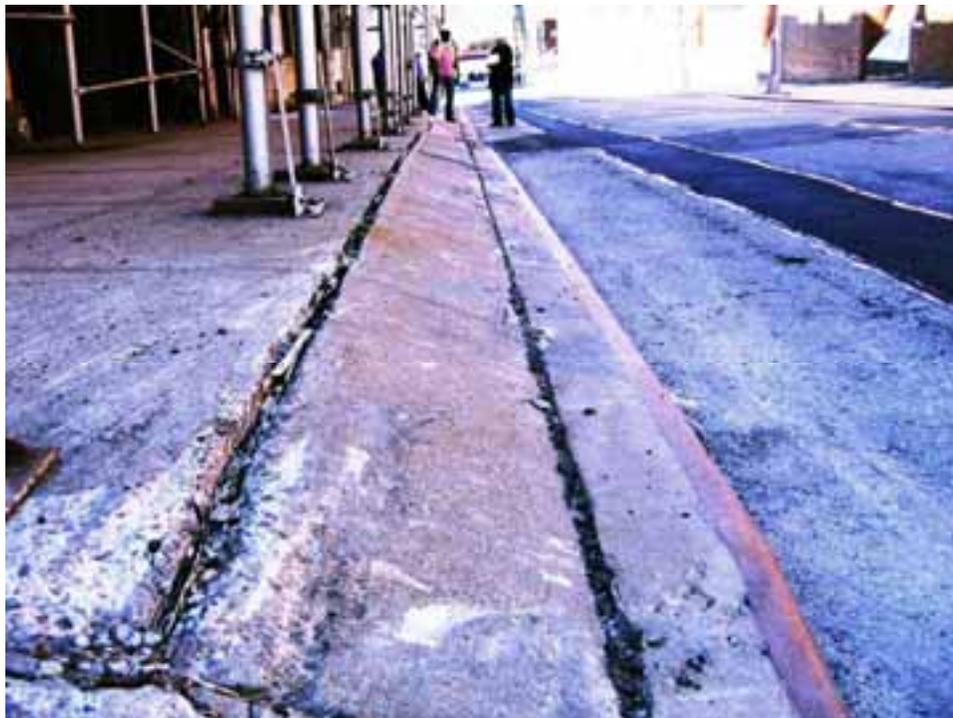
Photograph 1998-17-Q

1. *“The stone cladding above a door opening on the south façade is cracked and appears to be an unsafe condition for people using this entrance due to the potential of falling debris”*. Earth Tech was not able to locate the entrance described in the AKRF report. Earth Tech assumes that the condition has been corrected as part of on-going renovation of the building; the current main entrance from West 131st Street appears recently renovated (see photo O).
2. *“On the West 132nd Street sidewalk, an expansion joint has widened. This strip between the curb and the widened joint is steeply sloped, which is a potential tripping hazard for pedestrians”*. Earth Tech concurs with this statement (see photos P and Q).

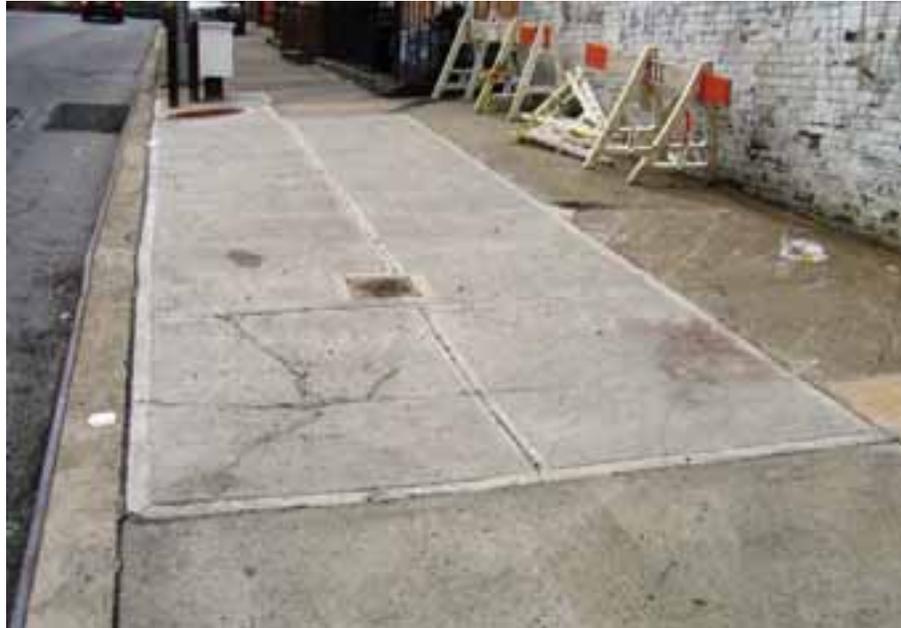
Photograph 1998-24-K

- The sidewalk at West 131st Street is in fair to poor condition with several cracks; the worst condition is at the western side close to the building, where, due to differential settlement, the concrete sidewalk slabs create a tripping hazard for pedestrians (see photos A, H and I).
- The sidewalk at West 132nd Street is in fair to poor condition with an area of cracked and spalling concrete slab (see photos J and K).
