<b>SITE CONDITION: FAIR</b>
-----------------------------

## Block 1998 Lot 38

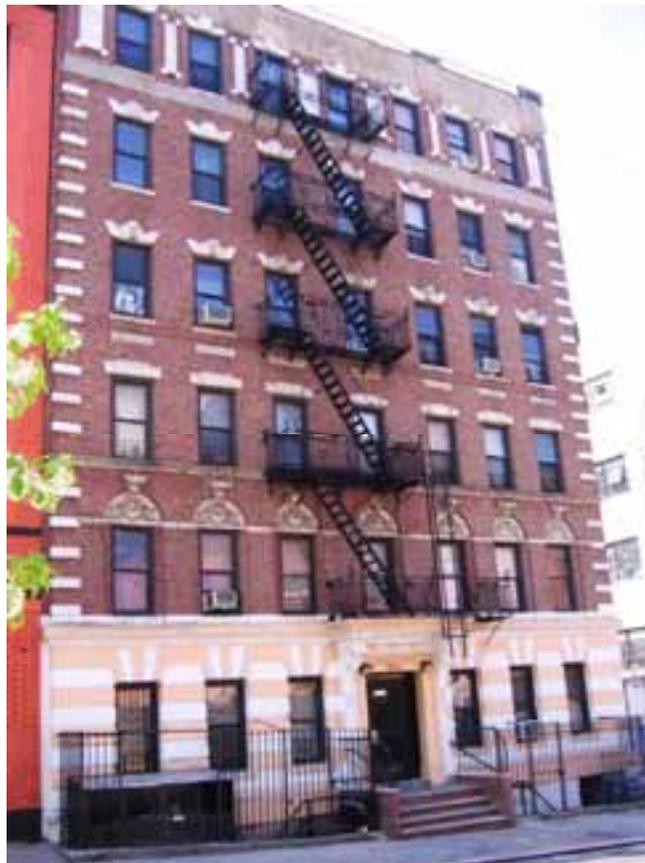
**Photograph 1998-38-A**

Lot 38 is located at 602 West 132<sup>nd</sup> Street between Twelfth Avenue and Broadway. The 4,996-sf lot contains a six-story 21,786-gsf residential building (see photo A). According to the Department of Finance RPAD Master File, the building was constructed in 1905, with subsequent alterations recorded in 1986. Earth Tech reviewed the NYC Department of Finance Automated City Register Information System (ACRIS) and found that the City of New York acquired the property in 1978. At the time of the AKRF report, Lot 61 was zoned M1-2; however, it has since been designated C6-1 as part of the Special Manhattanville Mixed Use

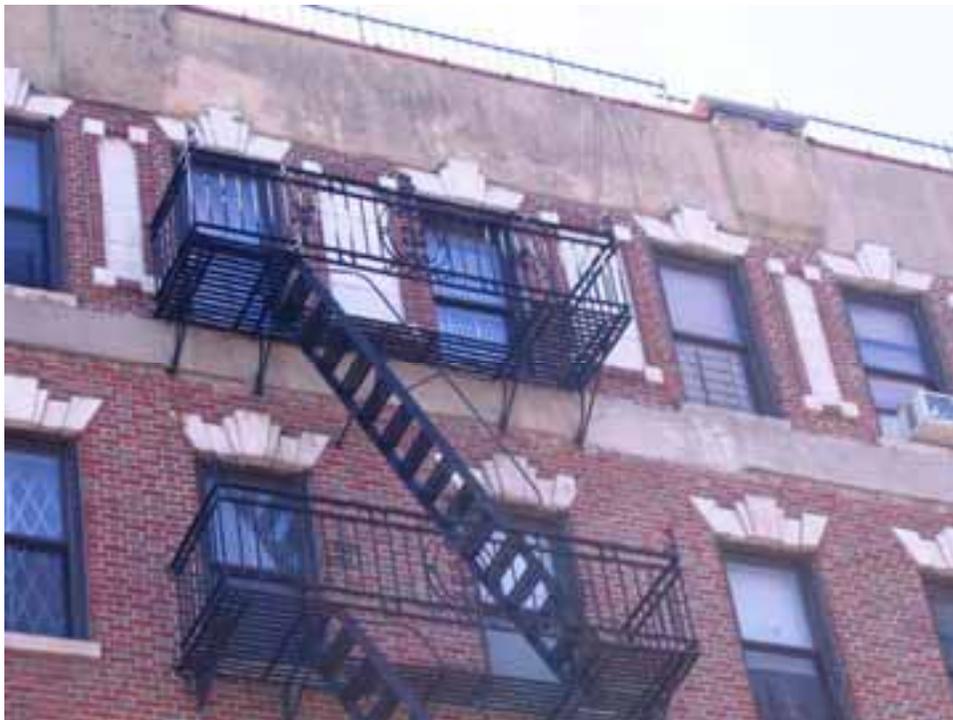
**Photograph 1998-38-C**

There are medium sized cracks and minor spalls in the repair work on the north exterior wall (see photos B, C and D), it also has water stains, typically at the window sill, and at other random locations. The west exterior wall has minor fine-line cracks (see photo E). The roof membrane was not accessible.

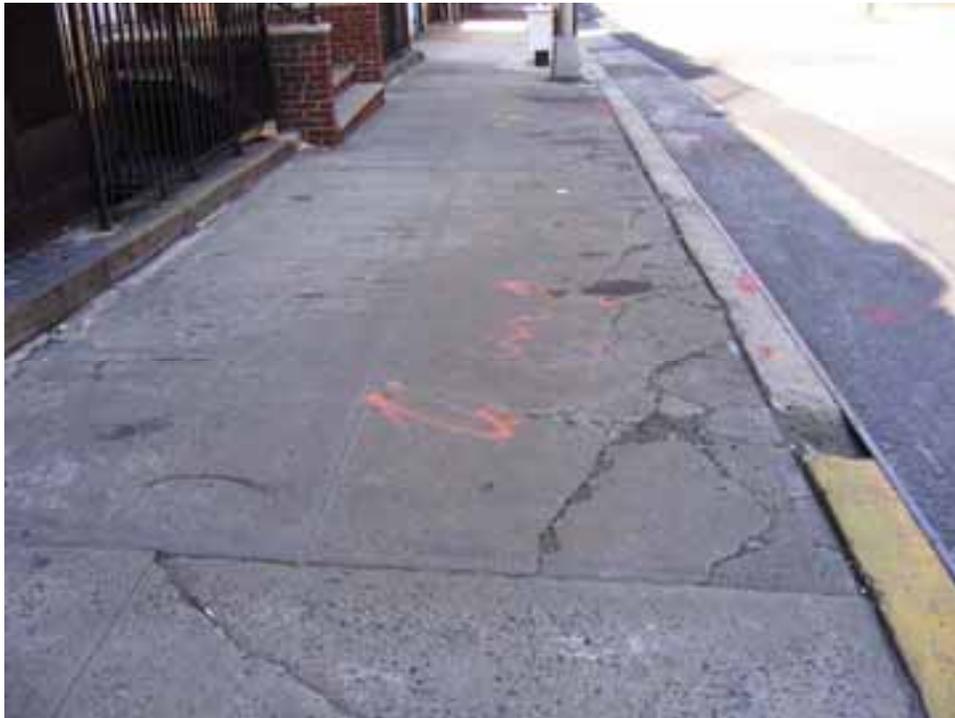
**Photograph 1998-38-G**

AKRF reported no health and safety concerns for this building, except for the poor condition of the sidewalk. Earth Tech did not observe any vegetation on the sidewalk on West 132<sup>nd</sup> Street, but concurs with the evaluation of the sidewalk as being in poor condition (see photos F and G).

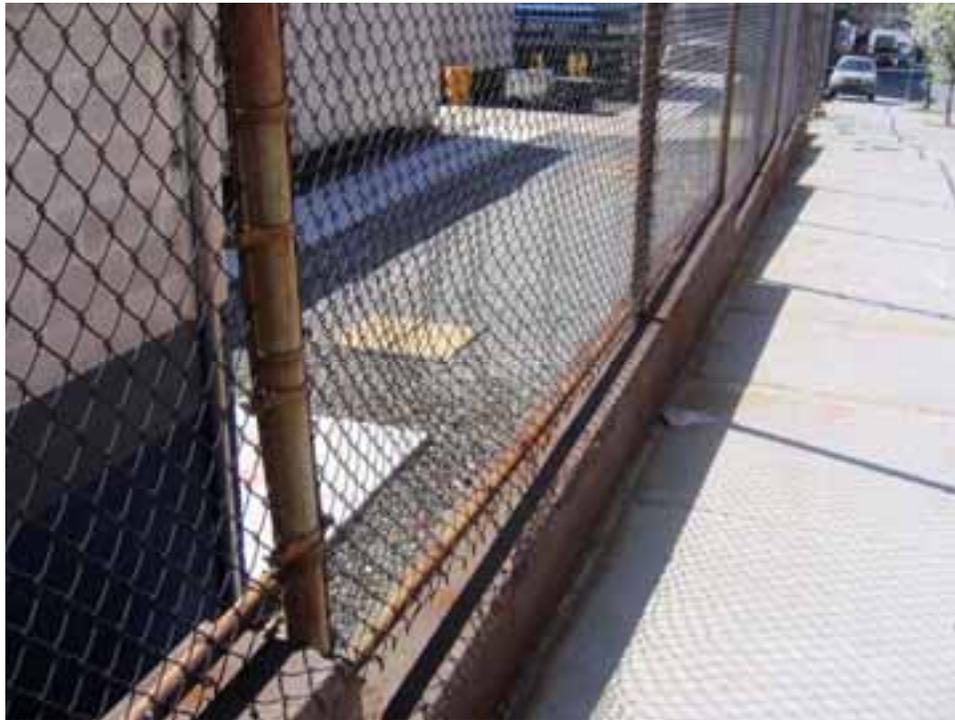
Photograph 1998-49-G

As evaluated by Thornton Tomasetti and later reported by AKRF, the site buildings are in good condition overall. The site was available for exterior survey only when inspected by Earth Tech on April 4, 2008. Earth Tech generally concurs with assessment of site condition as good. The Con Edison equipment appears to be clean and all structural framing, columns, bracings, etc., show no sign of deterioration (see photos B and C). However, a few deficiencies were noted: Minor ponding of water is visible on the roof carrying the equipment (see photos D and B); a wide horizontal crack is observed at the lintels level above all five doors of the Transformer room along West 132<sup>nd</sup> Street (see photos E and F). A chain link fence along West 132<sup>nd</sup> Street is damaged and lightly rusted (see photos G and H).

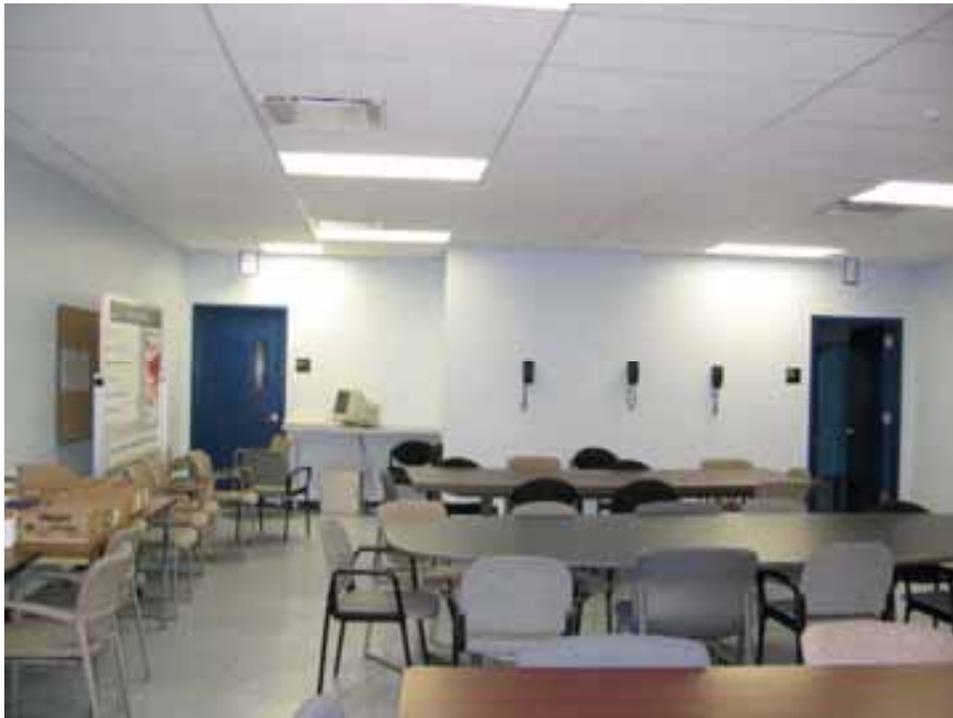
Photograph 1998-57-B

AKRF did not report any health and safety concerns for this building, and Earth Tech noted that subsequent to the Thornton Tomasetti survey, a new exit door was installed in the eastern wall next to a roll-up door, apparently correcting the lack of a fire exit (see photo H), along with the new safety bollards, and safety stripping on the floor (see photo I). Also, the then vacant office space in the northwest corner of the building, reported in a substandard condition, has been renovated into office/employee facilities and is in good condition (see photo J and photo B).

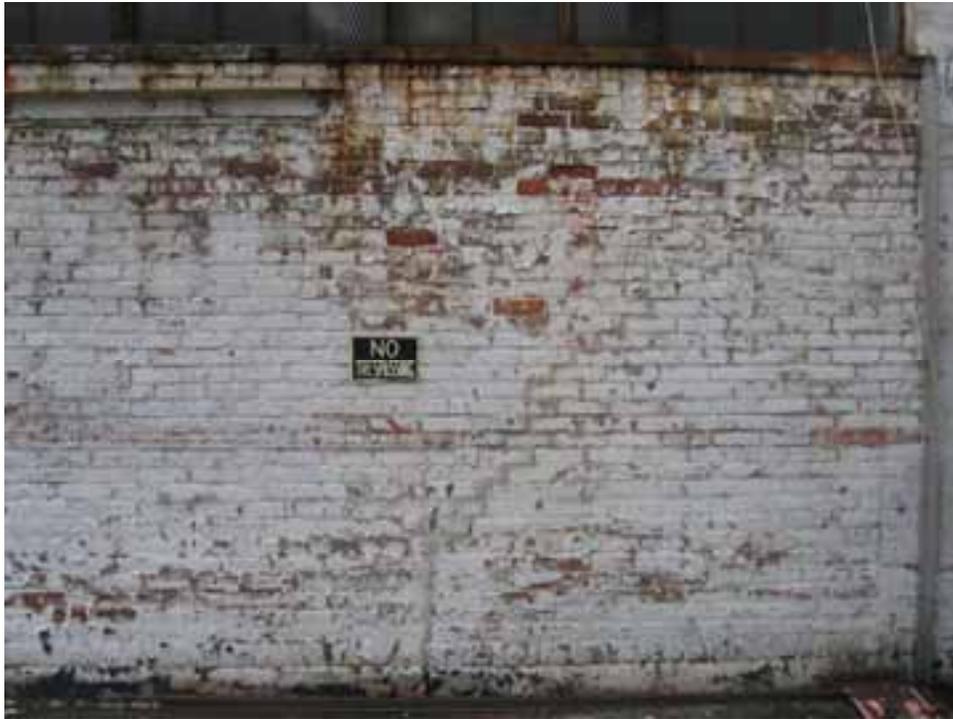
**Photograph 1998-57-E**

- The exterior paint at building’s east wall (at yard) is deteriorated and is spalling throughout the whole façade, - a potential health hazard (see photo K and photo E).
- The internal ramp connecting Lot 57 and Lot 61 does not have a guardrail, - a safety hazard (see photo L).
- The roof access ladder and hatch do not meet code and need to be upgraded, - a safety hazard (see photo M).
- The exterior exit stair on West 132<sup>nd</sup> Street does not have a landing and therefore does not meet code requirements (see photo N).
- Cars are routinely parked on the sidewalk of West 132<sup>nd</sup> Street - a safety hazard to pedestrians (see photo O).

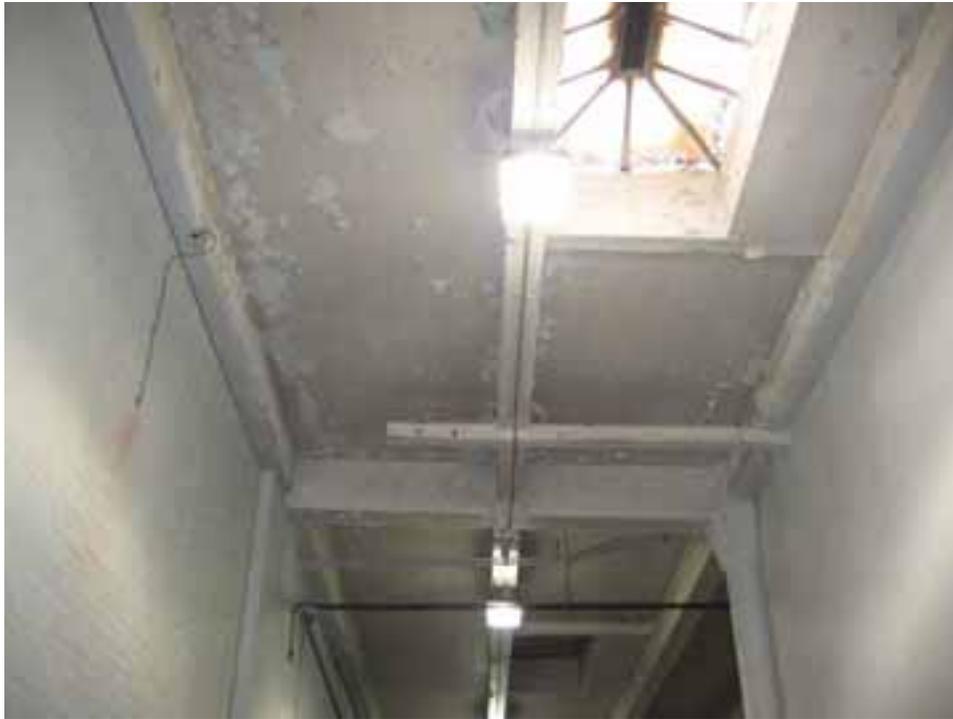
**Photograph 1998-61-G**

During the inspection by Earth Tech on March 5, 2008, no major interim or permanent repairs were observed to correct or mitigate the reported deficiencies as noted during previous inspection except that the second floor walls were cleaned and painted (see photo B and photo C), the lintels over the exterior windows were cleaned, repaired and painted (see photo D and photo E). Previously reported deficiencies which included medium to wide cracks in the foundation walls, cracked and missing concrete encasements for steel beams (see photo F and photo E), extensive paint peel off (see photo G) and minor spalling on the soffit of the roof slab remained evident.

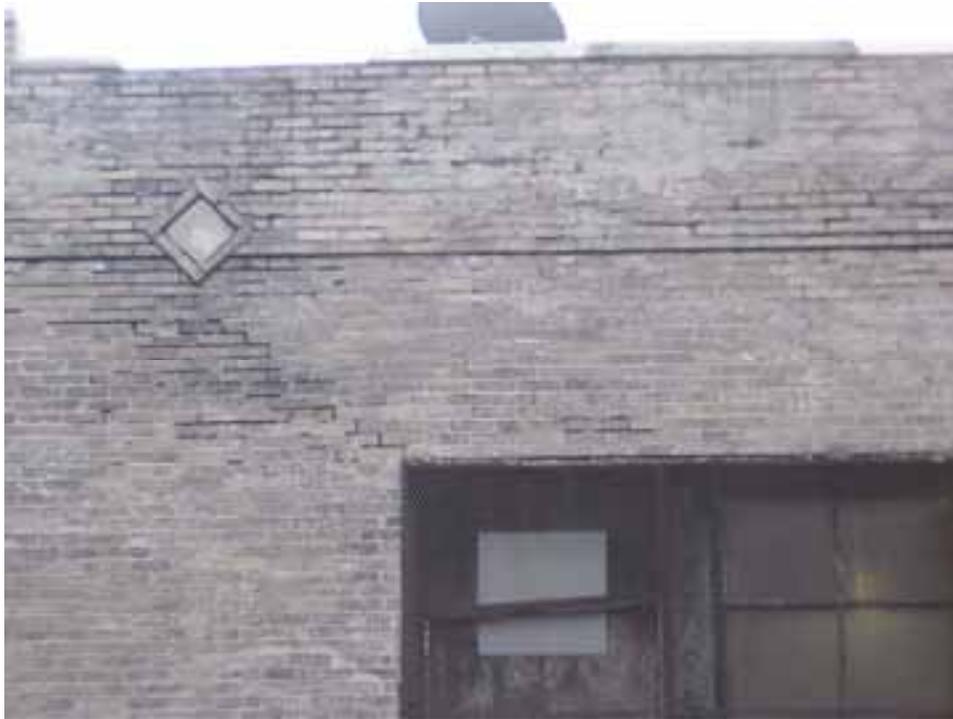
**Photograph 1998-61-I**

The brick facing along W 132nd street and 12th Ave. is in poor condition with moderate to severe cracking, stepped cracking, and bulging over an 8 feet to 10 feet wide area near the parapet is evident (see photo H, photo I and photo J). This distress in the exterior wall is likely the result of the buildings' age and lack of maintenance, in particular of water infiltration, probably through deteriorated parapets, roof system and exterior walls.

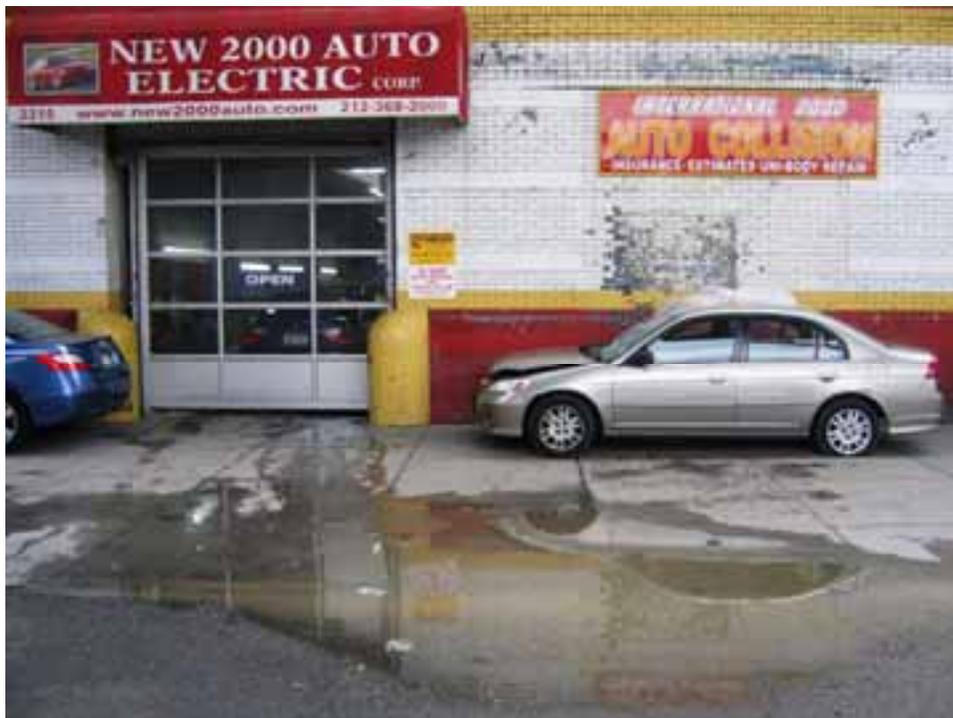
Photograph 1998-61-O

- There are only roll-up doors and no exit doors from this space. What might have been an exit door (on West 132<sup>nd</sup> Street), appears to have been blocked by the bathroom facility at some unknown time. The door remains closed with a shutter door and padlocked from outside (see photo K).
- “A fuse box located directly above sink”, as noted in the AKRF report, remains a safety hazard (see photo L).
- “Auto-painting that appears to be performed without proper ventilation systems”, as noted in the AKRF report, remains a health concern.
- “Parking of cars on the sidewalk”, as noted in the AKRF report, continues as a safety concern for pedestrians (see photo M and photo N).
- Stalled water, observed on the day of the Earth Tech survey on Twelfth Avenue sidewalk, is the evidence of improper drainage, and a health and safety concern for pedestrians (see photo O).

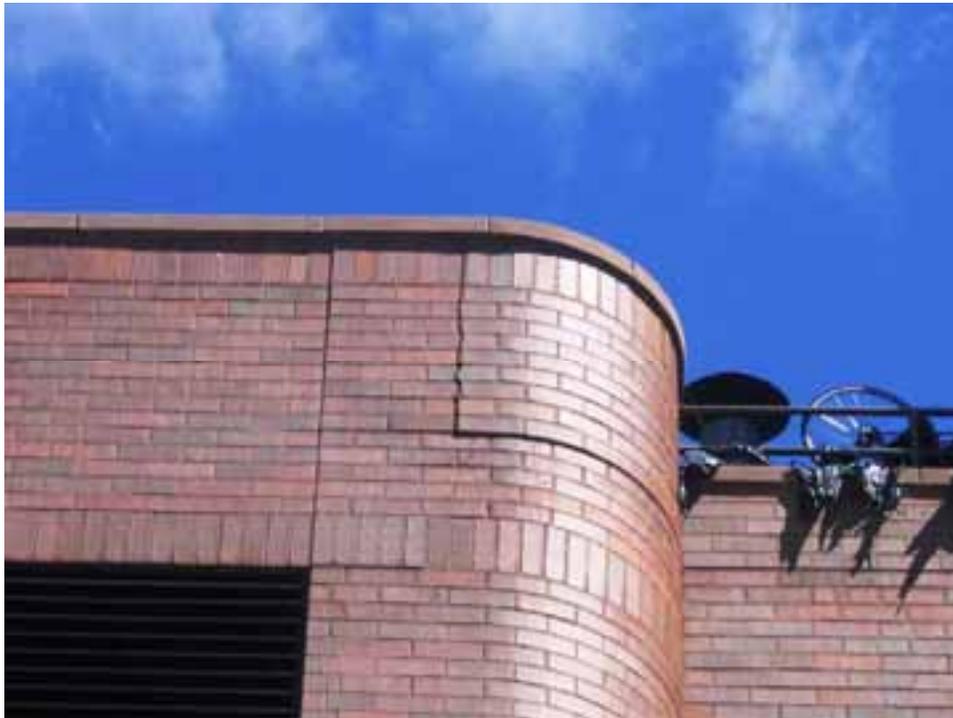
**Photograph 1999-1-C**

1. The exterior wall exhibits step, vertical and horizontal cracking typically along the portions of the wall that are on a horizontal curve (see photos B, C and D).
2. The exterior walls have spalls at various locations (See photos D, E and F), and the bricks should be repointed at various locations (see photo G).

- It appears that inadequately provided control joints in masonry wall are the reason why the signature rounded corners, especially on the south façade, consistently exhibit the signs of face brick cracking (see photos C, D and V). In several locations, the face brick has been chipping off (see photo W), presenting a safety concern for pedestrians.

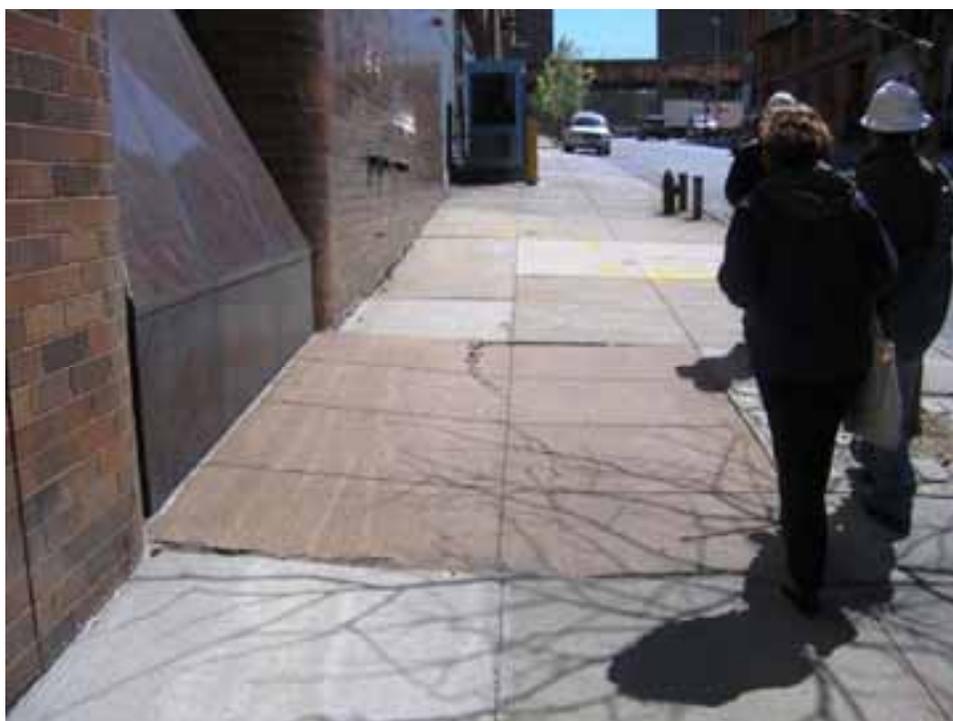
Photograph 1999-1-L

3. Settlement of the sidewalk typically at the base of the exterior walls (See photos H, I and J), and random cracking in the sidewalk (see photos K and L).
4. Recent partial sidewalk repair (see photo M).
5. The pavement at the south entrance area is spalled (see photo N).
6. Minor corrosion at the west picket fence and its railing (see photo O) .

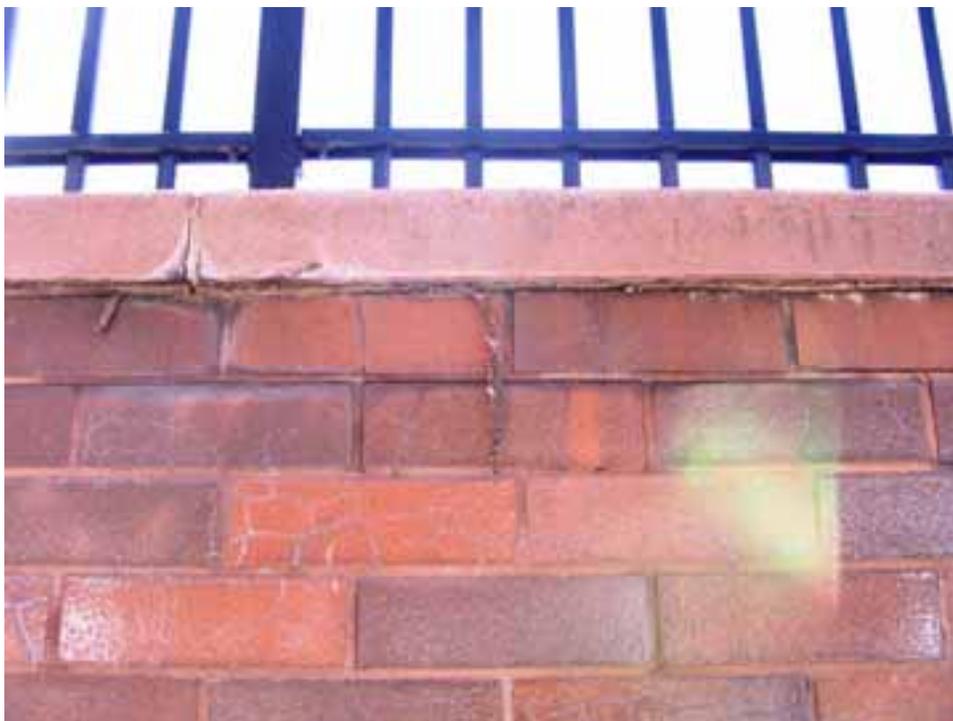
Photograph 1999-1-X

- The masonry retaining wall at the northwest part of the property exhibits the signs of poor maintenance with deteriorated and loose caulking and extensive face brick cracking (see photos X and Y), presenting a safety concern for pedestrians.

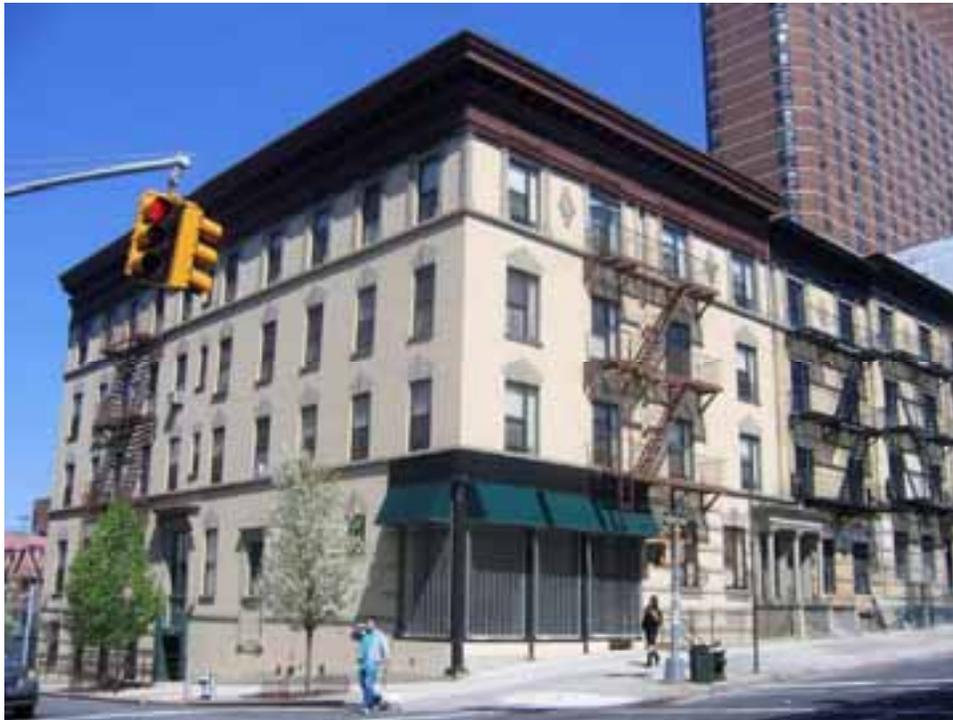
**Photograph 1999-29-A**

The exterior walls, windows, entrance areas, access ramp and/or fire escapes are in good condition (see photos A, B and C).
