ALTERNATIVES ANALYSIS WITH BCA CONDITIONS ASSESSMENT UPDATE

**VICTORIA THEATER
235-237 WEST 125TH STREET
NEW YORK, NY
ALTERNATIVES ANALYSIS**

Conditions Assessment Update

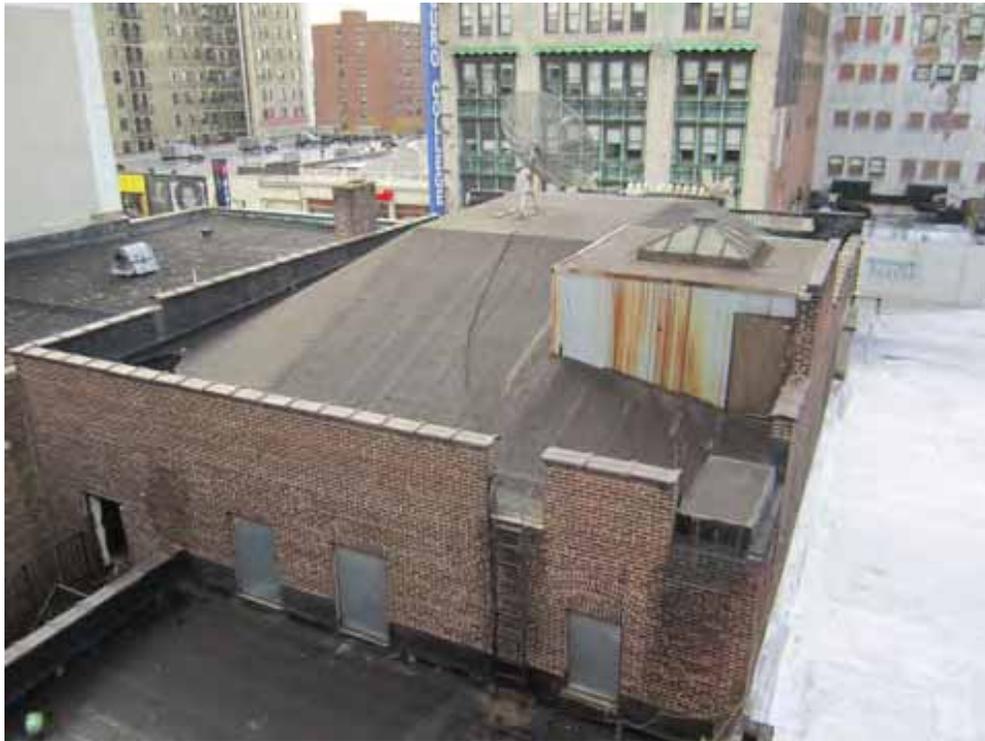
Figure: 1 **Location:** South Roof

The PACA report described the roof of the south building as essentially flat. This image shows the pitched south roof as viewed from the north roof. A satellite dish penetrates the center of the roof. The bulkhead at the west side of roof is corroding.

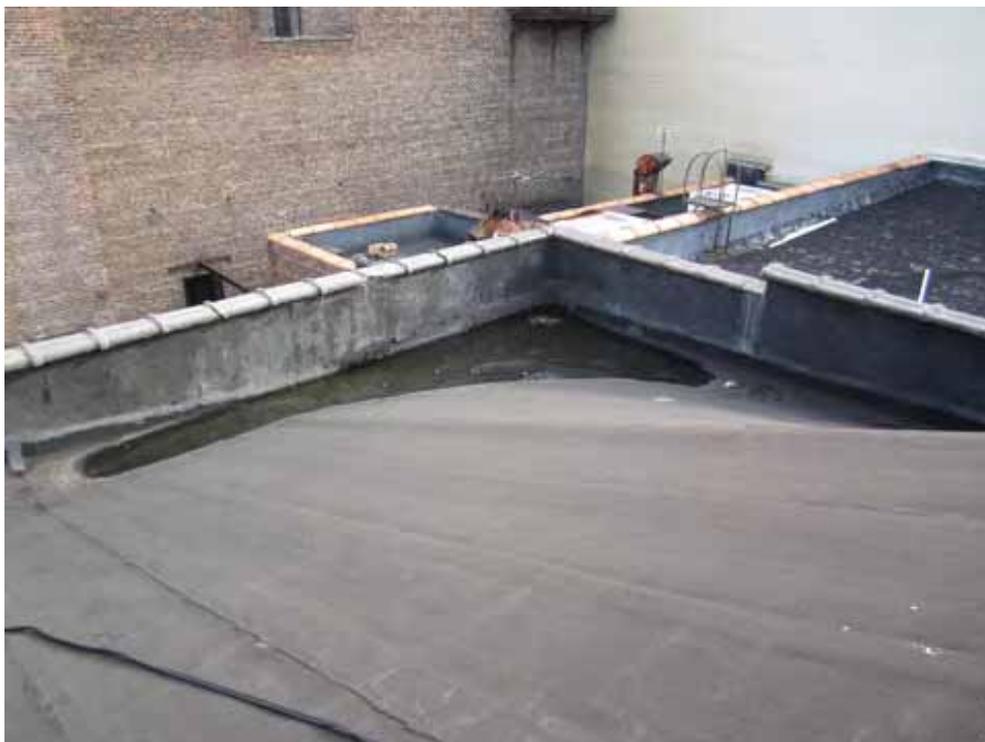
Figure: 2 **Location:** South Roof

The PACA report described the condition of the roof covering and parapets as poor. BCA noted pooling water at the northeast corner.

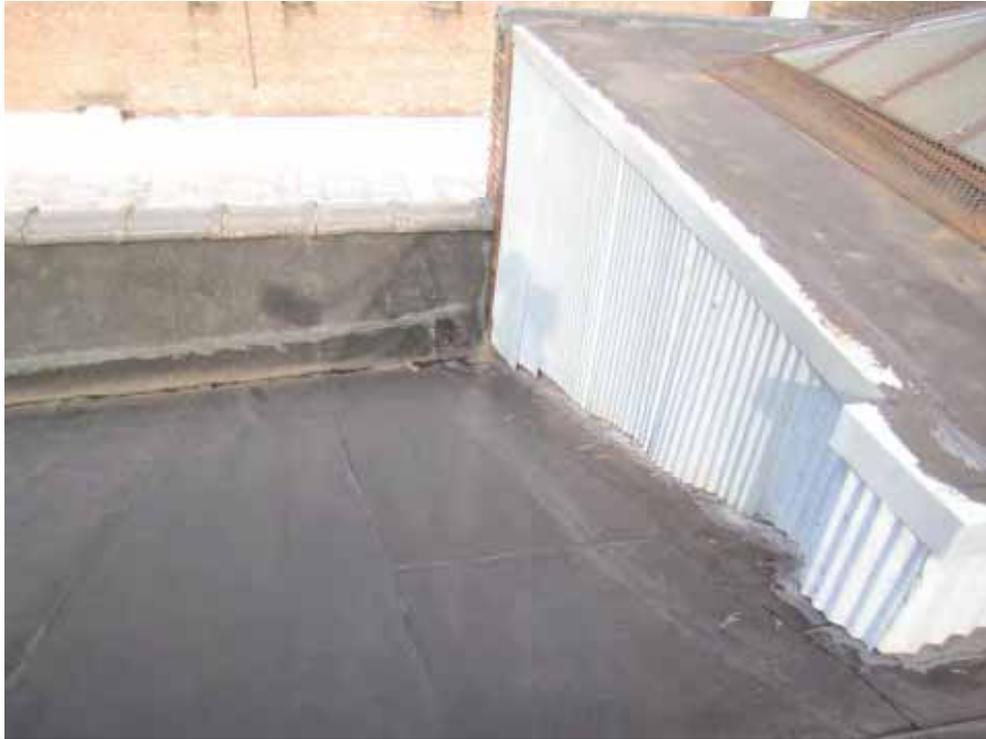
Figure: 3 **Location:** South Roof

The PACA report described the condition of the roof covering and parapets as poor. BCA noted an open seam at the connection of roofing membrane and parapet.

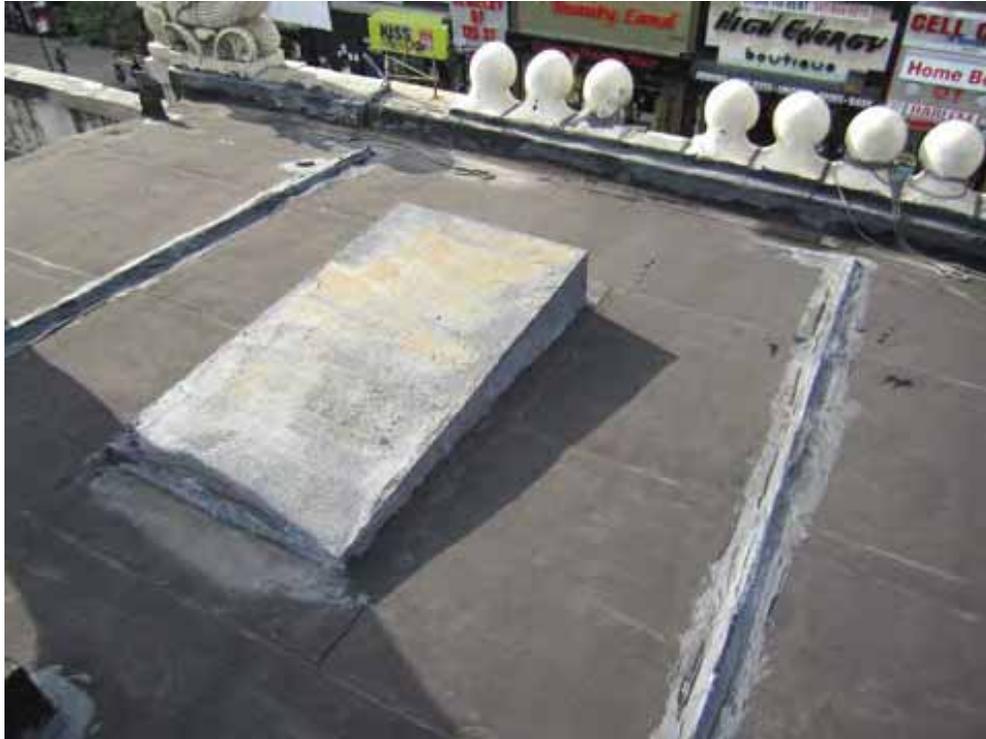
Figure: 4 **Location:** South Roof

Deteriorated sealant around angle, capped roof penetration, and two north-south facing roof-penetrating strips. It is likely that these elements are remnants of the structure that once supported the vertical marquee.

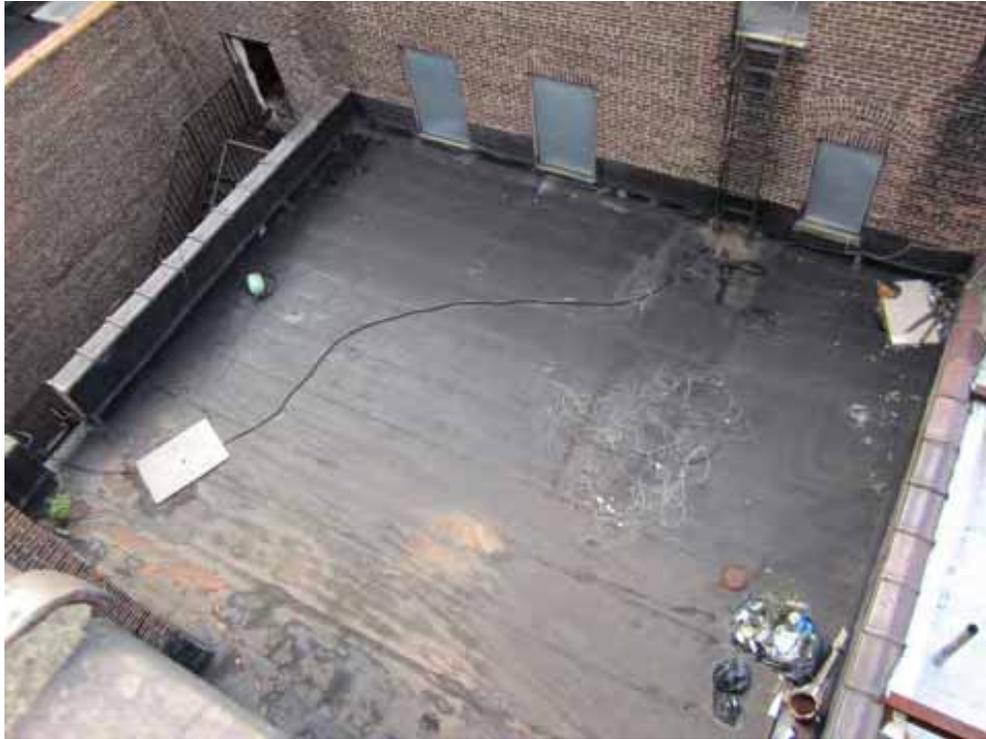
Figure: 5 Location: Foyer Roof

As noted in the PACA report, the roof over the Foyer is essentially flat. Evidence of pooling water is visible at the perimeter of the roof. BCA noted biological growth at the northeast corner. The windows of the south building have been infilled.

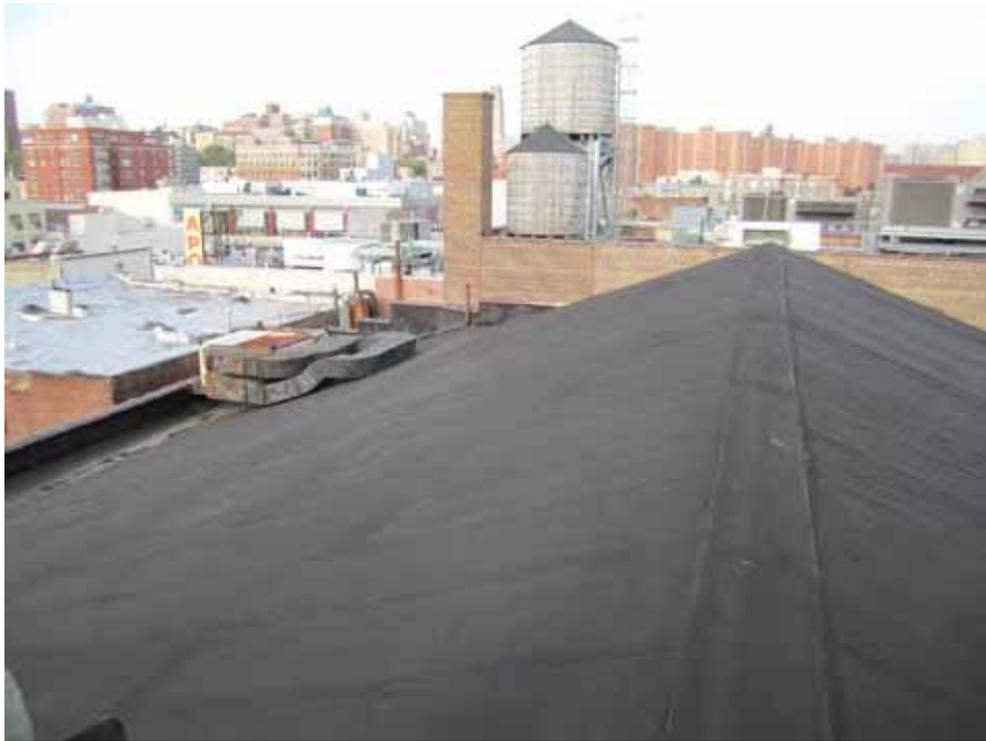
Figure: 7 **Location:** North Roof
Pitched roof above auditorium seating, looking southwest. The PACA report noted the north roof was inaccessible during their survey.

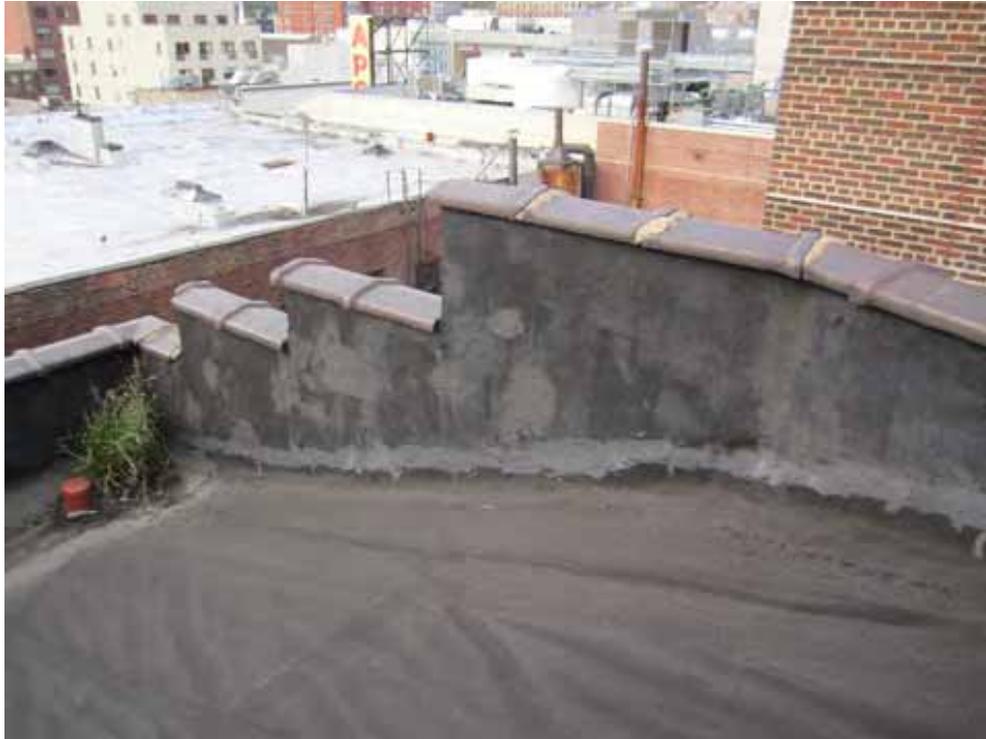
Figure: 8 **Location:** North Roof
Drain at southwest corner is clogged; biological growth is present. The PACA report noted that water and ice were overflowing from gutters and leaders.

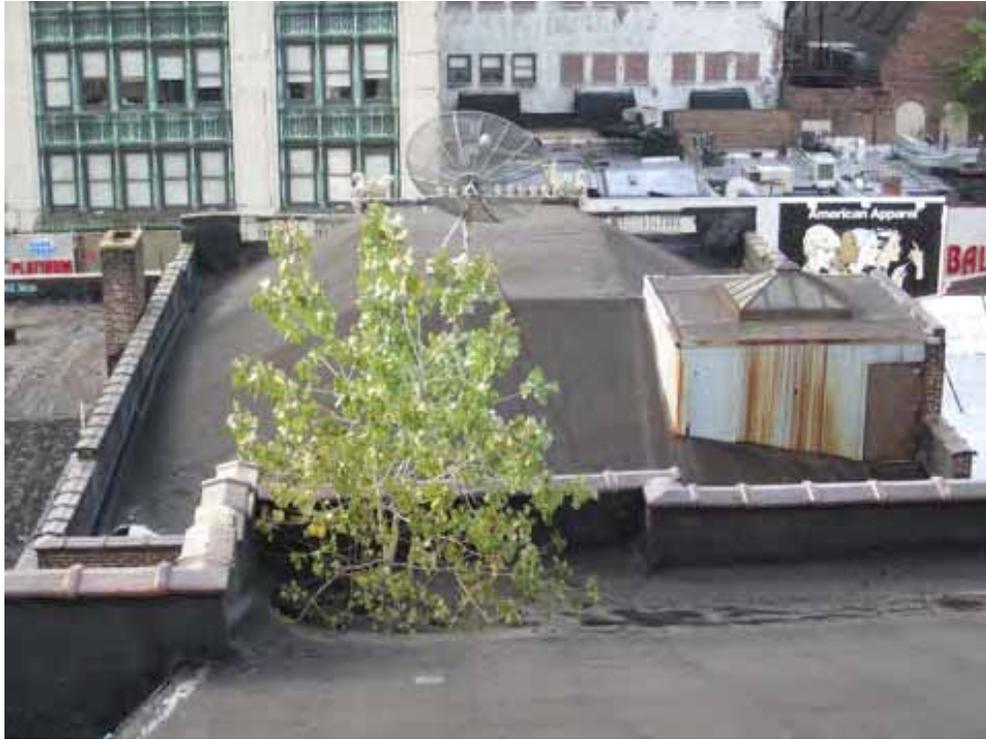
Figure: 9 **Location:** North Roof
Tree growing at the southeast gutter of the roof. The PACA report did not identify this condition, as the north roof was inaccessible during their survey.

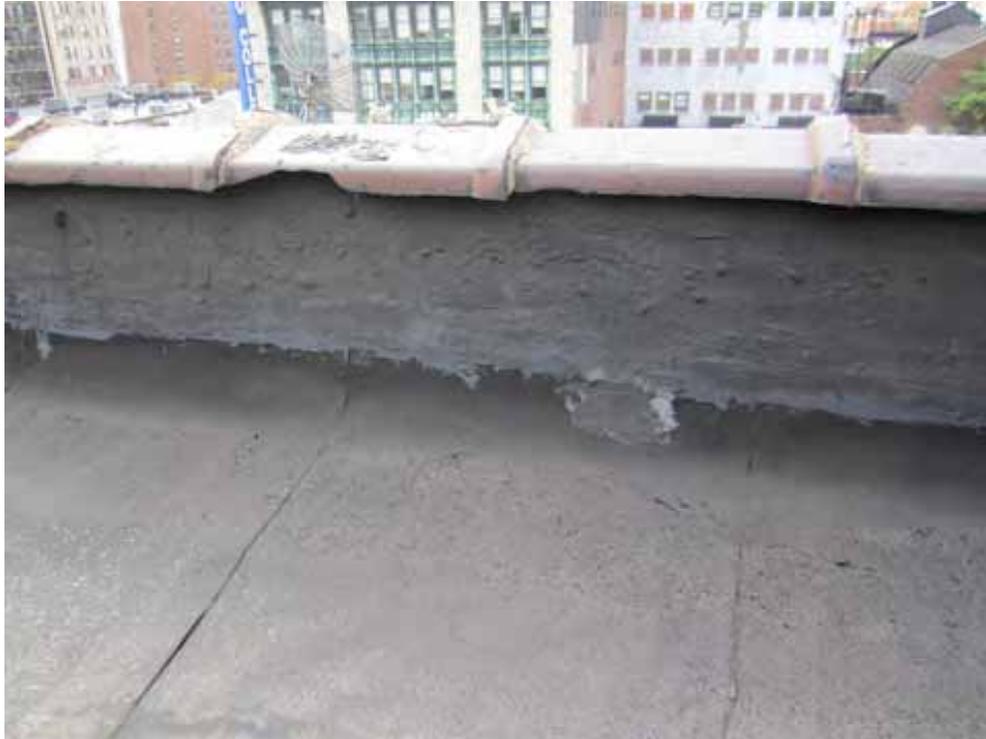
Figure: 10 **Location:** North Roof
Isolated coping stones are chipped. The flashing is coated with a deteriorated bitumen coating. The PACA report did not identify this condition, as the north roof was inaccessible during their survey.

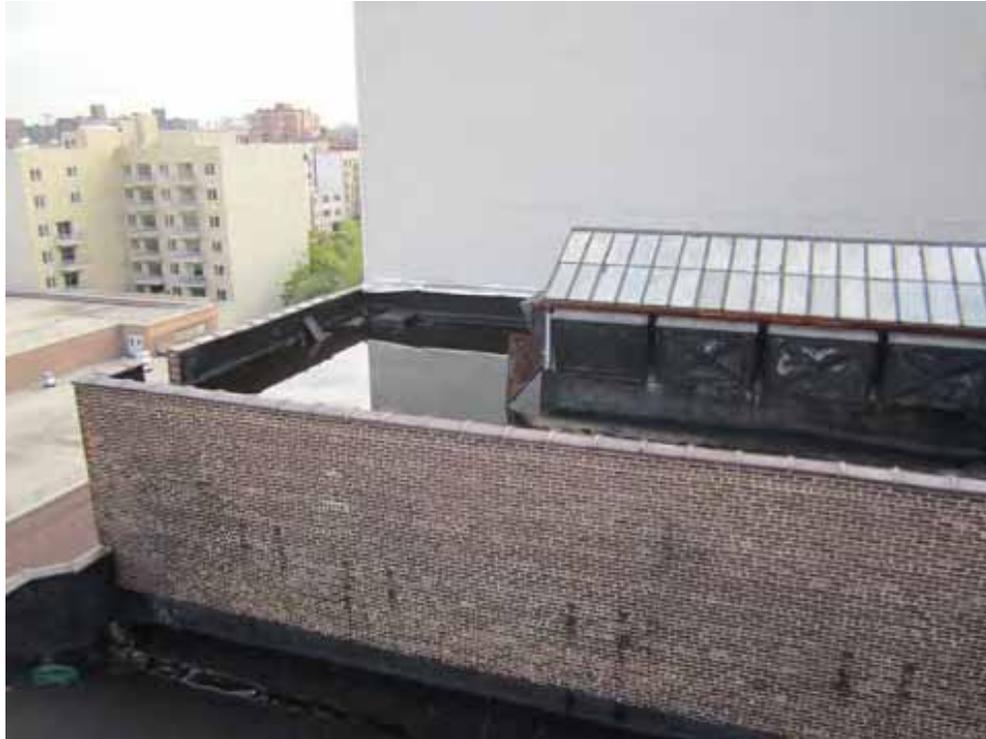
Figure: 14 Location: North Roof

Pooling water on the north end of the flat roof over Theater 5. Water infiltration is ongoing at the northwest corner of the building. Biological growth is visible at the base of the wall, in the gutter of pitched roof.

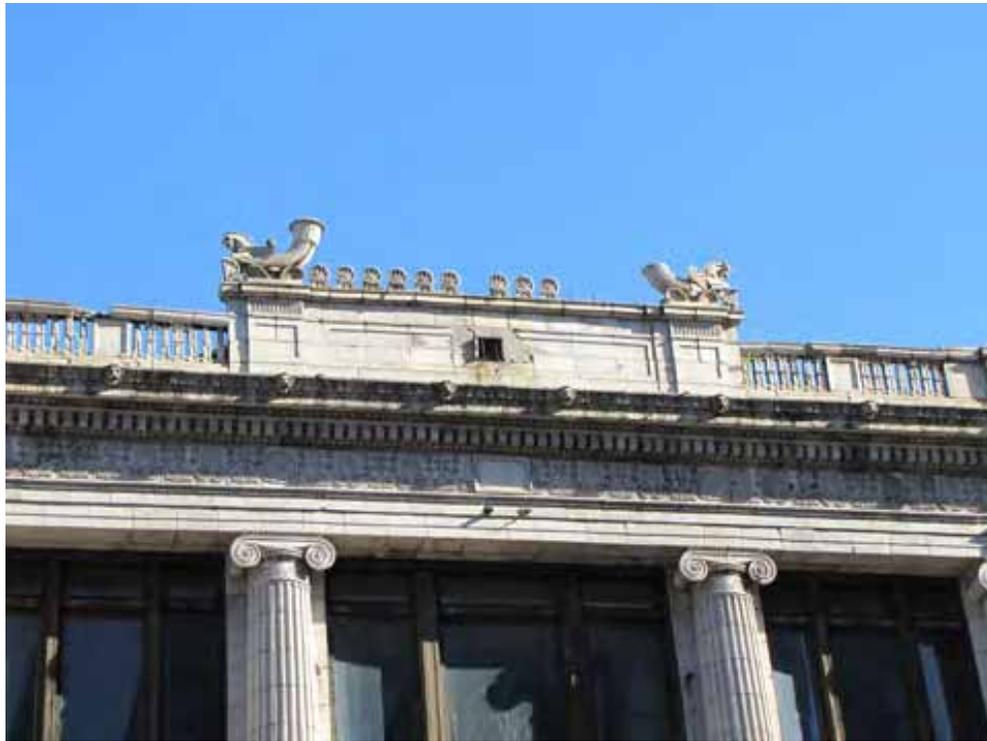
Figure: 20 Location: South Façade

The PACA report noted there were initially 14 acroteria between two rhytons (cornucopia sculptures). Archival photos suggest there were originally 10 acroteria and a larger decorative element behind the vertical section of the marquee. See Figure 17.

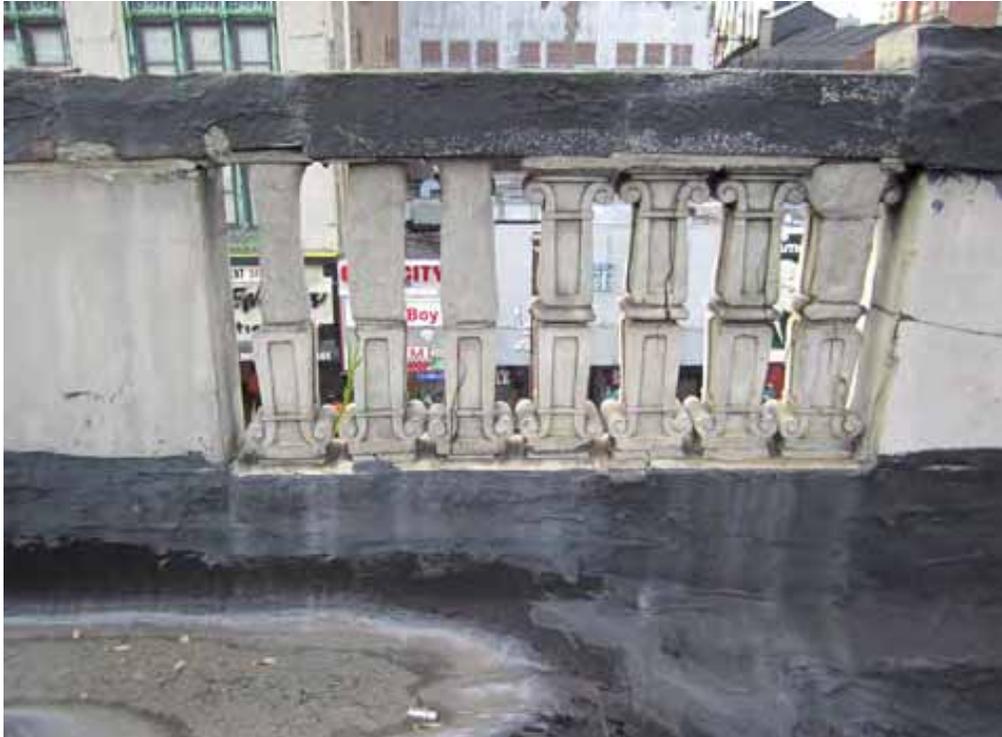
Figure: 21 Location: South Façade

Deteriorated terra cotta and patching material at balustrade. As noted in the PACA report, the flashing has been coated with a bitumen material. The top of the balustrade is also coated. Biological growth is visible at the base of the left baluster.

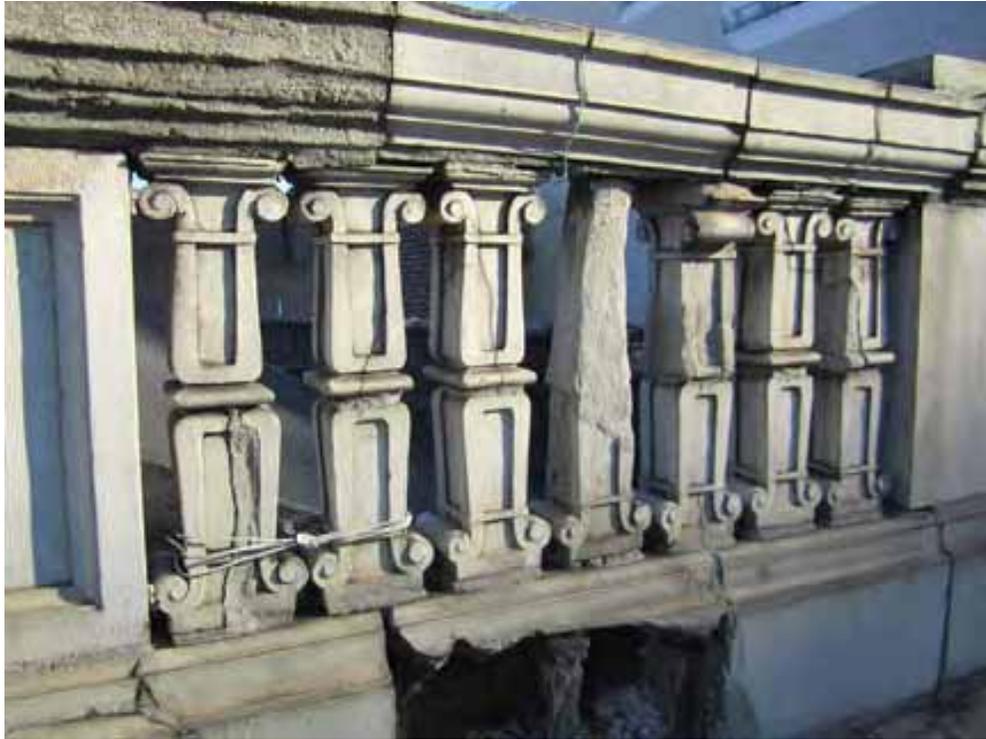
Figure: 22 **Location:** South Façade
Deteriorated terra cotta and patching material at balustrade. As noted in the PACA report, the coping tiles show signs of lifting and deterioration.

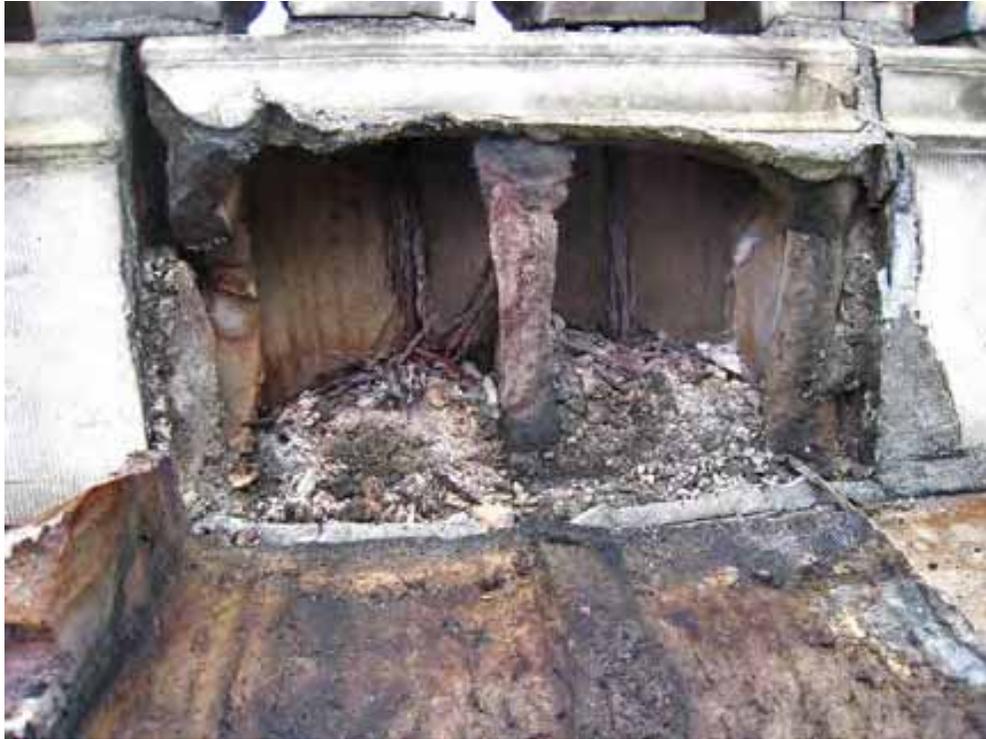
Figure: 24 Location: South Façade
BCA probe XI, located at the cracked terra cotta base of the east balustrade, revealed severely corroded steel rods supporting balusters above.

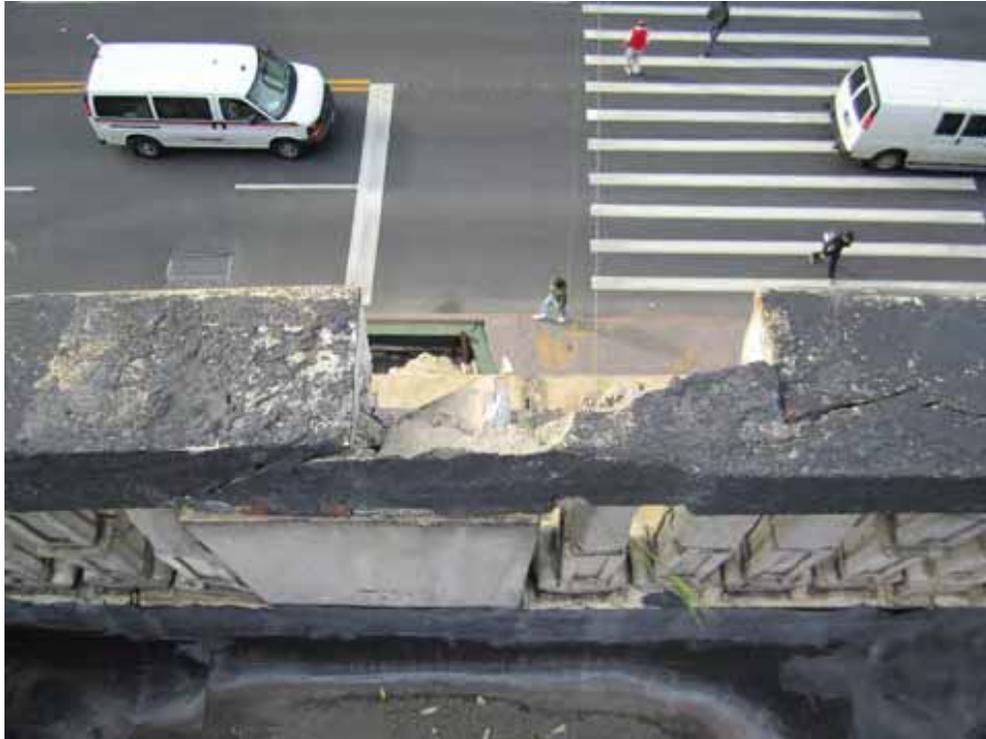
Figure: 25 Location: South Façade
Large loss in the balustrade railing at the parapet. This condition is not visible in survey photos included with the PACA report.

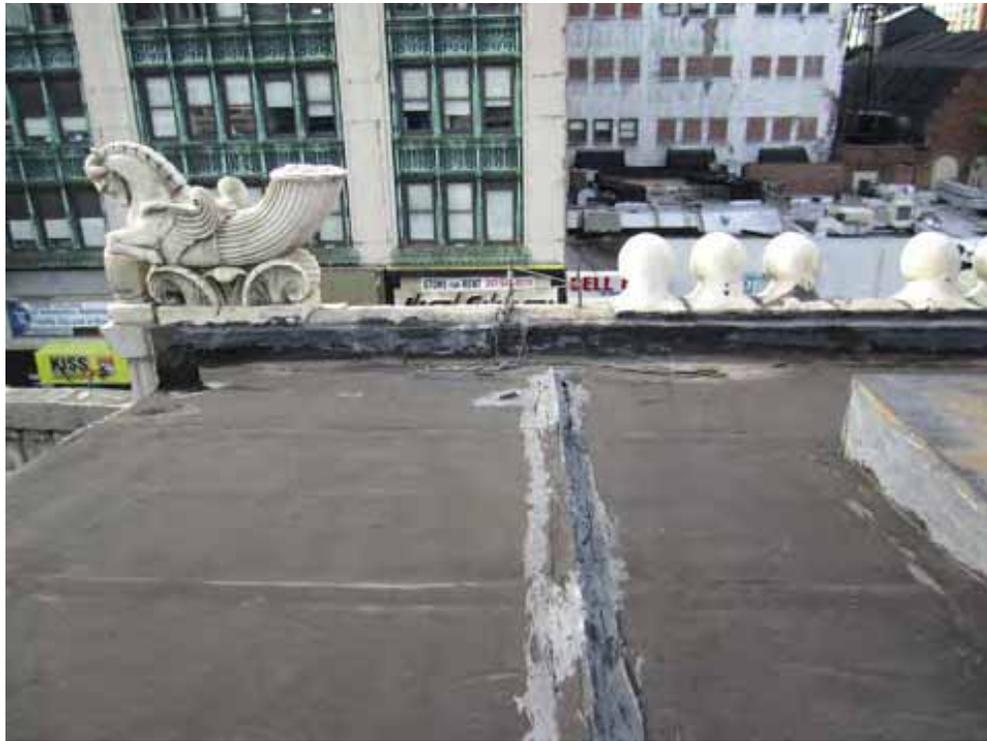
Figure: 26 Location: South Façade
As noted in the PACA report, several acroteria and pieces of the east rhyton are missing.

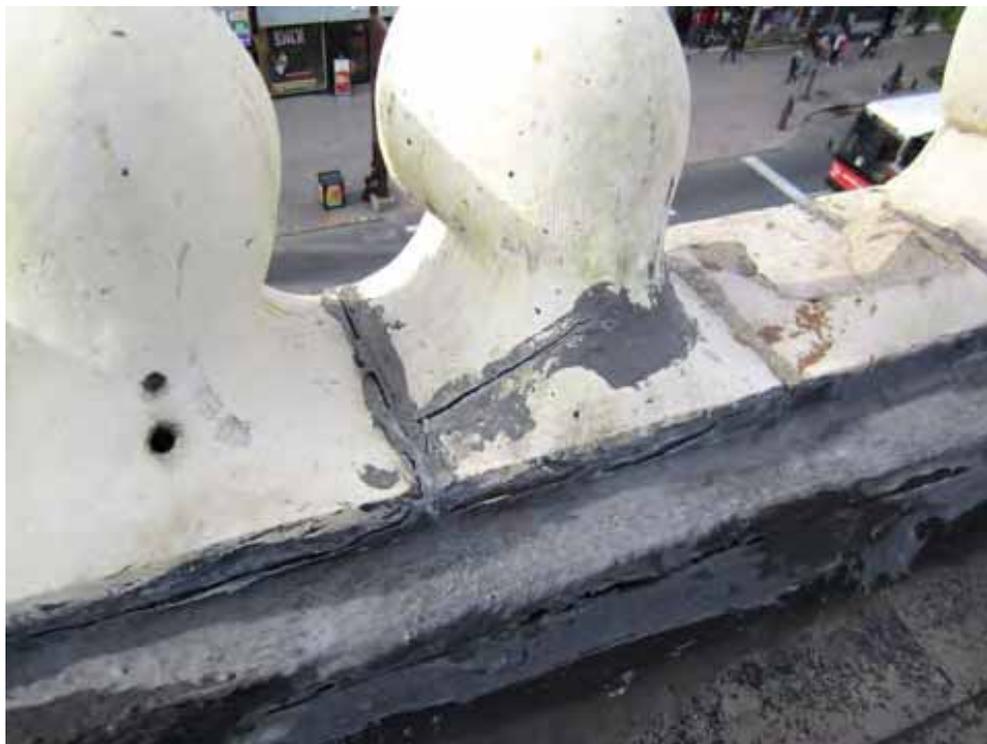
Figure: 27 Location: South Façade
Cracked acroterion with deteriorated, inappropriate repair material at crack and joint. The PACA report did not identify these conditions.

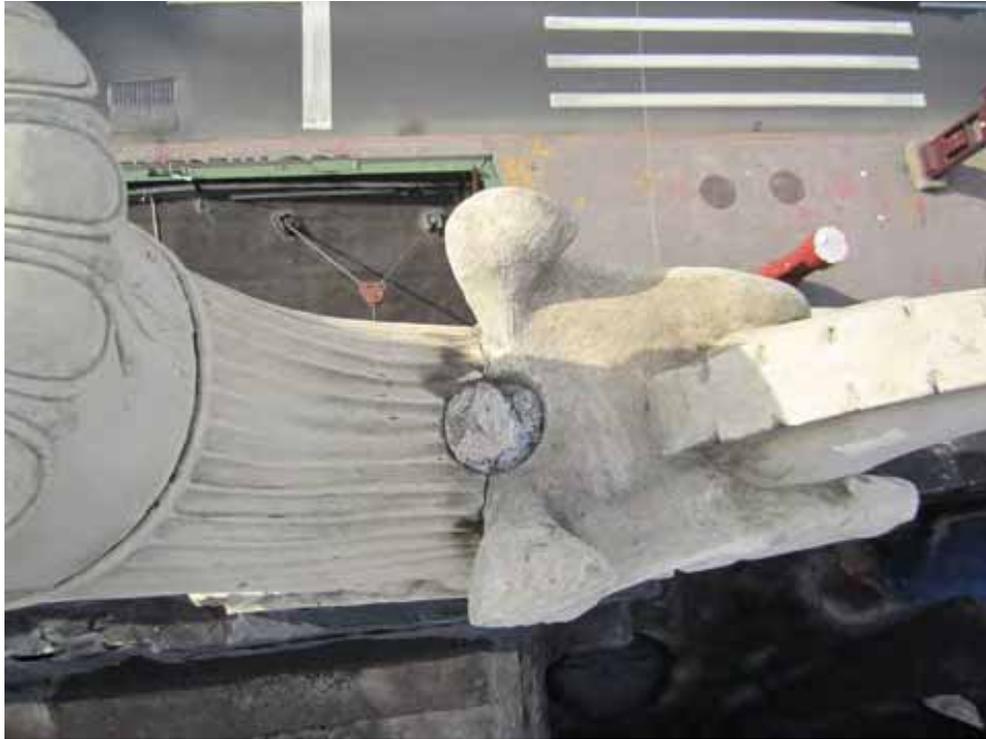
Figure: 28 Location: South Façade
Crack and previous patching material at the west rhyton. The PACA report did not identify these conditions.

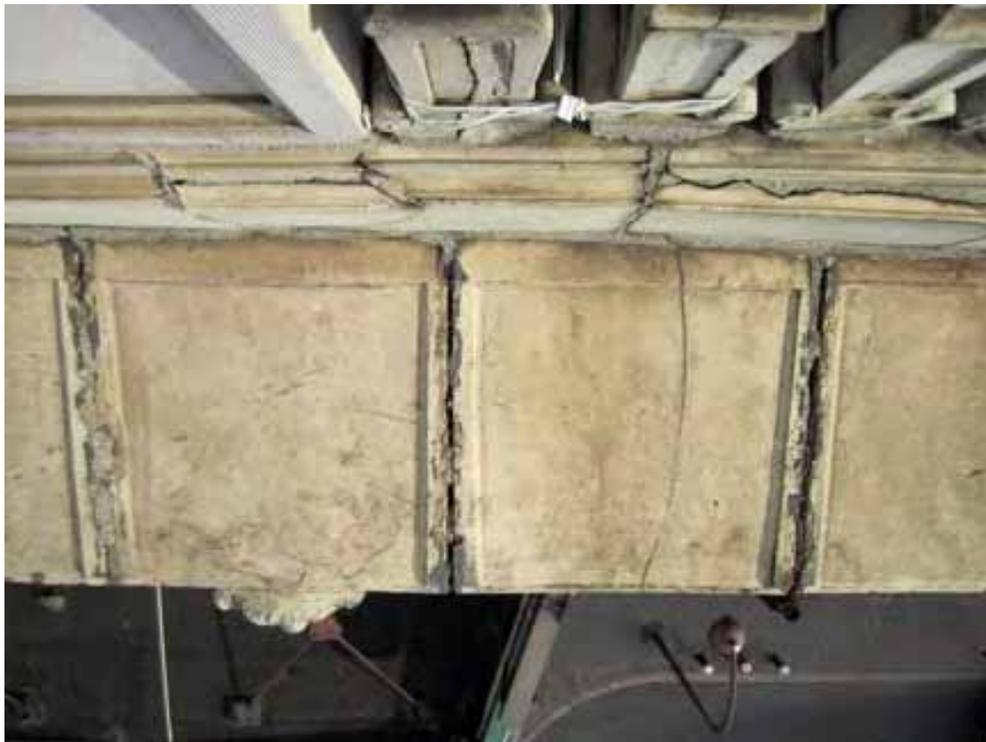
Figure: 29 Location: South Façade
Cracks in balustrade and open joints at cornice blocks. The PACA report did not identify these conditions.

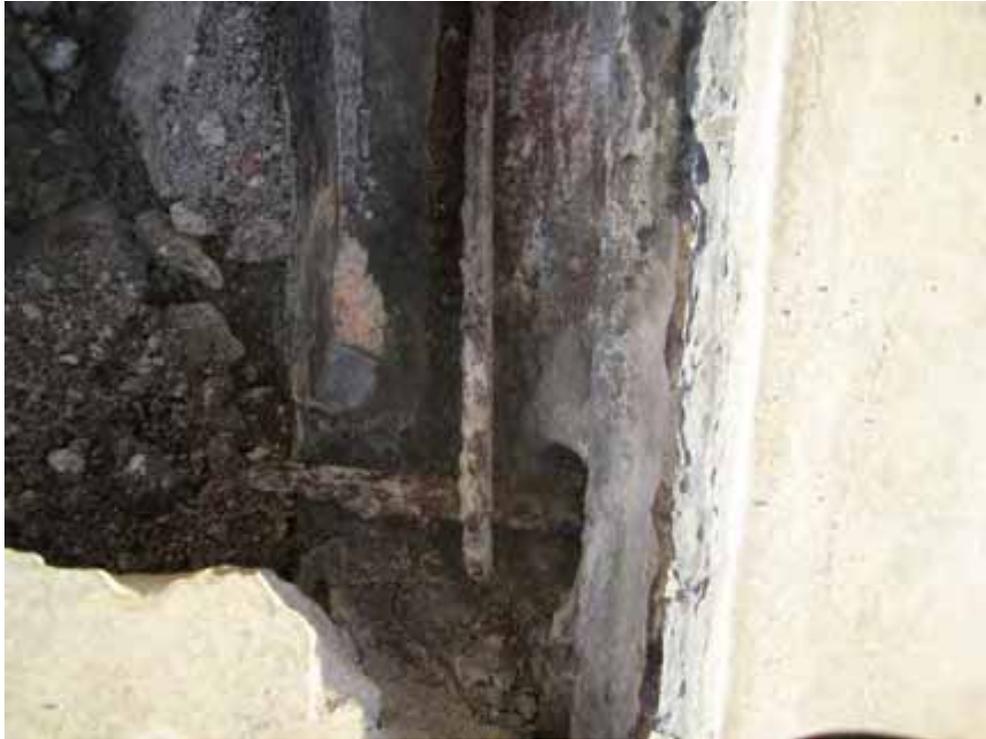
Figure: 30 Location: South Façade
BCA probe X2 (top view), located at the cracked top of a terra cotta cornice block below the east balustrade, revealed severely corroded steel rods and hooks.

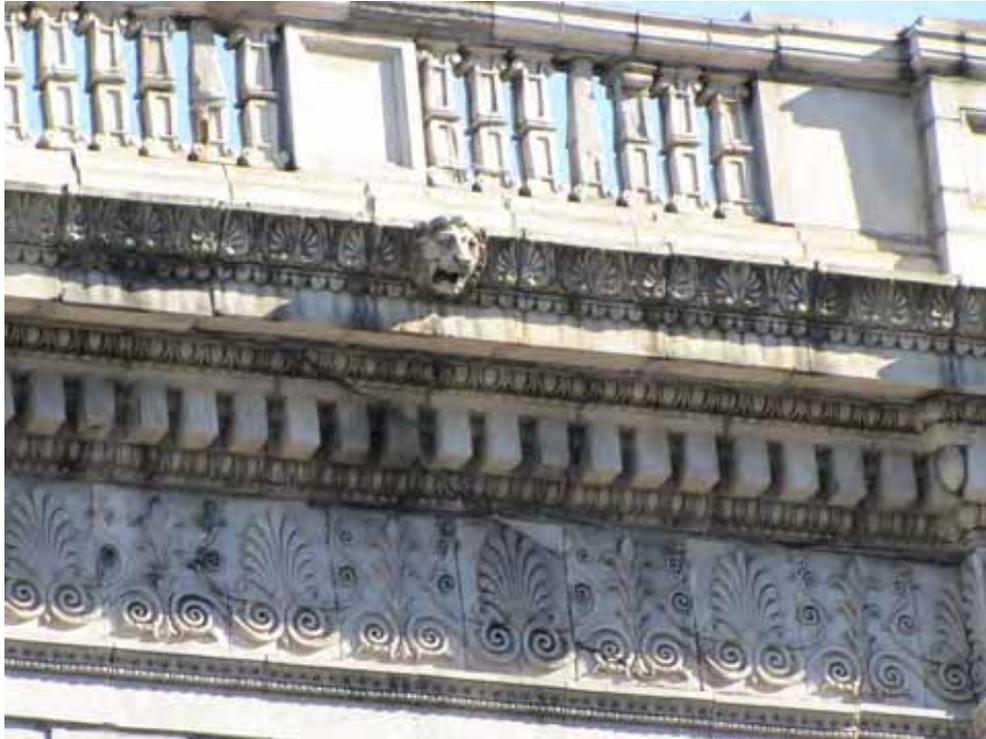
Figure: 31 Location: South Façade
Crack through multiple terra cotta units at the cornice and frieze. The crack appears to align with the steel structure behind, indicating corrosion of the steel structure. The PACA report did not identify these conditions.

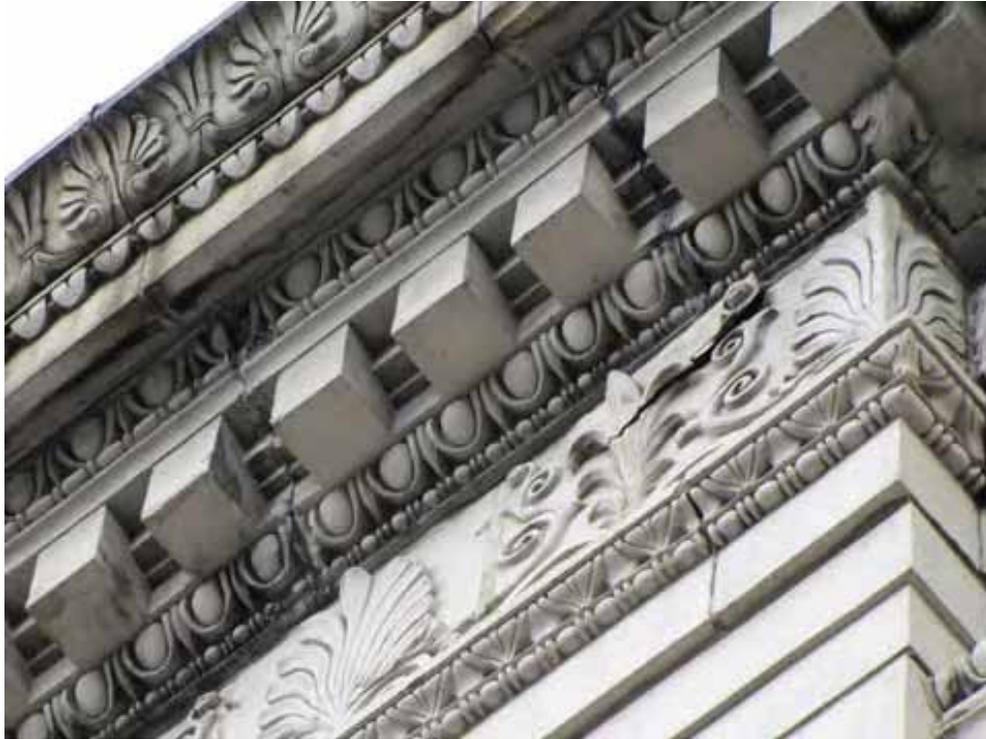
Figure: 32 Location: South Façade

Spalling terra cotta at decorative frieze below cornice. BCA also found small pieces of spalled terra cotta on the roof of the marquee. The PACA report did not identify spalling terra cotta as a condition.

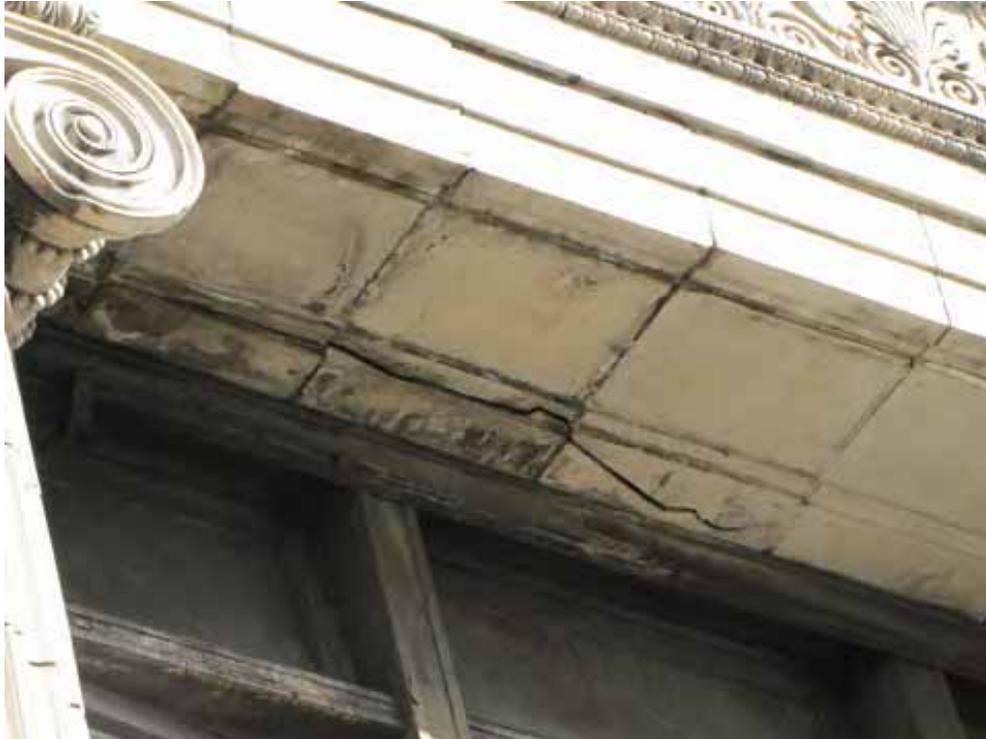
Figure: 33 Location: South Façade

Crack in terra cotta soffit above third story, east window. The PACA report did not identify this condition.

BCA Probe X3, located at the cracked soffit above the third floor, east window (Figure 33), revealed the construction of the hanging terra cotta units. The steel rods, anchors and structure exhibit corrosion.

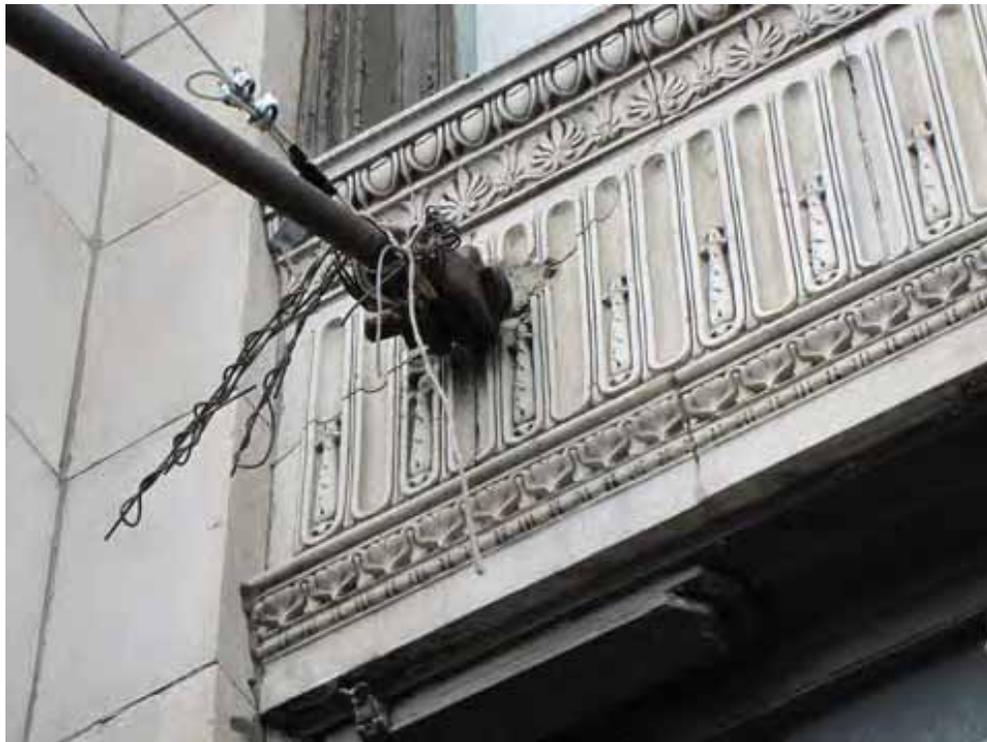
Figure: 37 Location: South Façade
Cracks and previous patching material at non-original marquee anchor. The PACA report noted that cracking was typical at marquee anchors.

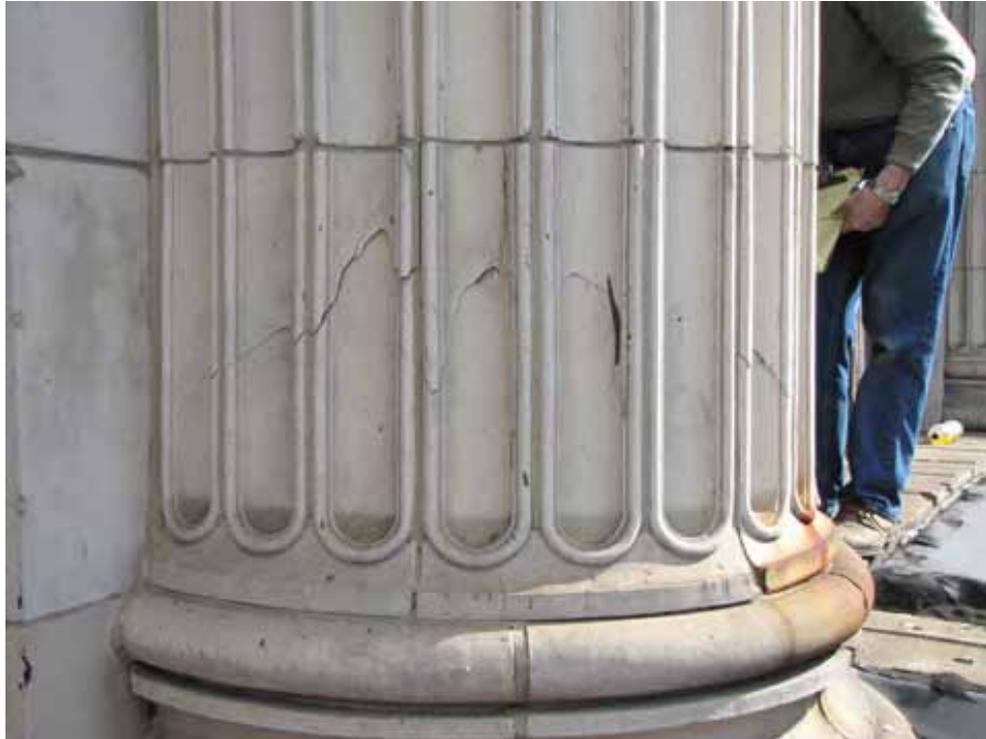
Figure: 39 Location: South Façade

Cracking and spalling terra cotta flutes at the west column. The PACA report identified these columns as not accessible for survey.

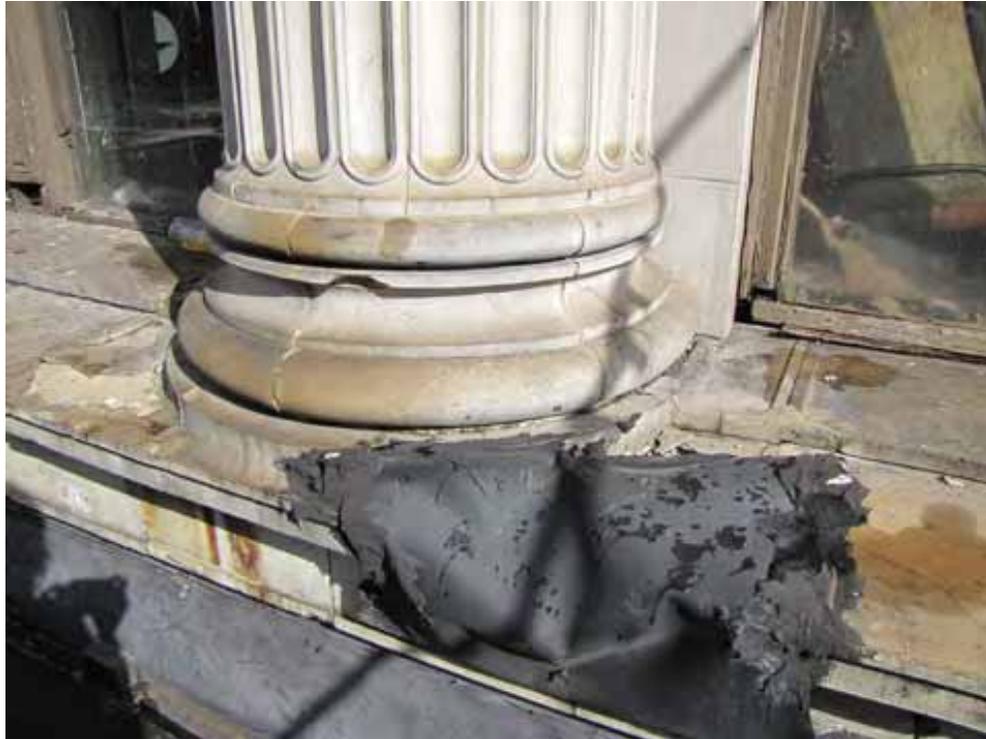
Figure: 41 **Location:** South Façade
Inappropriate and failed water protection at terra cotta sills. Cracks and spalls are typical at sills and bases of columns. The PACA report identified the columns as not accessible for survey.

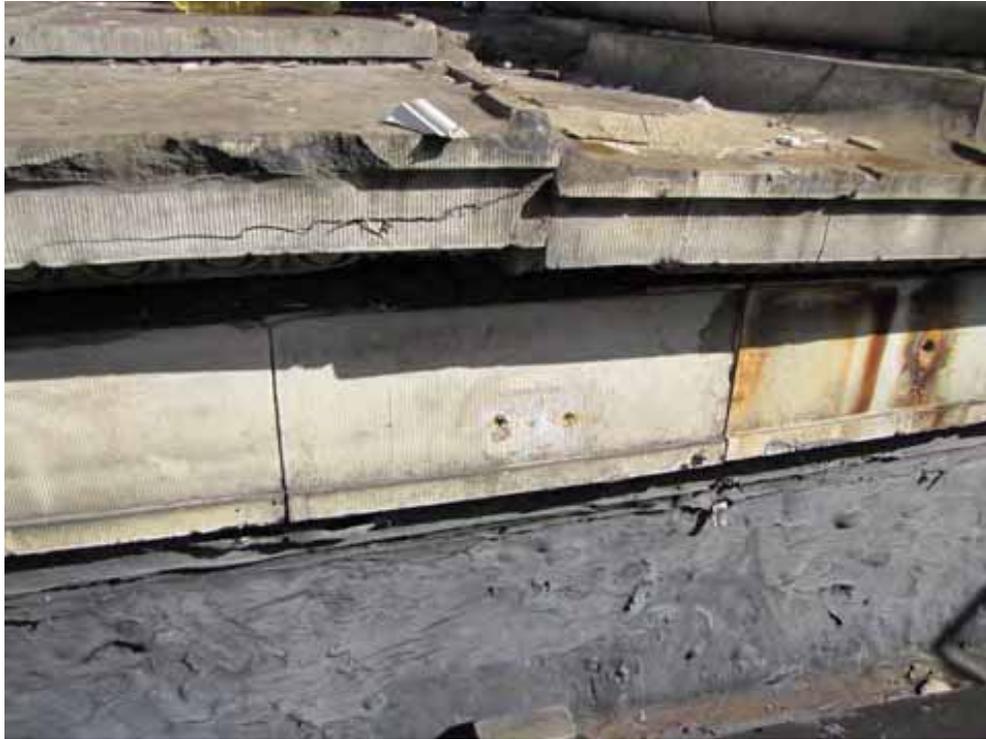
Figure: 42 Location: South Façade
The terra cotta sills are lifting, cracking, and spalling. The PACA report did not identify these conditions.

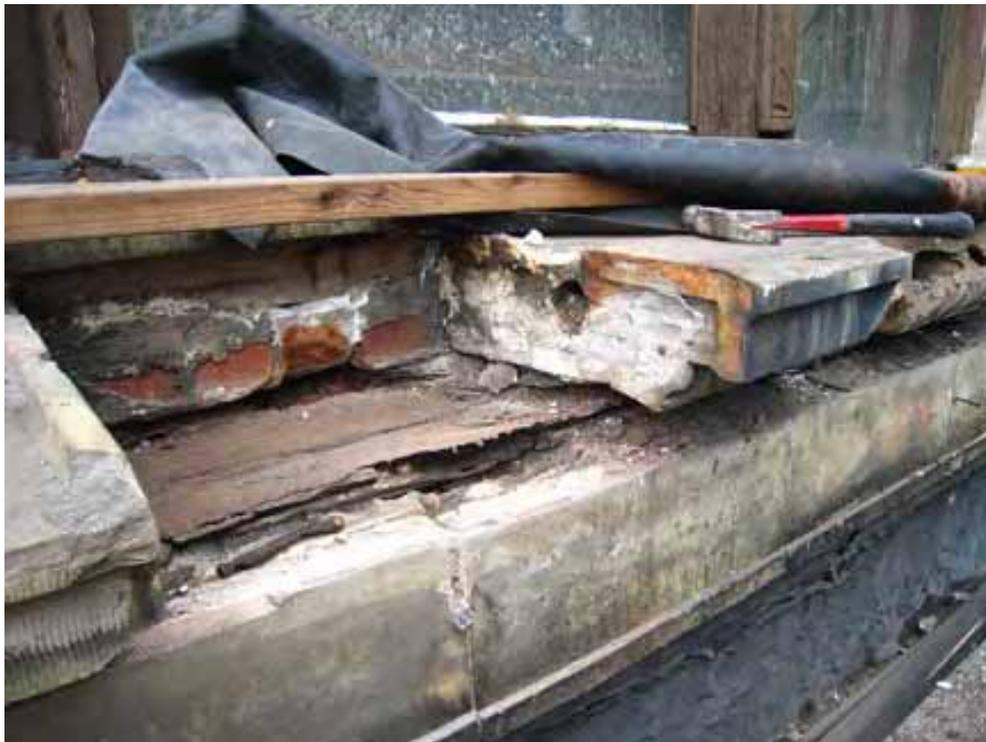
Figure: 43 Location: South Façade
BCA probe X5, located at the terra cotta sill below the center window, revealed severely corroded/missing steel rods and structure. Note the loss of section at the flanges of the spandrel beam below the removed terra cotta unit.

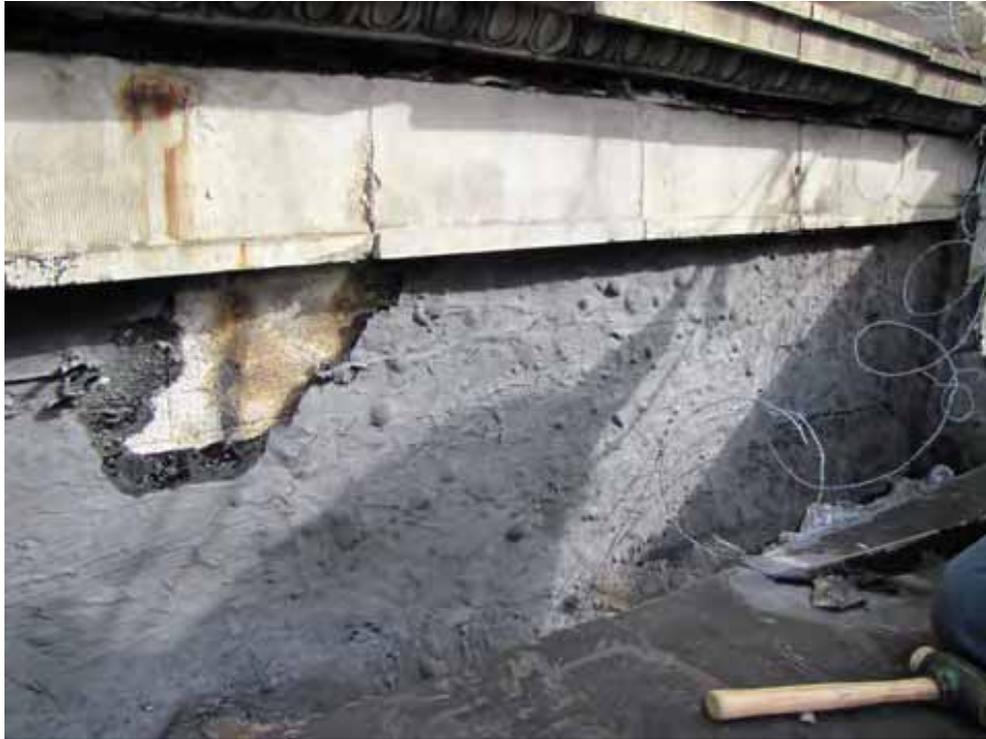
Figure: 44 **Location:** South Façade
Deteriorated waterproofing material. The PACA report did not identify this condition. Behind the failed bitumen material, BCA identified stucco with faux joints. The origin of the material is unknown.
