ALTERNATIVES ANALYSIS WITH BCA CONDITIONS ASSESSMENT UPDATE

**VICTORIA THEATER
235-237 WEST 125TH STREET
NEW YORK, NY
ALTERNATIVES ANALYSIS**

Conditions Assessment Update

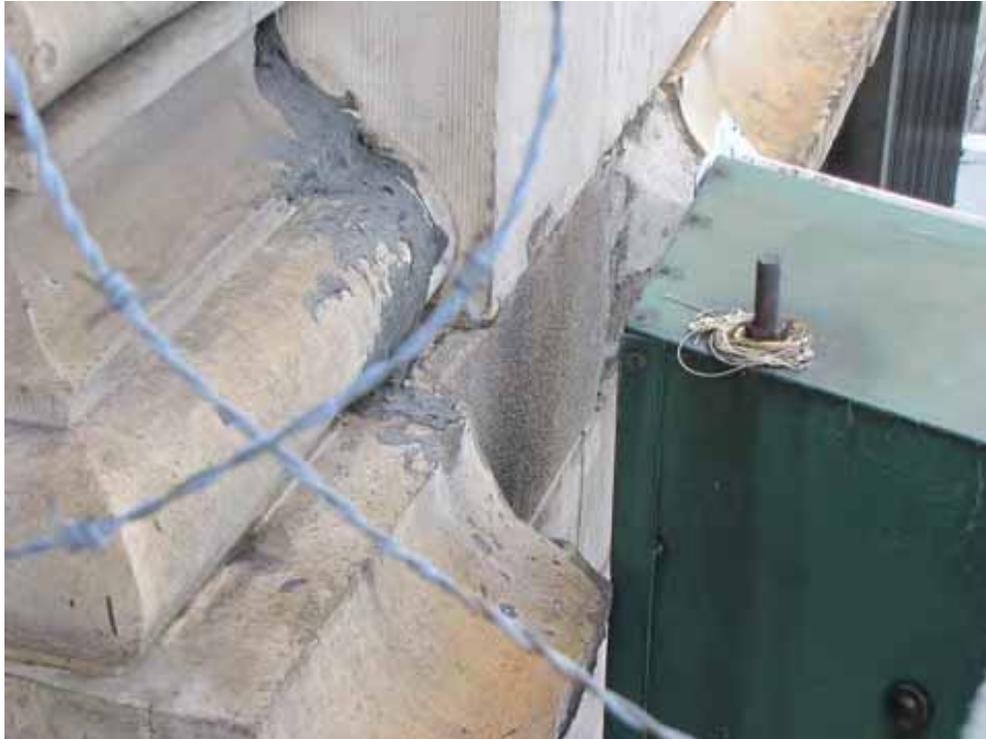
Figure: 45 **Location:** South Façade
Terra cotta units are missing near edges of marquee. These units were likely removed during marquee alterations. The PACA report did not identify these missing units.

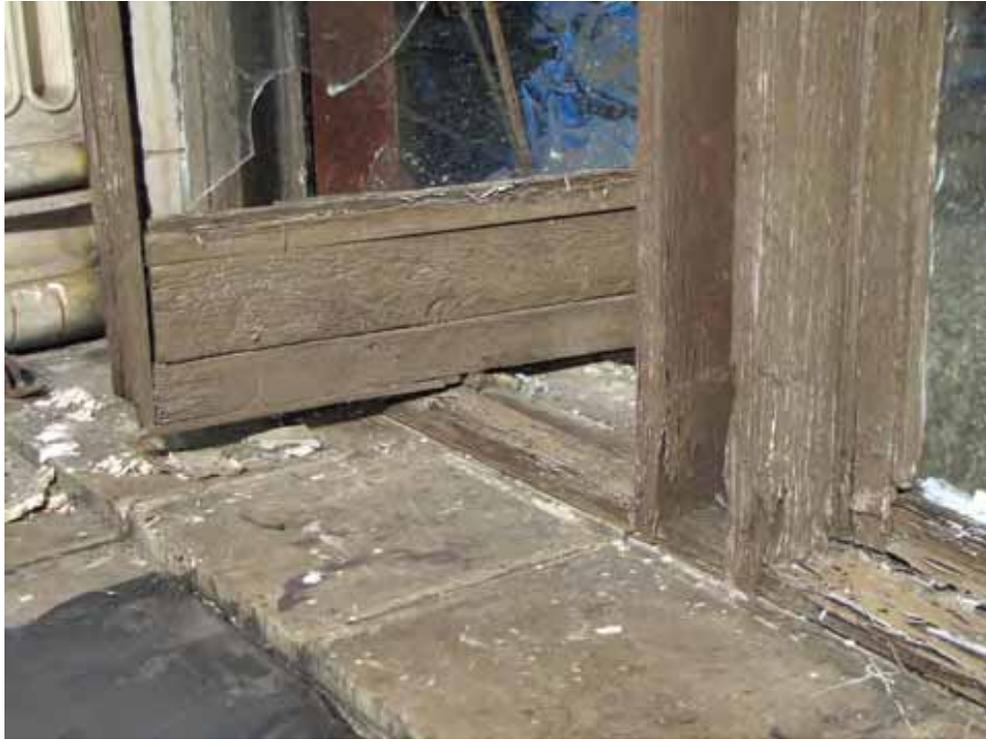
Figure: 46 **Location:** South Façade
The PACA report noted only minor damage to wood window frames. Wood windows and frames now exhibit significant deterioration. Broken glass was visible at center window.

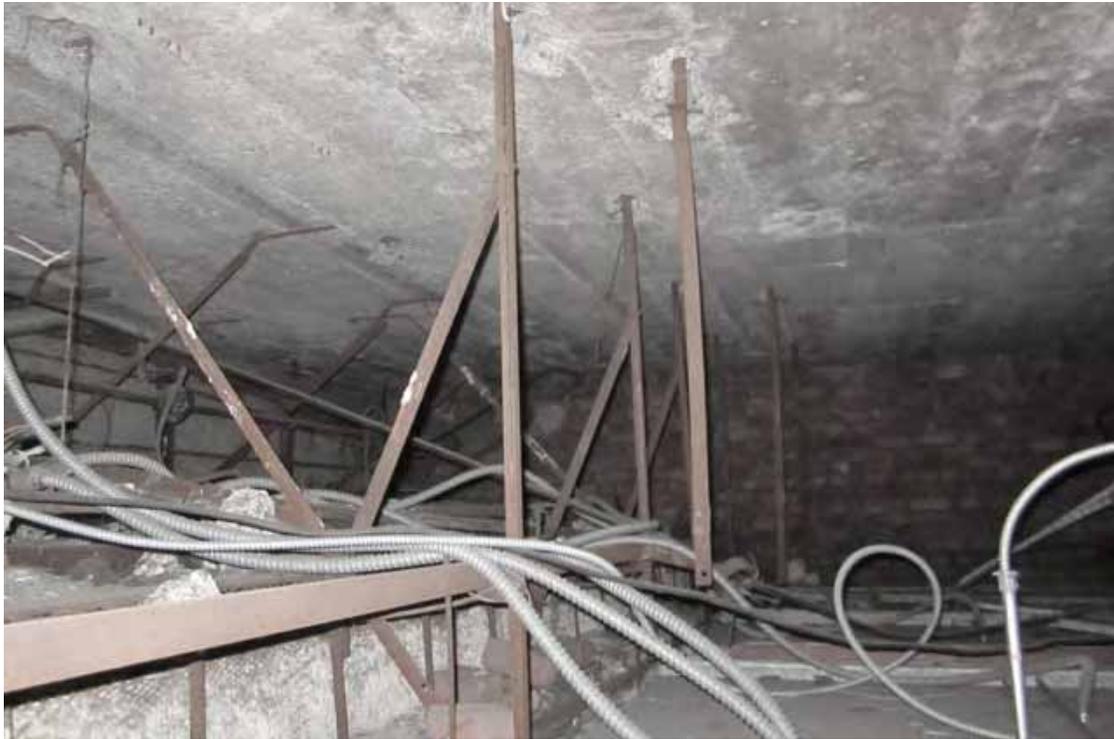
Figure: 70 Location: Lobby

BCA Probe 18 through the ceiling in the ticket booth allowed for review of the interstitial space above the lobby ceiling. The plaster ceiling in the lobby is suspended from concrete with ferrous attachments.

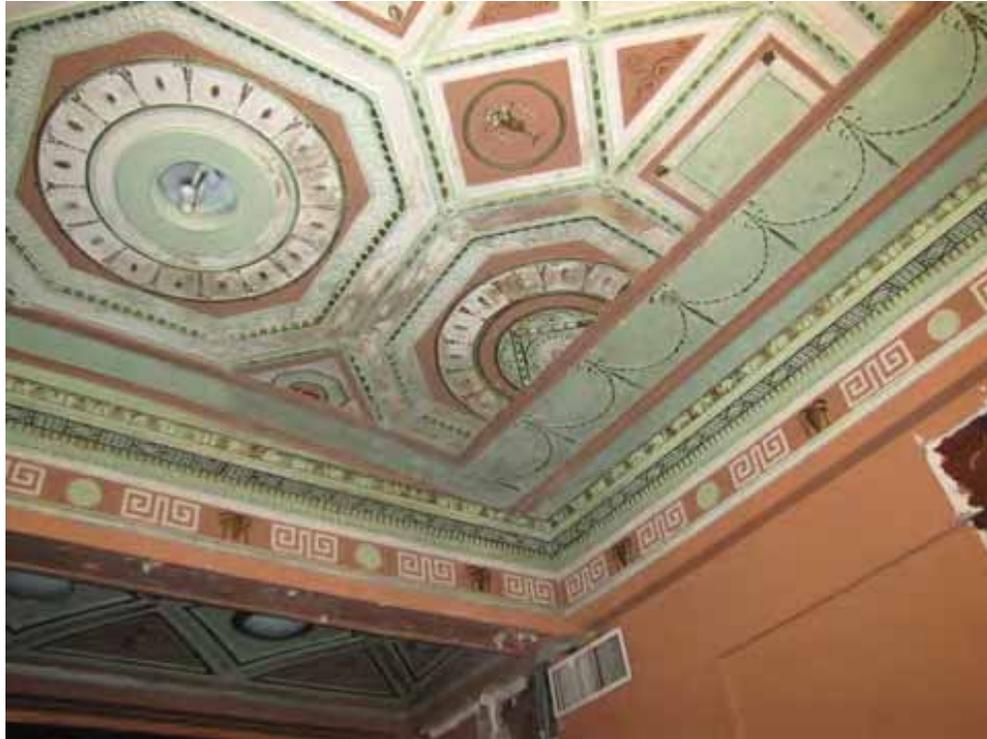
Figure: 71 Location: Lobby

Water damage is visible at northeast corner of the center lobby ceiling. The PACA report did not identify this damage.

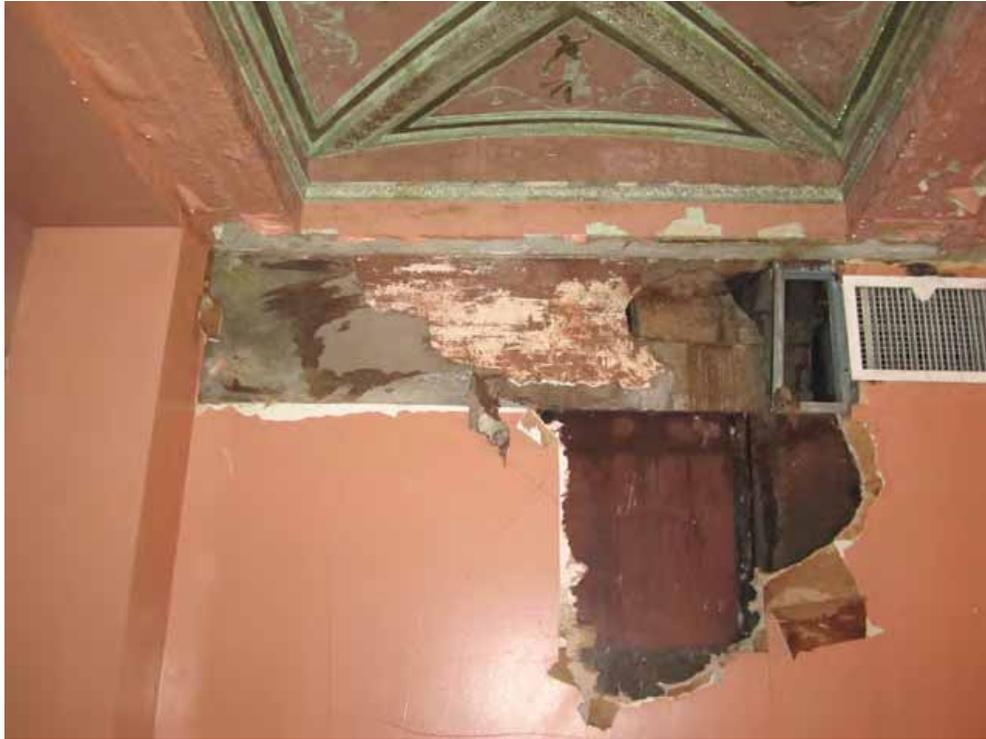
Figure: 72 Location: Lobby

Active water infiltration in the northeast corner of lobby. Gypsum board and plywood wall finishes were previously removed, exposing plaster. The plaster is saturated with water. The PACA report did not identify damage in this area.

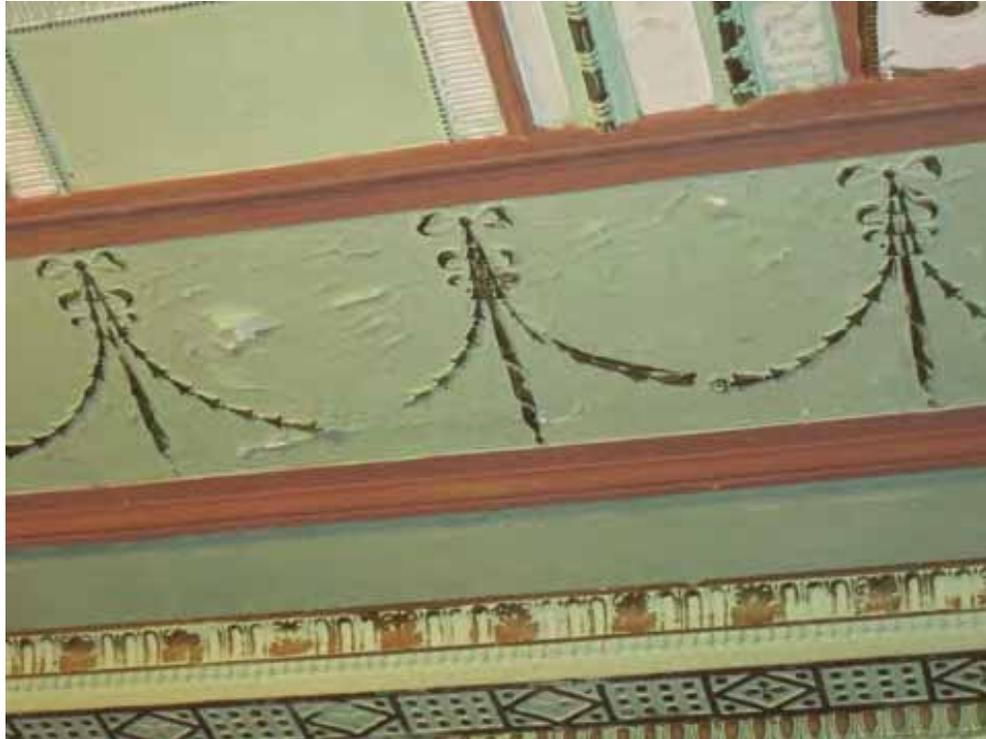
Figure: 73 Location: Lobby

Raised plaster ornament is missing and detached in isolated locations. As noted in the PACA report, paint flaking is typical at the decorative ceiling.

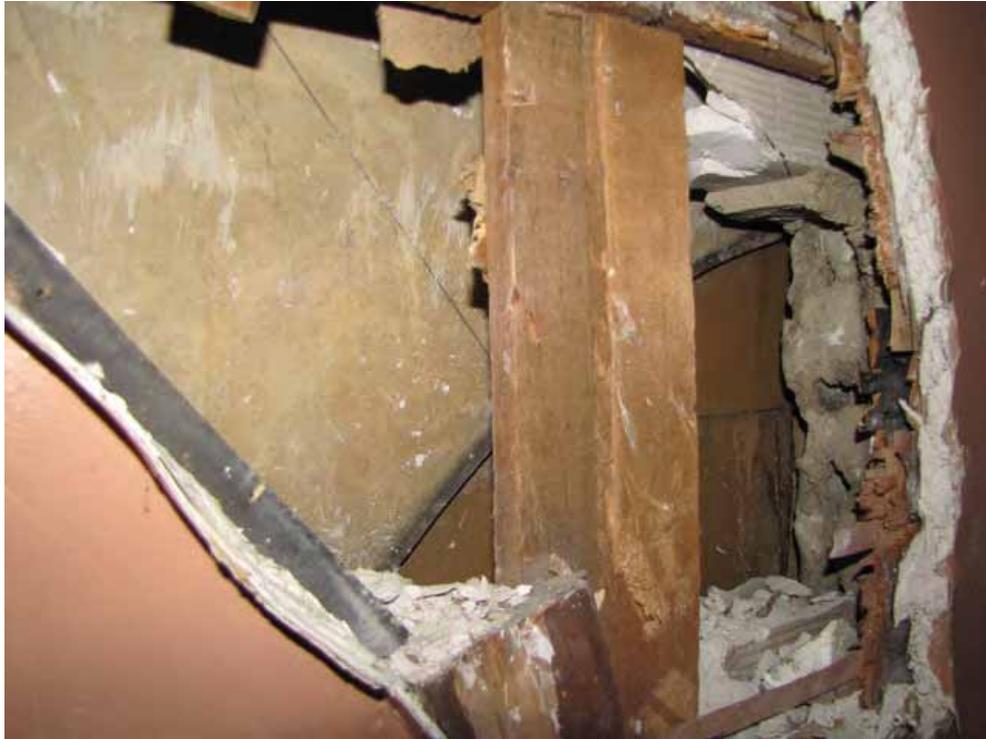
Figure: 81 Location: Lobby

BCA Probe 10D revealed the location of one of the arched mirrors originally installed on the east wall of the lobby. As noted in the PACA report, the historic marble wall cladding is still present on the east wall, behind gypsum wall board and fire block.

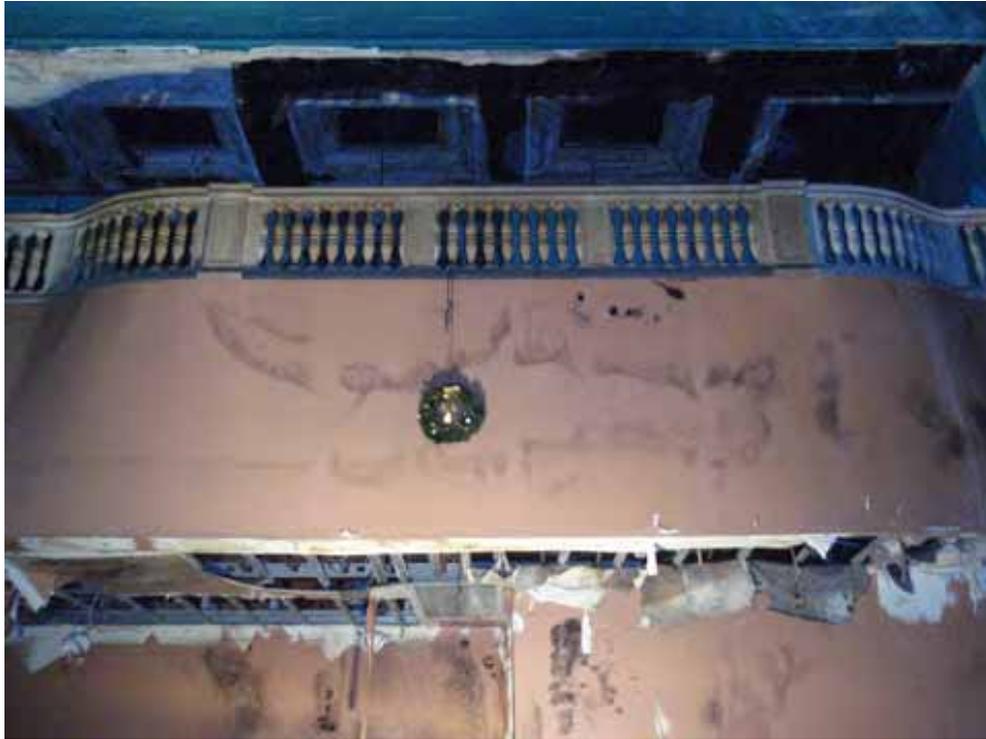
Figure: 100 Location: Foyer

The PACA report noted water infiltration at the perimeter of the room. The water damage appears to be significantly worse than during the PACA survey. The finishes above and below the balcony have fallen. Mold is visible on the walls.

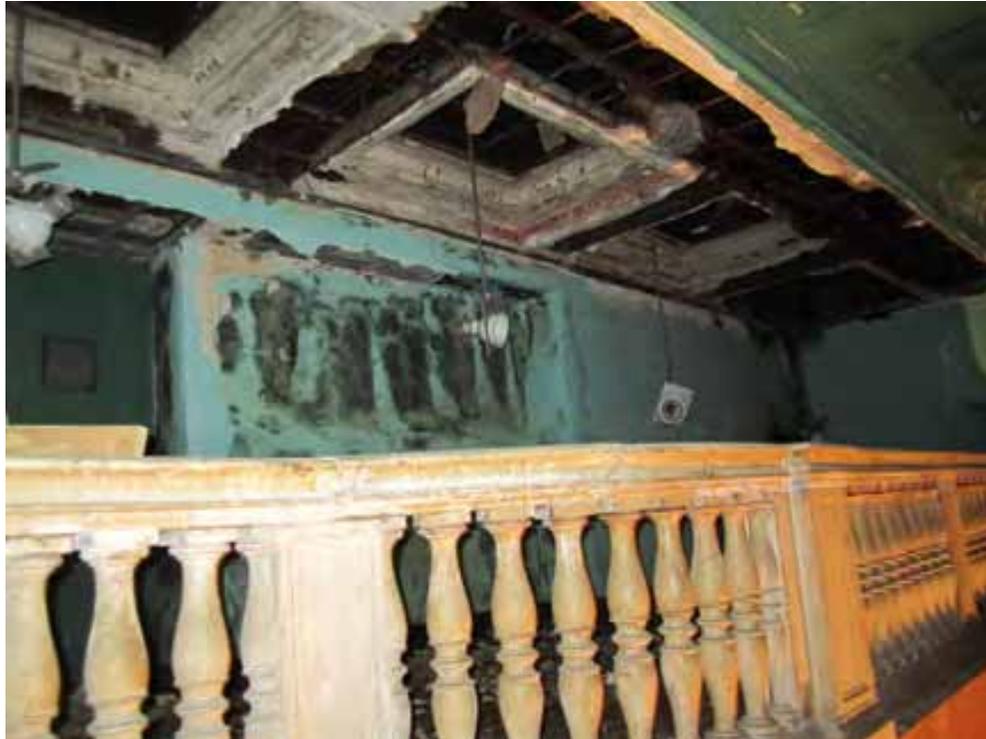
Figure: 106 Location: Foyer

Water infiltration is ongoing over the balcony, where the south building and north building connect. Historic and modern finishes at the ceiling have fallen. Mold is visible on the walls. The PACA report did not identify damage in this area.

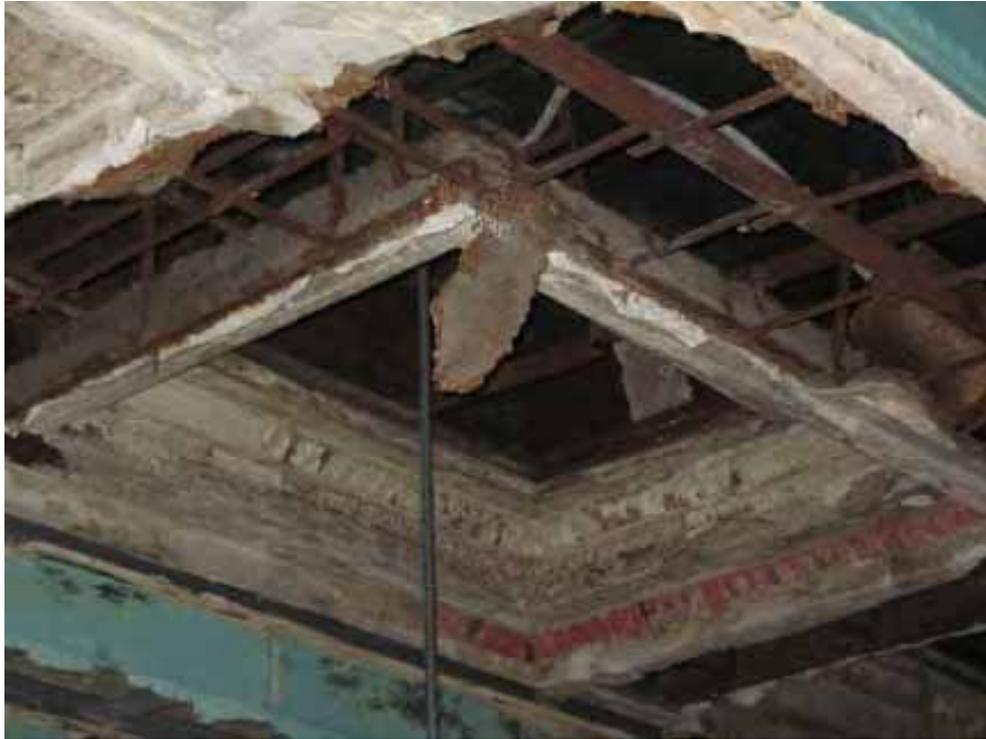
Figure: 106 Location: Foyer

Water infiltration is ongoing at the balcony. Ceiling finishes have fallen. The ferrous metal framing and expanded lath that supported the plaster coffers are corroded. Mold is visible on the walls. The PACA report did not identify damage in this area.

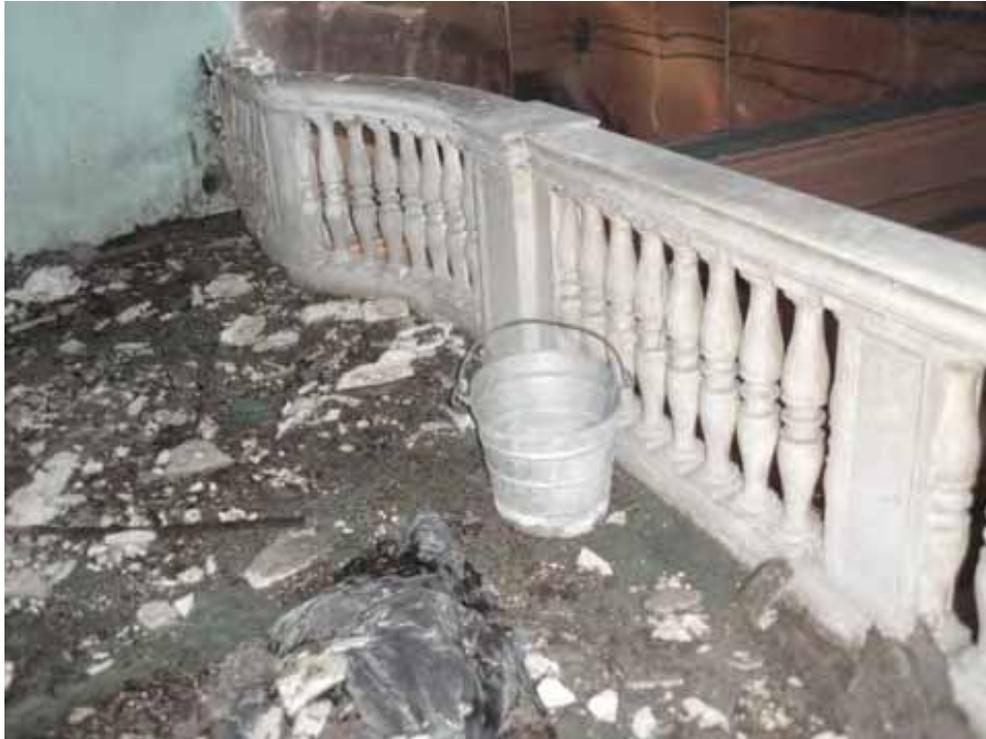
Figure: 107 Location: Foyer

Ceiling debris fallen onto balcony. The PACA report did not identify damage in this area.
