Block I 129, Lot 49

Location, Use, Zoning, and Ownership

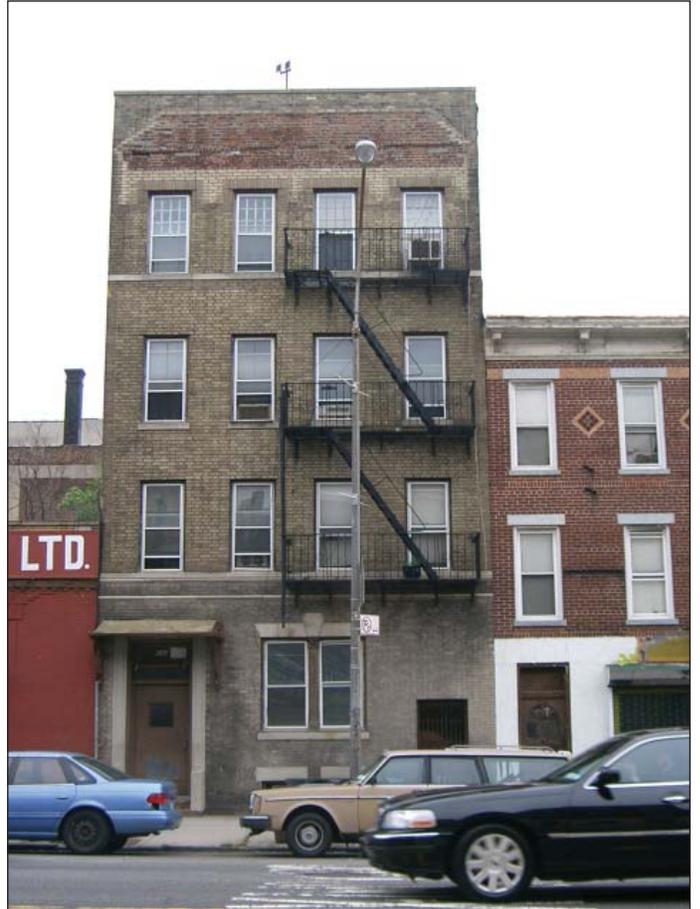
Photograph 1129-49-A

Lot 49 is located at 540 Vanderbilt Avenue between Pacific and Dean Streets. The lot is occupied by a four story 6,420 gsf multifamily residential building (see Photograph A).

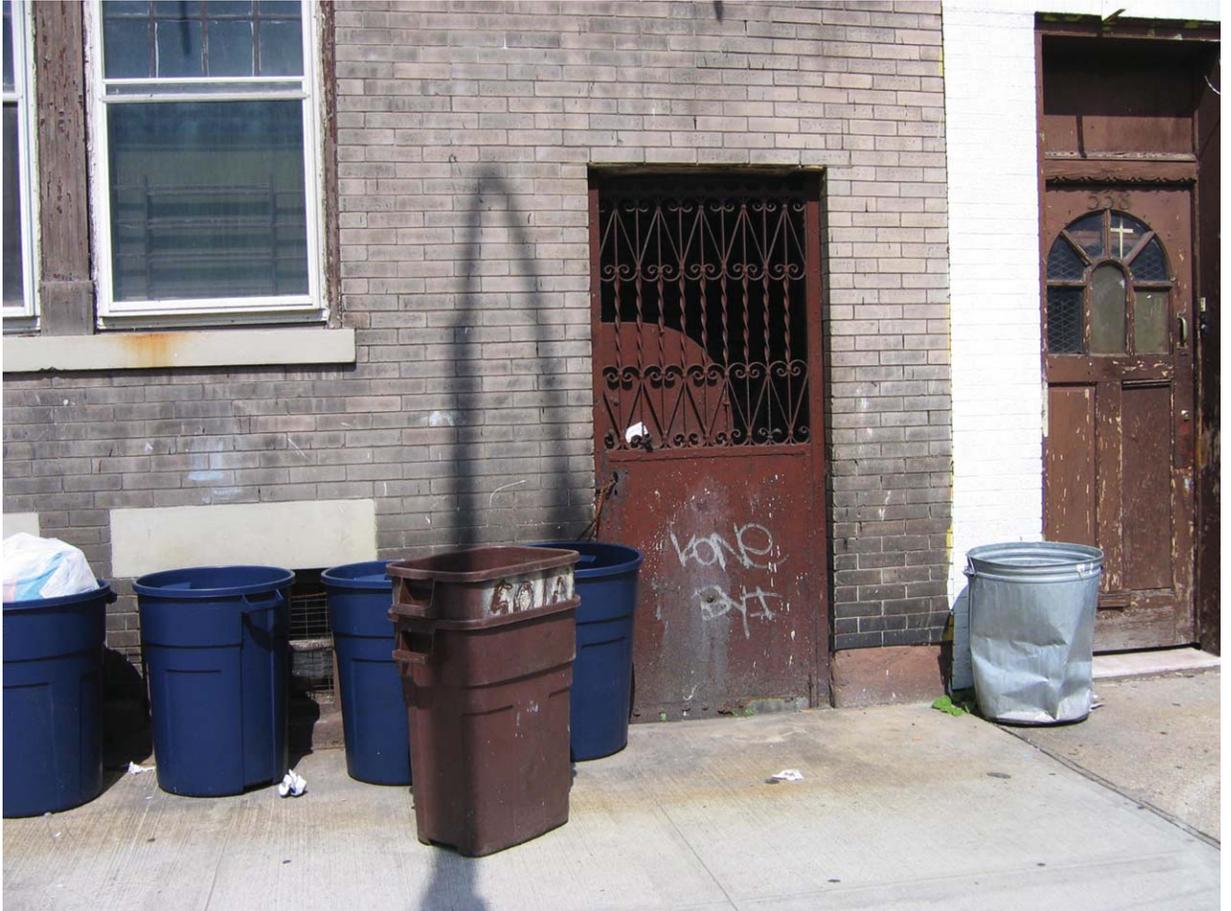
Photograph 1129-49-1

AYDC has maintained lot 49 in substantially the same condition it was in when the property was purchased in April 2005. Apart from some graffiti painted on the door of the building on lot 49 (see Photograph I), the building's exterior appears to be in fair condition. However, as shown in Photographs B through H, the building's interior is in a state of disrepair. Severe water damage is evident on several walls and ceilings. Mold is visible in many areas of the building (see Photographs C and F) and pools of moisture within portions of the walls and ceilings have caused the paint to bubble and peel (see Photographs C, D, and E). In some areas, entire layers of drywall are peeling off the walls (see Photograph B). As shown in Photograph G, paint is peeling from the ceiling surrounding the skylight in the stairwell. This is most likely a result of water leaking into the building from the rooftop. And as shown in Photograph H, graffiti has been painted on the inside of the building's front door.

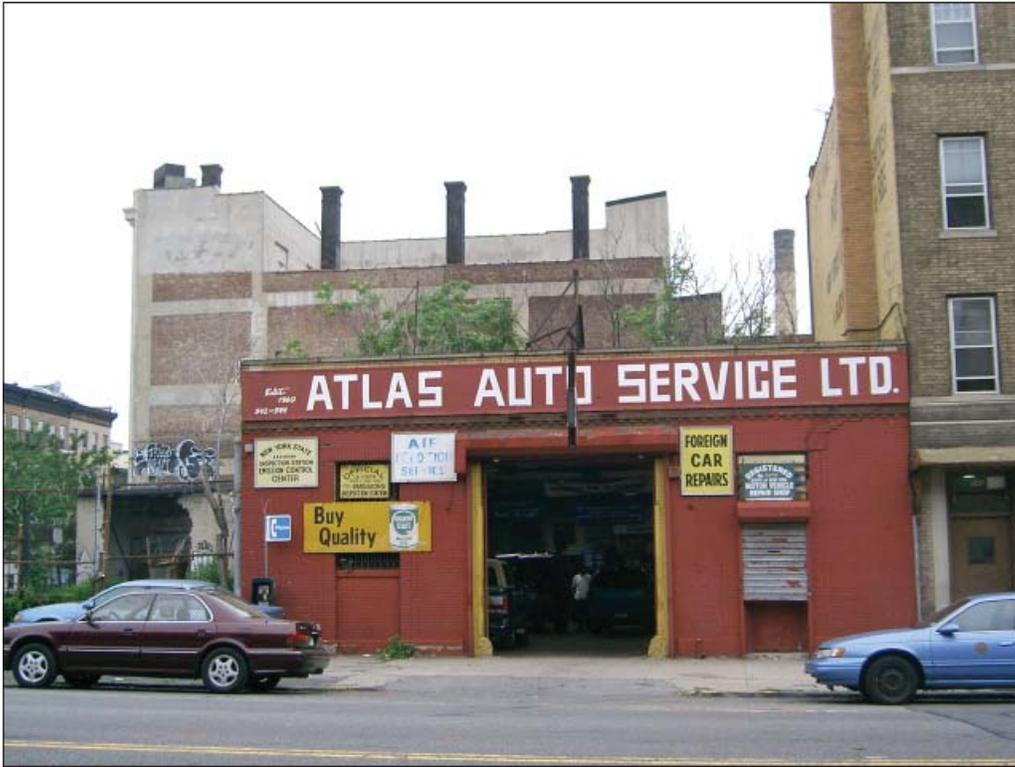
Photograph I 129-50-A

Lot 50 is located at 542 Vanderbilt Avenue between Pacific and Dean Streets. The lot is occupied by a single story 2,960 gsf industrial building currently used as an auto repair shop (see Photograph A).

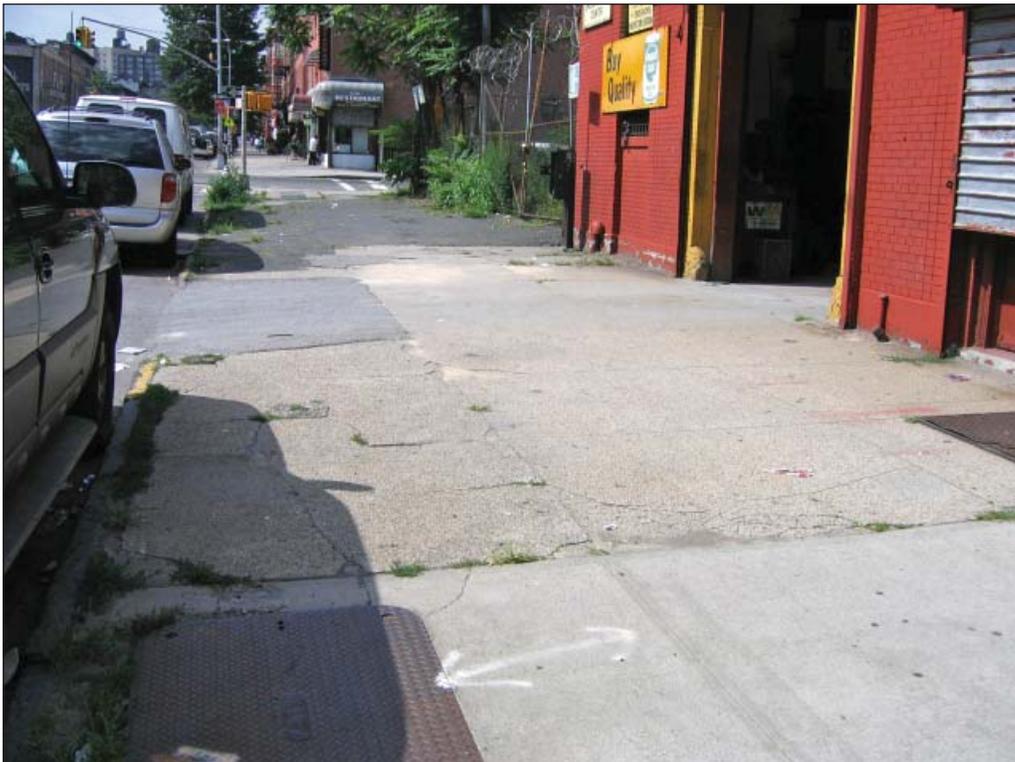
Photograph I 129-50-B

The sidewalk in front of lot 50 is cracked and uneven in places (see Photograph B) and the tin roof inside of the building has rusted to the point of disintegration in some areas (see Photograph C). No other unsanitary or unsafe conditions were identified as part of the visual assessment.

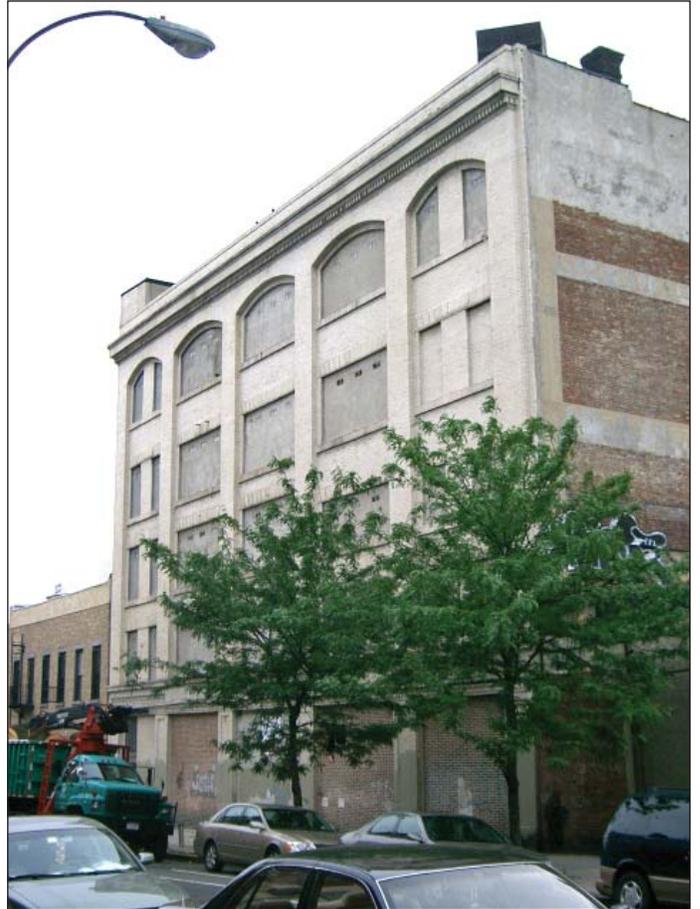
Photograph 1129-54-A

Lot 54 is located at 546 Vanderbilt Avenue at the corner of Dean Street and Vanderbilt Avenue. The western portion of the lot hosts a vacant five story 36,080 gsf industrial building (see Photograph A) and the eastern portion of the lot is vacant (see Photograph B).

The five-story building on lot 54 also appears to be in poor condition. All of the windows have been permanently sealed (see Photograph A) and some of the brickwork on the façade above the Dean Street entryway is missing, exposing the support beams beneath (see Photograph I). The metal door to the building is rusted and there is crumbling concrete below the door. Just east of the doorway is a filled entrance with concrete steps that are chipped and broken. Inside, there is paint flaking off of many of the walls and ceilings, and small cracks run across many of the walls (see Photographs J through L).

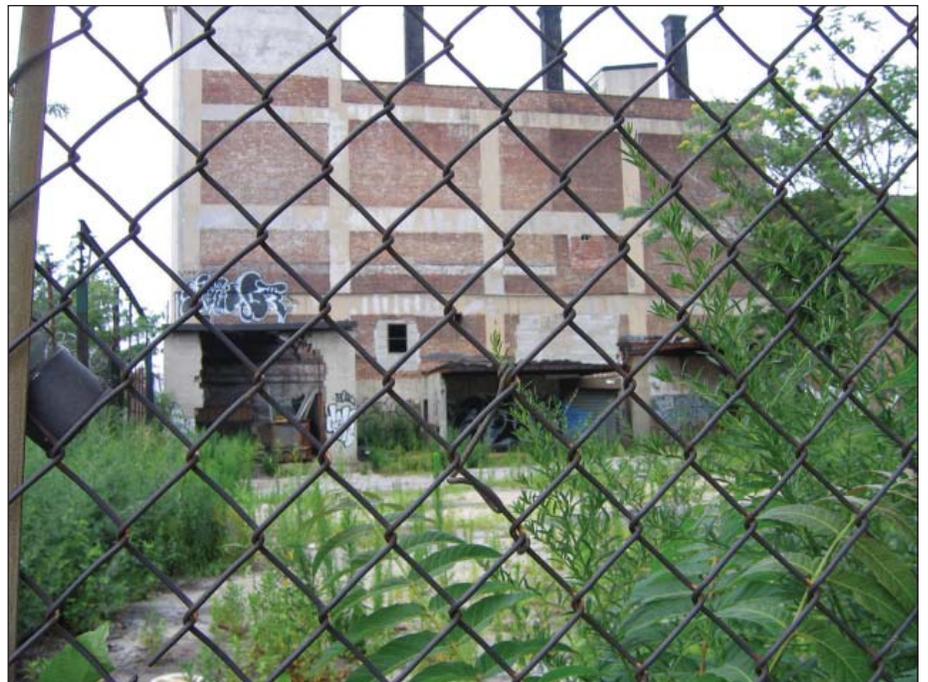
Photograph 1129-54-B

Graffiti covers many of the surfaces on lot 54, including the façades of the five-story building, the dilapidated structures adjacent to the main building, and the wall of the building on adjacent lot 50 (see Photographs B, F, G, and H), which faces in onto the empty portion of lot 54.

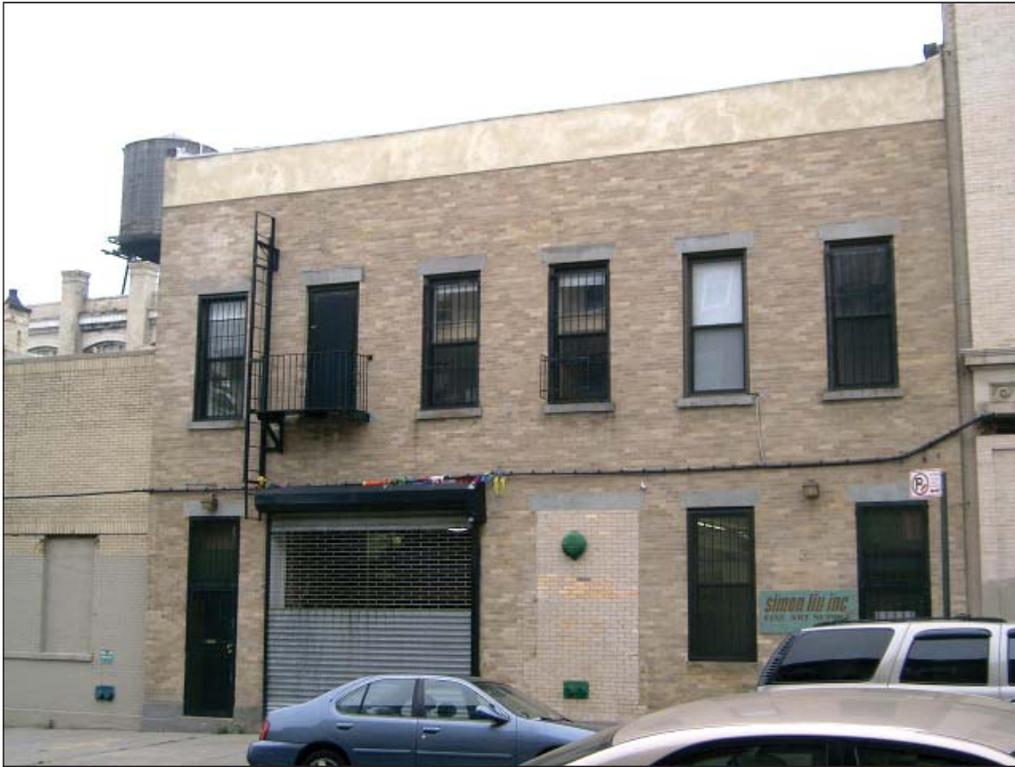
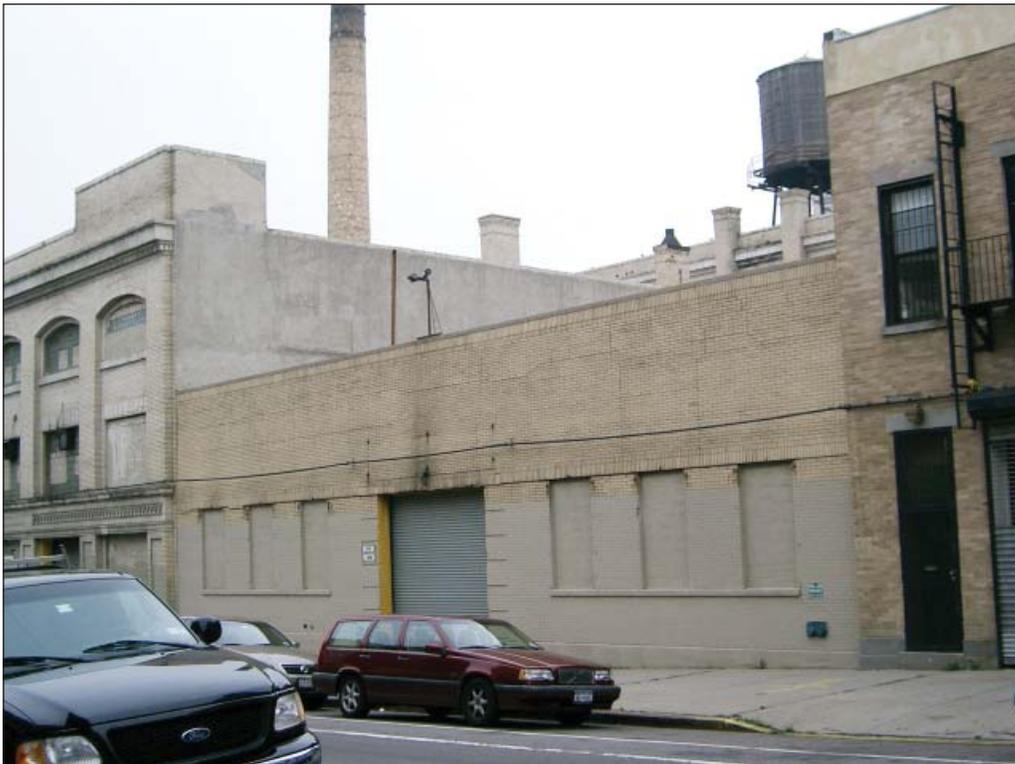
Lot 62 is located at 645 Dean Street between Vanderbilt and Carlton Avenues. The lot hosts a two-story 8,800 gsf industrial building (see Photographs A and B). Lot 62 is located in an M1-1 zoning district. M1 districts allow high-performance light manufacturing uses and often serve as buffers to adjacent residential or commercial districts. According to the New York City Department of Finance, lot 62 is owned by Goldberg Liu Realty Inc. The property is currently under contract by AYDC. The closing is anticipated to take place in August 2006.

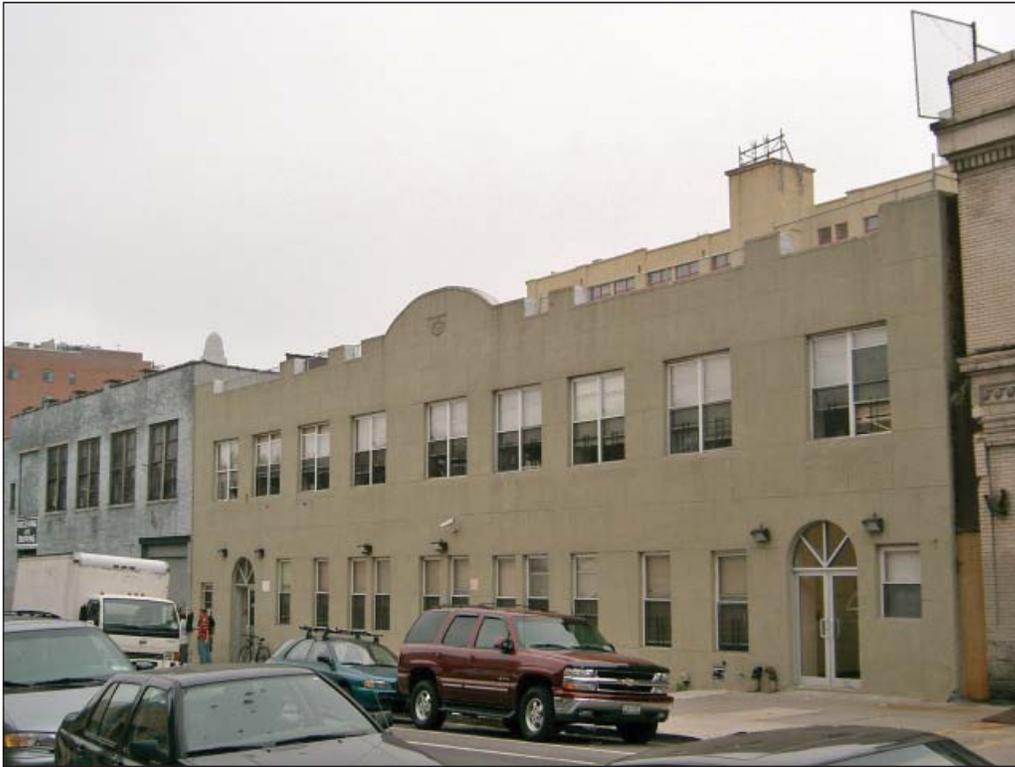
Photograph I 129-76-A

Lot 76 is located at 603 Dean Street between Carlton and Vanderbilt Avenues. The lot is occupied by a two story 22,000 gsf building that is currently used, along with the building on adjacent lot 21, to provide temporary housing for homeless families (see Photograph A). Lot 76 is located in an M1-1 zoning district with an FAR of 1.0. M1 districts allow high-performance light manufacturing uses and often serve as buffers to adjacent residential or commercial districts. According to the New York City Department of Finance, lot 76 is owned by G.B.S. Associates.

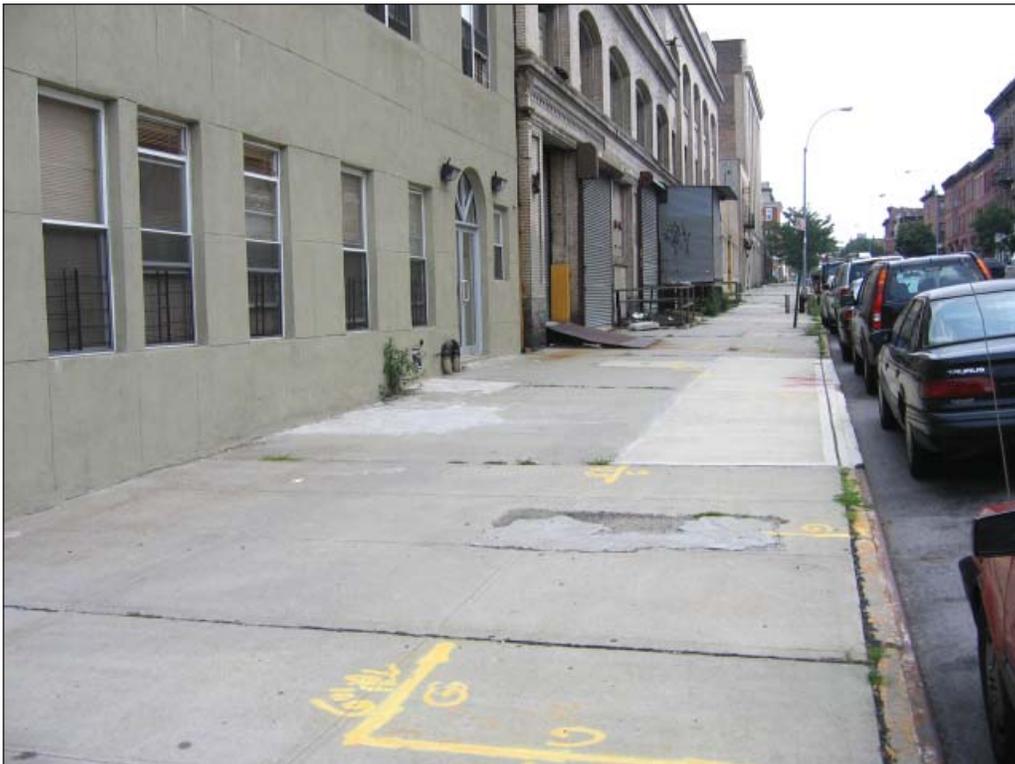
Photograph I 129-76-B

Apart from some minor cracks and poorly patched holes in the sidewalk in front of lot 76 (See Photograph B), no unsanitary or unsafe conditions were identified as part of the visual assessment.

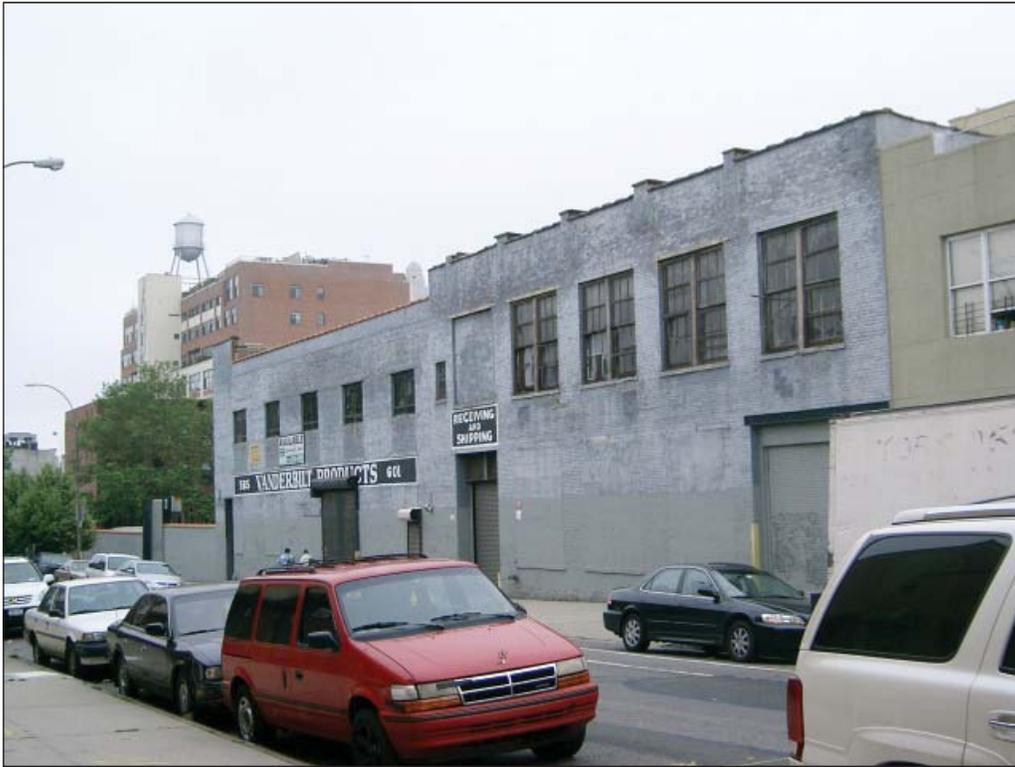
Photograph I 129-81-A

Lot 81 is located at 585-601 Dean Street, between Carlton and Vanderbilt Avenues. Until Spring 2006, the lot hosted a vacant two story 30,070 gsf building (see Photograph A). The building was demolished by AYDC with approval from ESDC because of its dangerously deteriorated condition as described below.

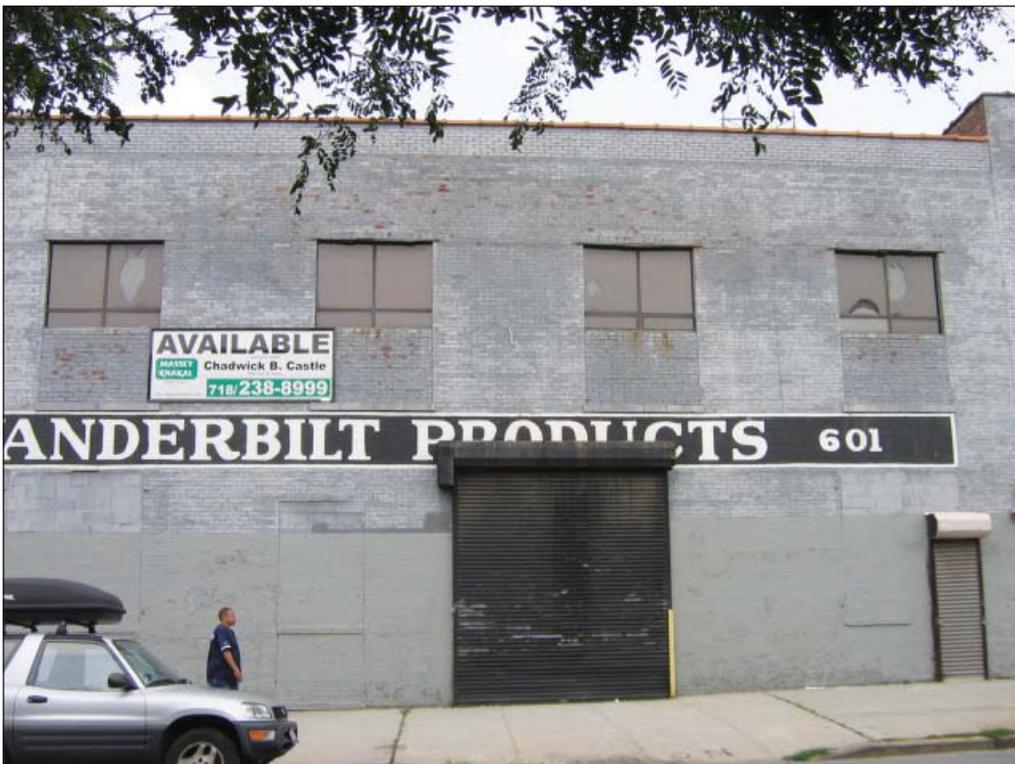
Photograph I 129-81-B

As indicated above, the building on lot 81 was demolished in Spring 2006. As shown in Photograph B, the paint on the façade of the building on lot 81 was flaking off and several windows were cracked or broken. Apart from those conditions, the building's exterior appeared to be in fair condition. However, the building's interior was in a state of severe disrepair. The building was littered with debris including broken office furniture and home furniture parts, old mattresses, empty boxes, and plastic bags filled with garbage (see Photograph C). Water damage was evident throughout the building—particularly on the walls and ceilings (see Photographs D and E). Along the walls, water damage had eroded some of the brick and concrete and water damage on the concrete ceiling exposed the ceiling's metal supports. Exposed electrical wires could also be seen hanging from the ceiling.
