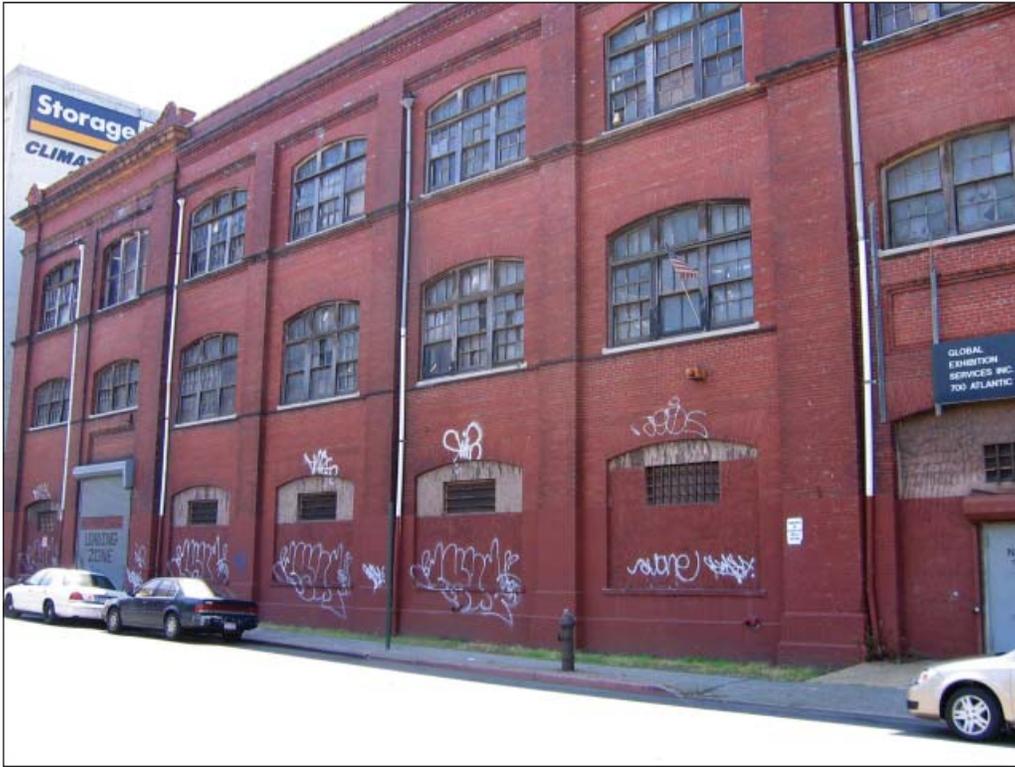
Photograph I 120-19-A

The ground floor of the building on lot 19 is painted with graffiti and some of the window panes on the second and third stories of the building are broken or missing (see Photographs A and B). Sections of the sidewalk in front of the building are cracked and chipped and portions of the sidewalk are missing (see Photograph C). In addition, some of the brick on the western portion of the building's rear façade appears to be loose and crumbling (see Photograph D).

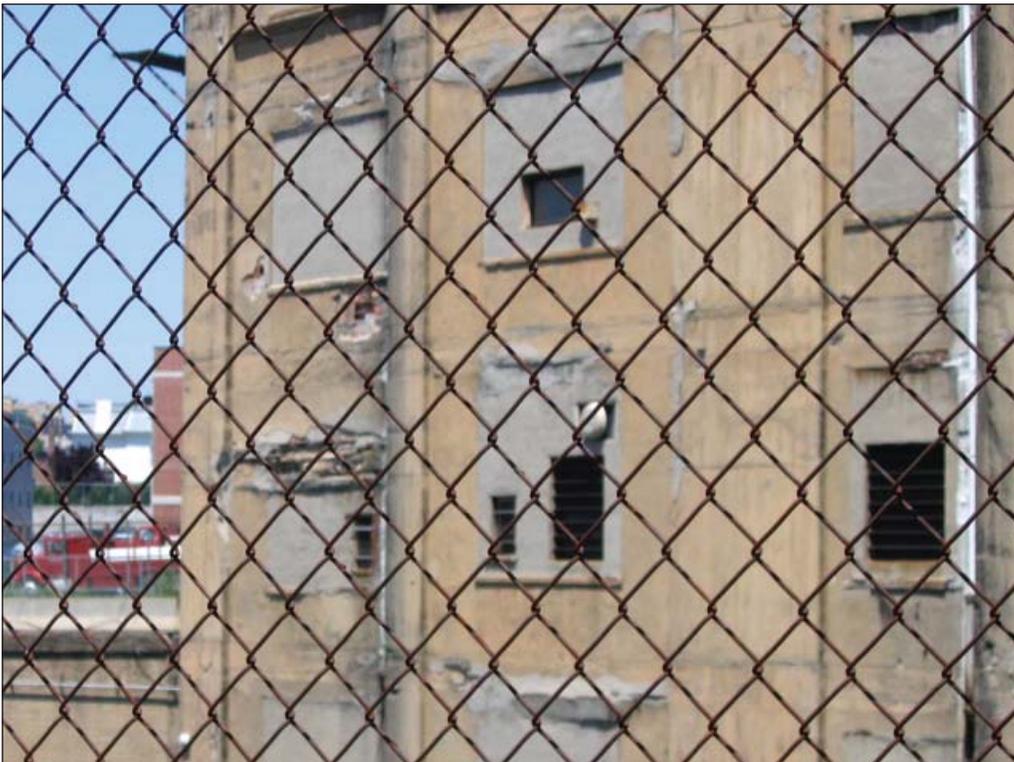
Photograph I 120-19-D

Although a structural due diligence survey has not been conducted for this lot, the loose brickwork described above may be indicative of structural damage.

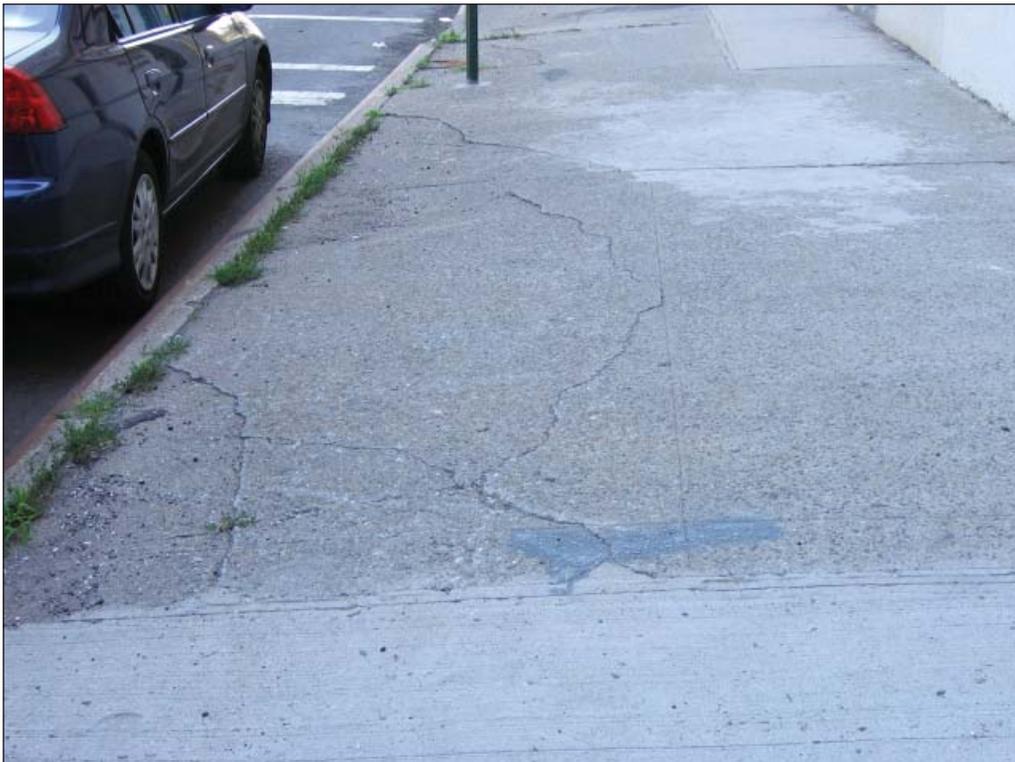
Photograph I 120-28-B

Other than some degradation in the sidewalk along lot 28 (see Photograph B), no unsanitary or unsafe conditions were identified as part of the visual assessment.

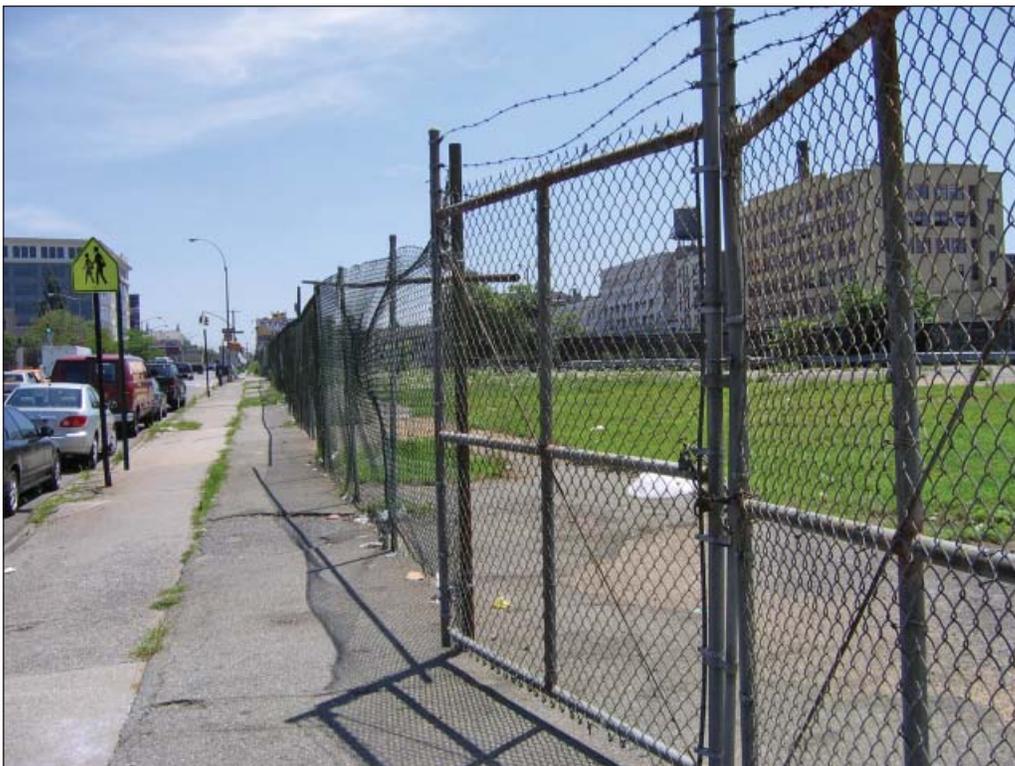
Photograph I 120-35-B

As shown in Photograph B, lot 35 is surrounded by a chain-link fence, portions of which are covered with barbed wire and sections of which are no longer standing upright. The lot itself is overgrown with weeds and the brick wall facing into the lot on the eastern portion of the lot is painted with graffiti (see Photograph C). In addition, as shown in Photographs B and D, the sidewalk along Atlantic Avenue is cracked and uneven and weeds have grown up through most of the cracks and along the curb.

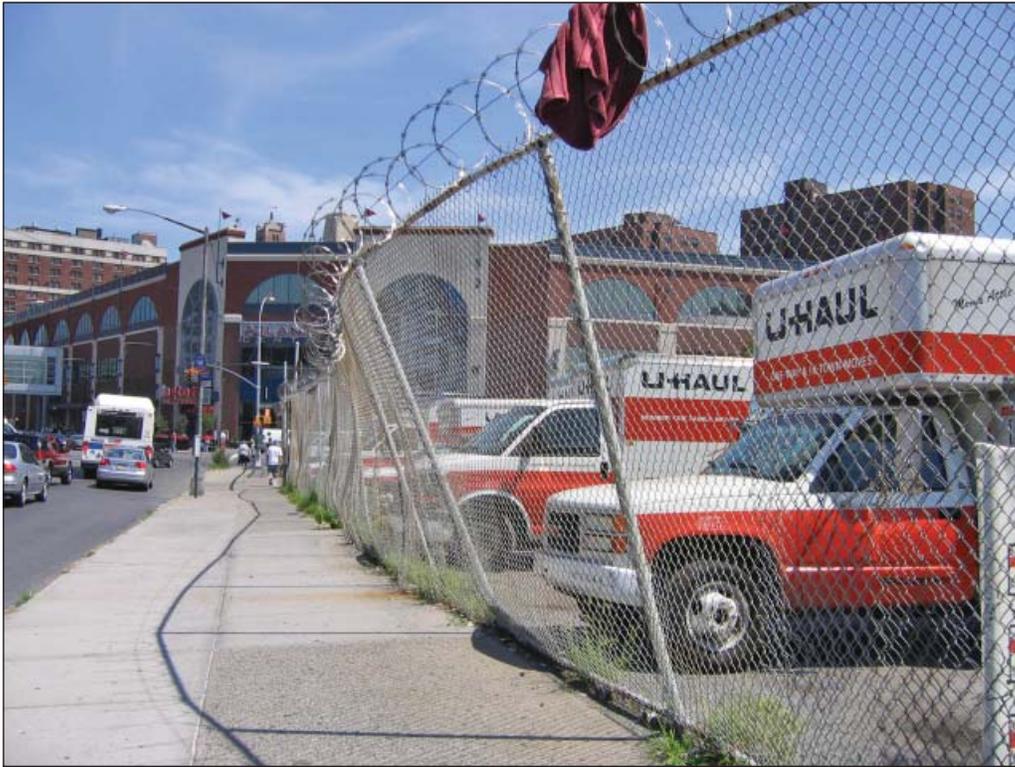
Photograph 1119-1/64-A

The fence surrounding the U-Haul facility is topped with barbed wire and leans outwards over the sidewalk in areas (see Photographs A and B), and the fence along Pacific Street is overgrown with weeds (see Photograph B). In addition, the sidewalk on the northern side of lot 1, along Atlantic Avenue is cracked and uneven (see Photograph C).
